Accident involving Airbus Helicopters EC130 B4
registered **F-GOLH**
on 24 October 2015
at Megève (74)

Time	At 11:45 ⁽¹⁾
Operator	Mont-Blanc Hélicoptère MBH
Type of flight	Commercial air transport
Persons on board	Pilot and six passengers
Consequences and damage	Two passengers injured, the pilot and four passengers slightly injured, helicopter destroyed

**Loss of control in yaw during take-off,
collision with the ground, in sightseeing flight**

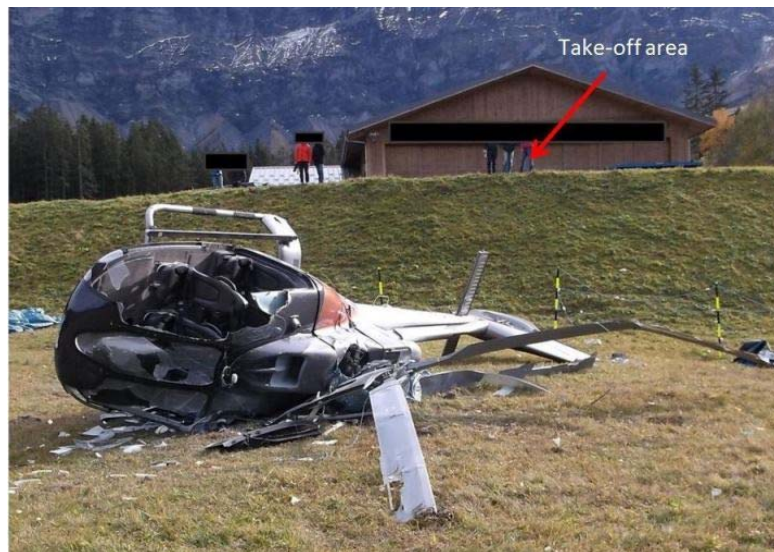
During this manoeuvre, the pilot lost the yaw control of the aircraft, which turned several times on itself before crashing below a slope adjacent to the take-off area.

The wreckage is located 25 meters to the north-north/west below the take-off area.

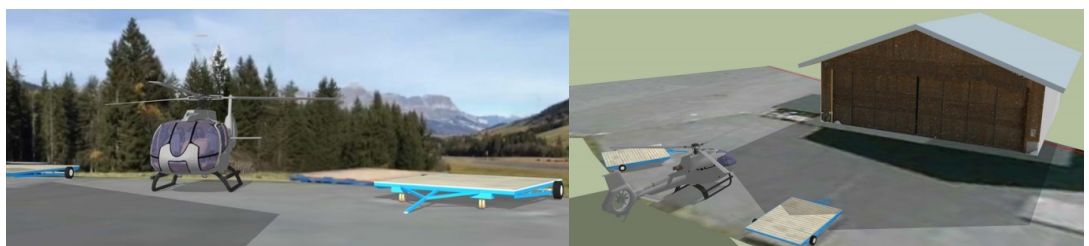
In order to be able to estimate the yaw rate from the video recording, the helicopter and its environment were modelled.

Modelling of aircraft and its environment (front and top views)

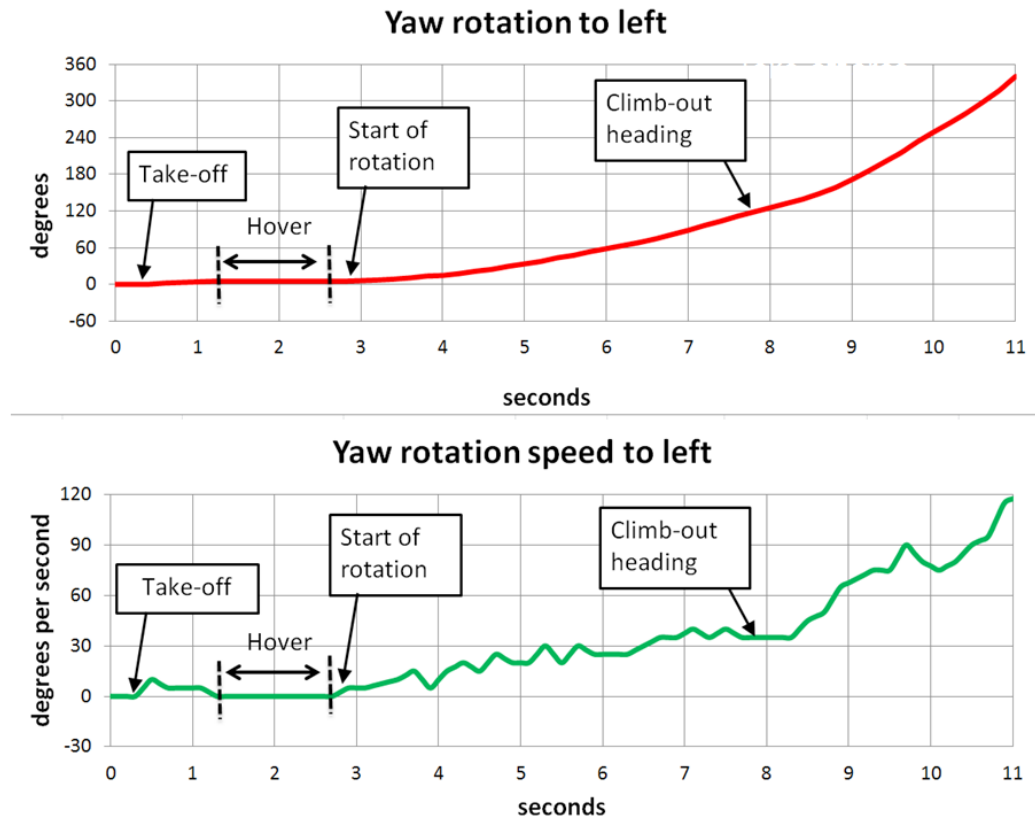
By superimposing this modelling with images extracted from the film, it was possible to precisely determine the angle of rotation of the helicopter relative to its initial position. By derivative, we deduced an approximate value of its rotation speed.

Note: Based on the recorded data, the pilot lowered the collective pitch control eight to ten seconds after take-off.

It was observed that the helicopter yaw rotation increased in speed when passing the climb-out heading.

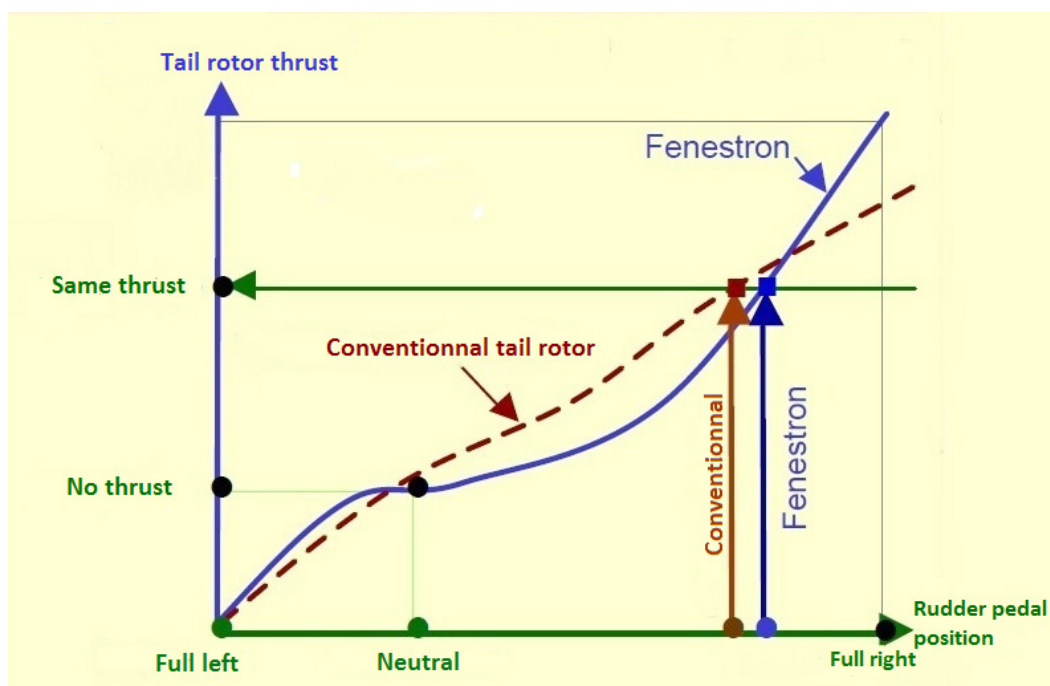
When hovering, full travel on the right rudder pedal has more effect on helicopters equipped with a fenestron than on those equipped with a conventional tail rotor.

To counteract a fast left yaw rotation with a fenestron, it is necessary to apply a sharp input to the right rudder pedal and maintain the movement until the rotation stops.

Curve of the force provided by the tail rotor according to the position of the rudder pedals
(from Airbus Helicopters documentation)
