Accident to the Cirrus SR22⁽¹⁾ registered **N19BV** on 16 May 2016 at Ailly sur Somme (Somme)

This is a courtesy translation by the BEA of the Report on the Safety Investigation. As accurate as the translation may be, the original text in French is the work of reference.

Decrease in engine power in cruise, activation of emergency parachute, collision with ground

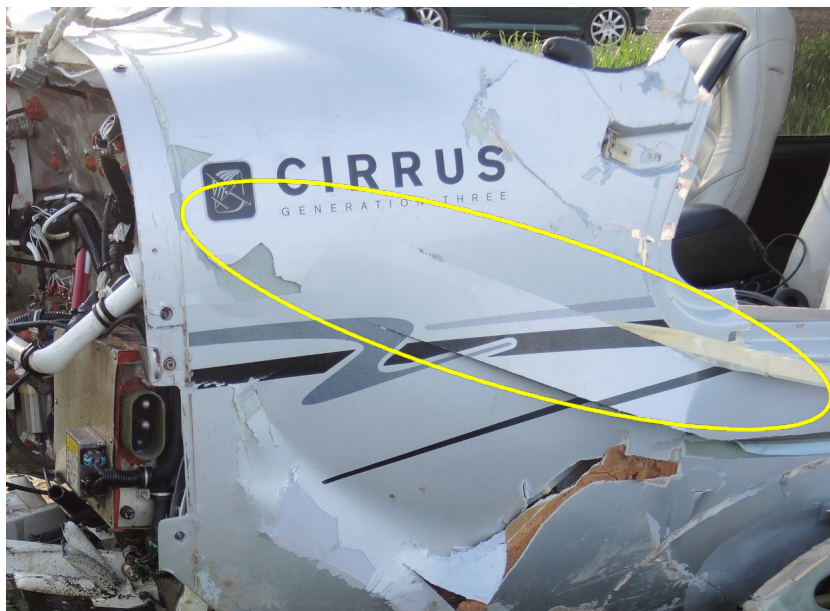
The aeroplane's emergency parachute was found deployed to the rear of the aeroplane. On a Cirrus, the first consequence of activating the emergency parachute is to slow down the aeroplane and apply a high nose-down attitude. Then, as it is deployed, the lateral straps of the parachute put the aeroplane into a level attitude. The lateral straps of the emergency parachute were found partially deployed on the left side (see Figure 1). This seems to indicate that the aeroplane had not yet recovered a level attitude on its collision with the ground.

Figure 1: lateral strap of emergency parachute on left side

During the accident flight, the activation of the emergency parachute at an estimated height of less than 300 ft compromised this manoeuvre from being carried out safely. The lateral straps of the emergency parachute were observed to be incompletely deployed on the left side, showing that the aeroplane was not yet in a level attitude on collision with the ground. The pilot knew his aeroplane well though and was aware that the emergency parachute must not be activated at a low height.

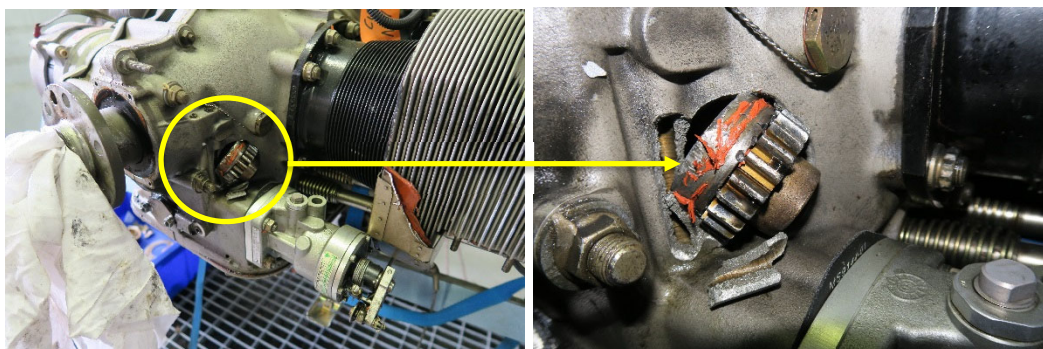
The alternator driven gear (No 4 on Figure 3), situated at the front right side of the engine was found embedded in the inner left wall of the engine housing which was pierced, also puncturing a machined oil duct in the housing (see Figure 4).

Figure 4: alternator driven gear embedded in wall of engine housing

When the alternator driven gear was thrown by the moving parts of the engine against the engine housing in which it became embedded, oil from the engine was sprayed outwards in an abundant quantity. The pilot's view through the windshield may have been substantially affected by this. The pilot controlled the deployment of the emergency parachute while the aeroplane was at an estimated height of less than 300 ft according to the recorded parameters. The investigation was not able to determine why the parachute was deployed at this height.

The abnormal loads at the mechanical coupling between the alternator driven gear and crankshaft drive gear were transmitted to the shaft which led to its fatigue fracture caused by rotating bending and then the release of part of the driven assembly which became embedded in the wall of the engine housing, puncturing an engine oil duct.

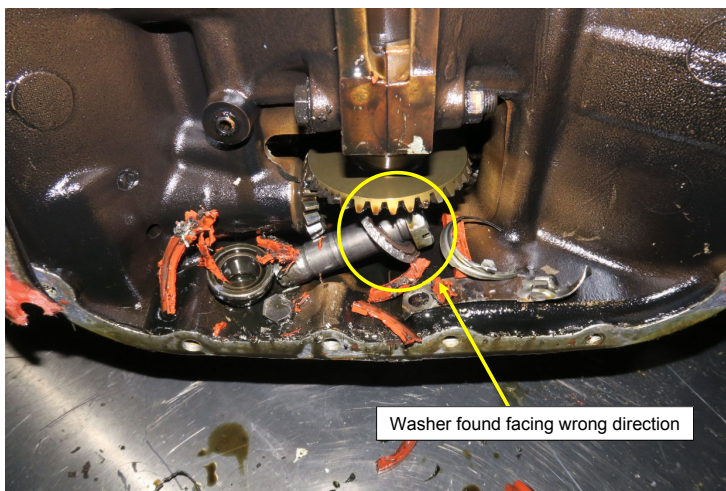
During the examination, it was found that the housing contained practically no oil. A large quantity of debris was found inside the engine housing. The thrust washer (see Figure 5 and No 3 on Figure 3) was found around the fractured alternator shaft (No 7 on Figure 3) with its copper colour face on the nut side (No 2 on Figure 3). The Continental documentation specifies that the washer must be installed with its copper colour face towards the alternator⁽⁵⁾.

Figure 5: photo taken by the BEA on opening the engine housing

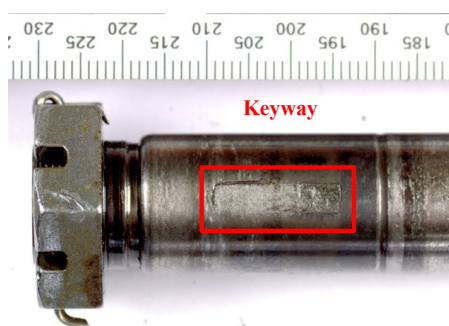
The alternator driven gear is nominally positioned on the shaft using a key. The latter was found sheared with part of it still in its keyway in the shaft. The keyway on the gear side had substantial wear.

Figure 8: Keyway on alternator shaft side

The thrust washer was found assembled in the wrong direction on the alternator shaft, with the copper face on the nut side. This copper face showed considerable wear which probably caused a loss of tightness of the assembly which led to the application of abnormal loads at the mechanical coupling between the driven gear and crankshaft drive gear. The hypothesis of a loss of tightness is corroborated by the unusual wear of the keyway.

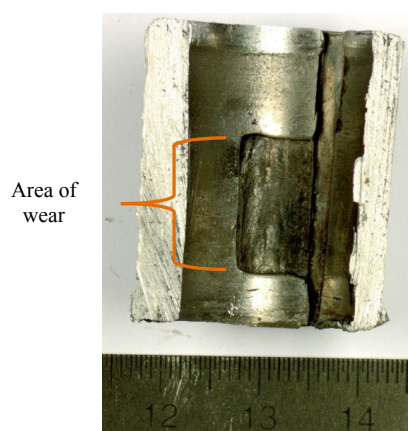
Figure 9: Section of gear inner ring with keyway

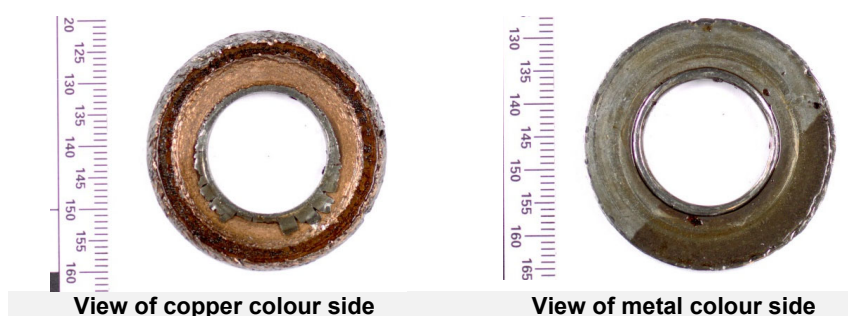
The thrust washer has a copper colour face which was heavily damaged and showed heterogeneous wear. The metal colour face on the other hand, had little damage.

Figure 10: thrust washer

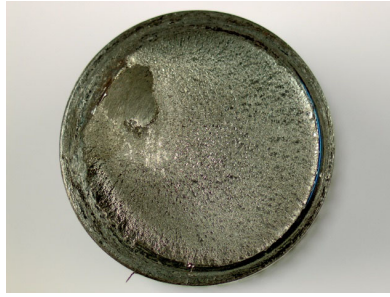
The alternator shaft was found broken into two parts, one of which was found loose in the bottom of the housing. The fractographic analysis of the fracture found the characteristics of a fatigue fracture caused by rotating bending. The characteristics of the material from which the alternator shaft was made, were checked at the BEA and were consistent with the manufacturer's specifications.

Figure 11: fracture surface of alternator shaft
