# Report

Serious incident on **24 May 2011**  
**during descent to Kuala Lumpur Airport (Malaysia)**  
**to the Dassault Falcon 7X**  
registered **HB-JFN**  
operated by **Jet Link AG**

**BEA**

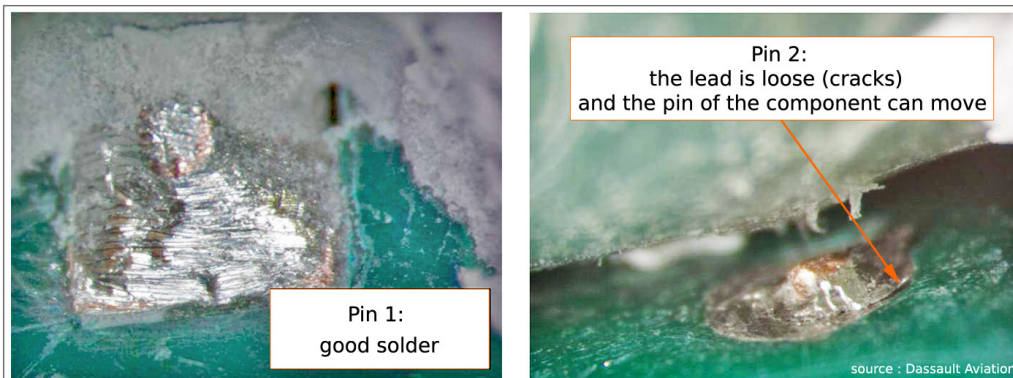
Figure 6 - solder defect on the L4 induction coil

- ❑ the impedance<sup>(9)</sup> value of component L4 was unstable, varying between the nominal value 0.5  $\Omega$  and abnormal values of up to 300 k $\Omega$  when slight pressure was applied to the component;
- ❑ one of the solders of the induction coil had cracks at the base, causing loss of the mechanical joint and the component pin could potentially move in the printed circuit board. This type of solder is called a “cold solder joint”.

The soldering defect created impedance fluctuations in component L4, causing the HSECU internal power supply to output an incorrect voltage, both in terms of absolute value and sign (+/-).

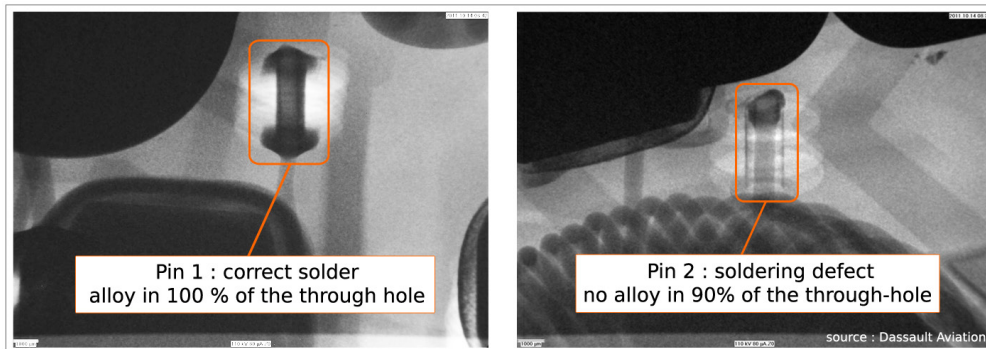
Figure 7 - X-ray of the soldering defect on the L4 induction coil

- ❑ that there was no alloy in 90% of the plated through-hole<sup>(10)</sup>;
- ❑ micro-cracks between the component and printed circuit board pin.

The presence of micro-cracks on the solder of one of the L4 induction coil pins was caused by insufficient heat during the soldering process. This was because the plated through-hole was not being properly insulated from the rest of the circuit board. Part of the soldering heat was therefore absorbed, preventing the creation of a proper solder.

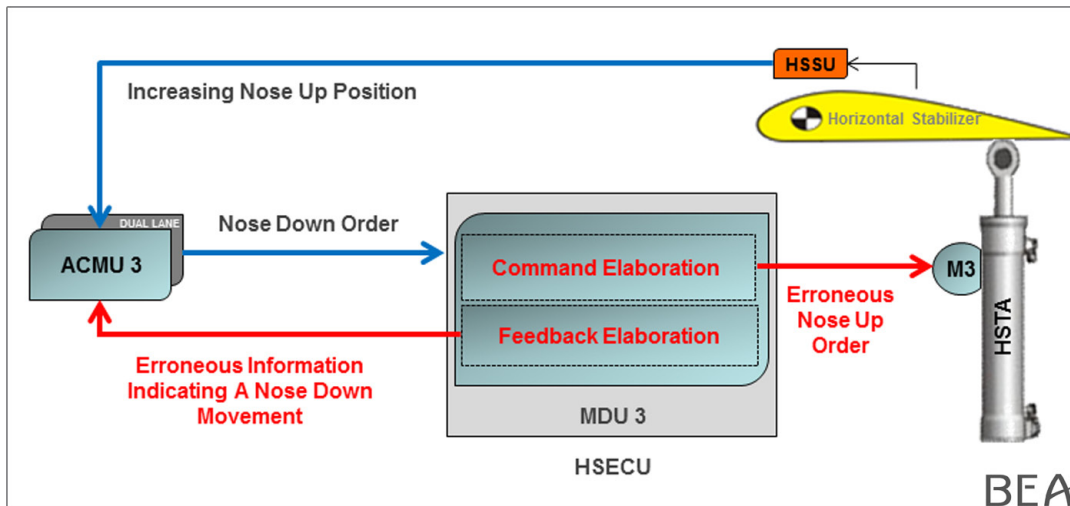
Figure 8 - Impact of the HSECU internal power supply malfunction

Due to this soldering defect, the HSECU control channel generated and transmitted a constant nose-up command to the THS motor, while sending a rotation speed signal to the ACMU that indicated a nose-down movement of the THS, as illustrated in the diagram below.

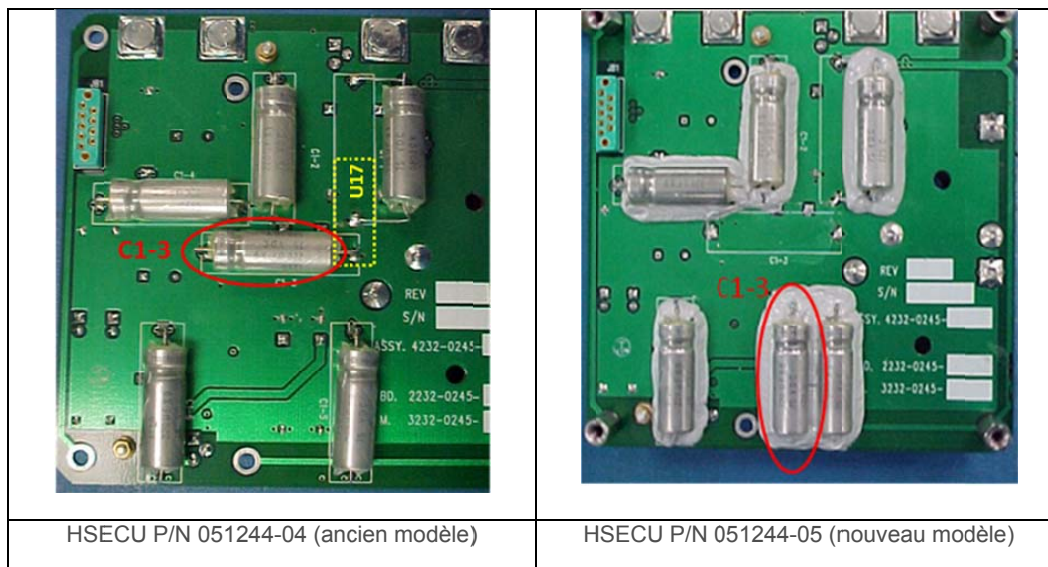
During investigations into the cause of the failure, the HSECU circuit boards were examined and two components on adjacent circuit boards were found to be in physical contact with each other.

This defect was only present on HSECU model 051244-04. Even though it did not contribute to the incident, Rockwell-Collins developed a new version of the HSECU (051244-05) in which one of the two components was moved:
