# **FINAL INVESTIGATION REPORT**

**ACCIDENT OF PIA FLIGHT PK-661 ATR42-500 AIRCRAFT  
REG NO AP-BHO NEAR HAVELIAN 24 NM NORTH  
OF BBIAP PAKISTAN ON 07 DECEMBER 2016**

Dated: 16 November 2020

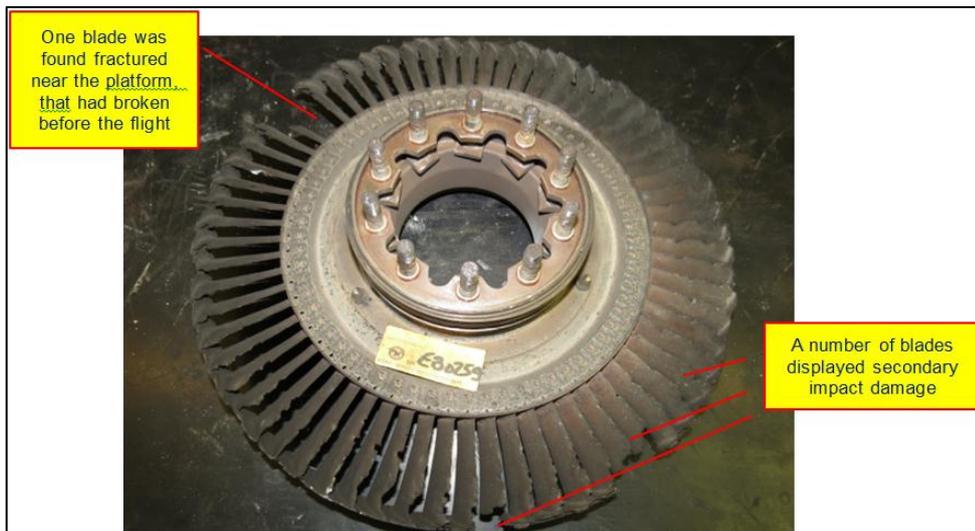
Figure 1-3: Power Turbine Stage 1 (PT-1) One Blade Fractured

(ii) Most probably, the PT-1 blade had fractured during previous flight<sup>17</sup> (Peshawar to Chitral), however this defect is not observable during regular operations.

1.1.4.3 Figure 1-2 hereunder shows a cross section view of PW127 Engine, along with its main components. The inner stage of two stages Power Turbine, being the first in sequence is Power Turbine Stage -1 (PT-1). Figure 1-3 shows Power Turbine Stage 1 (PT-1) removed from effected engine showing one blade fractured (that had occurred before the flight).

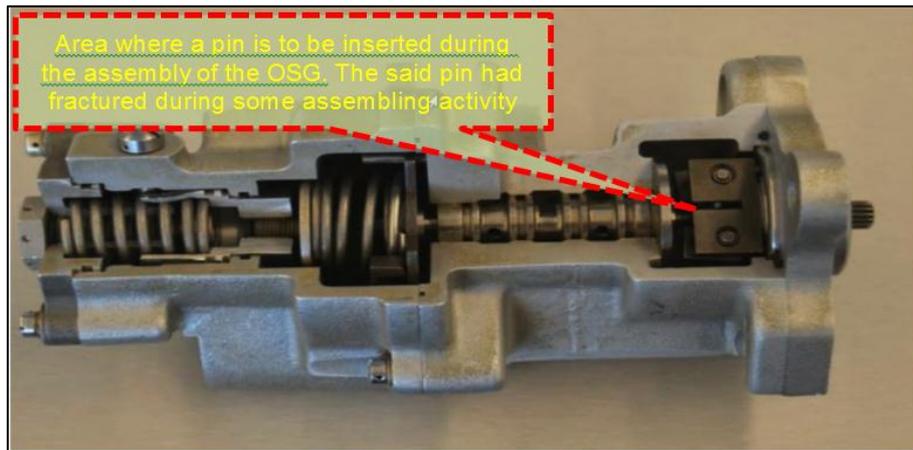
Figure 1-5: Cross Section View of OSG

1.1.4.4 The second pre-existing technical anomaly was a fractured pin inside the same side (ie left hand side) Overspeed Governor (OSG). This defect occurred during some maintenance activity performed on it. Advanced technical analysis has revealed that such defect alone (unless combined with abnormal metallic contamination leading to increased friction inside the pilot valve) may not have any impact on the performance of OSG. Figures hereunder show a serviceable OSG and cross section view of the area inside OSG which had a broken pin.

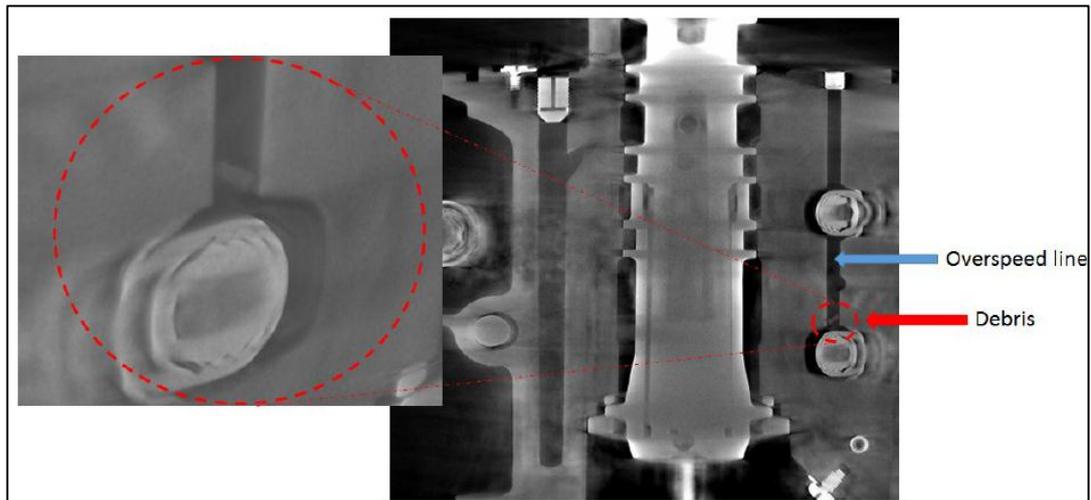
Figure 1-7: CT Scan Indicating Contamination in Overspeed Line of PVM

1.1.4.5 PVM contamination was most likely a pre-existing condition since contaminants, based on their size, could not go through filters / restrictions and were therefore not possibly due to engine contamination. This contamination was likely introduced when the propeller system LRU's were not installed on the gearbox. Figures hereunder show a serviceable PVM and debris found in overspeed line during CT scan.

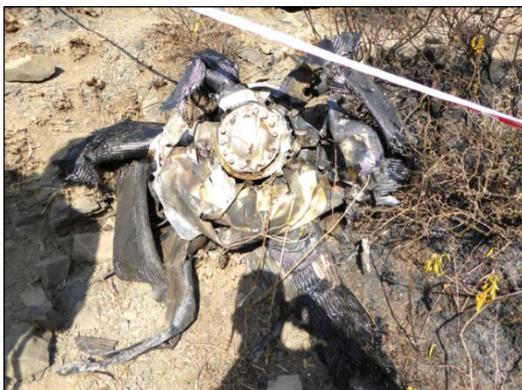
Figure: 1-45  
No 1 Propeller with Blades Installed and  
Signs of Ground Fire

(a) **No 1 Propeller Assembly:** It was found detached from the engine. The sign of post impact damage and fire / heat affects from ground fire were visible. All the blades were still connected with the assembly, though these were damaged due to impact and fire. It is generally the case when blades are not rotating at high RPM at the time of impact on ground. Few Counter Weights were found attached with the assembly and their position indicated that blades were at fine pitch angle post-impact. The last known positions of blades were marked on propeller for reference. Bull gear of RGB was found attached with the propeller. Bull gear of RGB was found attached with the propeller.

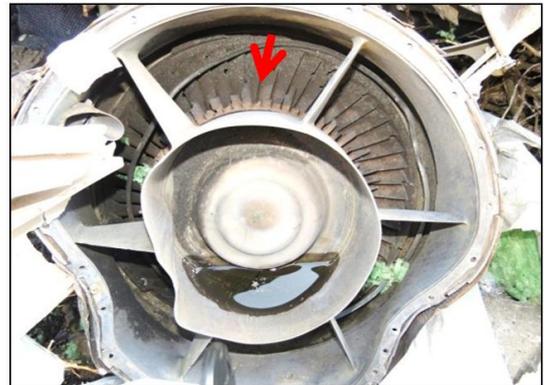
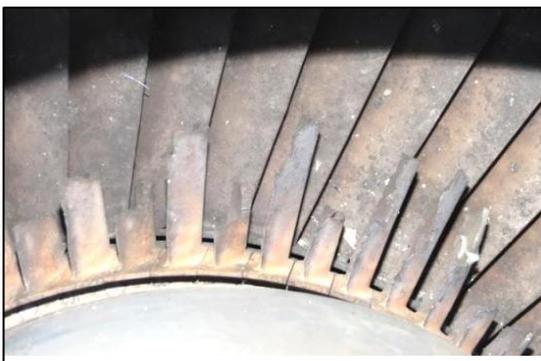
(c) **No 1 Engine (Turbo Machinery):** The engine was lying in vicinity of detached tail portion of aircraft towards left of main impact point. The exhaust duct was recovered in separated condition from engine. The visual examination indicated no apparent damage on 'LP Compressor' blades. The associated components were mostly found detached from the engine. The post impact damages were visible. The 2<sup>nd</sup> stage Power Turbine blades were found severely damaged. Similarly, sign of metallization (brownish colour) were consistent in the exhaust duct area as well, which got detached from the engine on impact with ground. Hence, it appears that this metallization was most probably caused in flight.

Figure: 1-54  
Damage on Power Turbine 2 (View from Rear End)

Figure: 1-55  
Power Turbine 2 Damaged Blades (Closer View )

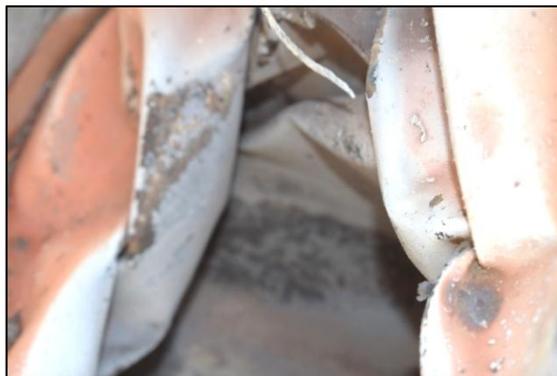
Figure: 1-59  
View of Tail Pipe – Sign of Metallization in Folds (Brownish Color)

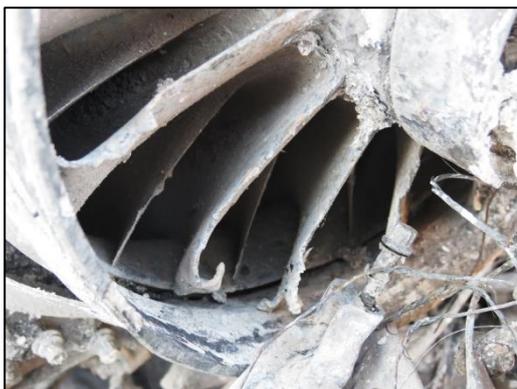
(d) **No 2 Engine (Turbo Machinery):** The engine was co-located with No 1 Engine most probably because it was moved during rescue operation. The visual condition of LP Compressor revealed bending of blades opposite to rotation. It generally happens when compressor is rotating at high RPM on impact with ground. No damage was observed in rear portion ie on Power Turbine blades. Similarly, exhaust duct got separated on impact and was recovered with no specific observation. The engine components installed on casing got detached on impact.

Figure: 1-60  
No 2 Engine LP Impeller – Blades Bent Opposite to Direction of Rotation

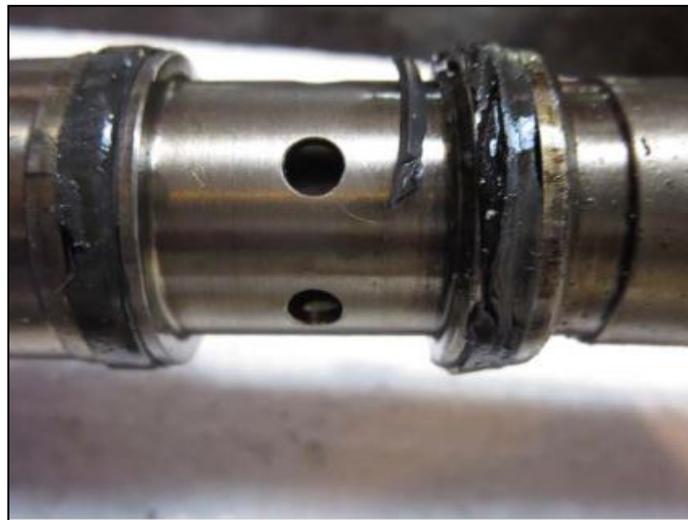
Figure 2-2: Transfer Tube and Seals – Damage Attributed to Teardown or Post-Crash Fire

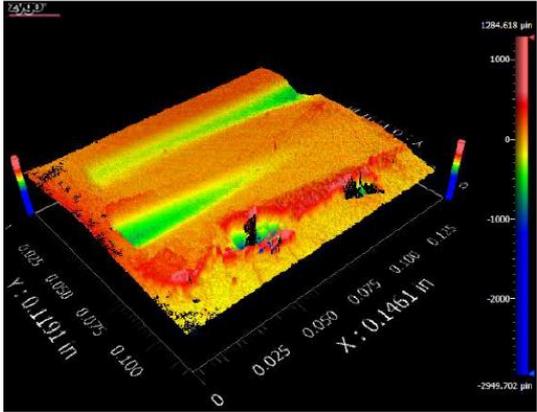
<p>Figure: 2-21</p>
<p>- The marks of the flyweights' toes (normal operation) are not centered on the bottom face of the pilot valve. The pilot valve is symmetric and can be positioned in two locations during re-assembly, without any effect on operation. These two locations produce two different wear patterns on the bottom side of the valve. The bottom face of the valve from the event hardware showed 2 distinct marks, indicating it had been re-assembled normally after original manufacture. The damage to the OSG pin as a result of an assembly attempt with the pin on</p>

<p>Figure 2-22: Marks Underlying a Change in the Contact Between Flyweights / Pilot Valve</p>

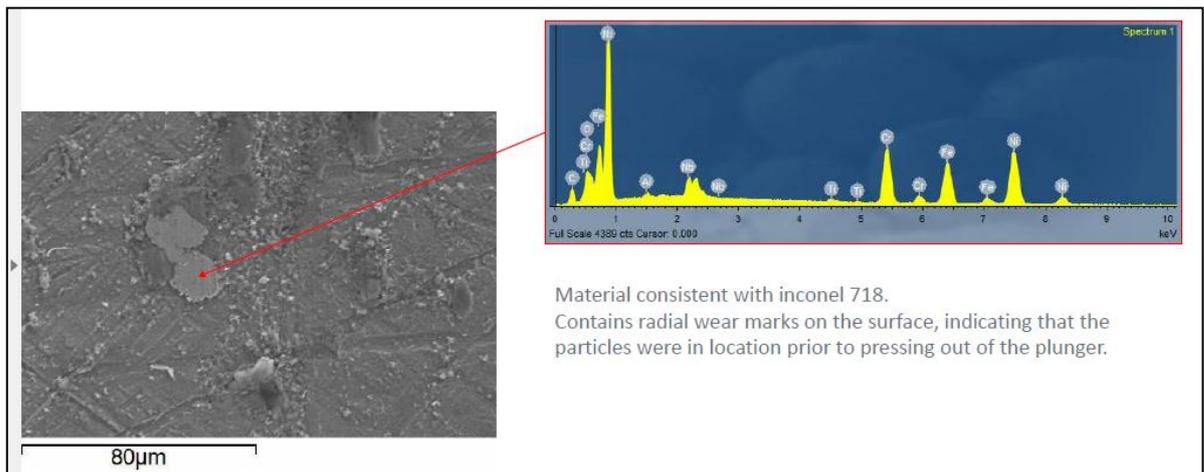
(ii) Metallic particle contamination was found inside the OSG pilot valve that had reached through the engine oil. This contamination was consistent with Inconel 718 of which the distressed No 6 bearing seal is composed. Engine oil was likely contaminated with these metallic particles around 10:56:01. The distress of the No 6 bearing and its seal was due to vibrations that occurred due to unbalanced PT shaft rotation. The PT was unbalanced due to a fracture of a PT-1 blade, most probably during the flight prior to the flight of the event.

Figure 2-25: Evidence of Inconel 718 in OSG

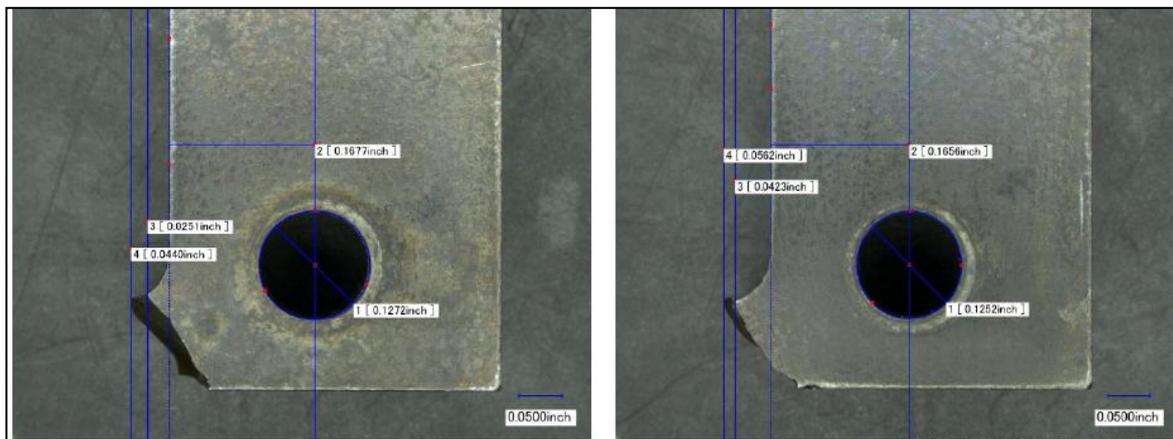
Figure 2-30: Broken Flyweights (No 1 at the Left, No 2 at the Right)

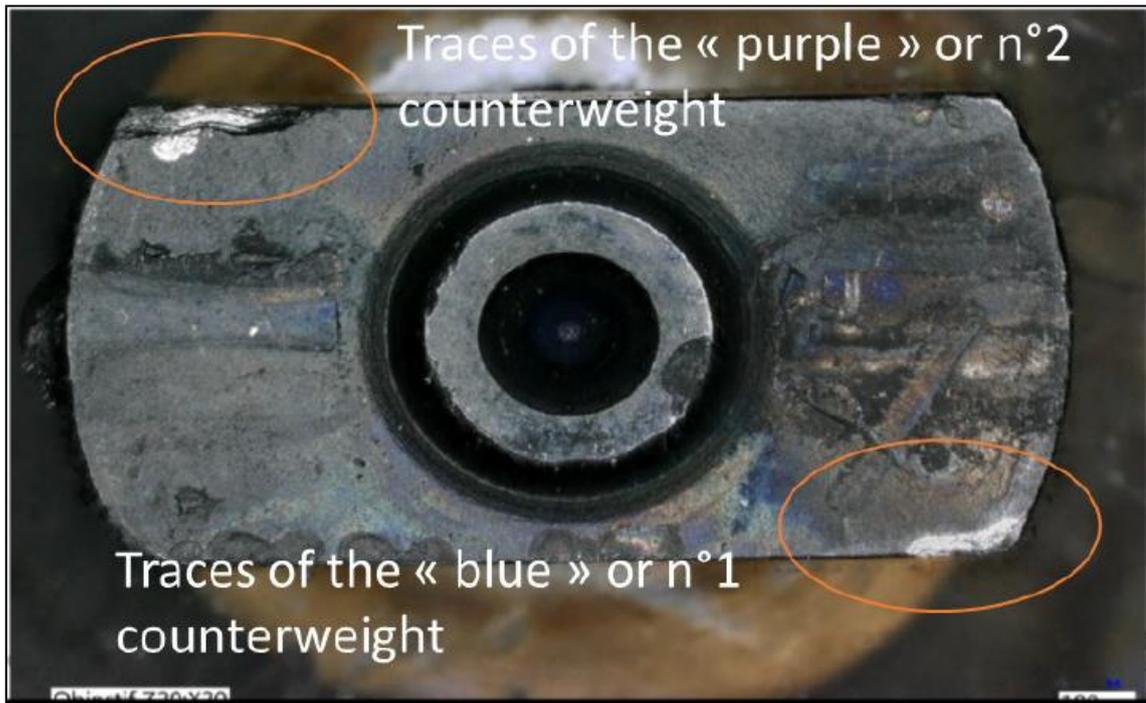
Figure 2-31: Wears on the Bottom Surface of the Valve

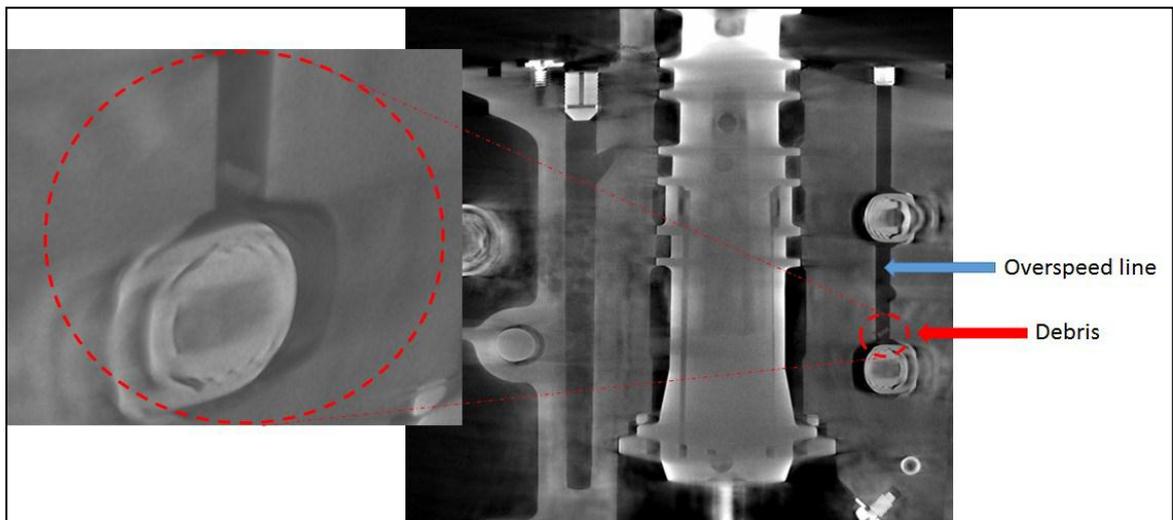
Figure 2-34: CT Scan of PVM - Debris inside the Overspeed Line

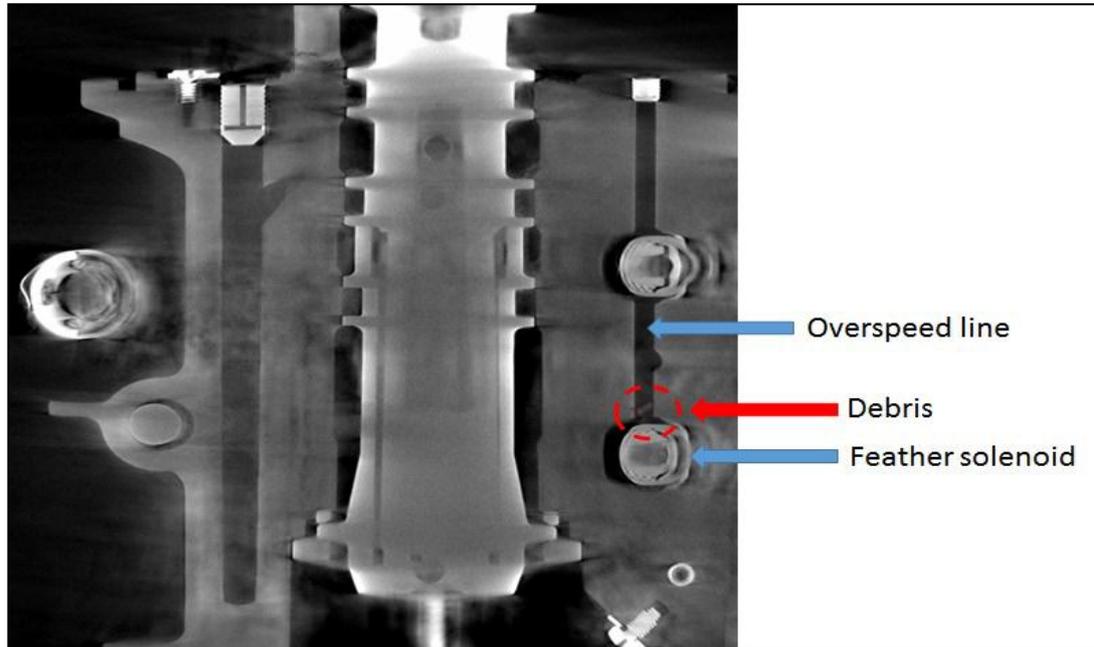
Figure 2-38: CT Scan - Debris Inside the PVM Overspeed Line
