# Rapport

Accidents survenus

entre l'**ULM Sky Ranger** identifié **63-RH**

et le **Mirage 2000 N n° 362** immatriculé **F-ULCU**

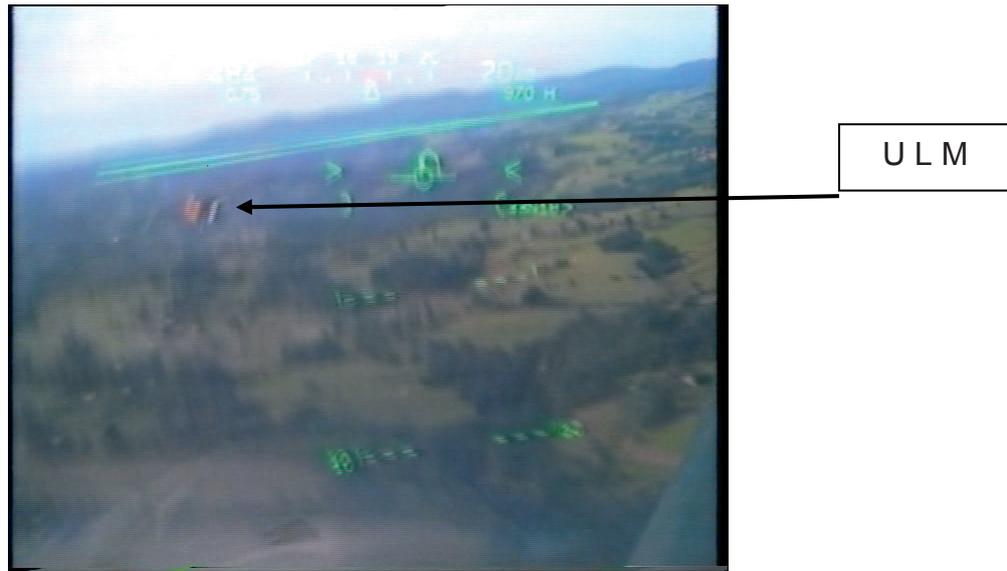
L'enregistrement VTH du F-ULCU a été analysé. Une copie a été transmise au BEA. La photographie ci-dessous a été extraite de cet enregistrement. Elle montre la position de l'ULM environ une seconde avant l'instant estimé de la collision. Les informations affichées ont permis de reconstituer les trajectoires respectives des avions.

L'angle de convergence entre les trajectoires des deux aéronefs est d'environ 30°. La manœuvre d'évitement réalisée par le pilote du Mirage 2000 N a été débutée environ une demi-seconde avant la collision, par un virage à droite à grande inclinaison (45°) et une action importante à cabrer. Le facteur de charge subi par le Mirage lors de cette manœuvre a été d'environ + 5,7G. Aucune manœuvre d'évitement de la part de l'ULM n'est visible sur l'enregistrement.

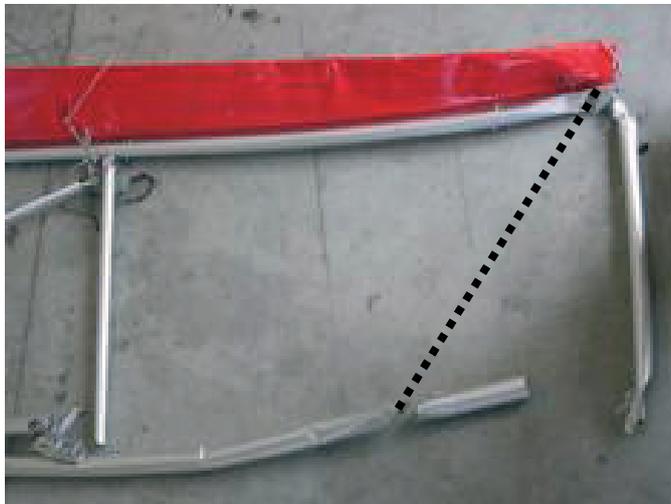
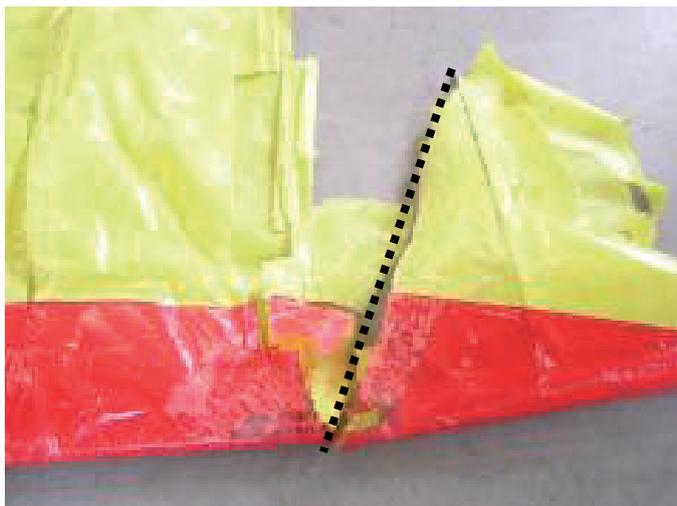
L'épave a été retrouvée dans un bois en bas d'une pente. Elle reposait pratiquement à la verticale, le moteur enfoui dans le sol. L'aile droite était reliée au fuselage. L'aile gauche a été retrouvée à environ cinq mètres en contrebas à gauche de l'épave. Elle était fortement endommagée et désentoilée.

Des éléments de la structure métallique de l'aile gauche ont été retrouvés à environ deux cents mètres de l'épave.

L'aile gauche a été reconstituée à partir des éléments retrouvés sur le site. Le tube de bord d'attaque est rompu en quatre parties. La partie la plus extérieure n'a pas été retrouvée.

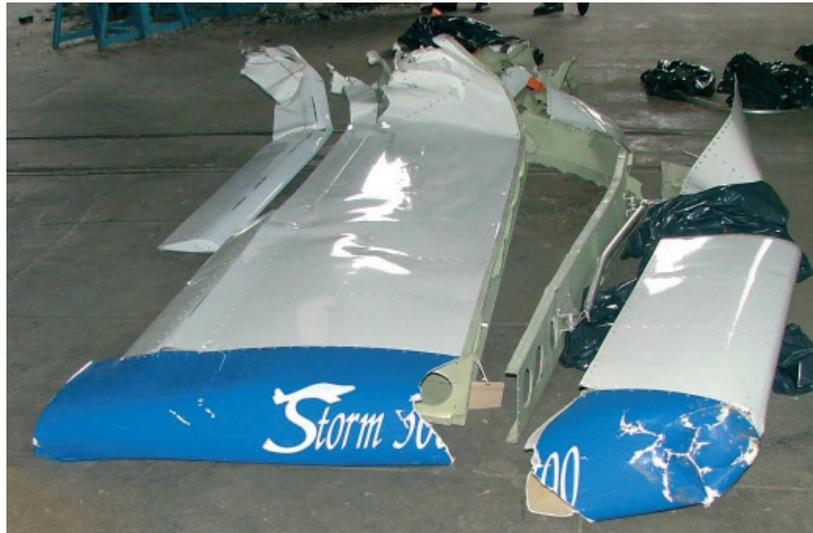
Aile droite reconstituée

L'aile droite de l'ULM a été reconstituée à partir des éléments retrouvés sur le site.

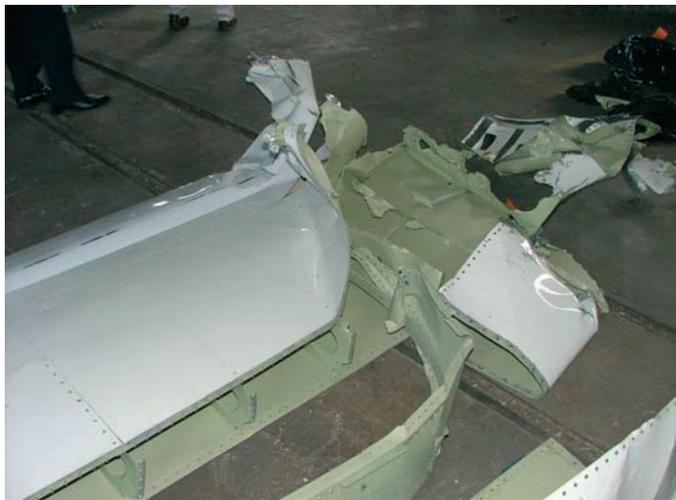
Extrados de l'aile, côté de l'emplanture de l'aile droite.

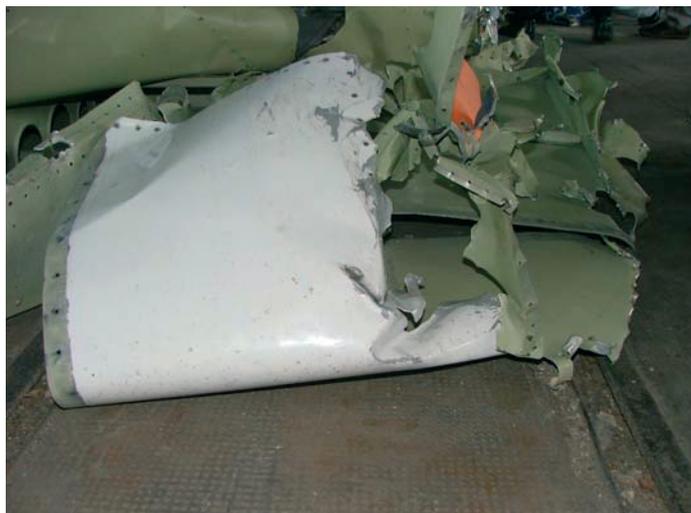
Carénage du bord d'attaque côté emplanture de l'aile droite.

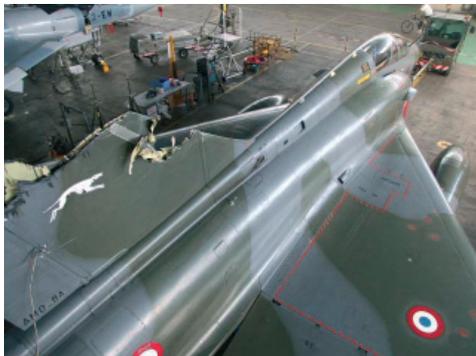
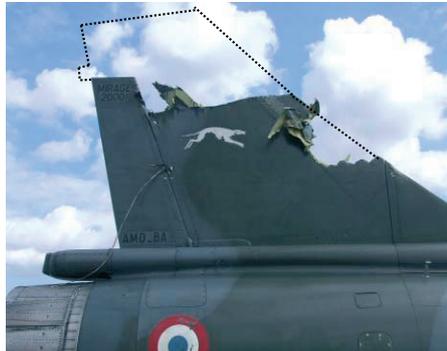
Le Mirage présentait des traces d'impact et des dégâts importants au niveau de la dérive. Des traces de frottements ont aussi été observées sur l'extrados de la voilure droite depuis les aérofreins jusqu'à l'emplanture des élevons.

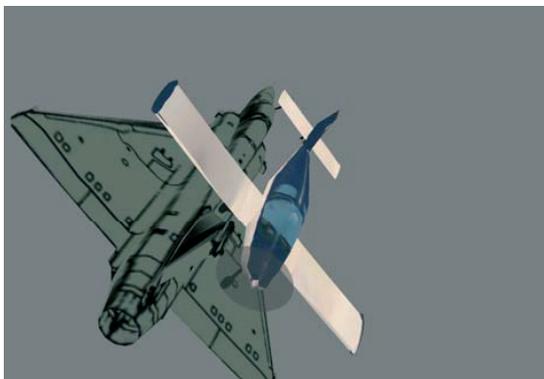
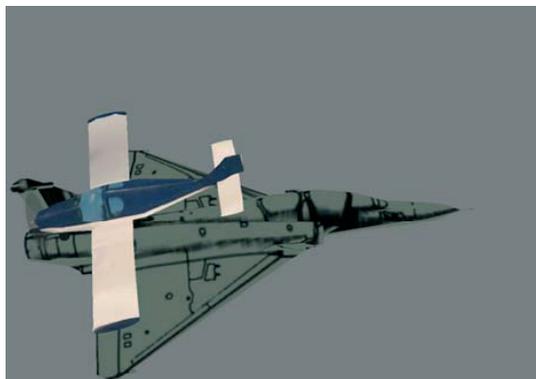
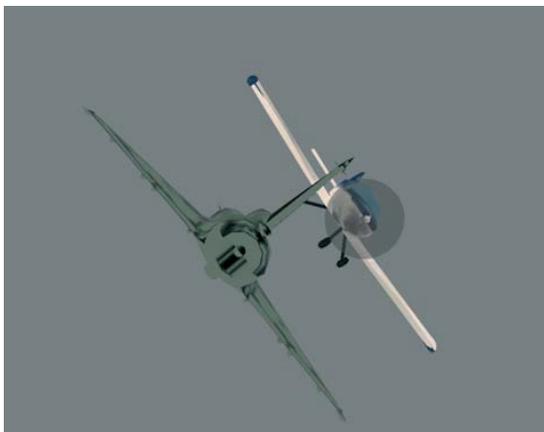
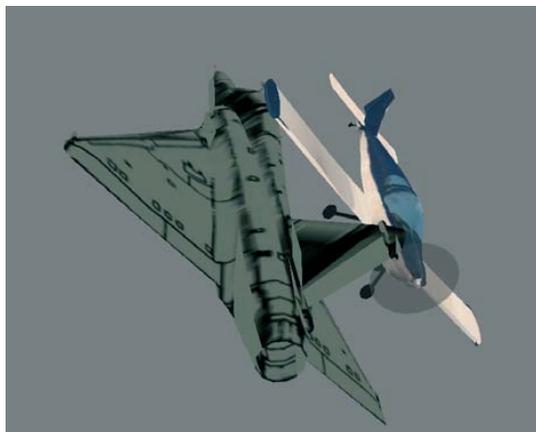
La trajectoire exacte du Storm 300 étant indéterminée, la séquence exacte de la collision n'a pas pu être complètement reconstituée. Cependant, les marques et ruptures sur l'intrados et l'extrados, les déformations du longeron avant de l'aile droite de l'ULM et les dégâts sur la dérive du Mirage ont permis de reconstituer l'attitude la plus probable des deux avions au moment où la dérive du Mirage a heurté l'ULM. La dérive a traversé l'intrados du bord d'attaque de l'aile droite de l'ULM dont le longeron avant a été arraché puis plié vers le bord de fuite. L'aile droite s'est alors repliée vers le haut et vers l'arrière avant de se désolidariser du fuselage.

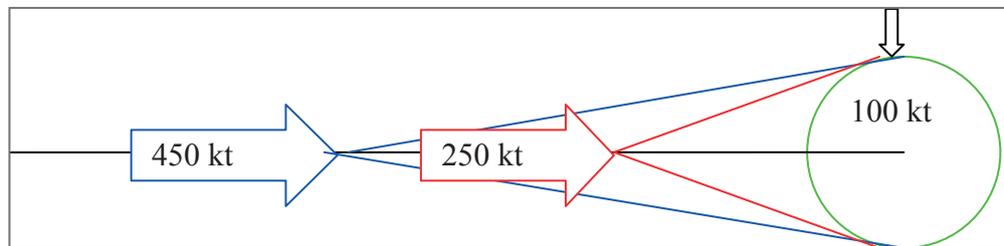
Cependant, comme l'illustre le schéma ci-dessous, en cas de rapprochement entre deux avions de vitesses différentes, le cône de conflit potentiel de l'avion rapide est étroit, alors que celui de l'avion lent couvre tout l'espace. Ainsi pour la détection d'un avion lent, toutes les ressources visuelles du pilote de l'avion rapide peuvent être concentrées dans un secteur angulaire restreint devant lui alors que pour l'avion évoluant à faible vitesse, la zone de surveillance doit être beaucoup plus importante.

Cependant, cela nécessite de projeter loin devant le regard afin de détecter un mobile. La mise en œuvre de techniques particulières de recherche est donc nécessaire.

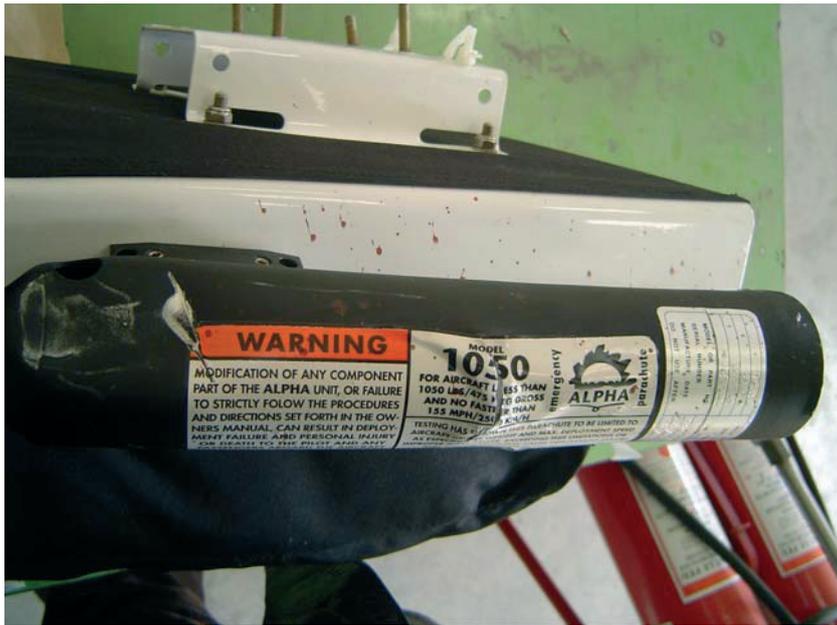
Tube de lancement

Une radiographie du tube de lancement a été réalisée en laboratoire. A la mise à feu, une pièce s'est placée de guingois, empêchant la séquence d'extraction des suspentes. L'expertise du tube de lancement et du lanceur a été réalisée par des spécialistes de la Préfecture de Police de Paris, sous commission rogatoire. A ce jour, les conclusions de l'expertise et les causes du dysfonctionnement du système de lancement du parachute ne sont pas connues du BEA.

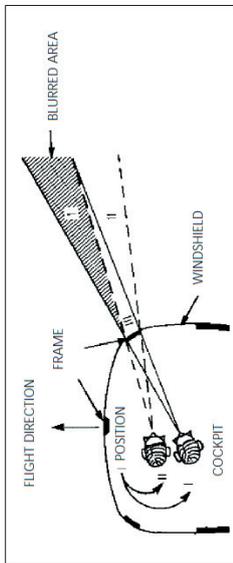
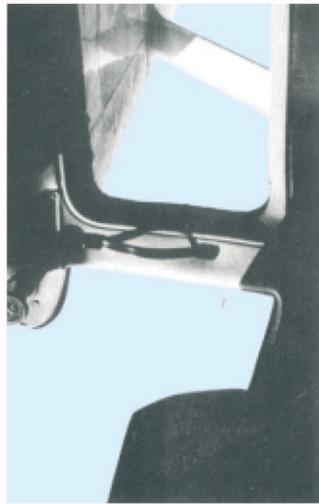
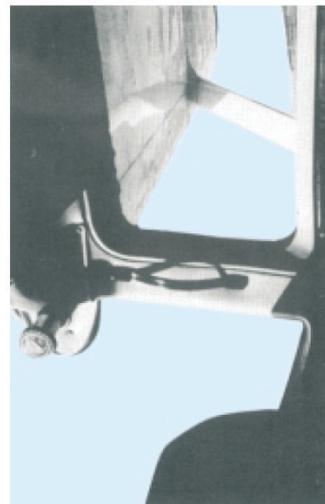
Figure 2. Effect of binocular vision

Aircraft is visible in the lower right hand windshield with the left eye

Aircraft is not visible with the right eye as it is obscured by the windshield post

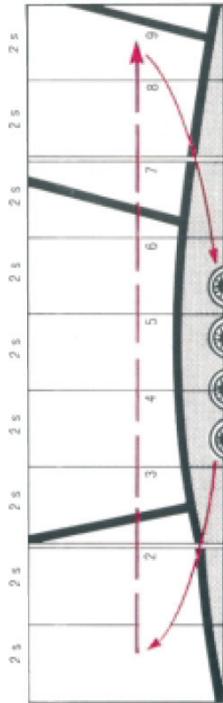
Figure 3. Side-to-side scanning method

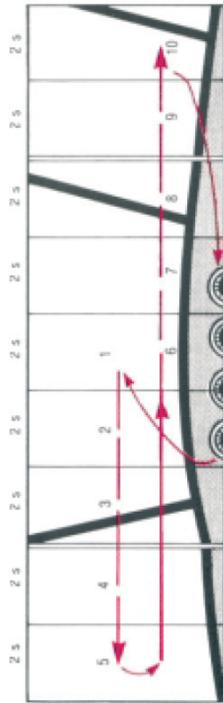
Figure 4. Front-to-side scanning method

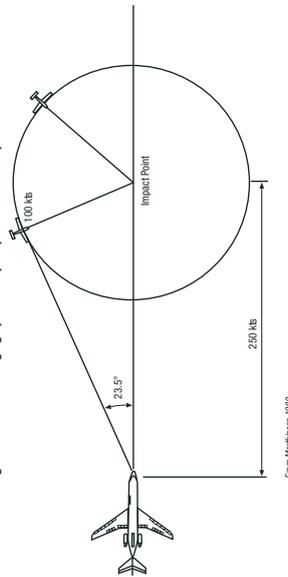
FIGURE 3: Illustration showing two aircraft converging upon an impact point at different points

In the case illustrated, two aircraft are converging upon an impact point at different speeds. The faster aircraft is travelling two and a half times faster than the slower aircraft. As a result of this, the faster aircraft will always have a slower aircraft in front of it. At all times leading up to the collision, any slower aircraft with which the faster aircraft will collide will appear at a point relatively close to the centre of the faster aircraft's scan. However, the faster aircraft will appear from any angle, even from a part of the sky not visible in the windscreen.

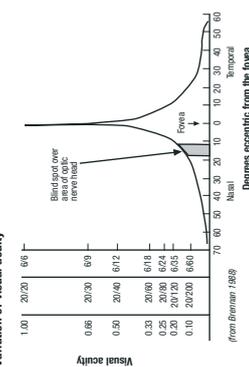
**FIGURE 5:**  
Variation of visual acuity

The variation of visual acuity (expressed as decimal, British and USA notation) at retinal sites eccentric to the fovea. The acuity at 5-degree eccentricity on the fovea is only one-quarter that at the fovea.

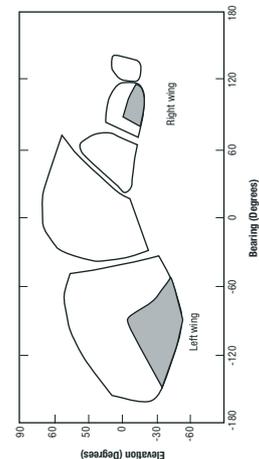
**FIGURE 6:**  
Limited cockpit visibility from a typical general aviation aircraft

In response to the Zagreb mid-air collision of 1976, Stanley Roscoe investigated the effects of cabin window-posts on the visibility of contrails (Roscoe and Hull 1982). Two significant effects were described:

First, an obstruction wider than the distance between the eyes will not only mask some of the view completely, but will result in certain areas of the outside world being visible to only one eye. A target which falls within such a region of monocular visibility is less likely to be detected than a similar target visible to both eyes.

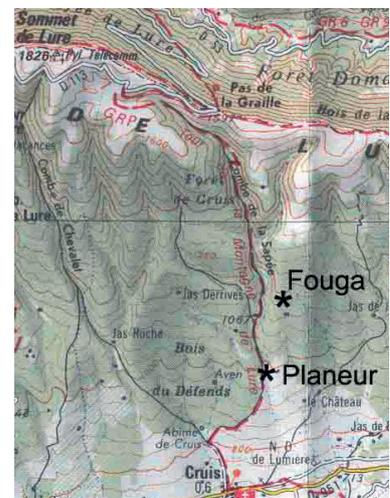
Des débris sont dispersés vers l'ouest/sud-ouest pour le planeur et vers le nord pour le Fouga-Magister.

Position des principaux éléments des deux épaves (carte IGN 1 :100 000)

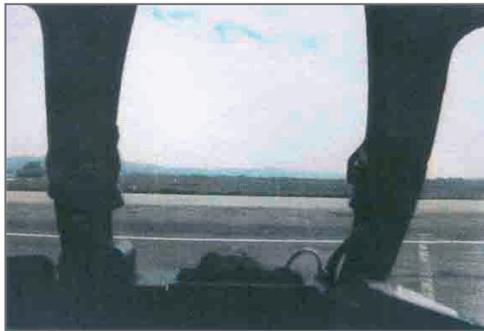
Vision par l'œil gauche vers l'avant

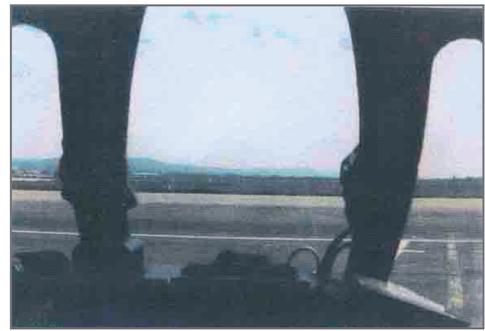
Vision par l'œil droit vers l'avant

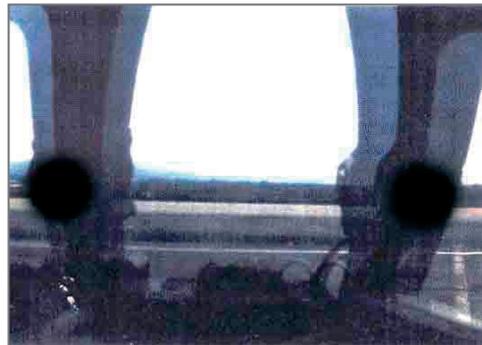
Vision par les deux yeux vers l'avant. Il reste des zones totalement masquées à l'infini. De plus, les taches aveugles peuvent exister au niveau des points assombris sur la photo.

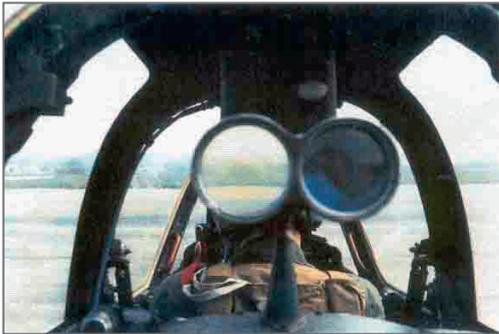
Vision par l'œil gauche vers l'avant

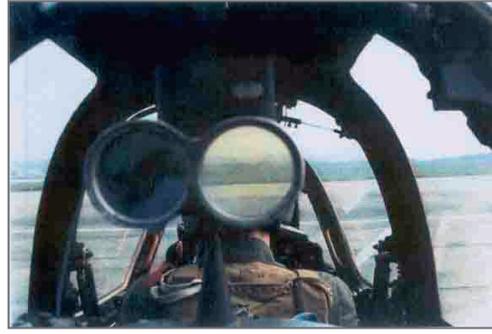
Vision par l'œil droit vers l'avant

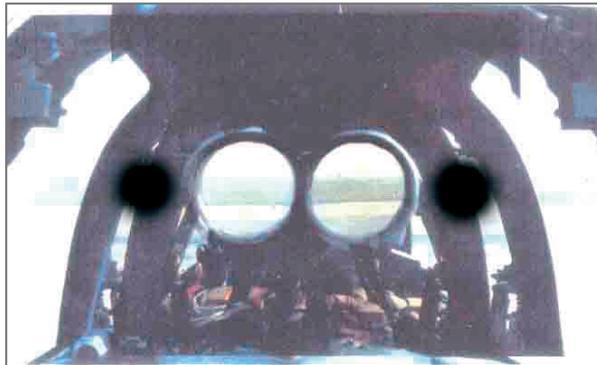
Vision par les deux yeux vers l'avant. La vision est gênée par le pilote en place avant et par les éléments de l'avion. Il y a, sur les côtés, des zones totalement masquées à l'infini. Les taches aveugles peuvent exister au niveau des points assombris sur la photo.
