TECHNICAL REPORT

**Accident to the Airbus A380
registered F-HPJE**

**and operated by Air France on 30/09/2017
en route over Greenland**

Phase III field campaign and part extraction

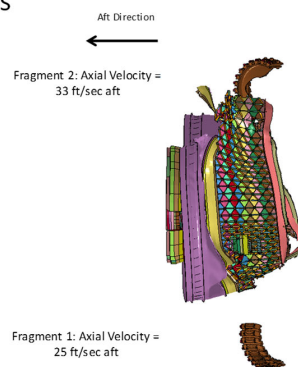
[Fig. 4](#) shows the scenario which was deemed to be the most consistent with the damage observed on the engine (Kevlar® belt, fan containment case, bulkhead damage etc.). It is actually half a revolution of the right hand image of [Fig. 3](#), as the o’clock angular position of the fan hub failure was arbitrarily chosen, and was modified to correspond to the damage observed on engine No.4.

Hub Fracture Analysis Predicts Two Major Hub Fragments

Note: all blades are expected to be released from the hub before fragments fall to earth

Fig. 4: Simulation results of the fan hub bore to rim rupture scenario, consistent with damage observed on engine

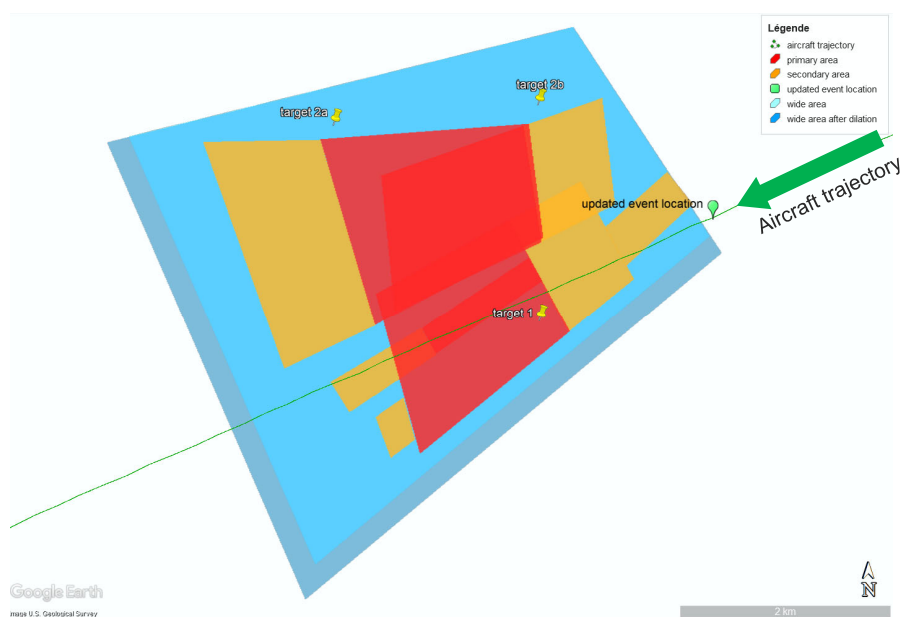
Fig. 20: Location of ONERA candidates 1, 2a and 2b with respect to search area

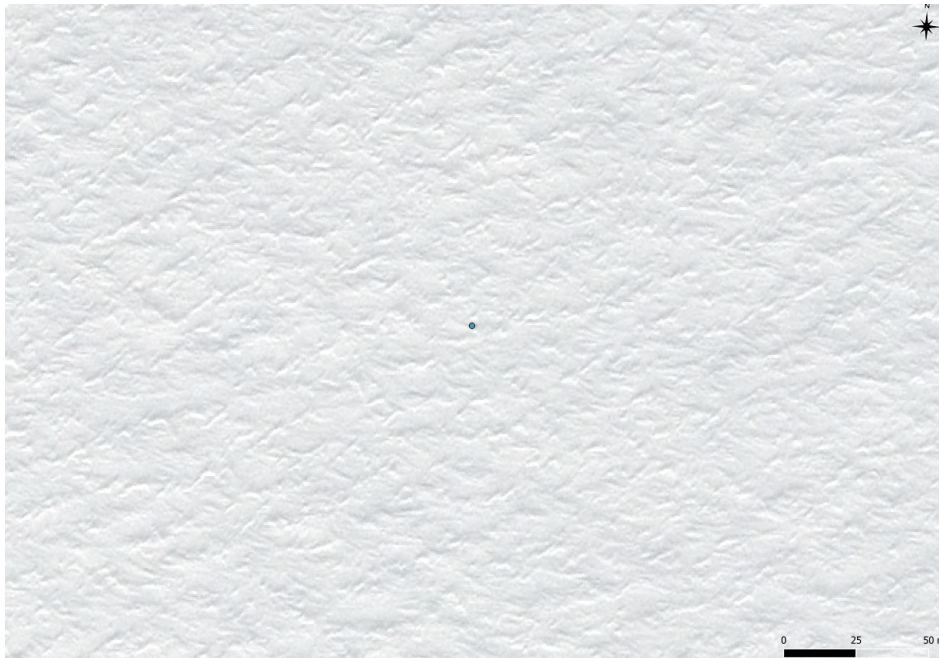
Fig. 26: most promising ONERA target location (blue dot) with background from Pleiades satellite image dated 11 October 2017. No part hub could be observed on the image in this area

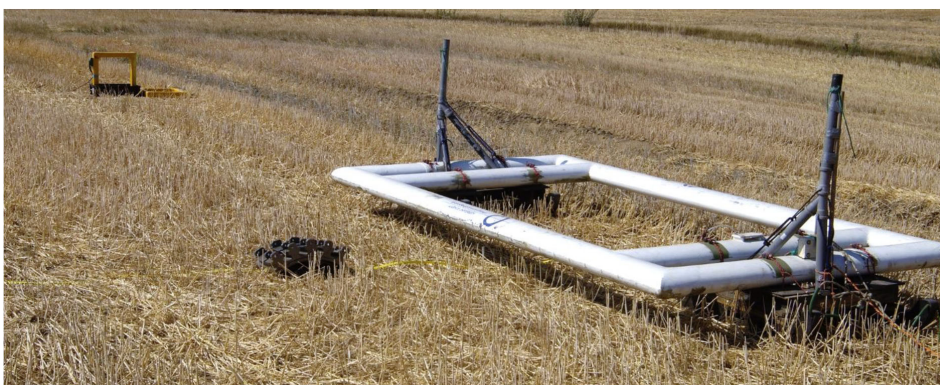
Fig. 29: Picture of test setup: test hub placed 2 m from center of transmitter frame

The equipment remained immobile while the test part was moved around to see the signal responses to the different positions (see [Fig. 29](#)). As the part could not be placed below the tTEM system, it was placed at the side which is a less sensitive direction than directly below. In a real field case, the equipment would be moving across and over the part.

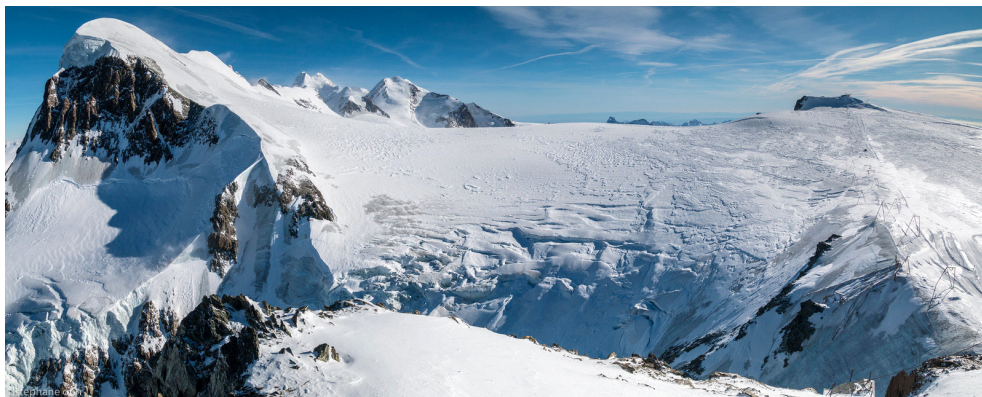
Fig. 31: Initial test location, “Breithorn Plateau” in center, with Breithorn (4,164 m), on left hand side. View from Klein Matterhorn. “Gobba di Rollin” ski lift is just visible on right hand side. Crevasses downstream of the plateau are clearly visible

To have low temperatures and a glacier to work on, it was decided to go to Zermatt, in Switzerland. First, a glacier between the “Klein Matterhorn” and the “Breithorn” was identified, also called the “Breithorn Plateau” ([Fig. 31](#)). The main advantage was that it was accessible by gondola and ski lift, even if its altitude was higher than 3,800 m (it is indeed the highest point reachable by gondola in Europe).

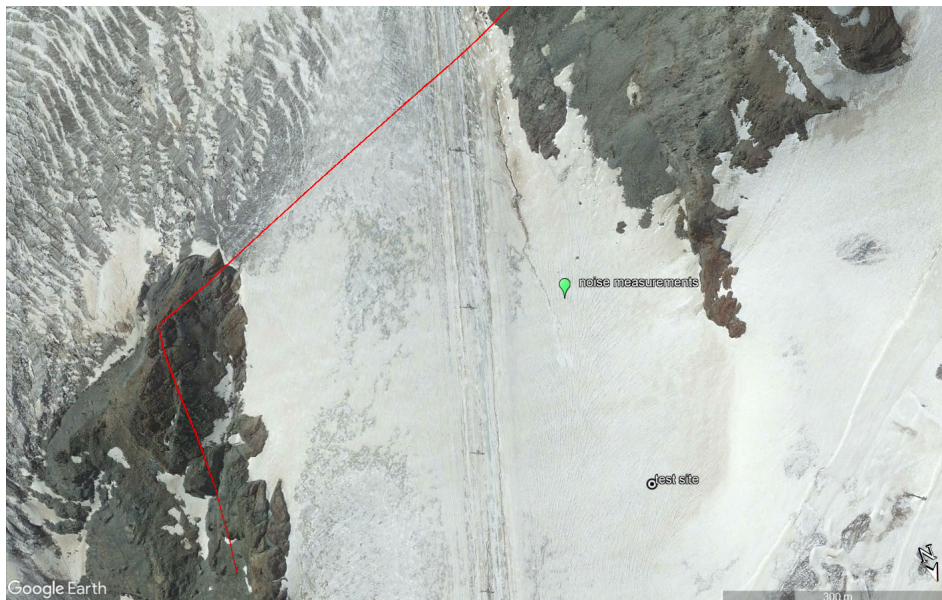
Fig. 33: Location of power lines (red lines) and noise measurements (green dot)

The cause of this noise was identified as being a power line that was, at its closest, 500 m from the test site as shown in [Fig. 33](#). This line was not initially spotted as concerns had been focused on the ski lifts. To confirm this, measurements were done while moving towards and away from this power line. This confirmed that the closer to the line, the higher the noise. Results are shown in [Fig. 34](#).

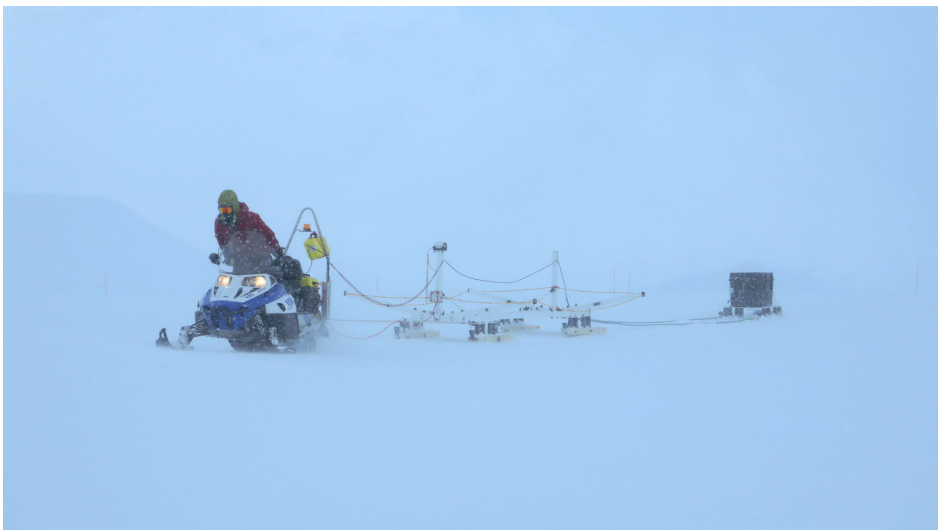
Fig. 35: Snowmobile towing SnowTEM during the test in Zermatt in low visibility conditions in a snow storm

However, the test in Zermatt made it possible to validate the mechanical behavior of the sensor towed by a snowmobile on a terrain which was, in certain points, similar to the search area in Greenland. In particular, the system behaved well when passing over sastrugi⁽¹⁹⁾, with travel speeds up to 20 km/h ([Fig. 35](#)). The force needed to tow the sensor was also measured. Peak levels of 150 kg were reached.

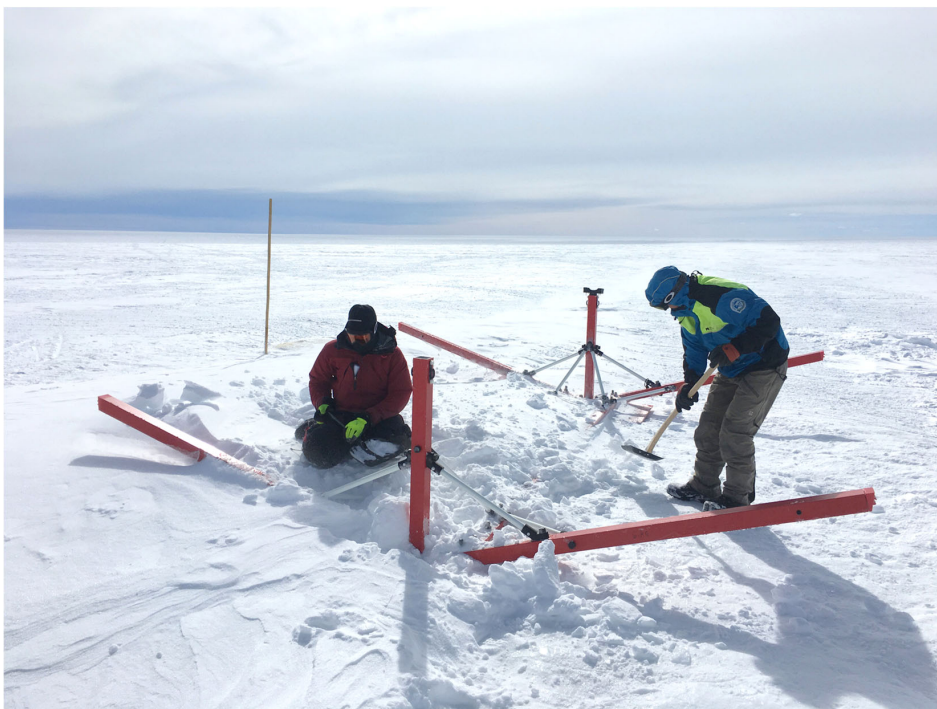
Fig. 36: Digging out one of the two SnowTEM systems after a snowstorm

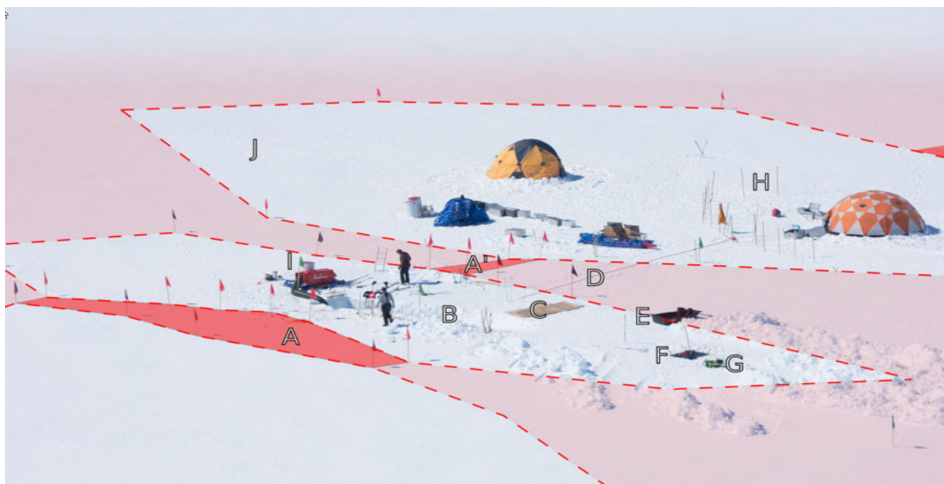
Fig. 42: Photograph from helicopter of excavation work-site as described in (Mankoff, et al., 2020). (A and A') Dark red graphic overlays between flags mark known crevasse locations as detected by GPR and DGNSS. Dashed lines enclose safe areas and pink marks unsafe areas defined with GPR data, the UHF basemap (Fig. 21), extensive snow probing and crevasse location uncertainty with distance from known crevasse locations. (B) Ramp out of pit. (C) Plywood used to cover pit overnight to prevent drifting snow filling. (D) Safety rope bridging crevasse between the northern (far) camp island and the southern (near) work island. (E) Sled. (F) Winch and winch platform. (G) Generator used to power winch. (H) Bamboo poles marking polar bear alarm trip-wire surrounding sleep tent. (I) Herman Nelson heater, hose and fuel barrel. (J) Helicopter landing zone. Photo by Austin Lines.

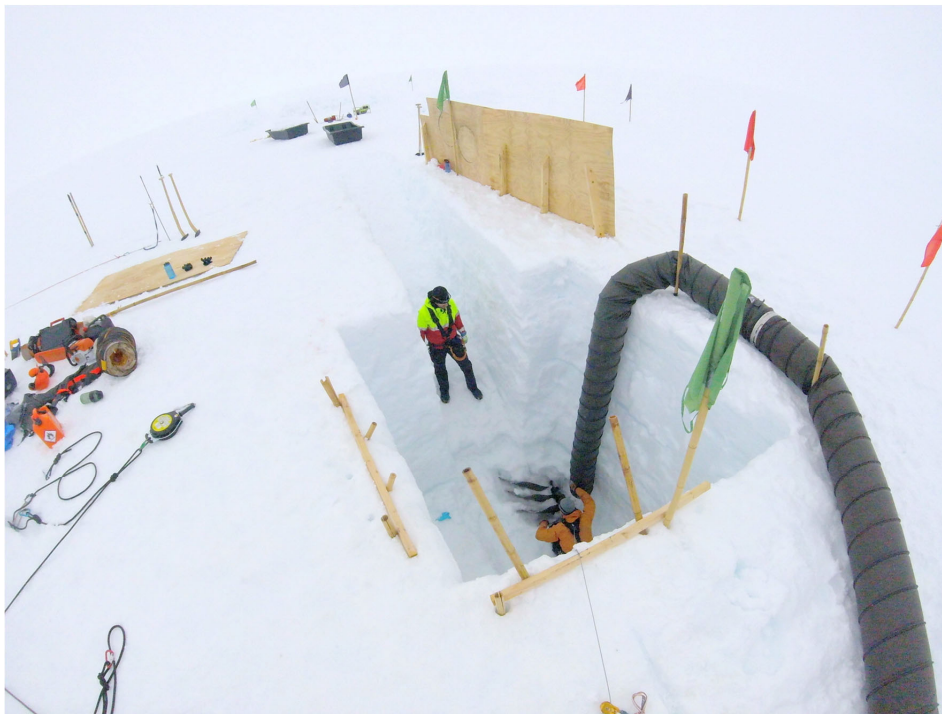
Fig. 43: Melting out snow and ice around part in 4 m deep hole. Photo by Arnar Ingi Gunnarsson

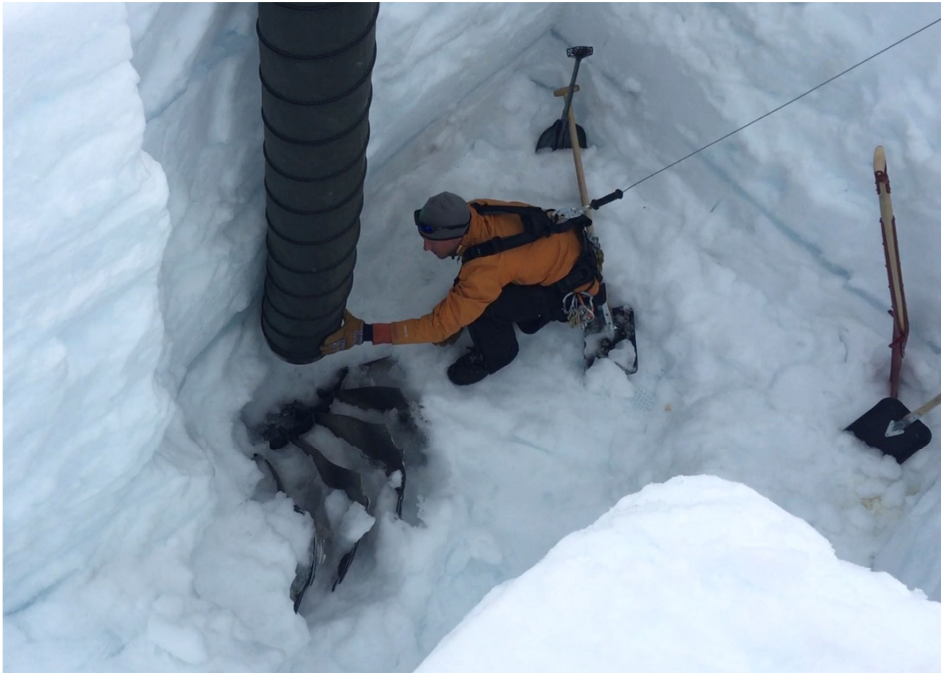
Fig. 44: Photo by Dirk van As, Greenland Guidance. Photo of Icelandic rescuer melting out fan hub

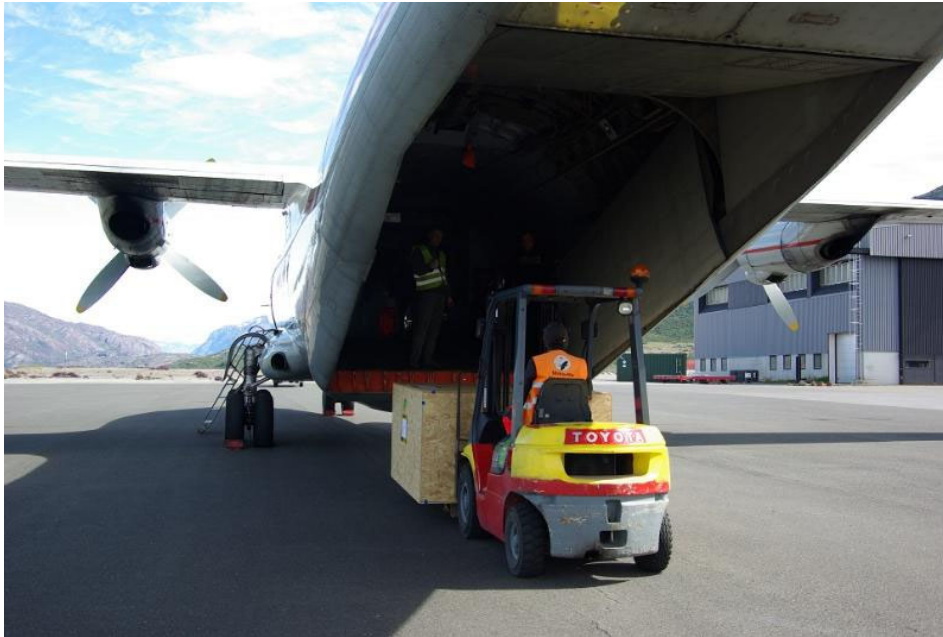
Fig. 45: Loading of crate with fan hub into transport aircraft, an Antonov 12

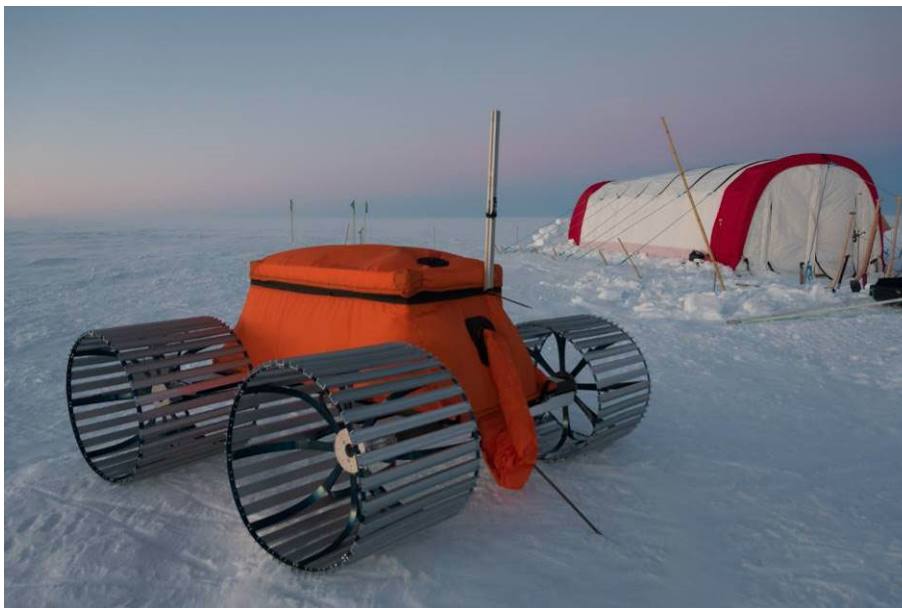
Fig. 48: Frostyboy autonomous vehicle

The second field campaign (CR2) also led by GEUS, in May 2019, used a SIR-30 GPR towed by a 4-wheel autonomous vehicle, “Frostyboy”, developed by the Polar Research Equipment group ([Fig. 48](#)). It was not able to detect the buried test fan hub, but this may have been the result of a number of compounding factors when attempting the test (such as radiofrequency interference from FrostyBoy’s communication system). The SIR-30 GPR had no false positives (ice lenses with a signal similar to the buried test hub). Any of a number of factors could have contributed to this difference, such as the difference in measurement frequency, radar systems, tow vehicles, tow speed, or post-processing.

The SIR-30 400 MHz antenna was used to sound the ice sheet to depths of 40 m and identify snow-covered crevasses. During the survey of the most promising ONERA target during the field campaign, it detected a highly reflective surface at a rough depth of 3.4 m. The signal was seen again at the same location in two more surveys. Given that the SIR-30 had not seen any false positives outside the crevasse field, and the strong signal was the only one of its kind seen during the different crevasse assessment surveys, this signal was deemed promising. However, based on the GPR experience from the first field campaign, it was not certain that the signal came from a metallic object until a similar signal was observed with the SnowTEM detector.

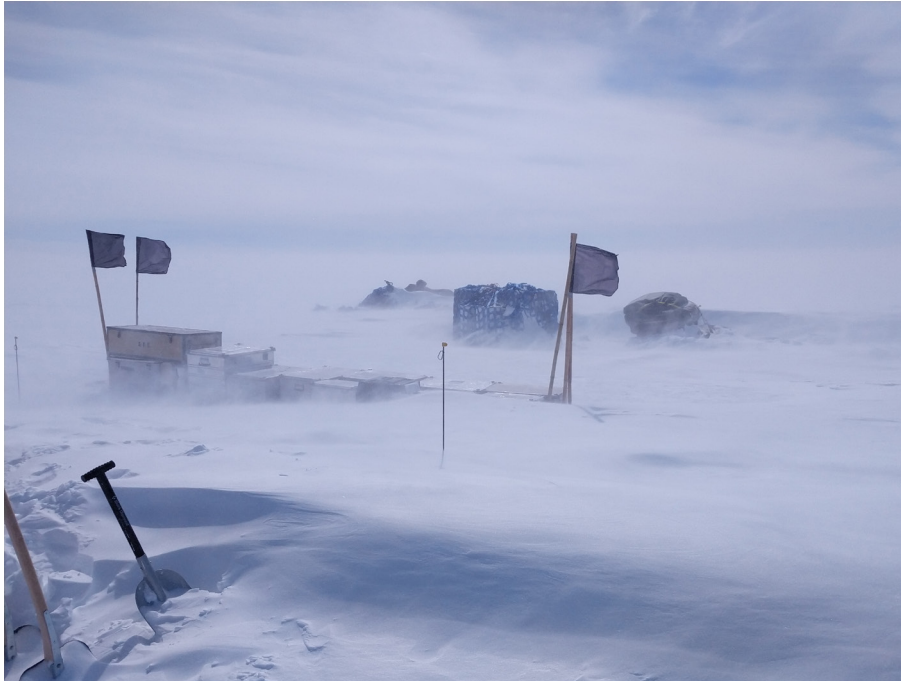
Fig. 50: Blowing snow burying equipment during a strong wind episode

For CR2 in May-June 2019, 24 camping nights were planned. Only 10 were spent on-ice. Helicopter flights were planned for certain days in advance. Due to high winds or clouds or both at Narsarsuaq, on the search site, or in-between, lots of flights had to be cancelled or rescheduled when possible, depending on helicopter availability. The initial planning envisaged the complete team being on site on 28 April 2019. In reality, because of weather hold-ups, almost nothing happened before 11 May when the last slings of hardware and five people were finally flown to the search site. Once on site, 20 to 30 % of the remaining days were still unworkable due to storms, and each storm required several hours of work to deal with snow drifts and buried equipment ([Fig. 50](#)). Temperatures ranged from -15 °C to +5 °C.
