Accident to the Airbus EC130 - T2
registered **3A-MVT**
on 25 November 2022
at Villefranche-sur-Mer (Alpes-Maritimes)

Conducting a flight under the influence of drugs, entry into a cloud layer, loss of visual references and loss of control, collision with terrain

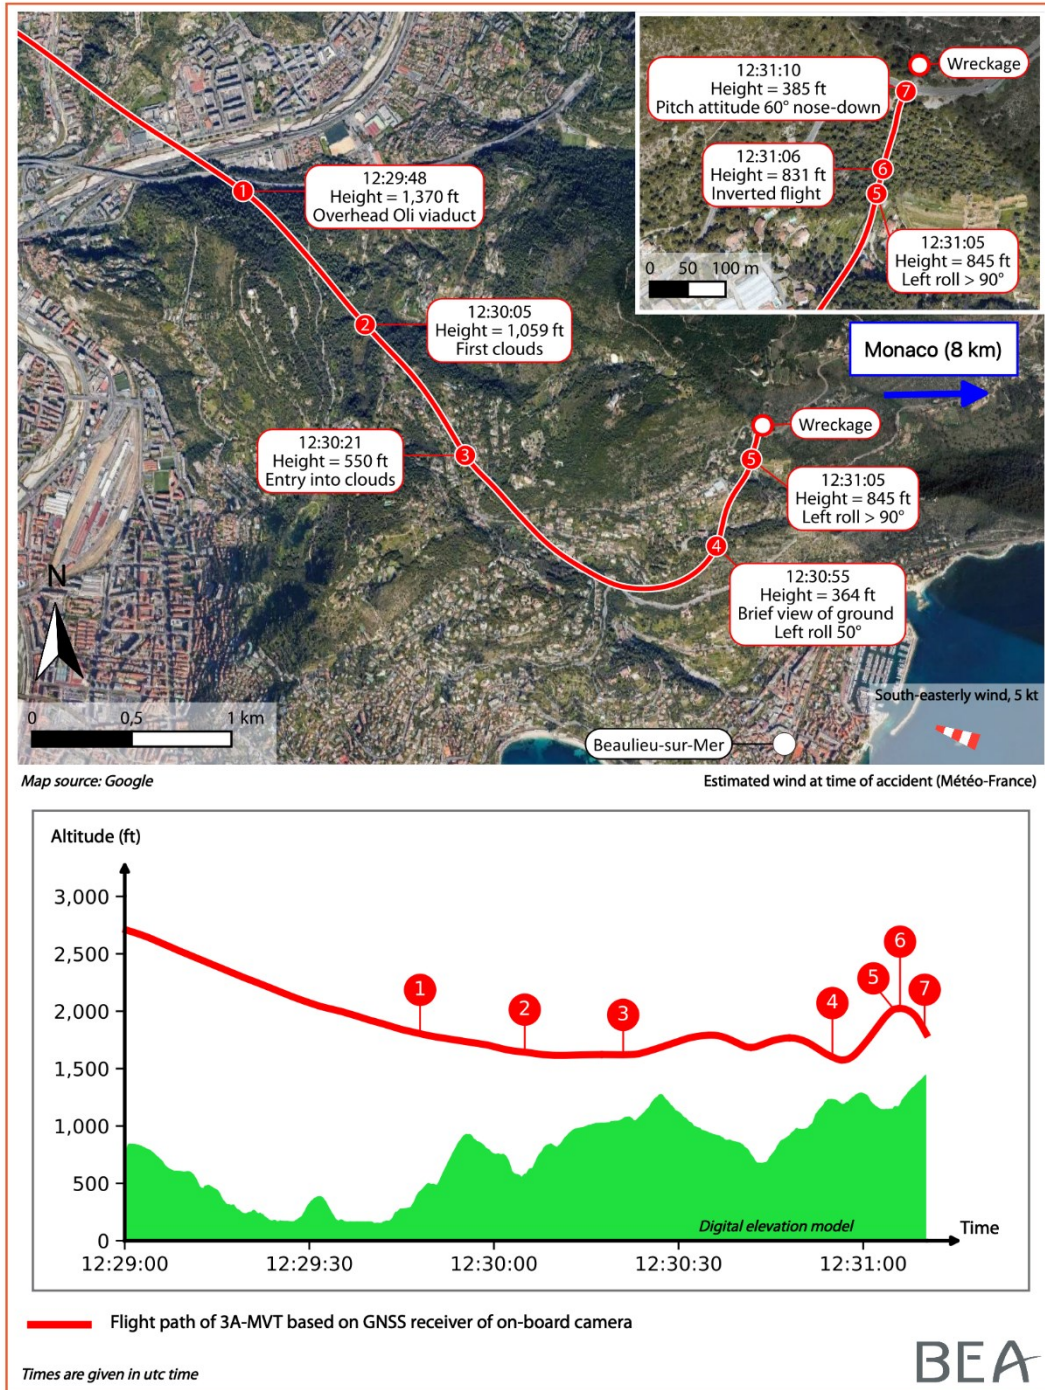
Figure 2: flight path of 3A-MVT approaching clouds and then in clouds

The helicopter flew over Oli viaduct at 12:29:48 (see **Figure 1**, point **1**) and slowed down to reach a speed of 105 kt. At 12:30:05, the helicopter encountered the first cumulus fractus (point **2**) and at 12:30:21, it entered the cloud layer (point **3**). The helicopter's IAS was 100 kt.

At 12:30:55, the ground was visible for a brief instant (point **4**), and the helicopter was in a 50° left bank. The pilot then abruptly banked the helicopter 16° to the right. The pilot's abrupt input on the controls caused the LIMIT² light to illuminate.

Ten seconds later, at 12:31:05, the pilot banked the helicopter by more than 90° to the left and entered a steep climb (point 5). At the top of the climb (point 6), the amber SERVO³, HYD 1 and HYD 2 lights and then the red MGB P and ENG P lights illuminated; the helicopter was inverted and rotated 180° around its yaw axis. At point 7, the helicopter was upright again with a nose-down attitude of 60°.

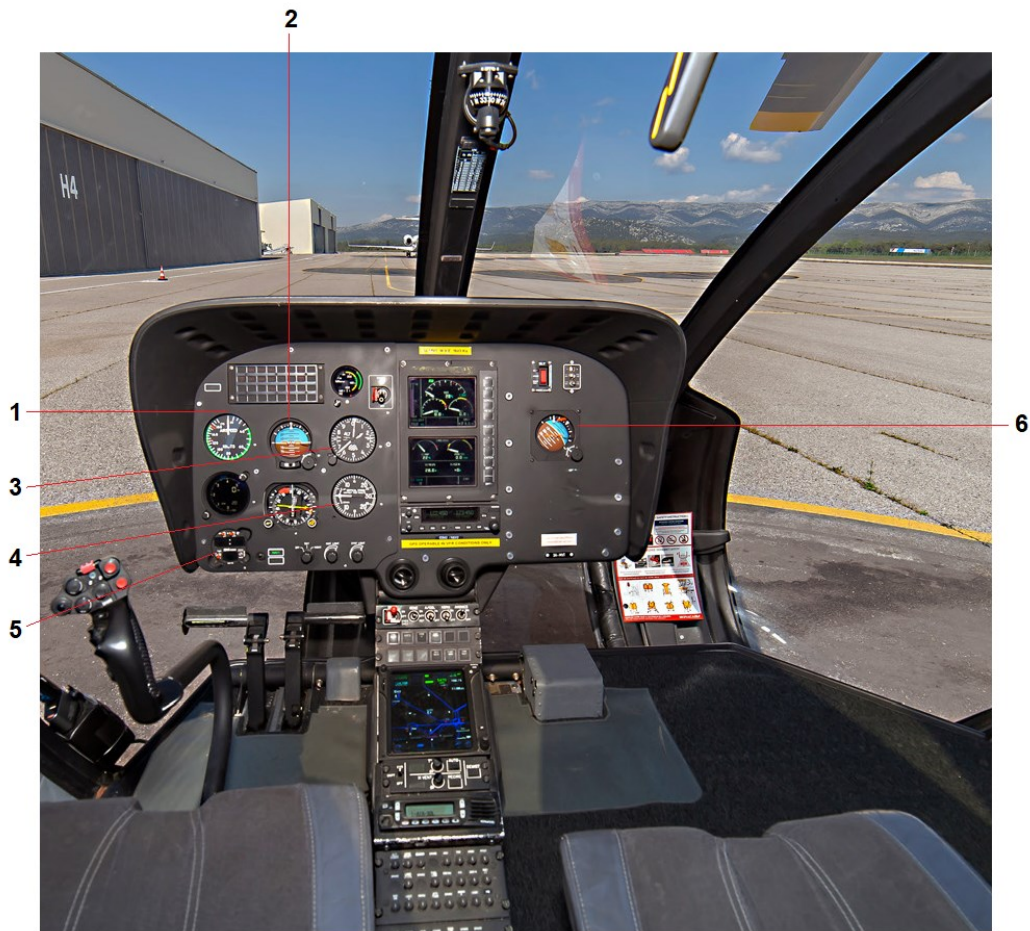
Figure 5: view of cockpit of 3A-MVT (source: Monacair, annotated by the BEA)

1.	Airspeed indicator
2.	Gyro-horizon
3.	Altimeter
4.	Variable speed indicator
5.	Chronometer
6.	Gyro-horizon

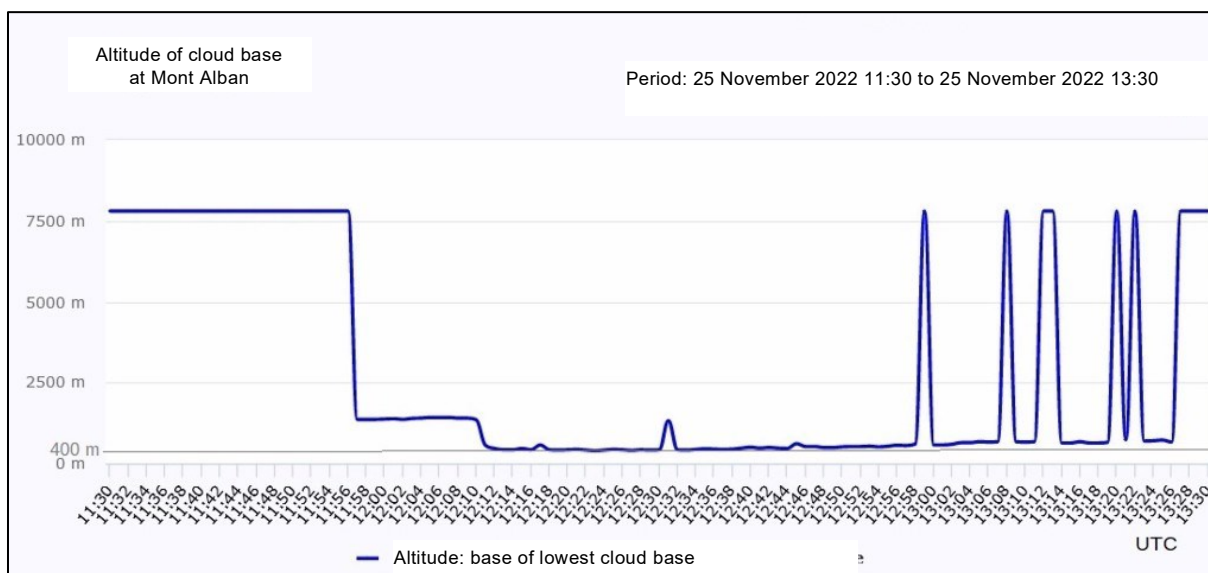
Figure 7: altitude of cloud base at Météo-France automatic weather station at Mont Alban (source: Météo-France, annotated by the BEA)

- the presence of low cloud between 12:10 and 13:00, with the cloud base at a varying altitude of between 1,300 ft (400 m) and 2,000 ft (600 m), except at 12:31 when the base was at 4,200 ft (1,300 m);
- quickly-passing low clouds after 13:00 with the cloud base at a varying altitude of between 1,600 ft (500 m) and 2,000 ft (600 m).

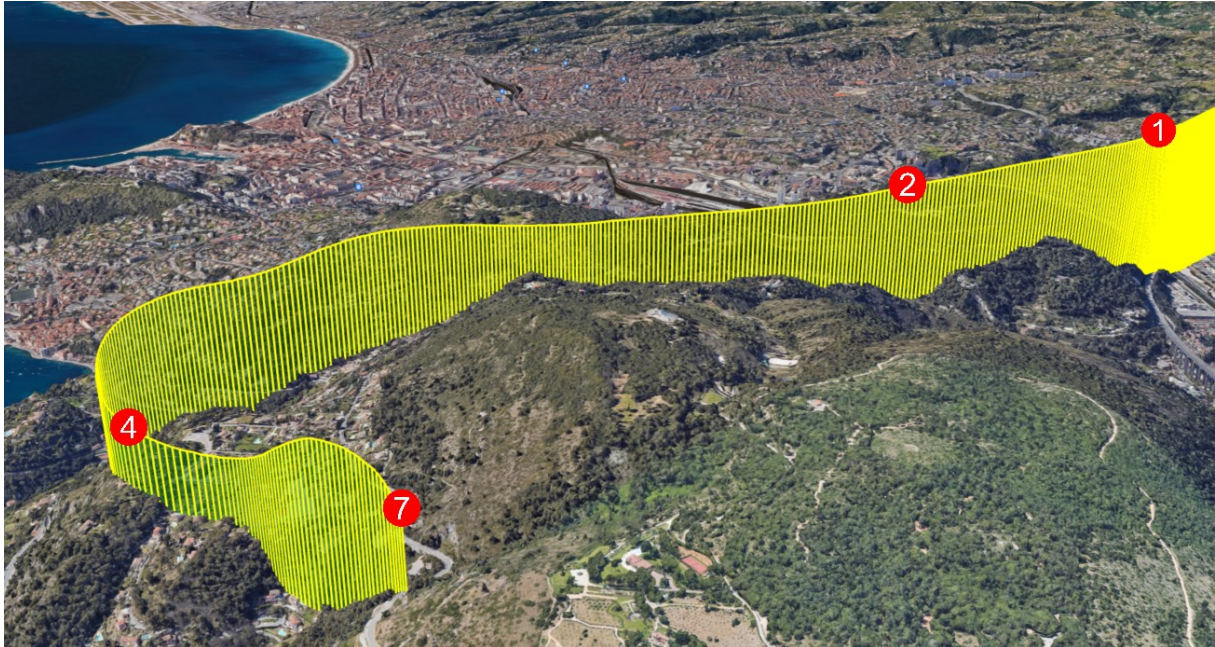
Figure 8: end of flight path of 3A-MVT (source: Google, annotated by the BEA)

- At point ① (see **Figure 1** and **Figure 8**): at 5 NM from the seashore, after flying over the motorway and before crossing the pass, the pilot decreased the speed to below 100 kt probably in reaction to the changing weather conditions with a reduction in visibility and the presence of low clouds. At this point, the pilot was able to observe the weather conditions over Nice and the airport that still allowed him to envisage without difficulty, a flight path in that direction to avoid the clouds ahead of him.

- At point ②: 17 s later, at 1.25 NM from the seashore, when flying over the pass, the pilot flew close to low clouds. Sixteen seconds later, the helicopter entered the cloud mass and started to take unusual pitch, roll and yaw attitudes.

- At point ④ : visual references (vegetation/house) were briefly visible. The pilot's inputs seem to indicate an unsuccessful attempt to correct the helicopter's attitude.

- At point ⑦: this is the last recorded image. The impact occurred around 50 m further on, very probably one or two seconds later.

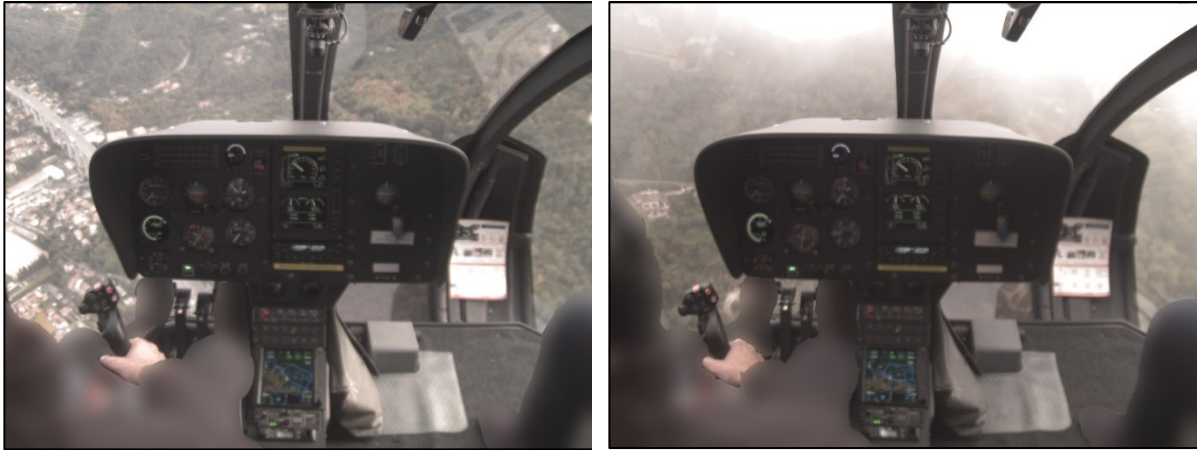
These two images show the helicopter flying (LH photo) outside the clouds and then approaching the first cloud banks (RH image).

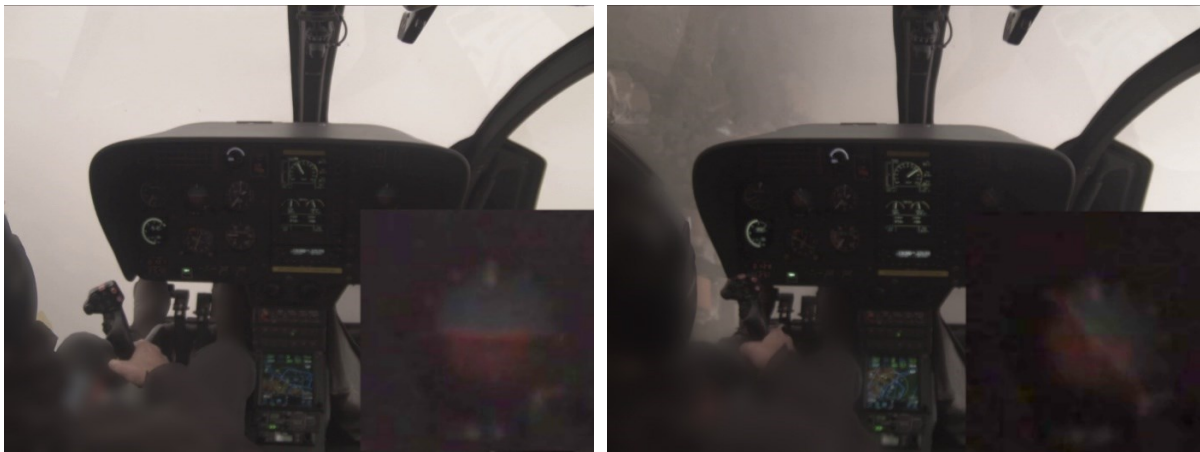
The LH image shows the absence of visual references, the helicopter is horizontal in level flight. The RH image corresponding to point 4 of Figure 8, shows that the external references are briefly visible (ground and houses on bottom left of image). At this point, the helicopter is in a left bank of around 50°.

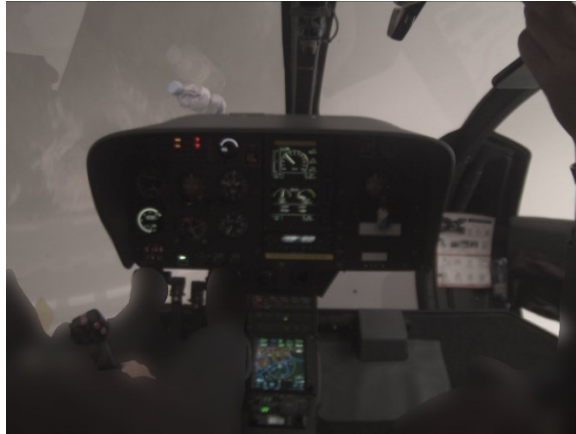
In this image, the helicopter's pitch attitude is 60° nose down towards the road visible on the bottom left side of the photo (near point 7). After a pull-out, the helicopter re-entered the clouds during the climb.

It collided with the terrain in steep climb, very probably during a pull-out. The helicopter and the rotor were nearly parallel with the slope of the terrain.
