Serious incident to the CESSNA 172 R
registered **F-HSNO**
on Thursday 7 March 2024
at Courchevel

**Take-off from a runway engaged by a snowplough, during
a sightseeing flight, in the mountains**

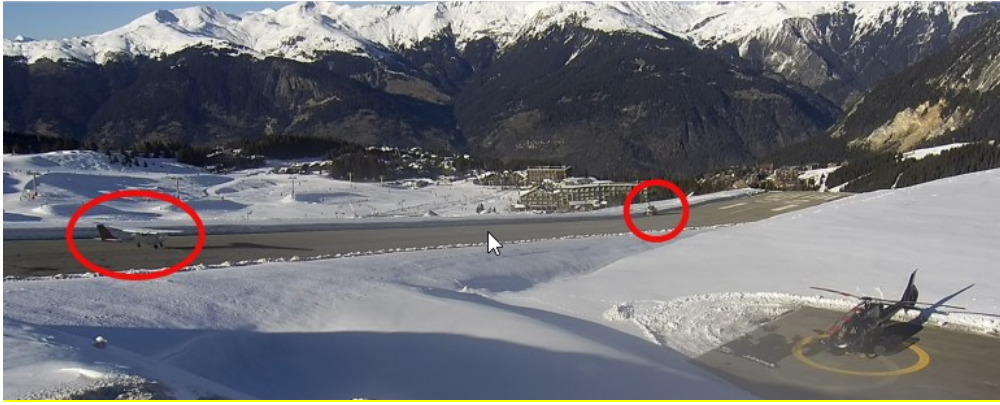
Figure 1: photo of take-off of F-HSNO (source: security camera)

The pilot of the aeroplane took off while a snowplough was clearing snow from the edge of the runway. Given the configuration of the mountain airfield and the slope of the runway, the snowplough was not visible to the pilot from the runway threshold. The AFIS officer's attention was focused on the position of a helicopter in transit in order to avoid a dangerous loss of separation with the aeroplane taking off. The AFIS officer had forgotten about the presence of the snowplough and therefore did not inform the pilot of the aeroplane about the snowplough before he took off. The driver of the snowplough did not hear the take-off announcement on the radio frequency or the noise generated by the aeroplane during take-off.

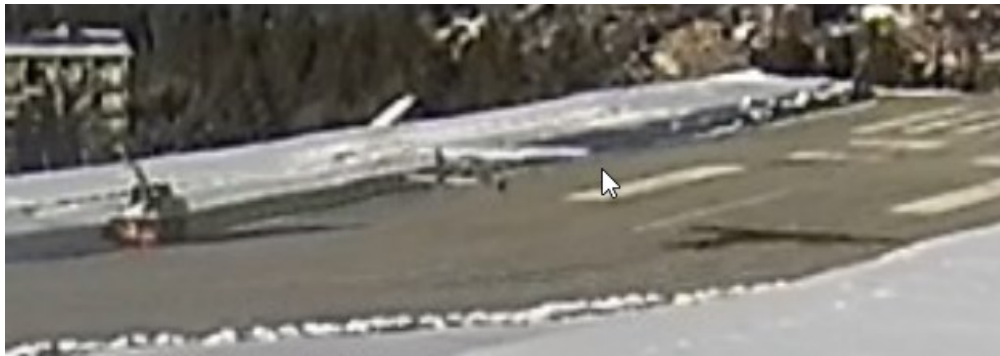
Figure 2: photo of take-off of F-HSNO (source: security camera)

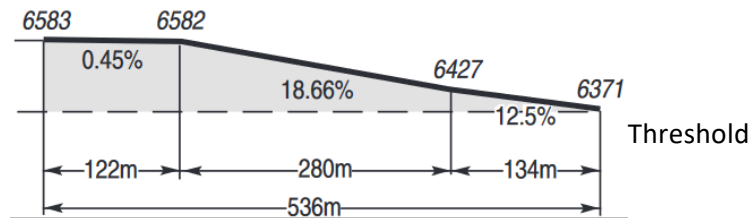
Courchevel mountain airfield is a restricted-use aerodrome with one paved runway oriented 22/04 measuring 536 m long; the threshold of runway 22 is situated at 6,371 ft. The profile of the runway is shown below:

Figure 3: lengthwise profile of runway 04/22 at Courchevel taken from VAC (source: SIA)

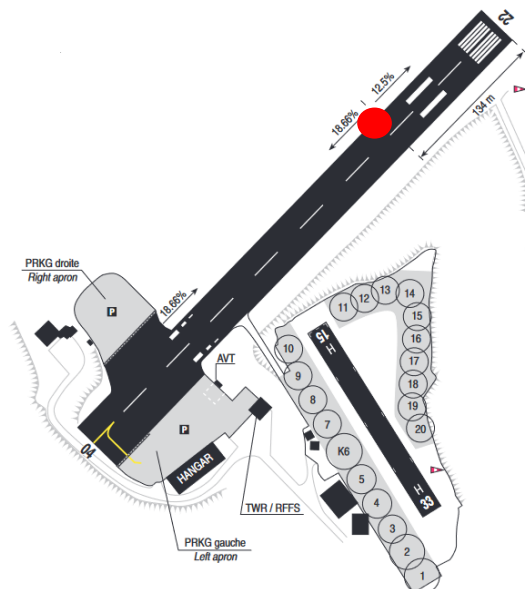
Figure 4: excerpt from Courchevel mountain airfield VAC with the position of the snowplough indicated in red (source: SIA, annotated by the BEA)

He started taxiing to threshold 04 and then called back the AFIS officer at the holding point and reported that he was ready for departure. The AFIS officer asked him to call back once he was lined up on the runway. The AFIS officer was still in contact with the Civil Defence helicopter pilot in order to determine his position and check that his flight path was not in conflict with the take-off path of F-HSNO. The AFIS officer transmitted the position of the helicopter to the pilot of F-HSNO. The latter reported that he was lined up and ready. The AFIS officer provided the wind information and the pilot took off. The aeroplane was at a height of a few metres when it passed next to the snowplough on the left-hand side of the runway, at around 150 m from threshold 22.
