TECHNICAL REPORT

Accident to the Airbus A380
registered F-HPJE and operated by Air France
on 30/09/2017 en route over **Greenland**

October 2017 - June 2018
Searches **Phase I & II**

BEA
Bureau d'Enquêtes et d'Analyses
pour la sécurité de l'aviation civile

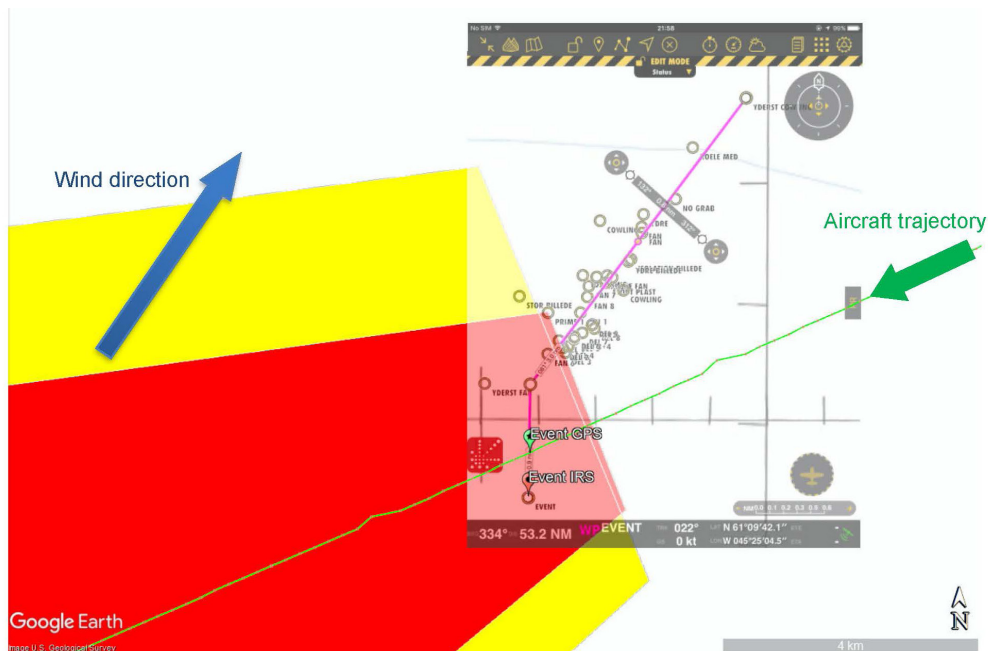
Fig. 5: map of debris located during first helicopter flight

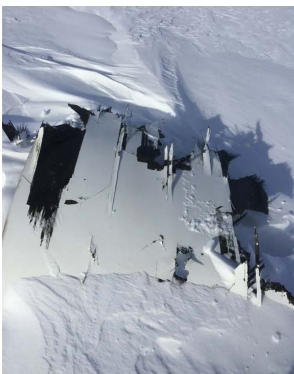
☐ N° 1: Bulkhead and fan containment case fragment: N61°45'40.1 W046°48'29.4 (Fig. 10)
☐ N° 2: Inlet part: N61°45'46.1 W046°47'52.2 (Fig. 11)
☐ N° 3: Part of composite cowl: N61°45'34.2 W046°48'22.6 (Fig. 12)
☐ N° 4: Kevlar belt: N61°46'08.9 W046°47'40.4 (Fig. 13)

Fig. 12: part of composite cowl

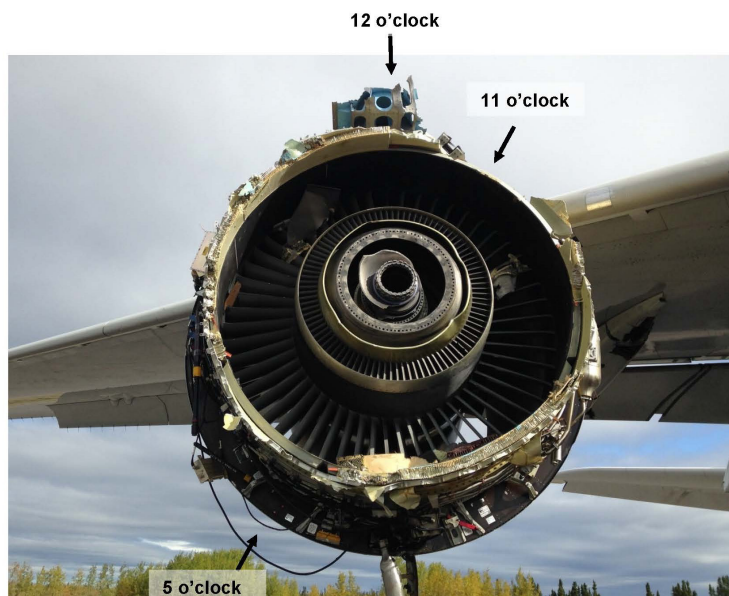
According to the damage observed on the engine, two areas exhibited significant damage consistent with the ejection of fan hub fragments. One was located at the 11 o'clock position on the engine, aft looking forward, the other at the 5 o'clock position (see Fig. 16 & Fig. 17).

Fig. 16: front view of engine N° 4 on aircraft after landing

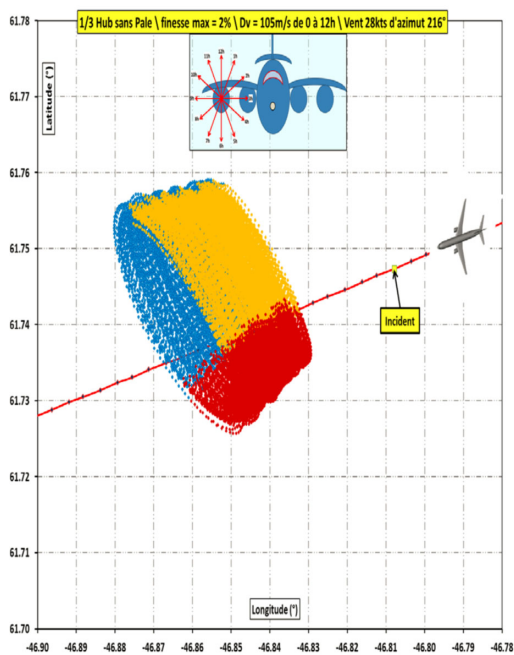
Fig. 18 to Fig. 21 show the distribution of the results depending on the angle of ejection, speed and lift/drag ratio, for a fragment of 1/3 of a hub. Angles of ejection are presented in different colours: yellow stands for the 5 to 9 o'clock position aft looking forward, blue for 9 to 1 (9 to 12 then 12 to 1) o'clock and red for 1 to 5 o'clock. Fig. 21 is an overlay of all the computed speeds of ejection.

Fig. 18: 1/3 of a fan hub with an ejection speed of 105 m/s (courtesy of Arianegroup)

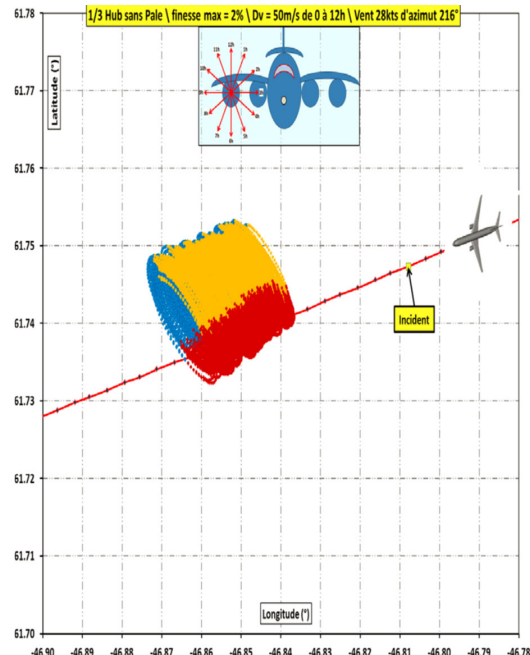
Fig. 19: 1/3 of a fan hub with an ejection speed of 50 m/s (courtesy of Arianegroup)

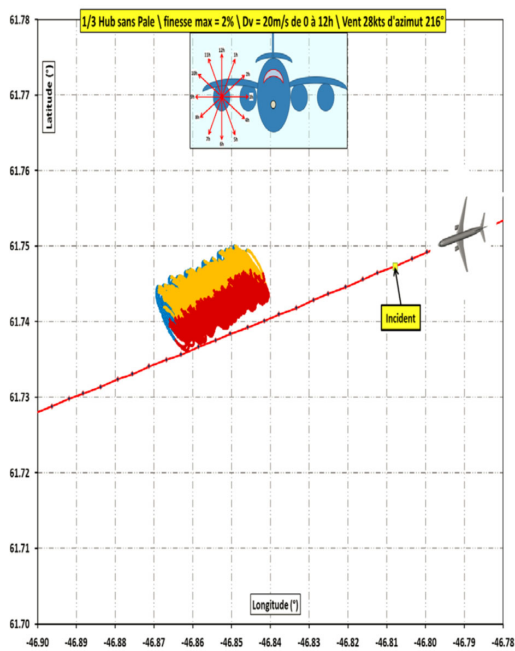
Fig. 20: 1/3 of a fan hub with an ejection speed of 20 m/s (courtesy of Arianegroup)

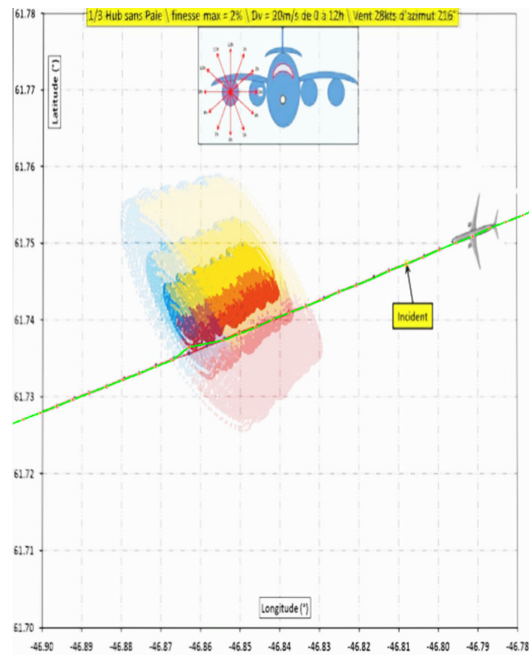
Fig. 21: overlay of the 3 computed ejection speeds for 1/3 of a fan hub (courtesy of Arianegroup)

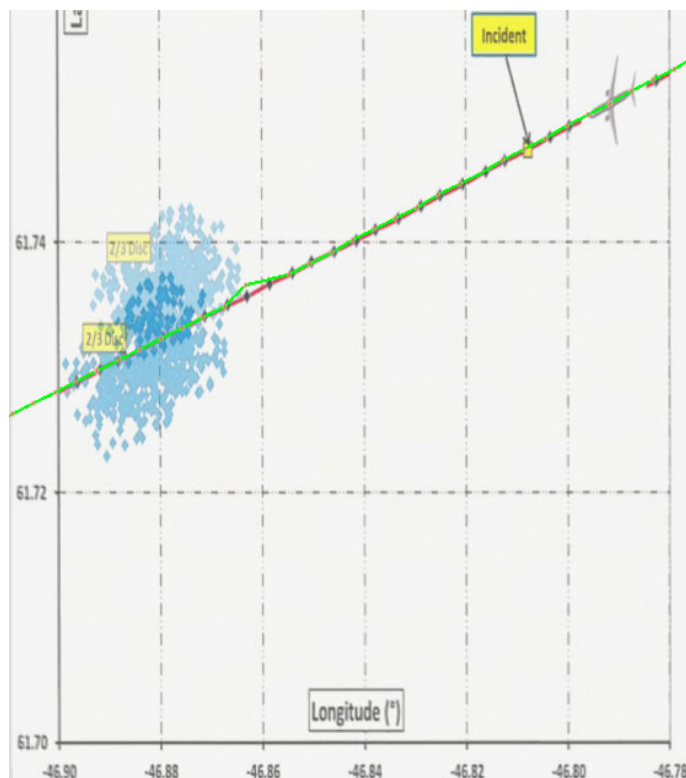
Calculations were also made for a fragment of 2/3 of a fan hub exiting the engine at the 11 o'clock position, aft looking forward, with an ejection speed of 0 and 105 m/s and lift/drag ratio from 0 to 5%. The computed points are shown in Fig. 22.

From the computations, it can be noted that a larger fragment (2/3 of a fan hub for example) will fall further west than a smaller one for the same lift/drag ratio.

Fig. 22: impact location computations for 2/3 of a fan hub

with an ejection speed of 0 and 105 m/s at 11 o'clock, lift/drag ratio from 0 to 5 %
(courtesy of Arianegroup)

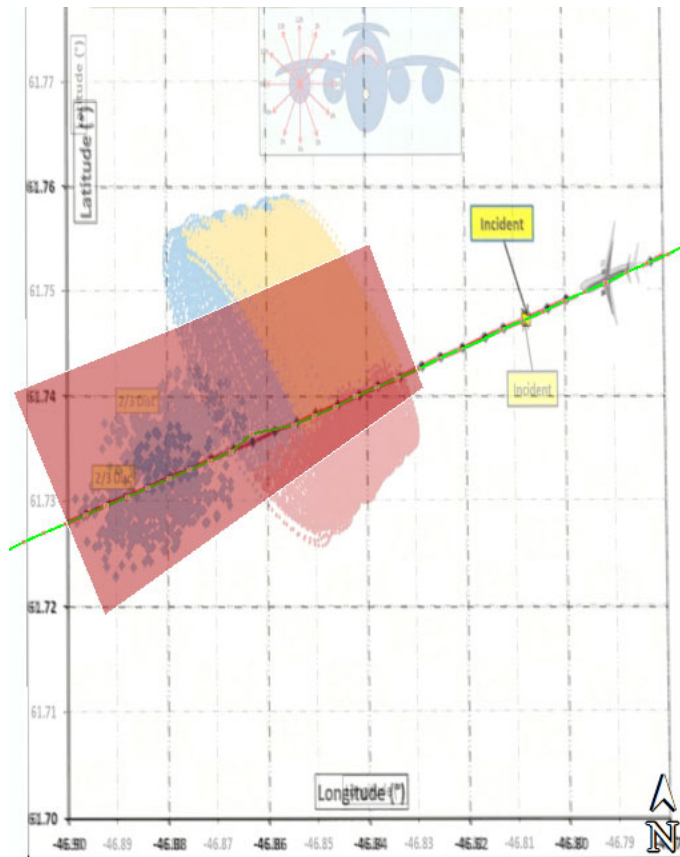
The resulting search surface, shown in Fig. 23 in red, encompasses the computation results for 1/3 and 2/3 of a fan hub and extends over 8.3 km^2. It was defined considering that an angle of ejection at 3 o'clock was not consistent with the damage observed on the engine. In the same way, no damage was observed on the fuselage so an angle of ejection of 9 o'clock was very unlikely. Therefore, the northern part of the blue and yellow points as well as the southern part of the red points were eliminated.

Fig. 23: search area considered after Arianegroup computation. Northern blue and yellow points correspond to the 3 o'clock ejection angle, which was not consistent with damage on the engine. Southern red points correspond to the 9 o'clock ejection angle (toward the fuselage), not consistent either

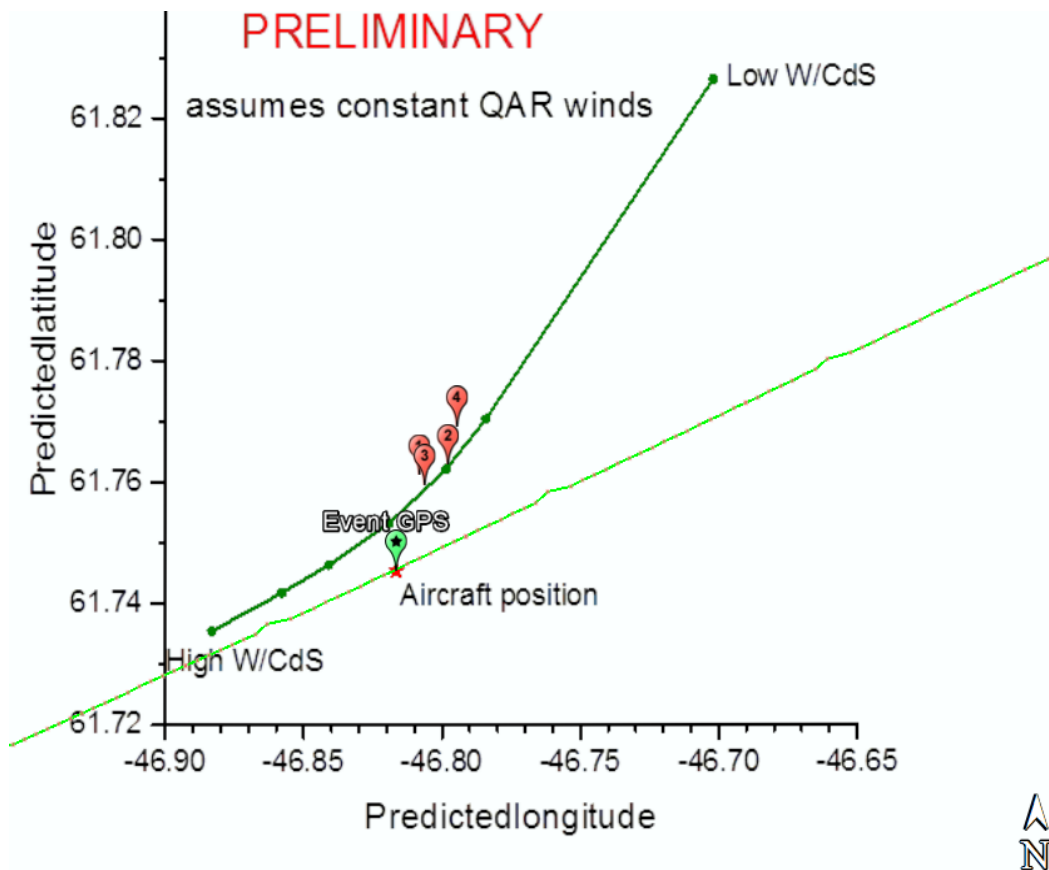
Assuming constant wind during the fall (27 kt, 214°) led to the curve in Fig. 24. In this diagram, points 1 to 4 were the recovered pieces of debris presented in paragraph 1.1:

Fig. 24: ballistic locus considering constant wind, with no ejection angle (courtesy of NTSB)

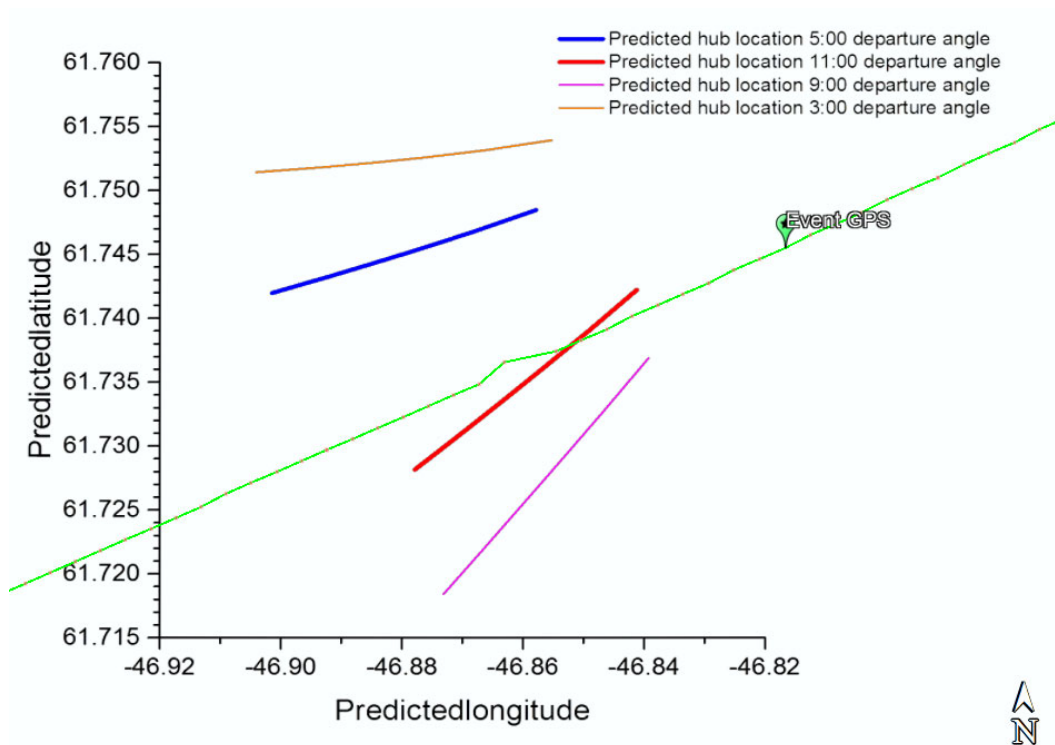
Physical evidence on the engine indicated departure angles of the fragments at 5 and 11 o'clock positions, aft looking forward.

This adds ballistic locus segments as shown in Fig. 25. The length of the locus reflects the range of estimated ballistic coefficients for the fragments. A range of ballistic coefficients that covered variation in size/shape between the two fragments was considered. The 3 o'clock and 9 o'clock exit angles were used to bracket the problem with a pure sideways departure from the airplane (9 o'clock is not realistic as no fragment hit the fuselage).

Fig. 25: predicted hub fragment location vs departure angle (courtesy of NTSB)

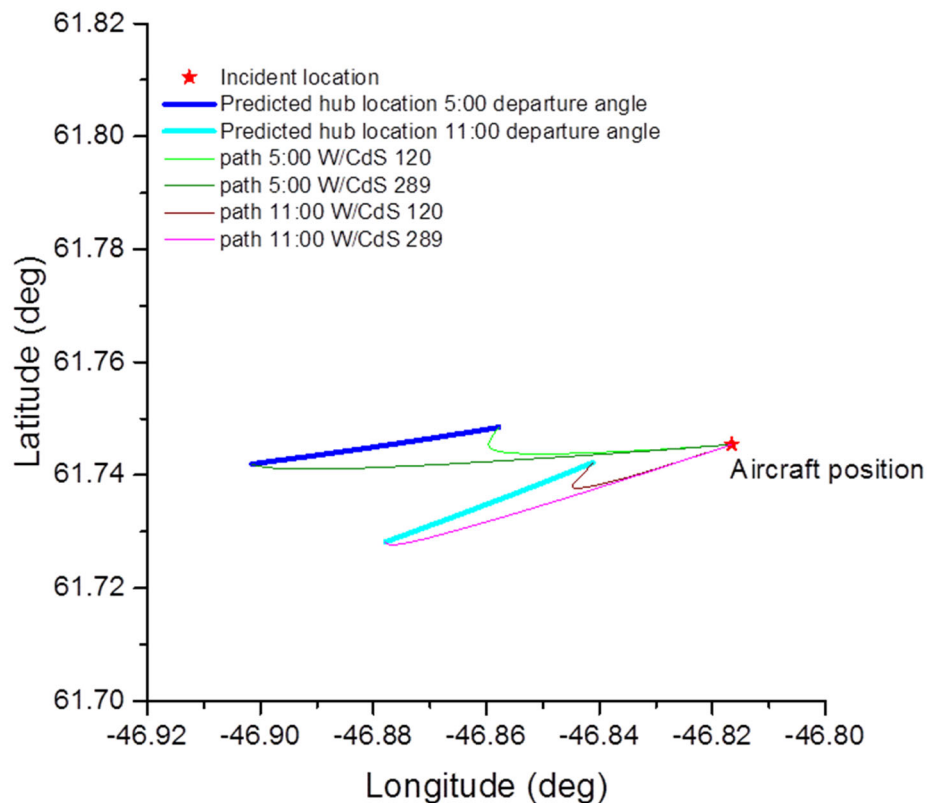
Fig. 26 shows the paths of the low and high ends of the ballistic range that were used for both the 5 o'clock and 11 o'clock engine exit angles.

Fig. 26: effect of ballistic coefficient range on predicted hub location
(courtesy of NTSB)

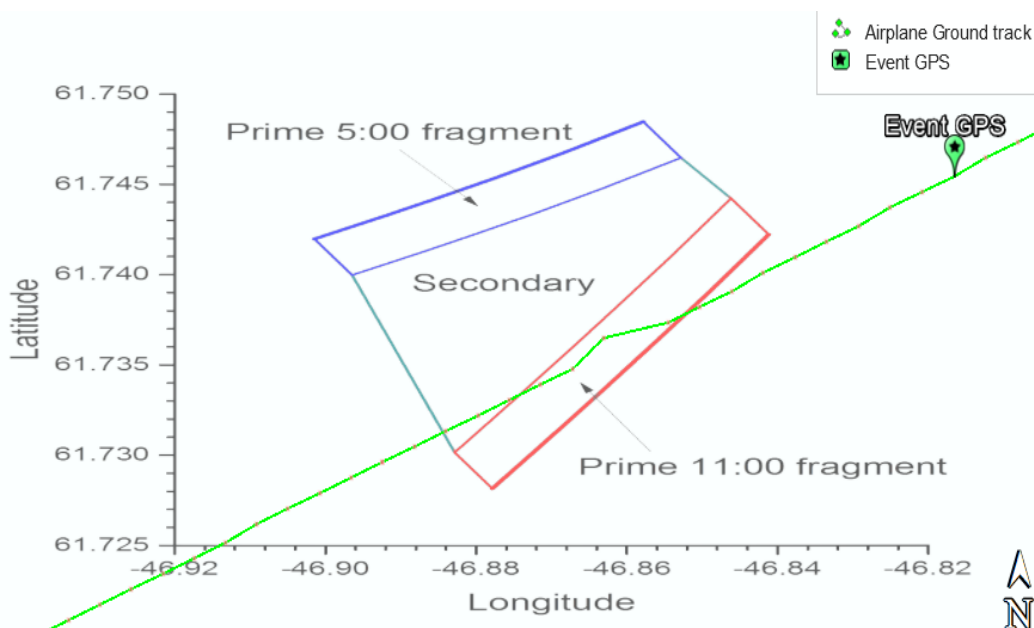
Some uncertainty in the angle of exit was considered to determine two primary search areas, see Fig. 27. The loss of energy is taken into account with the secondary area, as 100% of loss of energy would result in the ballistic locus presented in Fig. 24.

Fig. 27: NTSB primary and secondary areas (courtesy of NTSB)

In total, prime areas extend over 0.68 and 0.84 km^2 for the 5 and 11 o'clock positions respectively, and the secondary area extends over 2 km^2, for a total of 3.52 km^2.

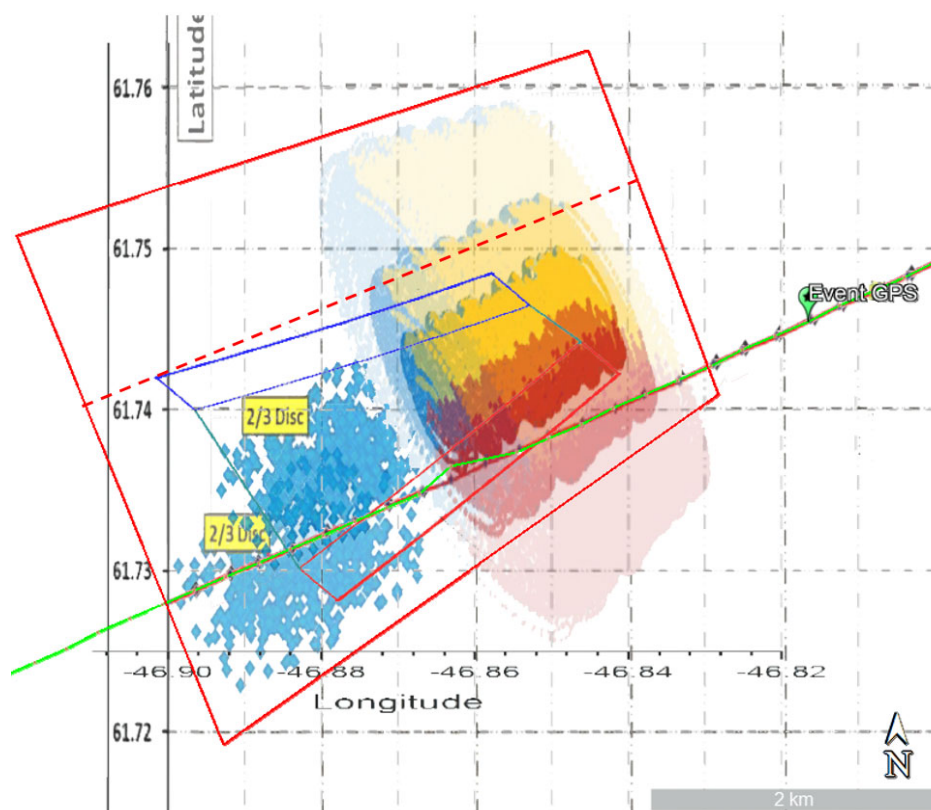
An overlap of NTSB and Airbus computations was displayed, leading to the search area presented in Fig. 28. This red box can be divided into two parts: the southern part is deemed as the most promising area with regards to the computations, as most of the calculation results stand in this area. The northern part is an extension of the southern part, encompassing the highest ejection speeds of the Airbus computation.

The total box is 12 km^2, while the southern part is 7 km^2 and the northern part, 5 km^2.

Fig. 28: search area (red box) encompassing Ariane ballistic computation (*1/3 and 2/3 hub*), and NTSB computation

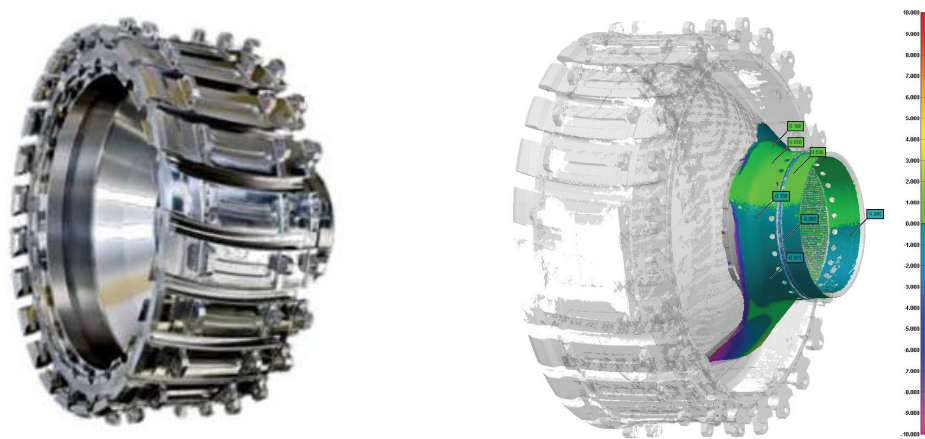
A fragment of 18 kg was still attached to the LPT (Low Pressure Turbine) shaft and recovered by the BEA during the on-site examination, leaving 220 kg still missing.

As part of the investigation, laser 3D scans were carried out on the recovered part of the hub and on an intact hub. This allowed, by subtraction, to assess the shape of the missing part(s) (see Fig. 33).

Fig. 33: intact exemplar fan hub (left picture) – recovered part from F-HPJE (in color, right picture)

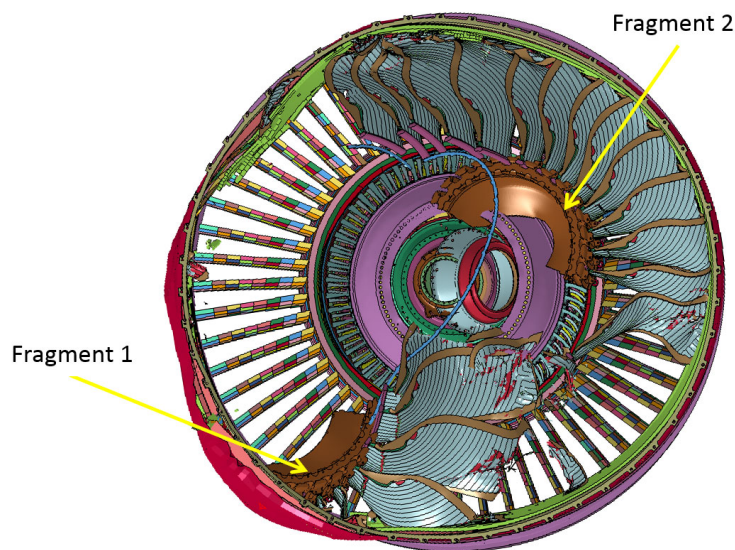
Damage on the engine exhibited two areas of potential ejection of the hub fragments: one located in the 5 o'clock position, aft looking forward, and the other in the 11 o'clock position. Moreover, a LS-Dyna simulation was performed by the engine manufacturer, Engine Alliance (Fig. 34). It showed that the hub would have separated into two parts if the fan hub body ruptured. According to the simulation, one fragment would weigh 91 kg and the other 127 kg. This is consistent, with a 2 kg error, with the size of the hub remnant found attached to the shaft.

Fig. 34: LS-Dyna fan hub failure simulation (picture courtesy of Engine Alliance)

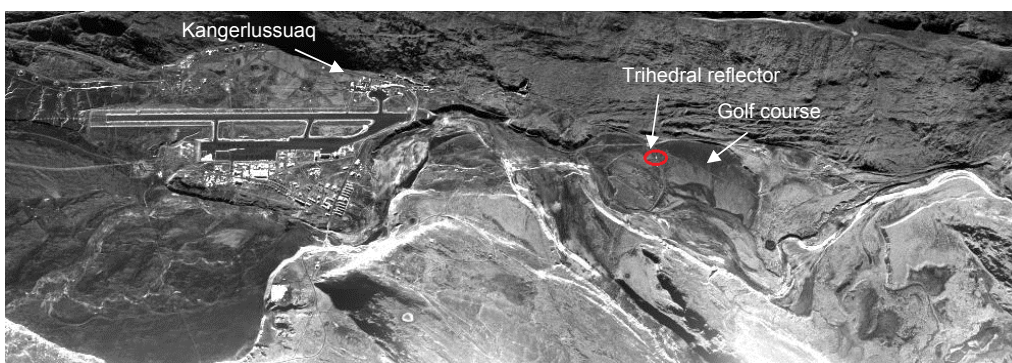
Fig. 52: X-band radar imagery of Kangerlussuaq area

Data post-processing started immediately after the flight. Electronic delays were measured and processing parameters were refined. Radar images of the areas were produced, as shown in Fig. 52. On this picture, the trihedral (red circle) could be clearly detected. It was also possible to see the ground features underneath the snow, demonstrating that snow was well penetrated by the X band.

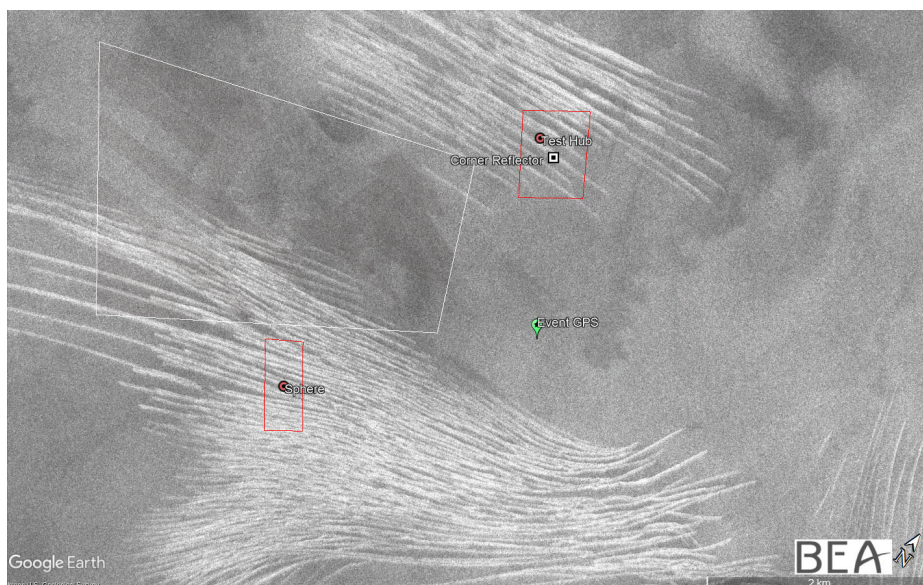
Fig. 57: search area with crevasses seen with P band

❒ The search area lay over a field of crevasses, clearly seen with the L and UHF (P) bands, and barely seen with the X band (see Fig. 57). An analysis over the crevasses indicated that the UHF (P) band could penetrate at least 15 m within the ice sheet/snow cover, the L band at least 3 and 5 m and the X band was believed to detect the surface only (or penetrate some surface snow).

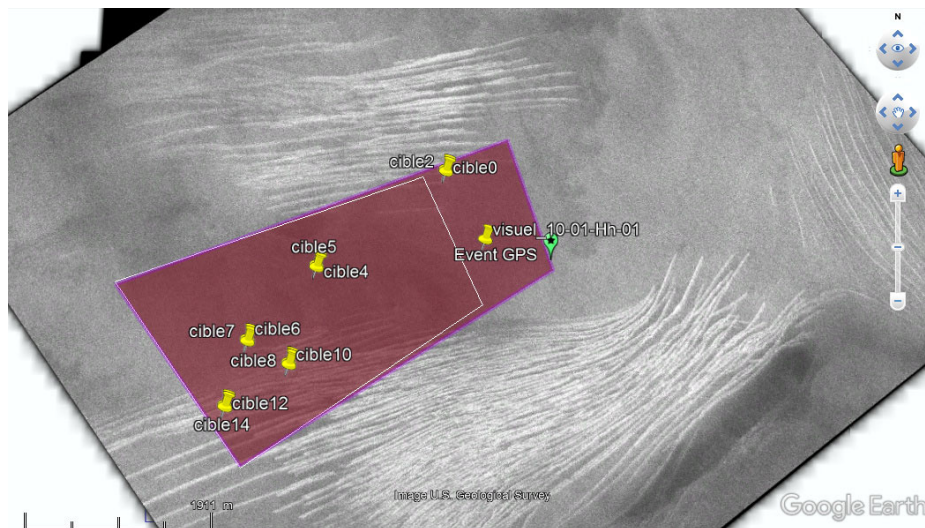
Fig. 69: potential points within search area, further analyzed for confirmation and relevance

With this new criterion, new targets were identified within the search area, but refinement and confirmation of the relevance of these targets was still being analyzed in the following days with advanced processing techniques (Fig. 69).

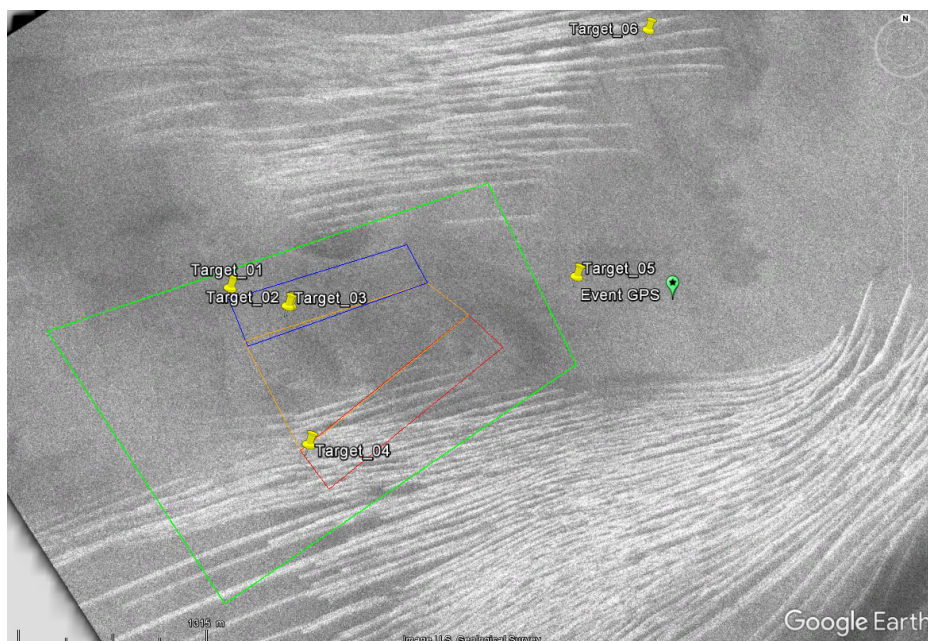
Fig. 70: targets identified by ONERA, given to GEUS team.
The background image is a radar image provided by ONERA from the measurement campaign showing clear crevasse fields

The target coordinates were given to GEUS. According to ONERA, a 5 m-radius circle had to be considered as a measurement uncertainty.

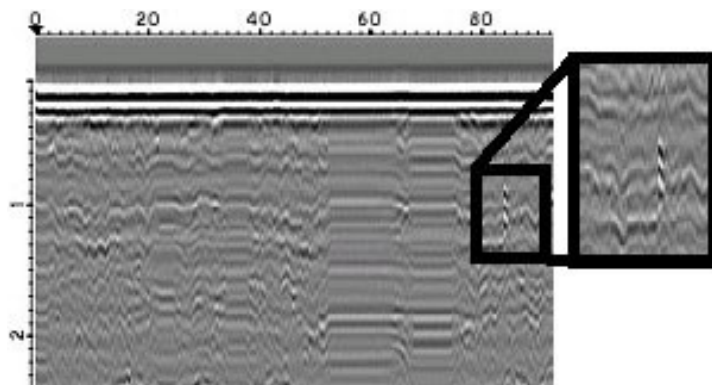
Fig. 73: test hub signature on GPR imagery

Based on this survey, they decided that it was safe enough to drive out and retrieve the buried fan hub and the corner reflector. The corner reflector was too close to the surface to show on the radar but the test fan hub was visible (Fig. 73). It seemed that the radar antenna should ideally be within one meter of the fan hub for the signal to be very clear so survey plans had to be revised for the radar grids to be denser. Initial passes were 5m in width. Based on the test hub results, the swath was determined to be too large for confident detection. The width of the detection passes was reduced to 2 m and finally 1 m.

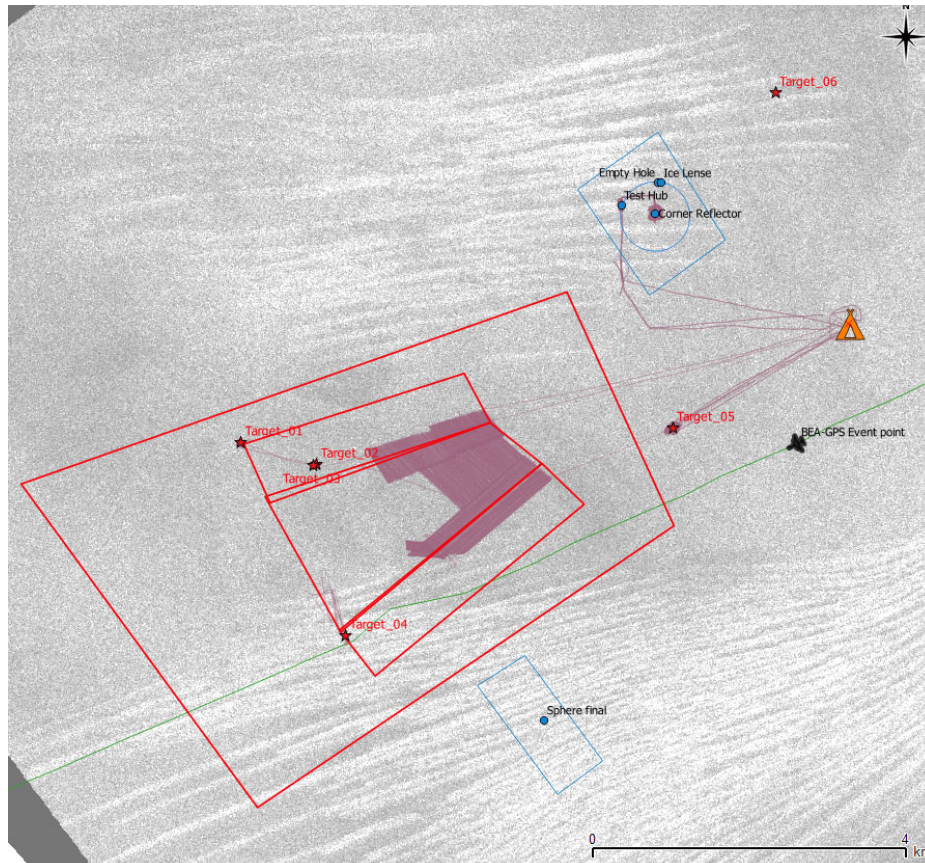
Fig. 77: ground search coverage (in purple) by GEUS team – background is a radar image in P-band

No further search was performed as the team encountered severe weather until the end of the campaign (see paragraph 3.5.3). The final radar coverage of the ground campaign is shown in Fig. 77. It represents approximately 430 km of 1 m wide radar tracks.

As the GEUS field campaign was based on target detections by the ONERA airborne campaign, once the six targets provided were looked at with no result, it had to be reconfigured into a systematic search campaign. Unfortunately, the GPR proved to be an inadequate sensor for a systematic search. Even with 430 km of search tracks analyzed, it could not be certified that if the part had laid under those tracks, it would have been detected.
