## Activation of ballistic airframe parachute: cognitive, emotional and physical mechanisms

### Appendix: Statements from pilots who activated a ballistic airframe parachute between 2015 and 2022

## 1 ACCIDENT TO THE AIRLONY SKYLANE IDENTIFIED 54AXD ON 9 JULY 2022 AT BOUEE

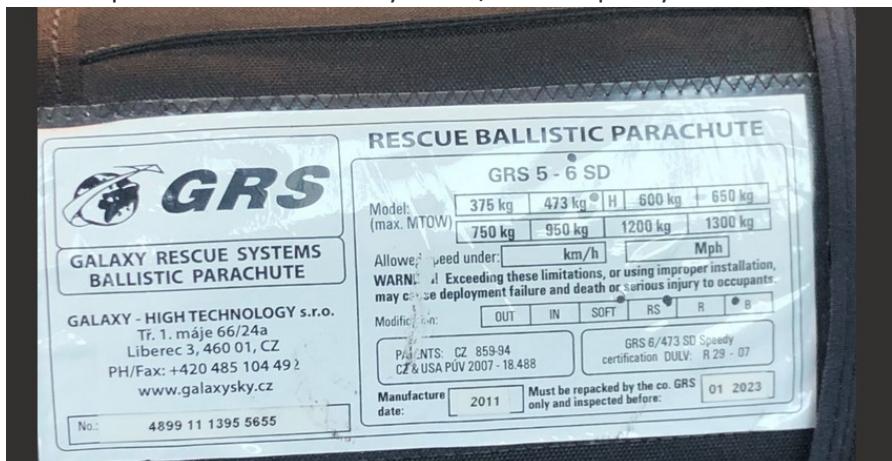
The ballistic airframe parachute was a Galaxy GRS 6/473 SD Speedy DULV.

Figure 2: photograph of characteristics of ballistic airframe parachute (source: pilot)

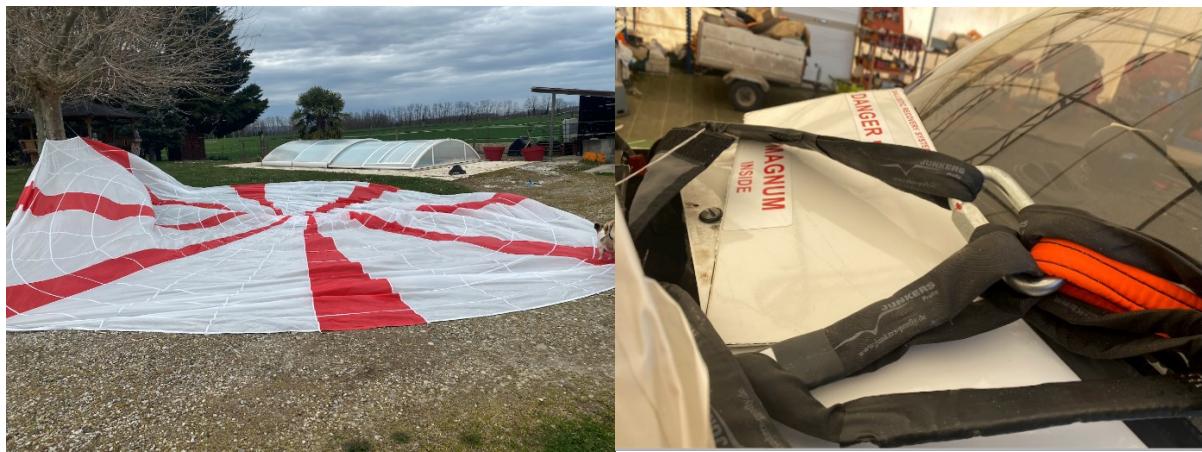
Figure 5: ballistic airframe parachute (on left-hand side: parachute canopy, on right-hand side: interfaces, harnesses)

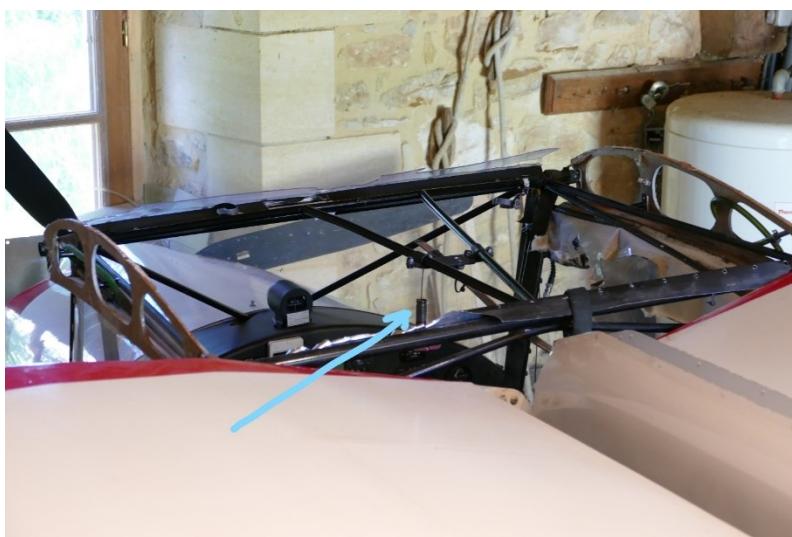
24QI was an Avid Flyer Lite, bought second-hand in 2008 in Germany where ballistic airframe parachutes are mandatory for microlights. The microlight was therefore already equipped with a BRS ballistic airframe parachute. The activation handle is located between the seats, at the height of the pilot's ear. The handle has to be pushed forward to activate the parachute.

Figure 7: photo of handle (source: pilot)

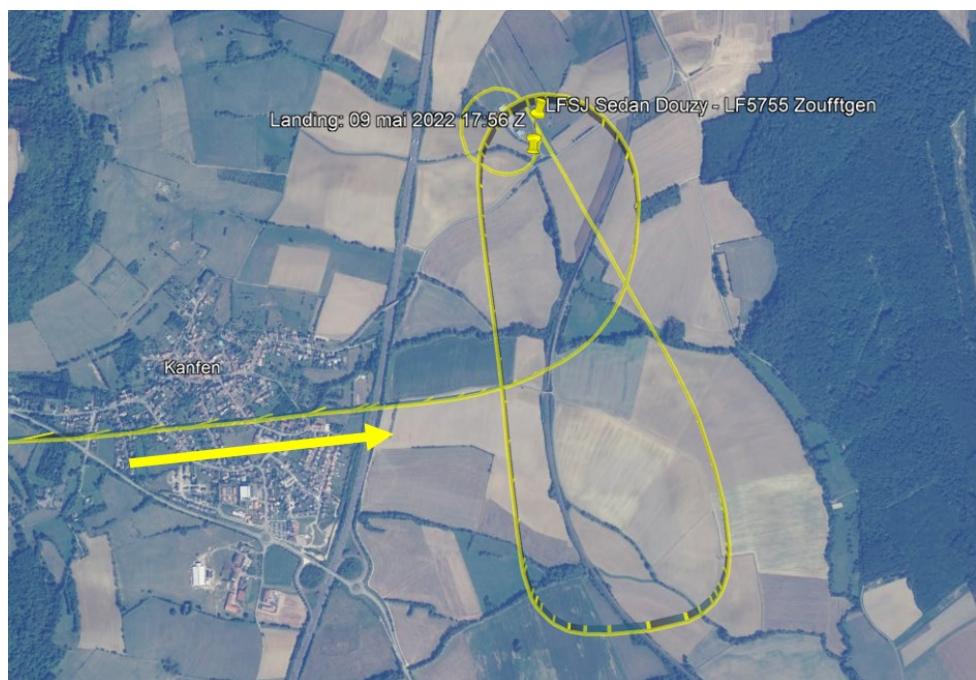
The pilot, unaccompanied, took off at 19:15 from Sedan Douz aerodrome for a flight bound for Zoufftgen microlight strip. On arriving at Zoufftgen, the pilot flew over the strip and then flew outbound on the LH downwind leg to land on runway 33<sup>3</sup>. On short final at Zoufftgen, during the flare, the pilot encountered alignment problems, with the nose of the microlight veering to the left-hand side. Not satisfied with his flare, he carried out a go-around. He realised that the rudder pedals were blocked with the rudder deflected to the left. The pilot tried to stabilize the microlight with the ailerons by carrying out a sideslip but his actions were only partially effective and the microlight had difficulty gaining height. The pilot carried out a long left-hand loop before arriving overhead the runway. Considering that the microlight was no longer controllable, the pilot switched off the magnetos and activated the ballistic airframe parachute. Due to the low height, there was not sufficient time for the parachute to completely open. The microlight collided with the ground and the pilot was seriously injured.

Figure 12: approach path to Zoufftgen on SkyDemon (source: pilot)

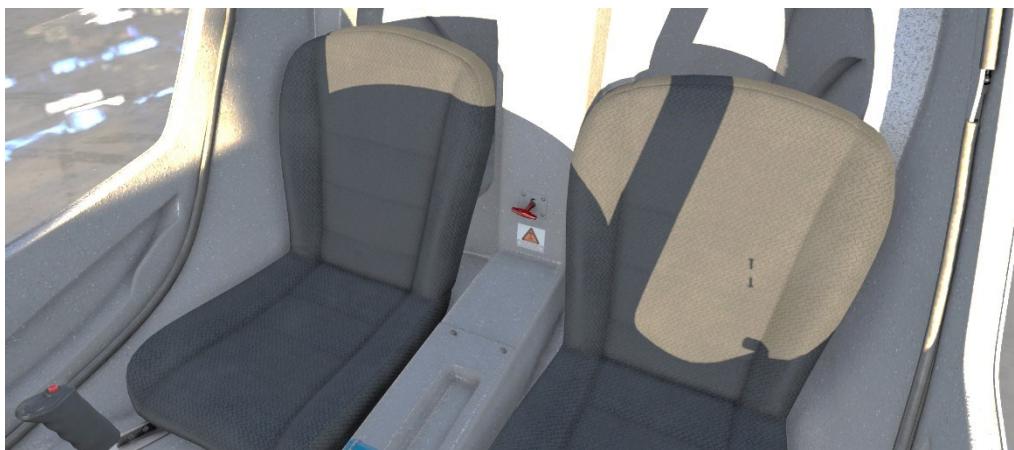
The microlight, owned by the pilot, was a Flight Design CTSL. The BRS parachute had been installed by the manufacturer, Flight Design. The handle is situated between the seat backs. To activate the parachute, the handle has to be pulled forward and out of its housing. According to the pilot, the handle has to be pulled around 25 cm. The microlight was substantially damaged by the accident, with damage to the propeller and the rupture of the landing gear.

Figure 15: activation handle
