Study BEA

Piston engine induction system icing

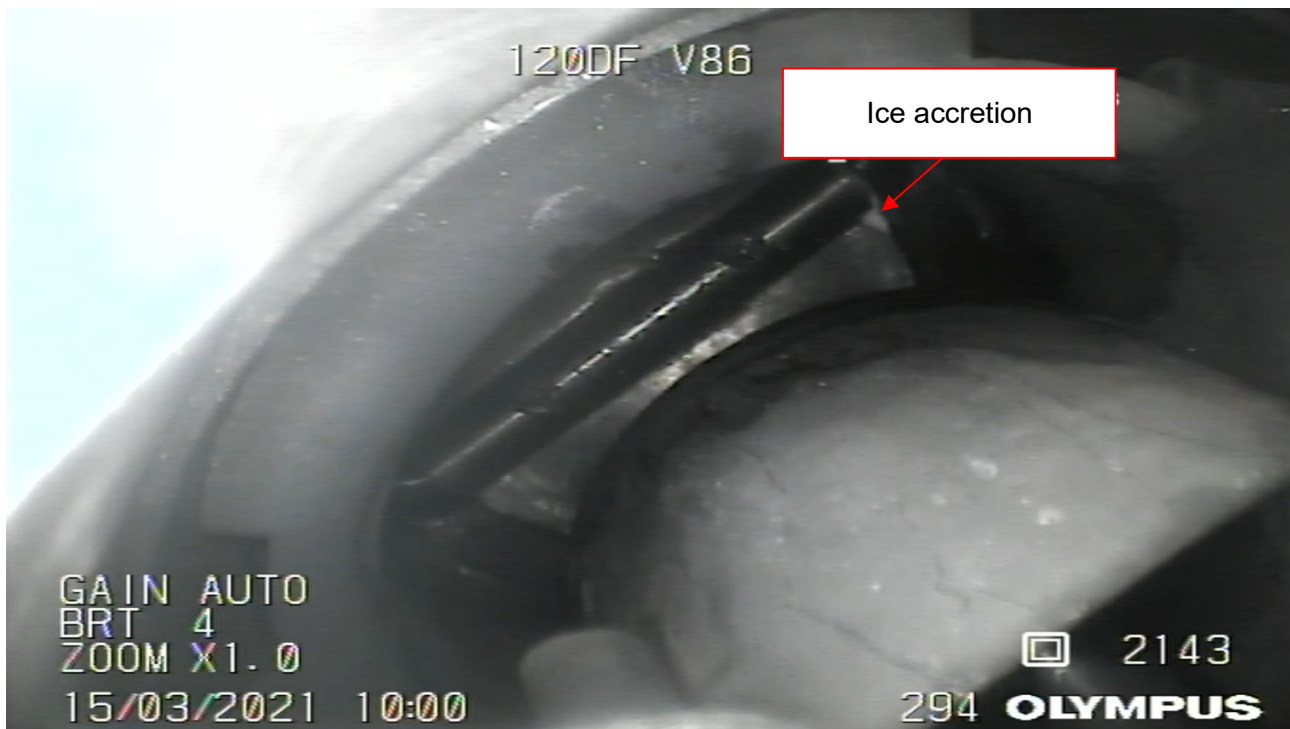
Figure 103: initiation of icing => time designated t_0
Source: BEA

The first symptoms were visual. A deposit of white ice formed very rapidly at the connection between the butterfly shaft and the butterfly, on one side (Figure 103). To facilitate understanding, this time is designated t_0 .

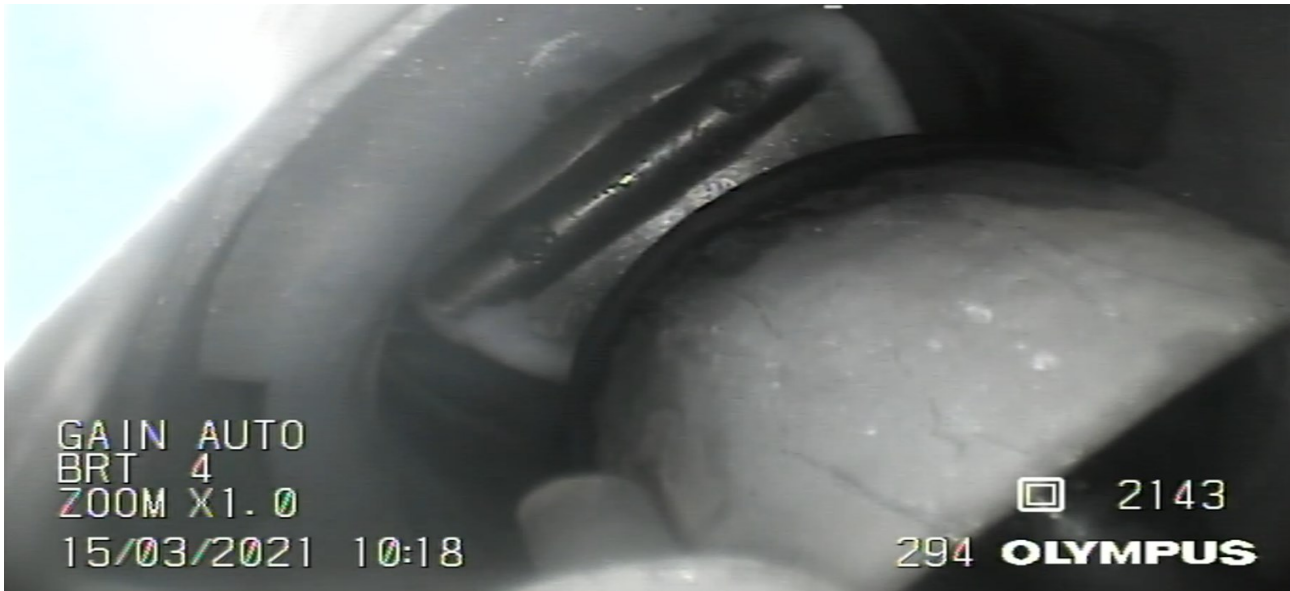
Figure 108: progress of icing => initiation of phase two => time designated t_1
 Source: BEA

During this phase, the engine speed rose to 1,700 rpm due to an input on the throttle lever. The time at which the speed rose to 1,700 rpm was designated t_1 (Figure 108).

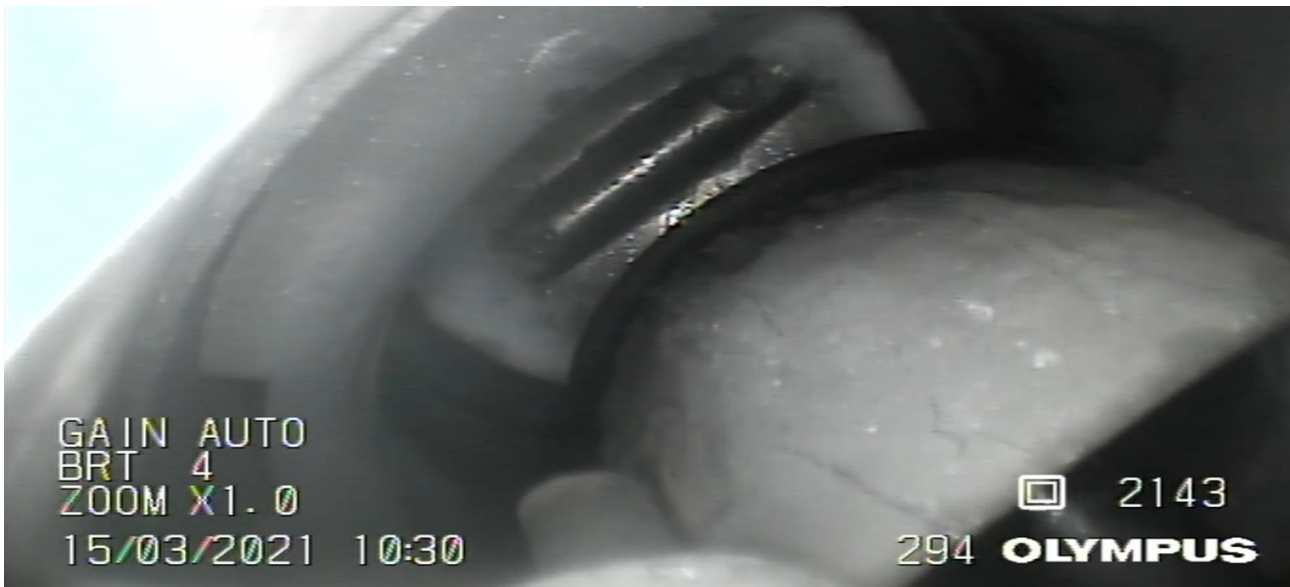
Figure 109: progress of icing => time designated $t_1 + 11\text{min}40\text{s}$
 Source: BEA

When the speed reached 1,700 rpm, it started to decrease linearly. The speed decreased by 110 to 120 rpm during the time period $[t_1, t_1 + 11 \text{ min } 40 \text{ s}]$ (Figure 109).

During this interval, the EGT decreased by around 80°C .

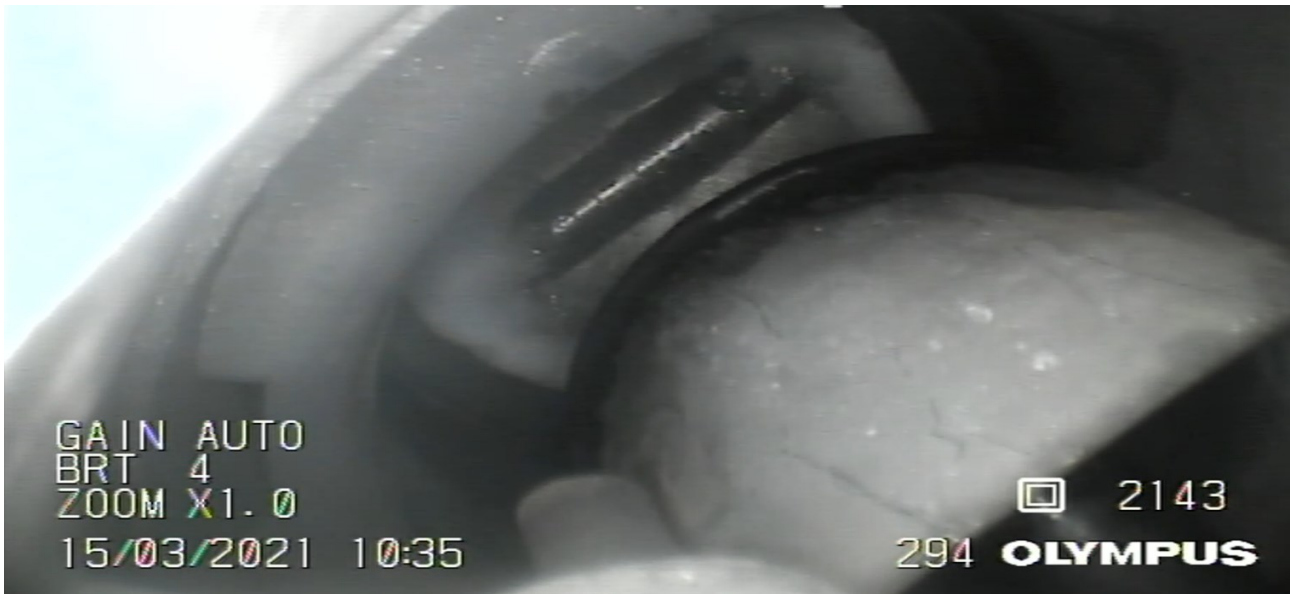
Figure 110: progress of icing => initiation of phase three => time designated t_2
Source: BEA

To facilitate understanding, the time at which the speed rose to 1,700 rpm was designated t_2 (Figure 110). At this time, the ends of the butterfly shaft and the outside edge of the butterfly were completely covered with ice.

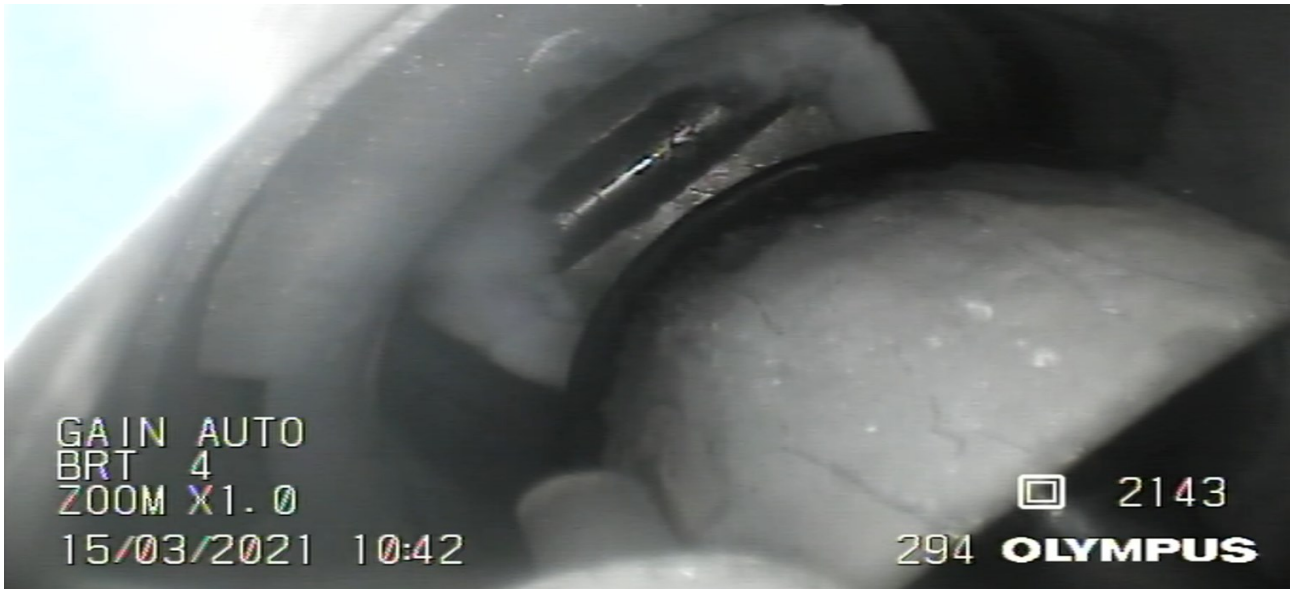
Figure 111: progress of icing => time designated $t_2 + 7$ min
 Source: BEA

As in phase two, when the speed reached 1,700 rpm, it started to decrease linearly. The speed decreased by 110 to 120 rpm during the time period $[t_2, t_2 + 7 \text{ min}]$ (Figure 111). The decrease in speed was more rapid than in phase two, which would suggest the non-linear formation of ice.

The speed of 1,700 rpm was maintained for 18 minutes. We noted that the amount of visually identifiable ice appeared to stagnate from $t_2 + 7$ min. The EGT, the temperature of the outer surface and the temperature downstream of the butterfly remained stable.

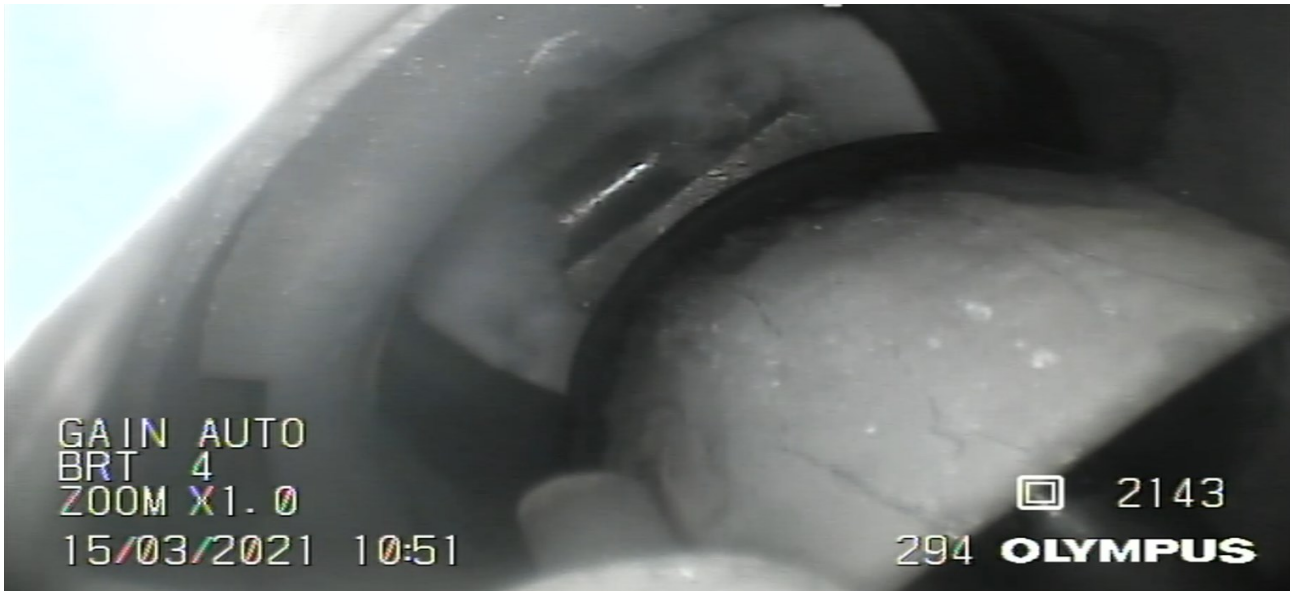
Figure 112: progress of icing => initiation of phase four => time designated t_3
Source: BEA

During this phase, the engine speed rose to 1,800 rpm due to an input on the throttle lever. The time at which the speed rose to 1,800 rpm due to an input on the throttle lever was designated t_3 (Figure 112).

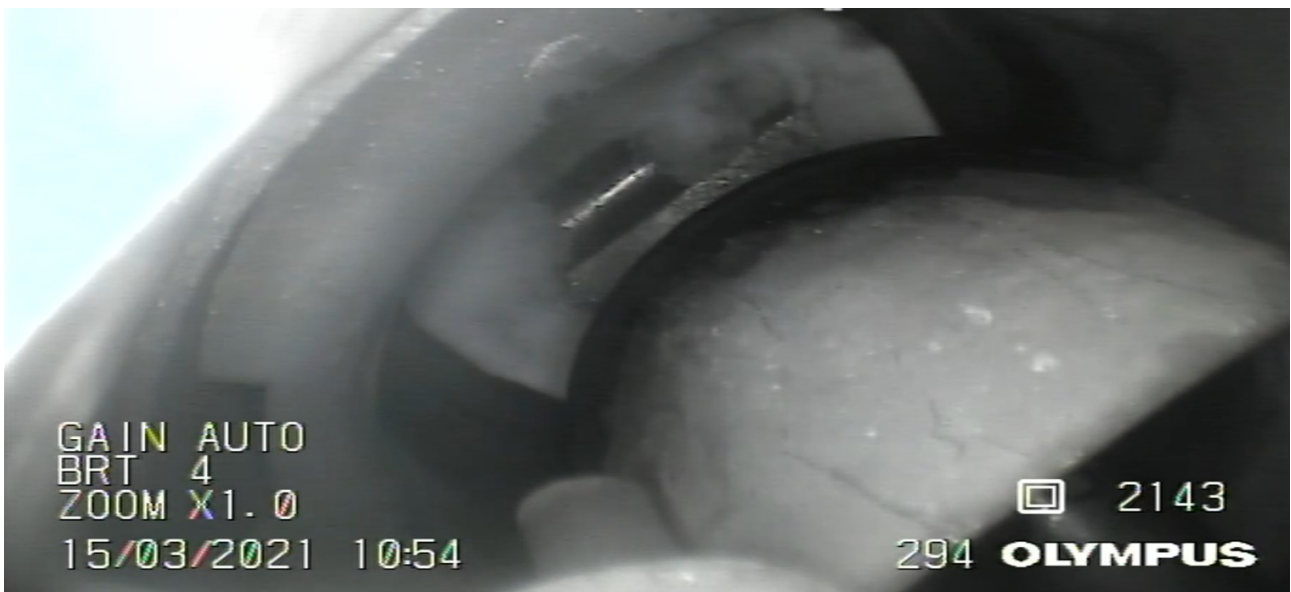
Figure 113: progress of icing => time designated $t_{3+3\text{min}20\text{s}}$
Source: BEA

When the speed reached 1,800 rpm, it started to decrease linearly. The speed decreased by 80 to 90 rpm during the time period [t_3 , $t_3 + 3 \text{ min } 20 \text{ s}$] (Figure 113). The EGT, the temperature of the outer surface and the temperature downstream of the butterfly remained stable:

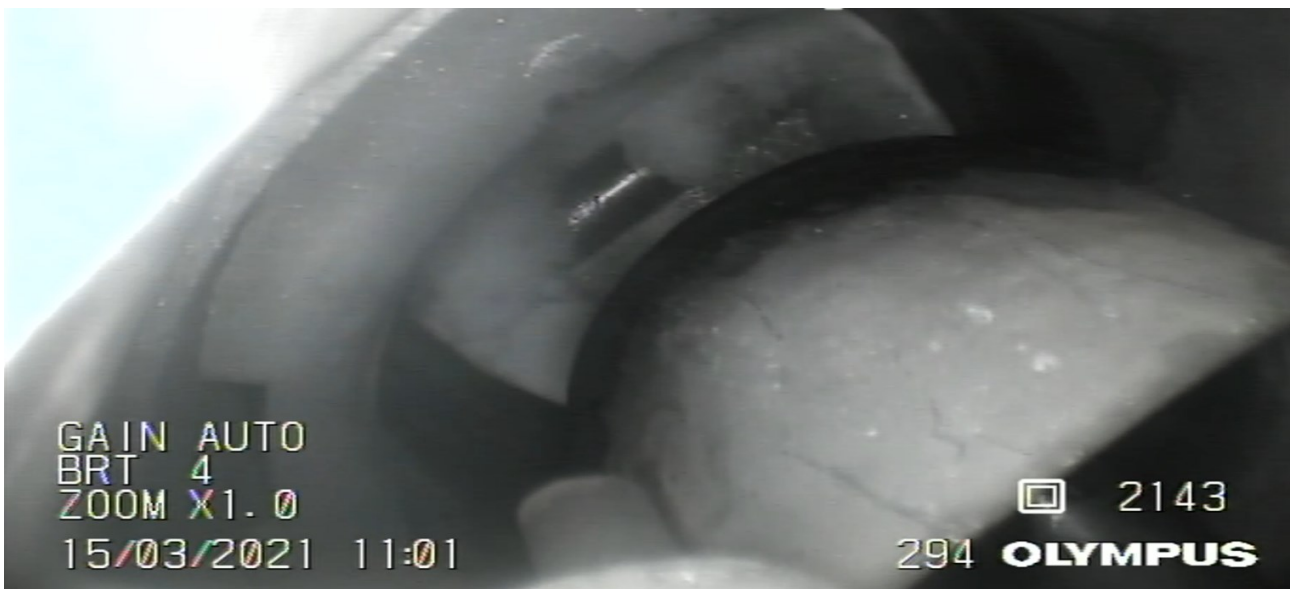
Figure 115: progress of icing => time designated $t_{4+4\text{min}}$
Source: BEA

When the speed reached 1,900 rpm, it started to decrease linearly. The speed decreased by 80 to 90 rpm during the time period $[t_4, t_4 + 4 \text{ min}]$ (Figure 115). The EGT, the temperature of the outer surface and the temperature downstream of the butterfly remained stable:

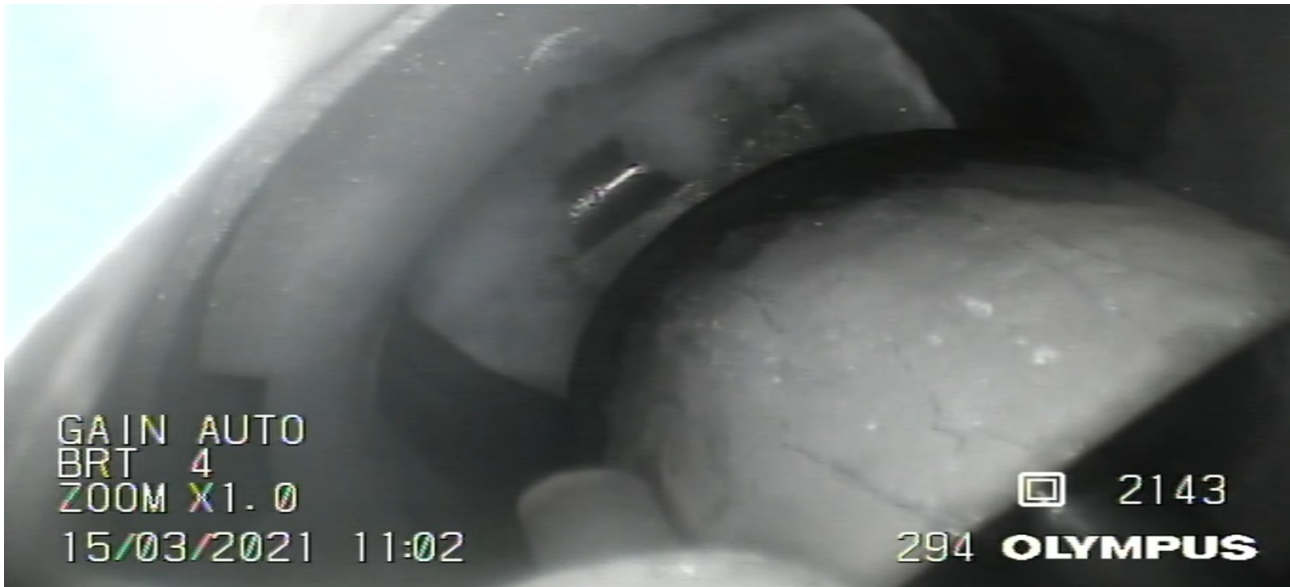
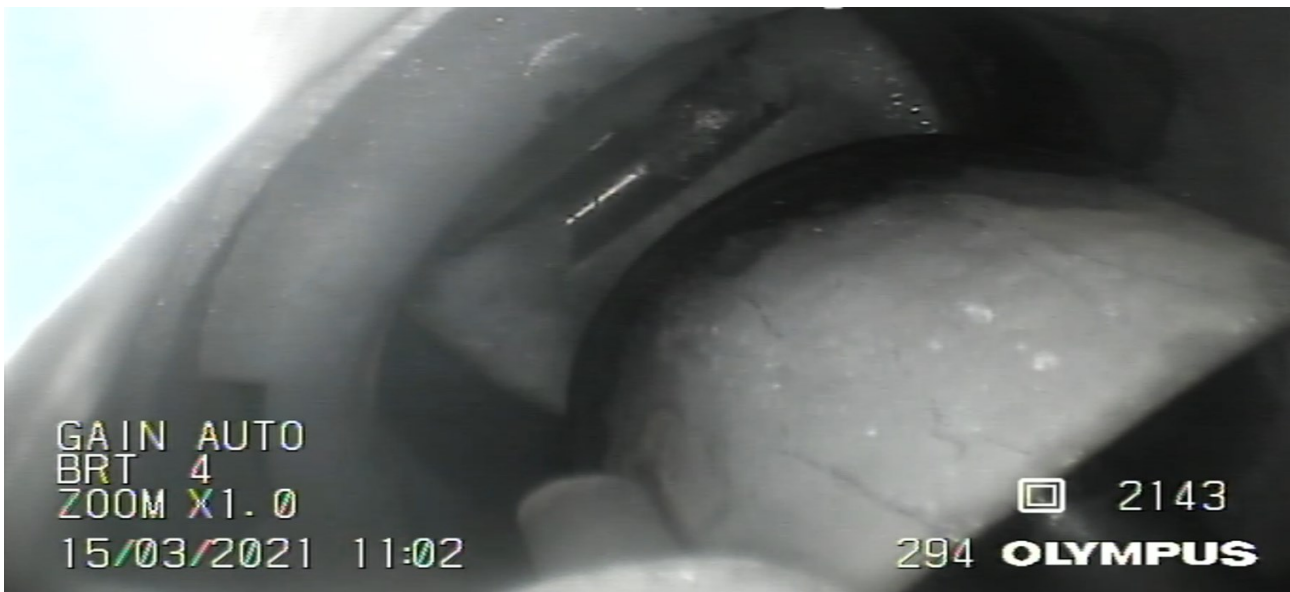
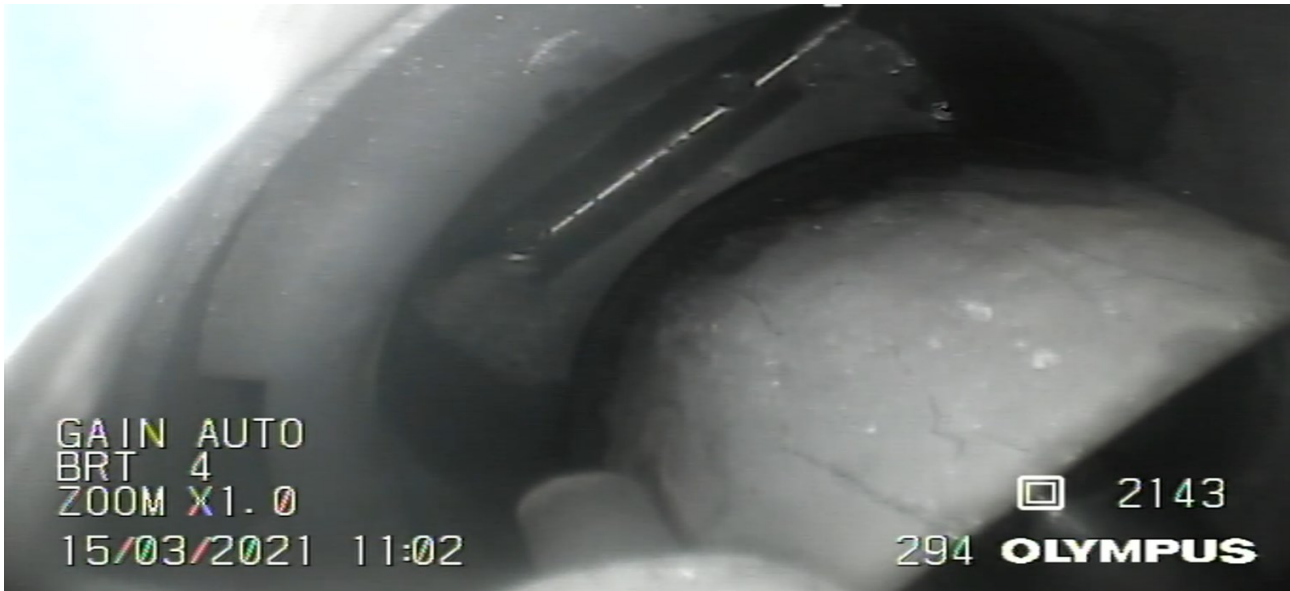
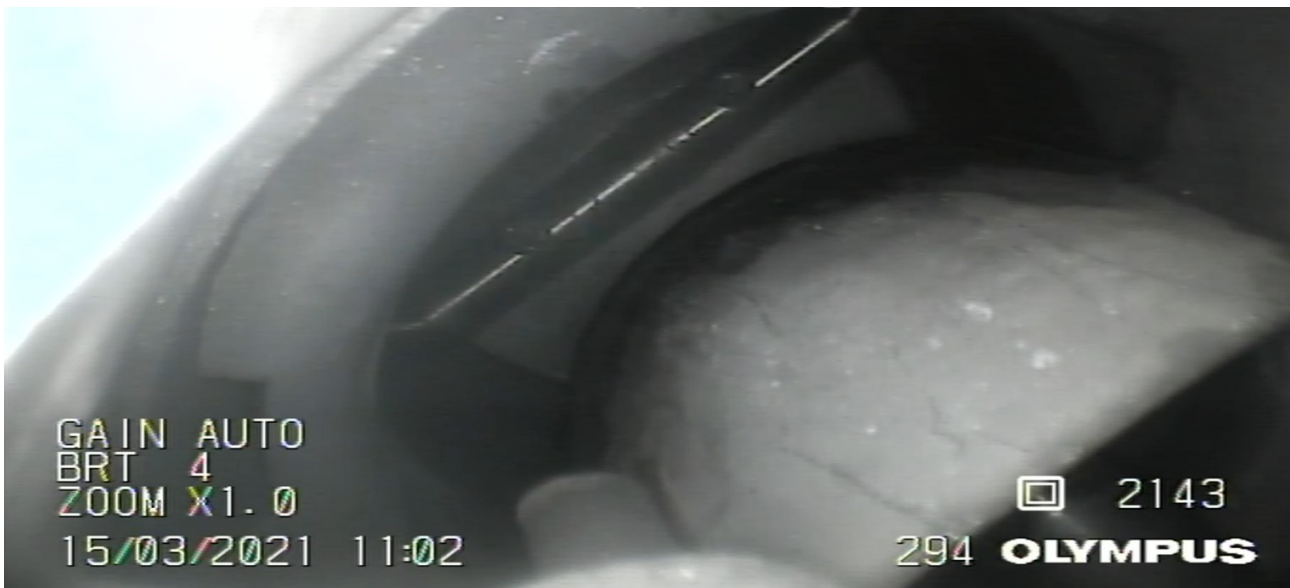
- $t_{5:5}$: immediately before activation of the heat system (Figure 116);
- t_6 : time when no fragments of ice could be seen (Figure 119);
- t_7 : deactivation of the heat system.

- $[t_5, t_6] = 11$ s;
- $[t_5, t_7] = 21$ s.

When the heat system was activated, there was an abrupt decrease in speed of around 150 rpm. The speed then increased very rapidly (without any input on the throttle lever):

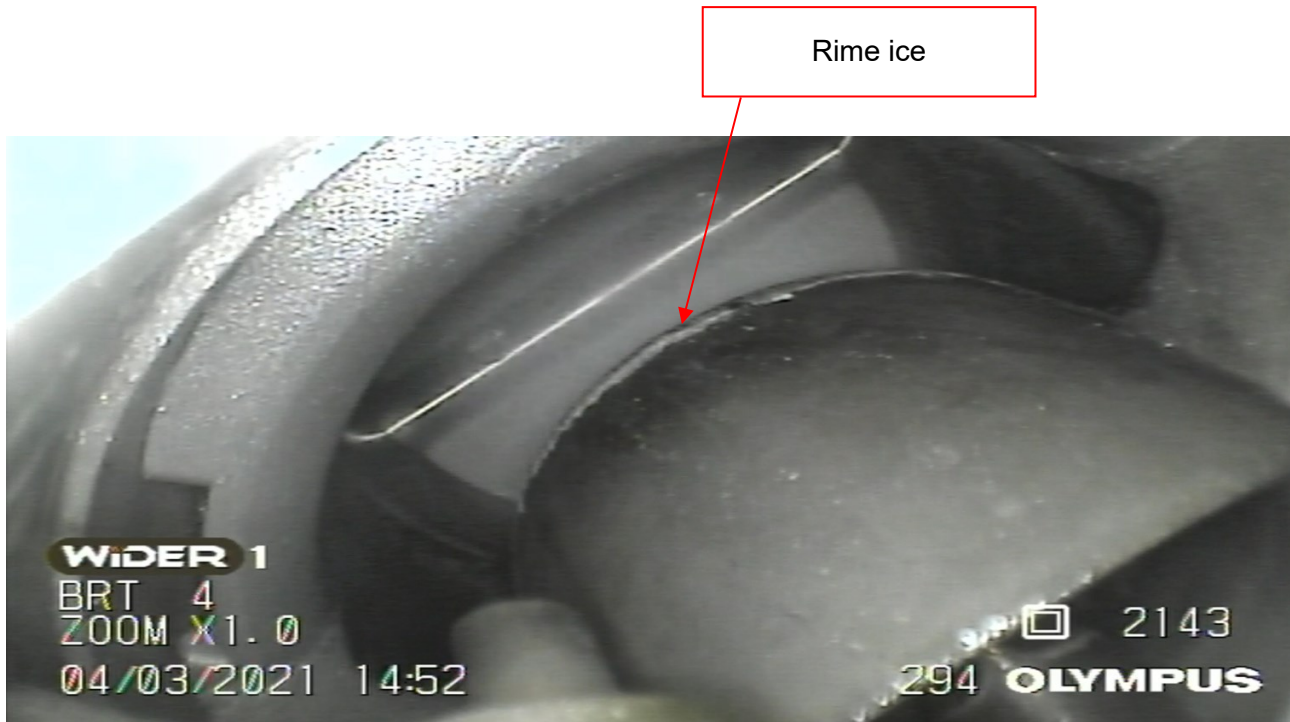
Figure 122: presence of rime ice on the outer surface of the venturi
Source: BEA

Rime ice was identified on several occasions on the outer surface of the venturi (Figure 122). This ice formation was very localised and superficial. During this phenomenon, no other ice formation was observed.

This formation of rime ice was identified during the very rapid increase in speed, beyond 2,000 rpm. During this increase in speed, the variation in temperature downstream of the butterfly valve was the parameter that varied the most. We noted an immediate decrease in this temperature of 3 to 9°C depending on the configurations.

After it had formed, the rime ice did not develop. It melted almost immediately as the speed decreased.

This phenomenon had no observable impact on engine operation.
