## **FOREWORD**

*This report presents the conclusions reached by the BEA on the circumstances and causes of this accident.*

The aircraft took off from Geneva Cointrin Airport bound for Bordeaux Mérignac at 7 h 42 and reached cruise level 200 at 8 h 24. At 9 h 03, as he had just started the descent, the pilot reported an engine failure. He decided to continue on track to the destination. He later informed Air Traffic Control that he could not feather a propeller. The aircraft continued to descend. At 9 h 29, the aircraft crashed into a field and caught fire.

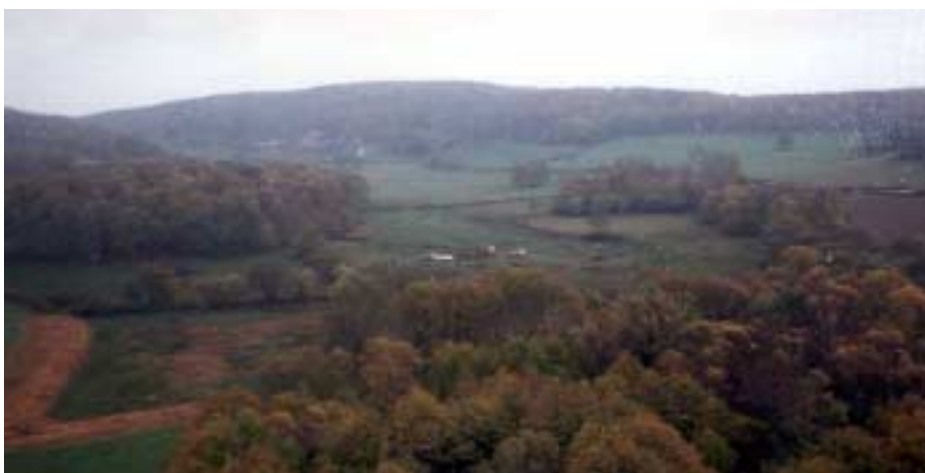
The wreckage of the aircraft was found in a field at «La Naute» located north-east of the village of Donzeil. There are fields surrounded by hills culminating at an altitude of 580 meters and whose mean altitude is 500 meters. The altitude of the wreckage was 515 meters (1,690 feet).

The wreckage was oriented south-west / north-east and was surrounded to the west, the east and the south by rows of trees. No tree showed traces of contact with the aircraft.

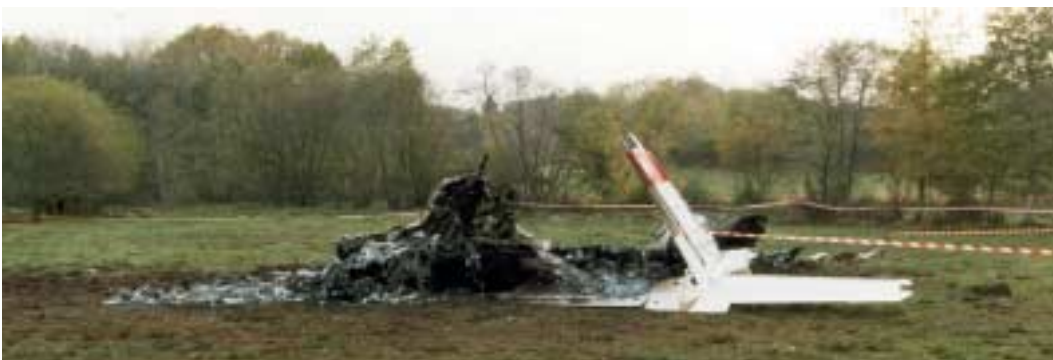
The entire airframe and engines were confined in an area comparable to that of the aircraft itself.

The airframe was dislocated: the cabin was resting on the left side after having pivoted 90 degrees, the door situated to the rear left of the fuselage was closed and blocked against the ground. The vertical stabilizer, the horizontal stabilizers and the elevator were separated from the rest of the airframe and had pivoted to the left through 90 degrees in relation to the cabin.

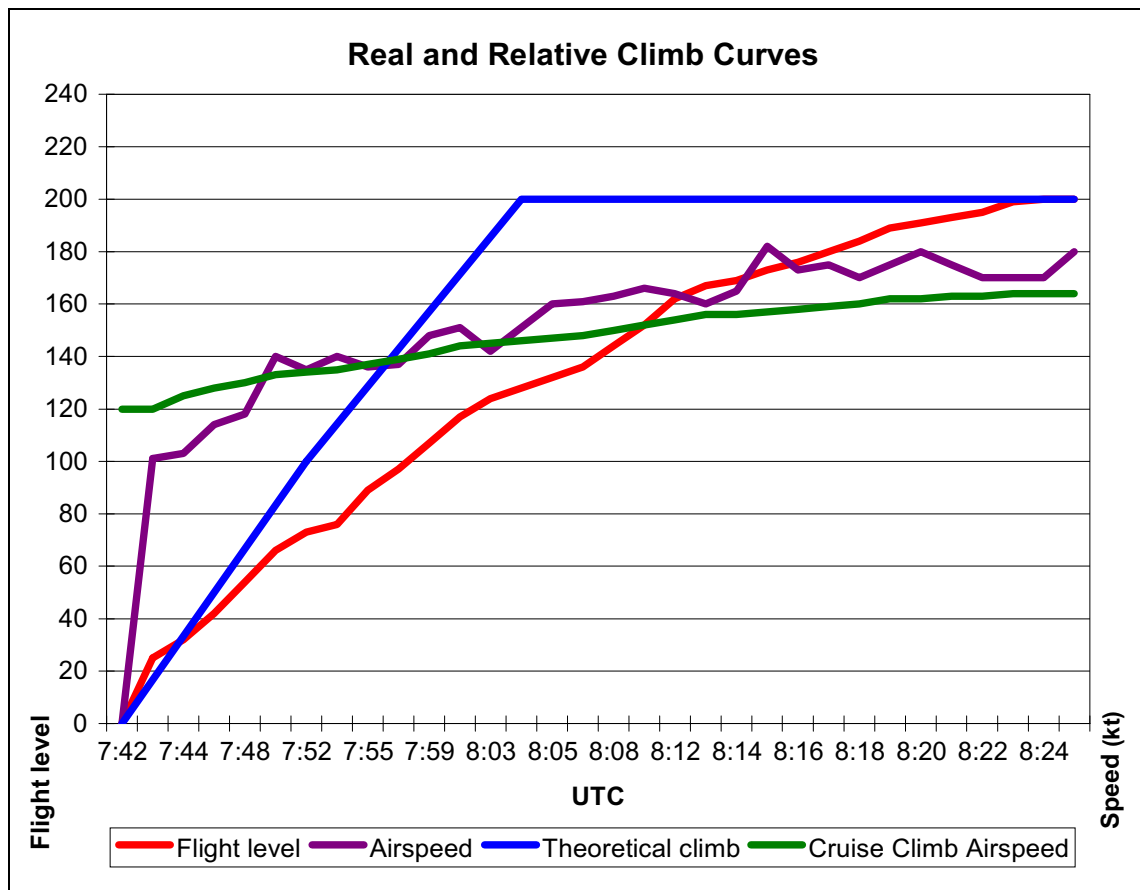
Climb to level 200, the final cruise level, took 42 minutes and was uninterrupted. Although the parameters for engine control used during this flight are unknown, a witness stated the pilot usually selected «cruise climb» flying parameters. As seen in § 1.6.5.1, the theoretical climb in this case takes twentyone minutes.

The real climb therefore took exactly twice as long as the theoretical time. This variation is highly significant. How can it be explained?

- During the first twenty-one minutes of climb, there was little variation between the aircraft's airspeed and that called «cruise climb». The aircraft would be expected to reach FL 200, but this was far from being the case as it only reached FL 130. What is even more surprising is the fact that the aircraft, which admittedly was flying faster than the theoretical 120 kt and thus was climbing less quickly, took another twentyone minutes to reach FL 200. This very slow climb, which should have alerted the pilot, highlights a major shortcoming in the aircraft's performance.
