Bureau Enquêtes-Accidents

R E P O R T

*on the events to the MD83
registered F-GHEI and F-GFZB
operated by Air Liberté
on December 2 1997
at Orly (94)*

**F-EI971202A
F-ZB971202A**

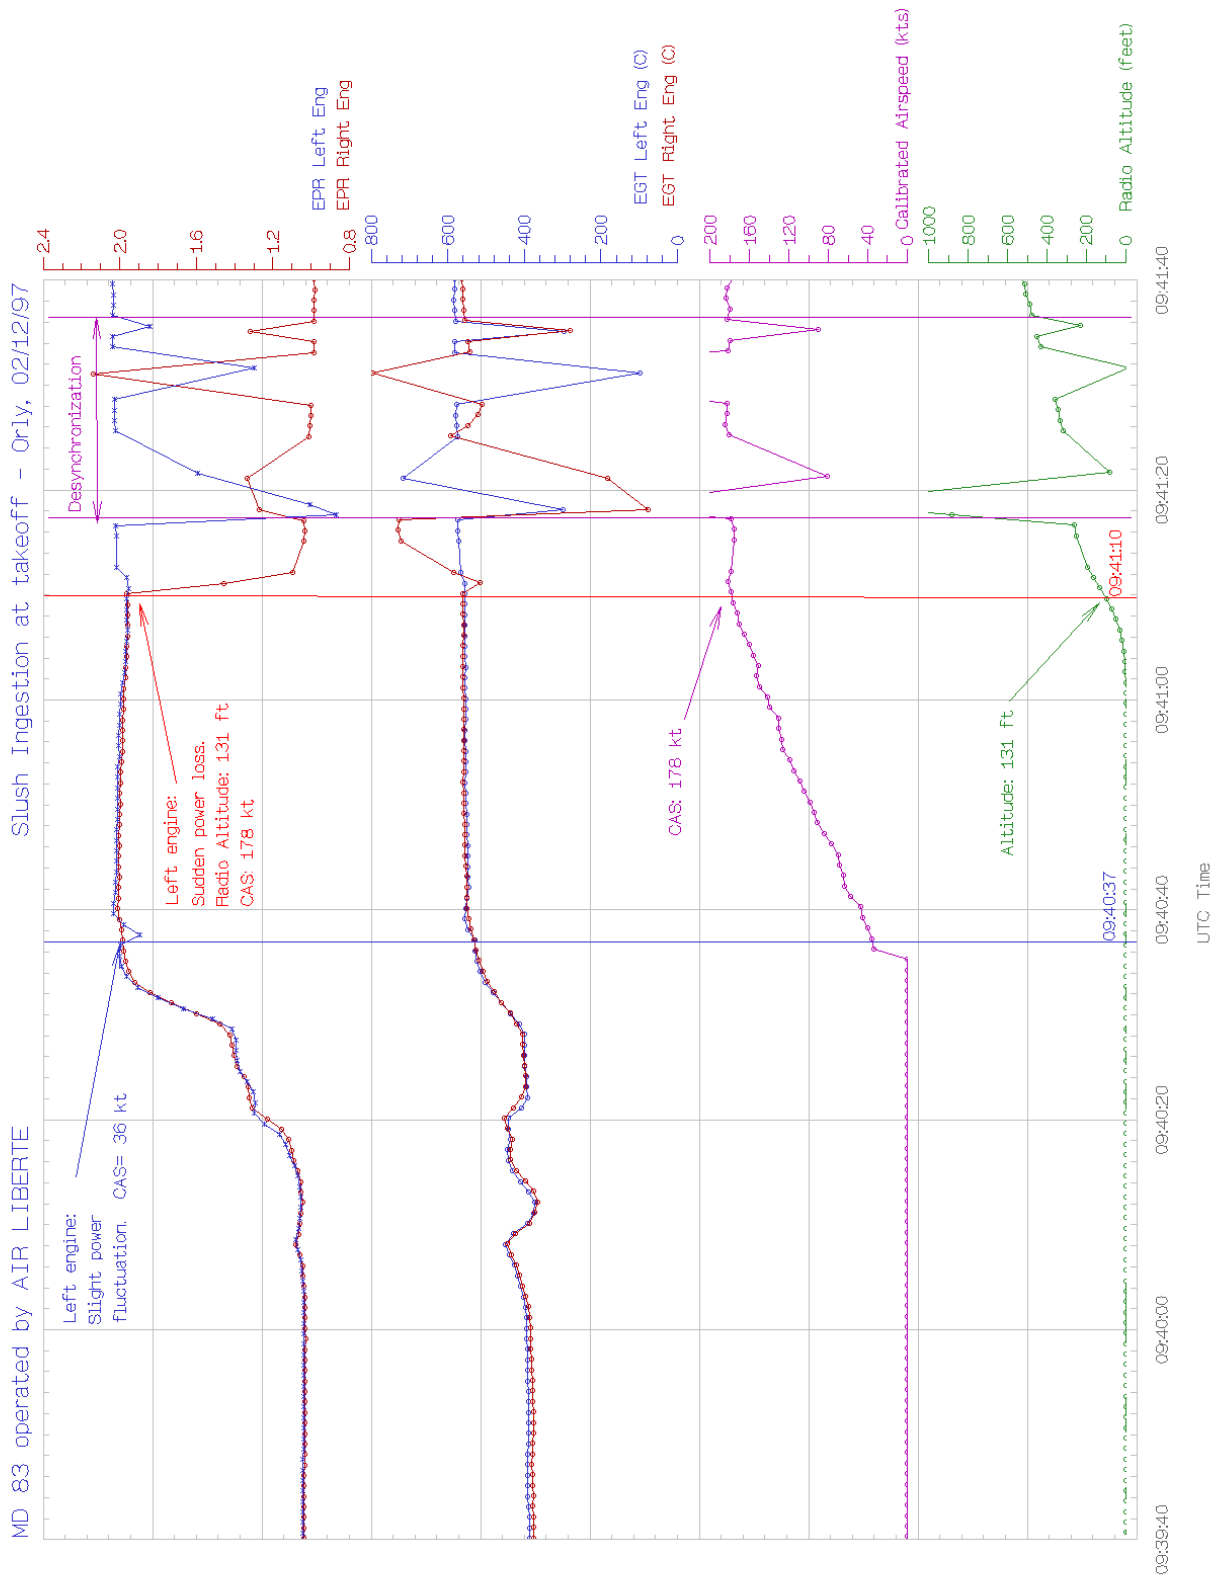
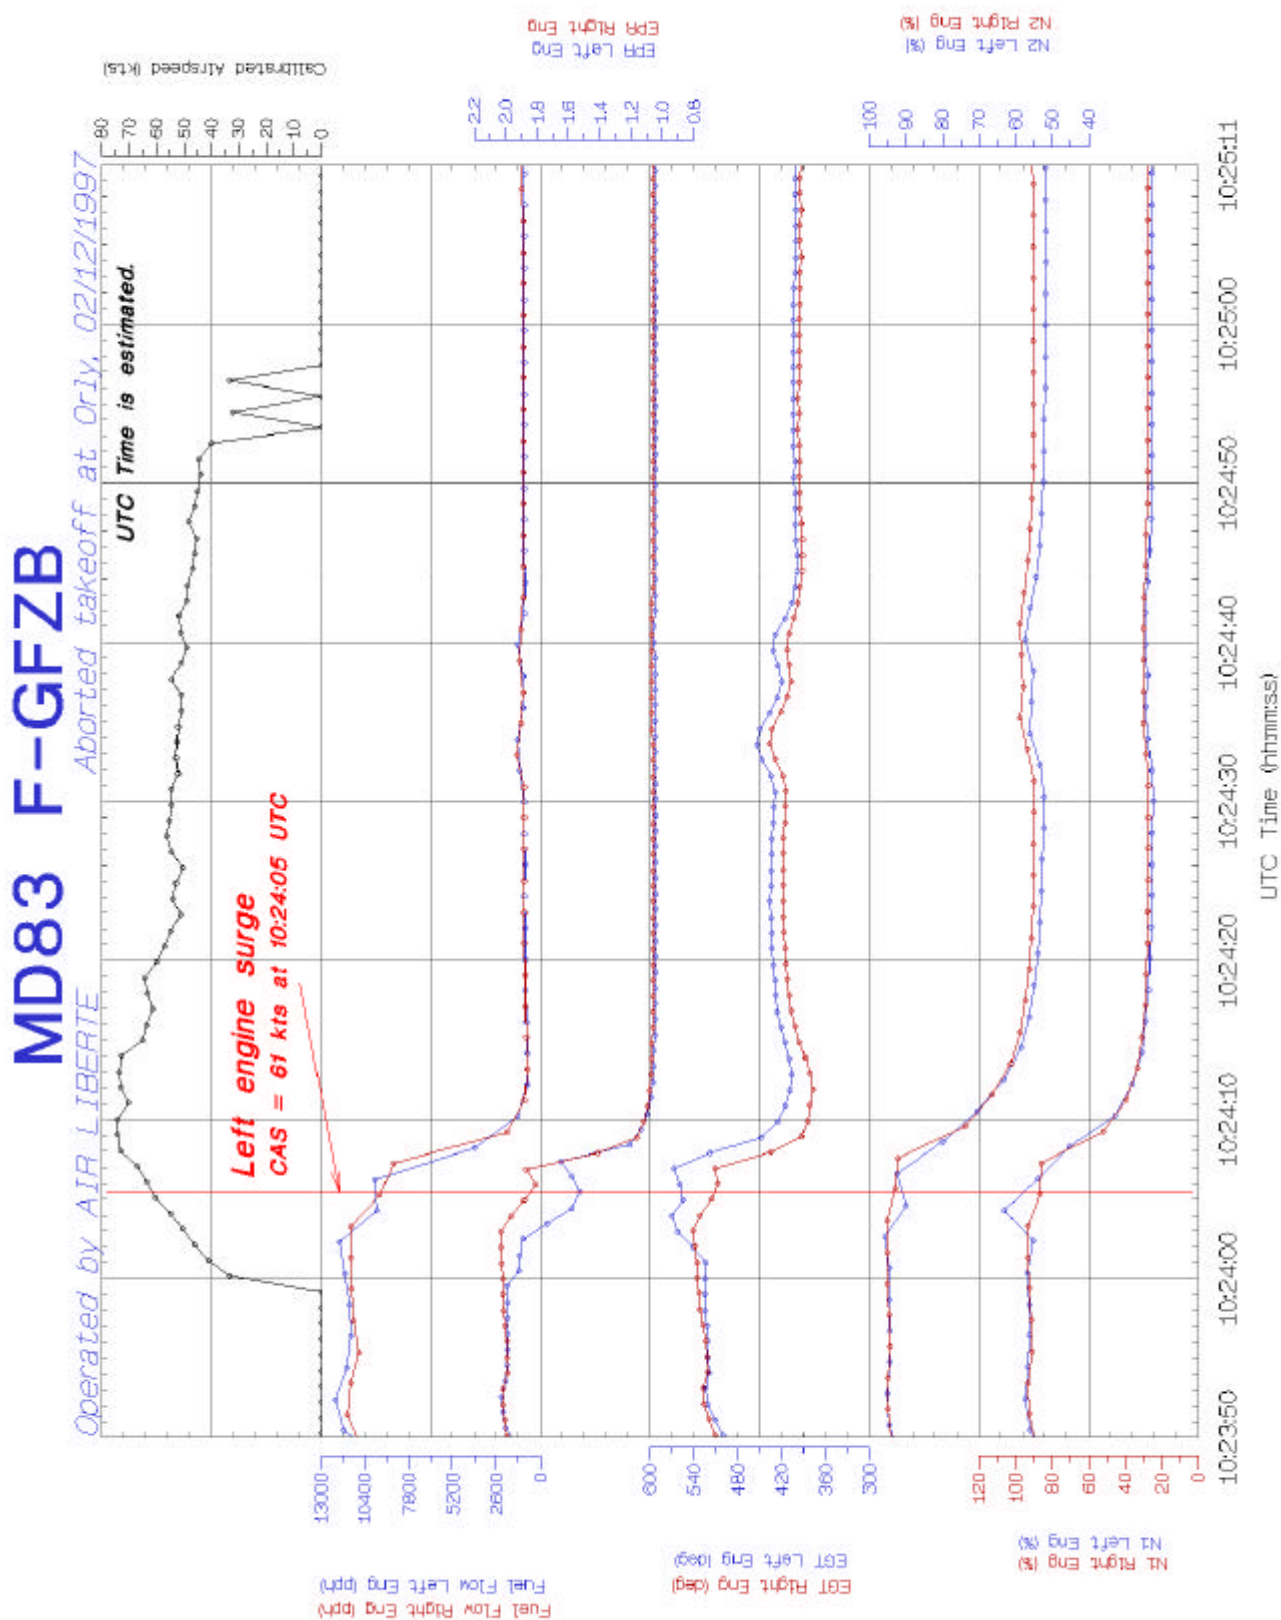
F-GHEI

The engine had absorbed a massive amount of slush which damaged the air intake, caused the rupture of eleven fan blades and damaged the leading edges of the remaining blades. Two fan blades in the left engine were also damaged.

Right engine fan blades were missing, destroyed or severely damaged (see appendix 4, plate 1).

The photos in appendix 4 show the severity of the damage sustained.
