*Accident
on 25 July 2000
at "La Patte d'Oie"
in Gonesse (95),
to the Concorde,
registered F-BTSC,
operated by Air France*

INTERIM REPORT (15/12/2000)

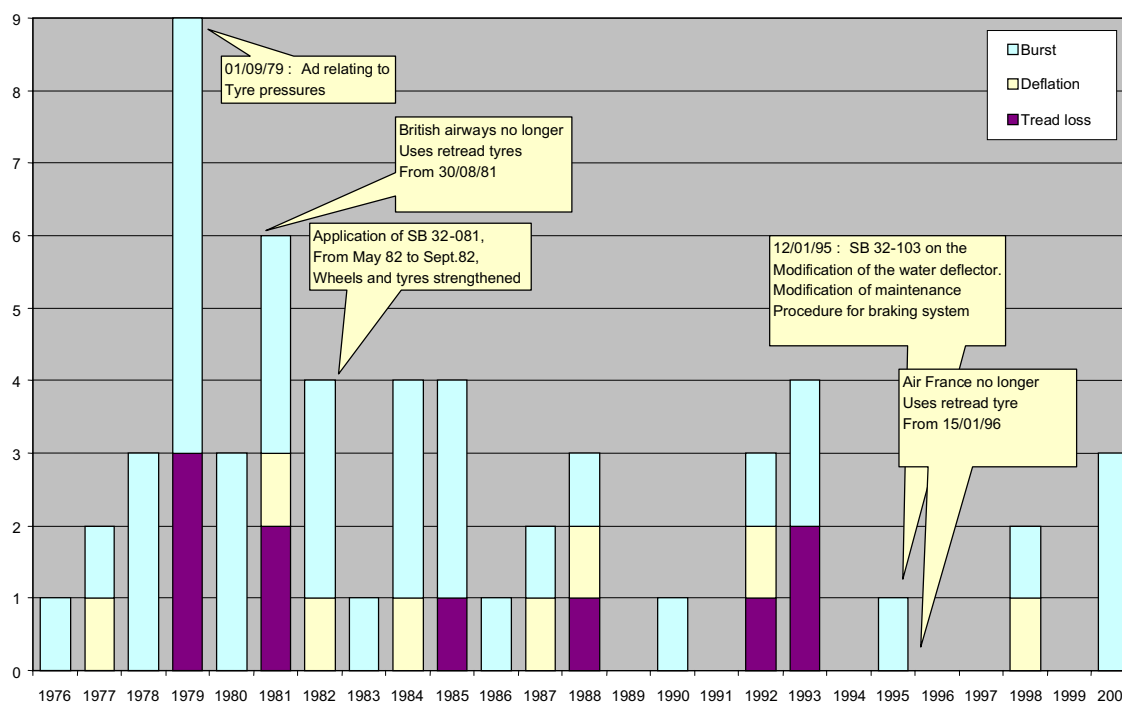
History of events involving tyres on Concorde (AFR ; BA ; confirmed)

- Twelve of these events had structural consequences on the wings and/or the tanks, of which six led to penetration of the tanks.
- Nineteen of the tyre bursts/deflations were caused by foreign objects.
- Twenty-two events occurred during takeoff.
- Only one case of tank penetration by a piece of tyre was noted.
- None of the events identified showed any rupture of a tank or a fire, whether leading or not to a significant simultaneous loss of power on two engines.

Twenty-one other events were notified by a single source, but no reports or detailed information exist for them. No mention was made of damage to the structure or the wings in any of them.

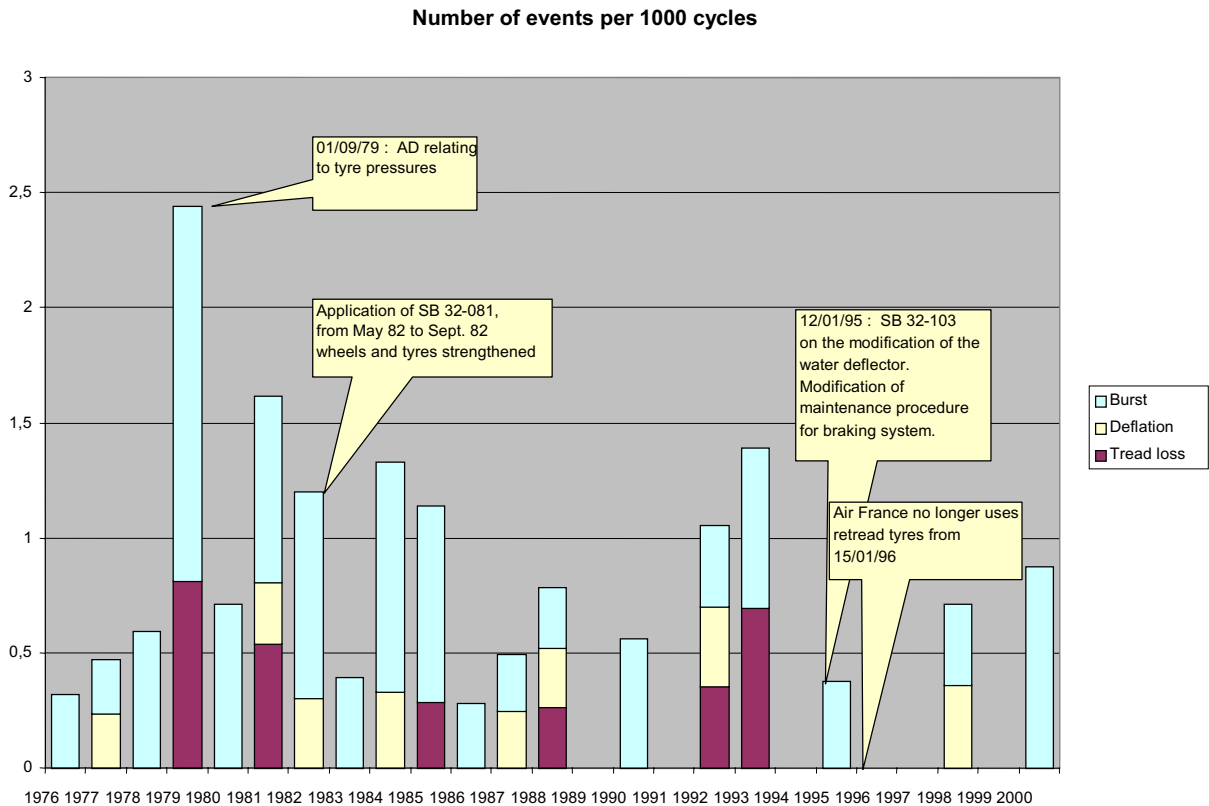
Reduced to the number of cycles, the evolution in the number of events is represented hereafter :

Note : bearing in mind the small number of events taken into account in this statistical approach, evolutions shown in this graph can only give an overall qualitative idea .

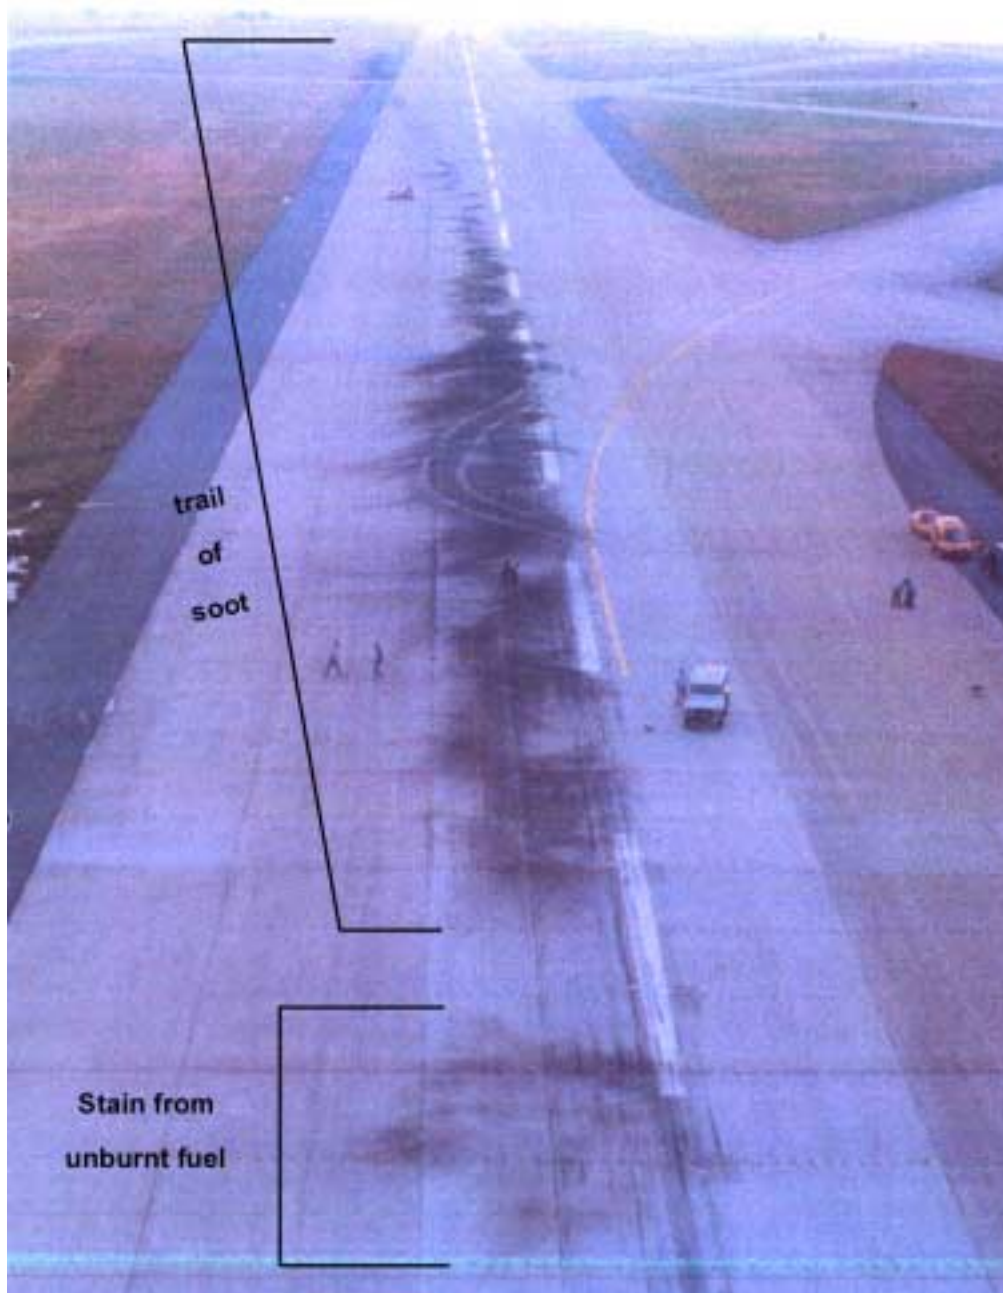
At 14 h 43 min 10 s, a clear, short noise is heard. The speed of the aircraft was 175 kt and the distance from the runway threshold was 1,722 metres. It was from that point onwards that the first parts of the water deflector, pieces of tyre and the metal strip from the DC 10 were found. A slight heading deviation to the left can then be noted at a rate estimated at 1°/s.

At 14 h 43 min 11 s, a very clear change in the background noise is heard and the first tyre marks from wheel n° 2 appeared on the runway. The speed of the aircraft was 178 kt and the distance run was 1,800 metres. The piece of tank 5 was found at this place. A large unburned kerosene stain was identified a few metres further on. Longitudinal acceleration was still nominal and constant (N_x : 0.268 g). In the following second, an incomprehensible word is heard. The speed was 182 kt and the distance run was 1,885 metres. The first traces of soot appeared on the runway. The Captain began to steer to the right and almost immediately began to pull the nose up. Engine thrust and longitudinal acceleration were still nominal.
