*Accident  
on 2 May 2000  
at Lyon-Satolas (69)  
to the Learjet 35A  
registered G-MURI  
operated by  
Northern Executive Aviation Ltd*

**REPORT**  
**g-ri000502a**

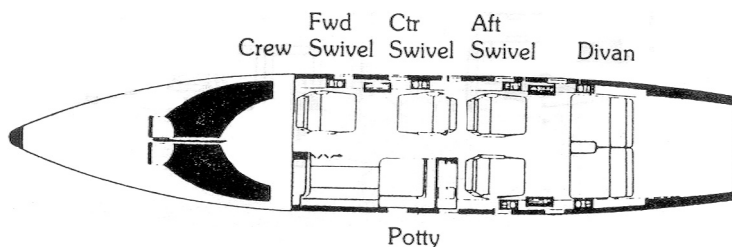
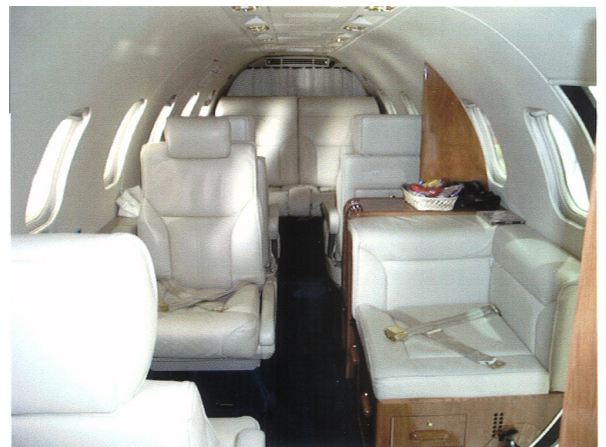
G-MURI was configured in “mid-cabin” version with seven seats. Two passengers were seated in seats at the rear of the cabin, the third in a seat facing them.

Since the fire broke out on the right side, where the emergency exit was situated, the passengers evacuated through the gap that had appeared at the front caused by the destruction of the cockpit.
