Accident
on 24 December 2000
at Tahiti Faaa Airport
to the DC10-10
registered N132AA
operated by Hawaiian Airlines

REPORT
n-aa001224a

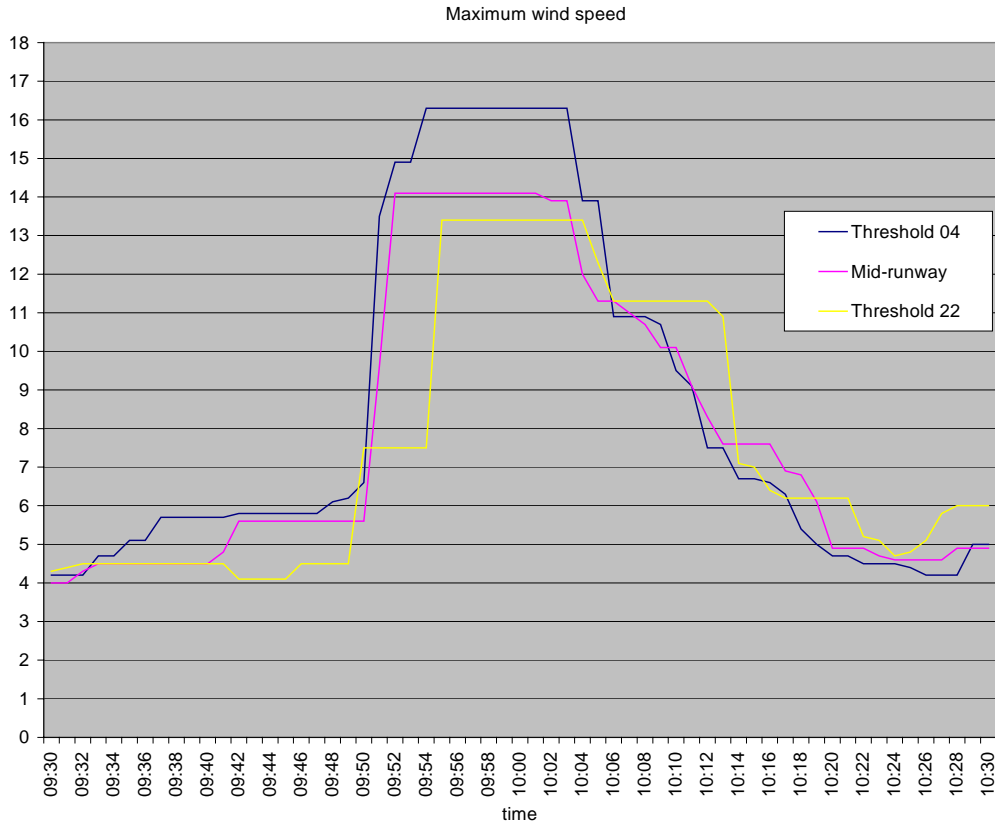
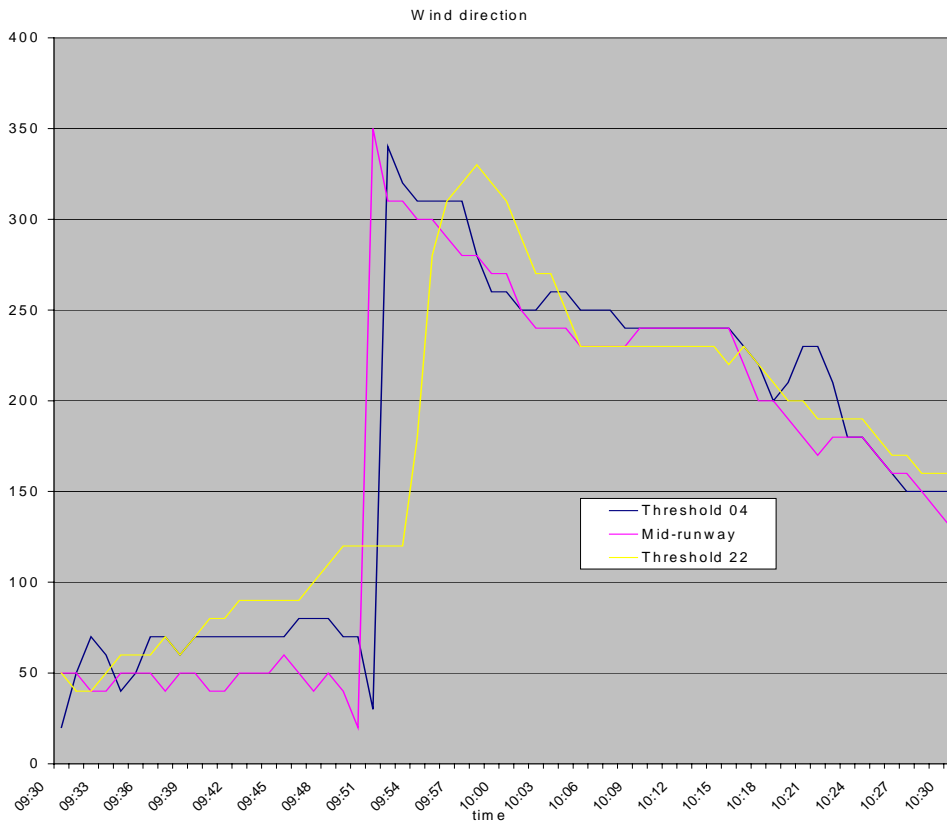
Between 9 h 47 min and 9 h 56 min, the wind speed increased rapidly, reaching 5.8, 6.1, 6.2, 6.6, 13.5, 14.9, 14.9, 16.3, 16.3 and 16.3 m/s at threshold 04, with a significant variation in direction. Between 9 h 52 and 9 h 53 min, the wind direction was 330° at threshold 04 while it was 310° at the meteorological station and 120° at threshold 22.

The variations in wind speed and direction indicate the presence of turbulent wind and windshear characteristic of a storm. The recordings also indicate that the stormy period lasted about fifteen minutes.

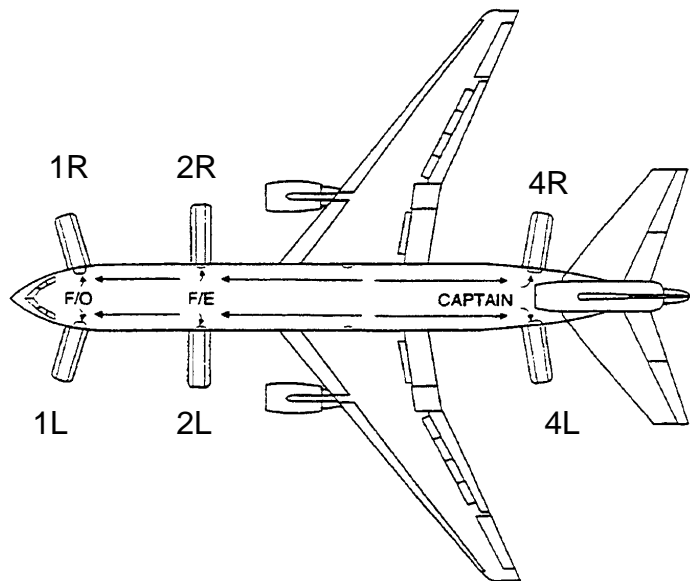
Given the sloping position of the airplane, the evacuation was carried out via the right center door emergency slide (2R) which was the only one considered to be usable. The slide at the left center door (2L) was also deployed but it seemed that the depth of the water was about fifteen meters. The lighting conditions made it difficult to evaluate the situation and advice was taken from the firefighters not to evacuate the passengers via that door. The end of the right slide was tied up to the sea wall located

at the end of the runway so as to give the passengers the shortest walk possible through the water, which was shallow on that side. The passengers were greeted by the firefighters, who had taken care to remove the barbed wire coils that were protecting the aerodrome against intruders from that side.
