*Accident  
on 5 November 2000  
at Paris Charles de Gaulle (95)  
to the Boeing 747-200  
registered TJ-CAB  
operated by Cameroon Airlines*

**REPORT**

**tj-b001105**

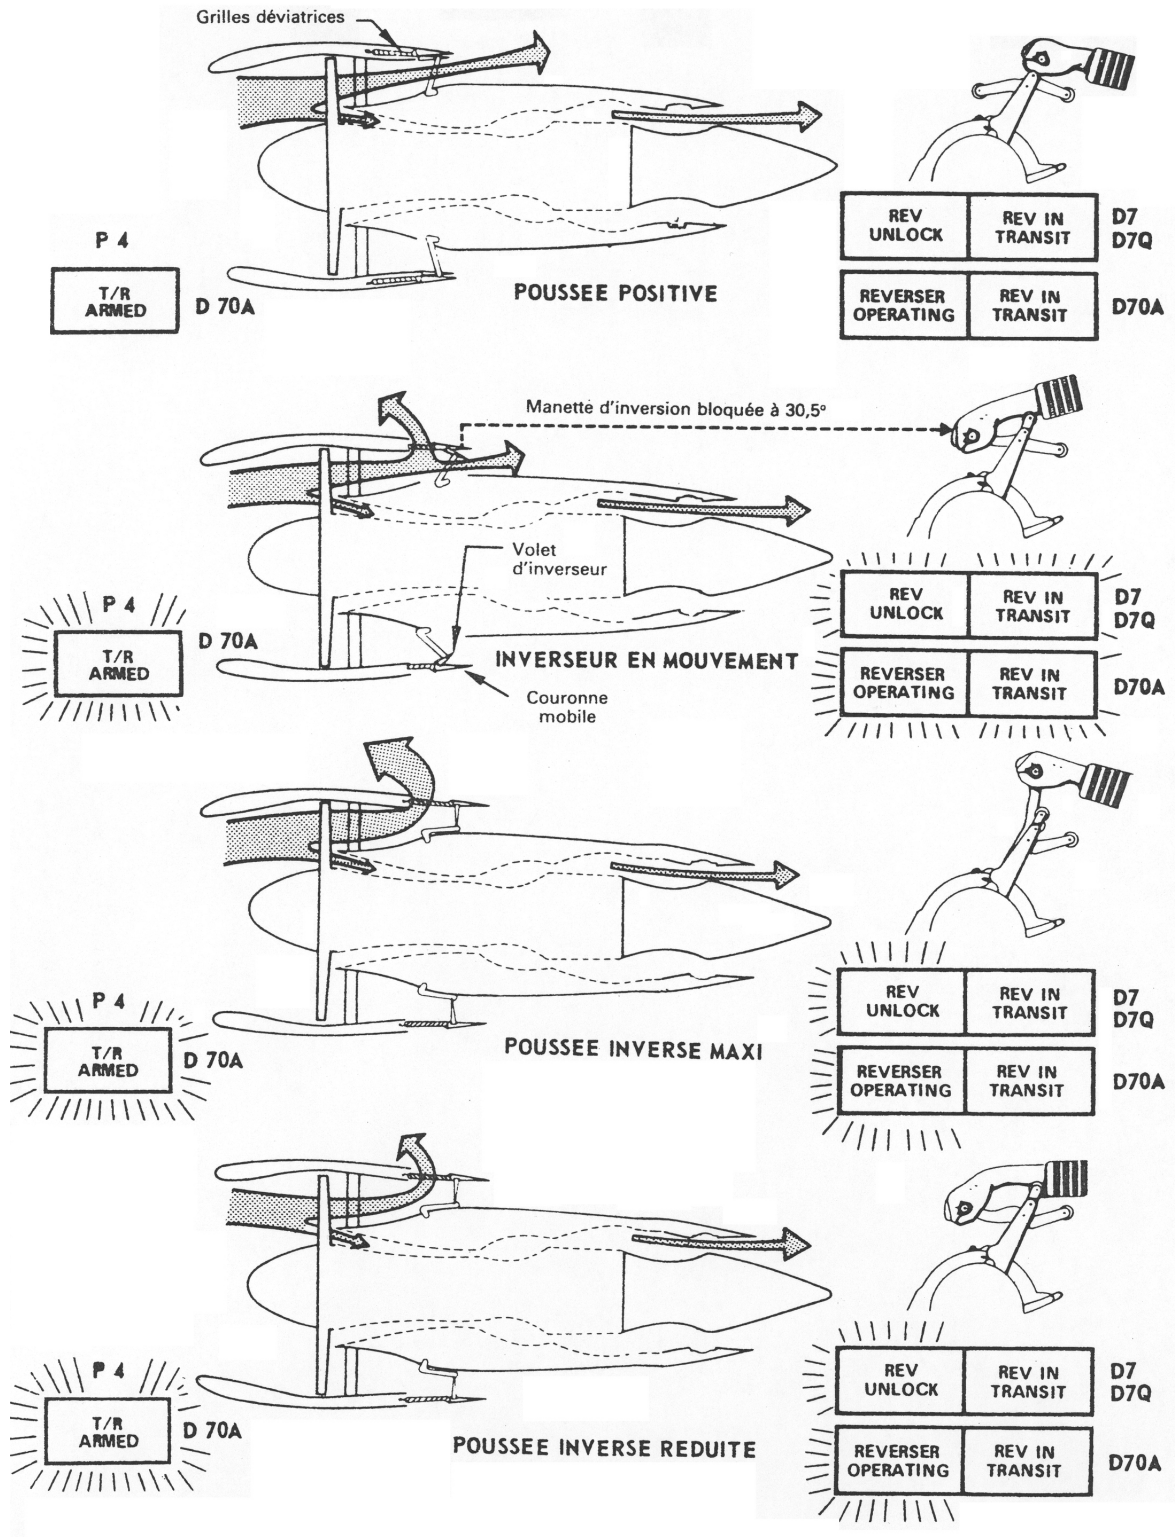
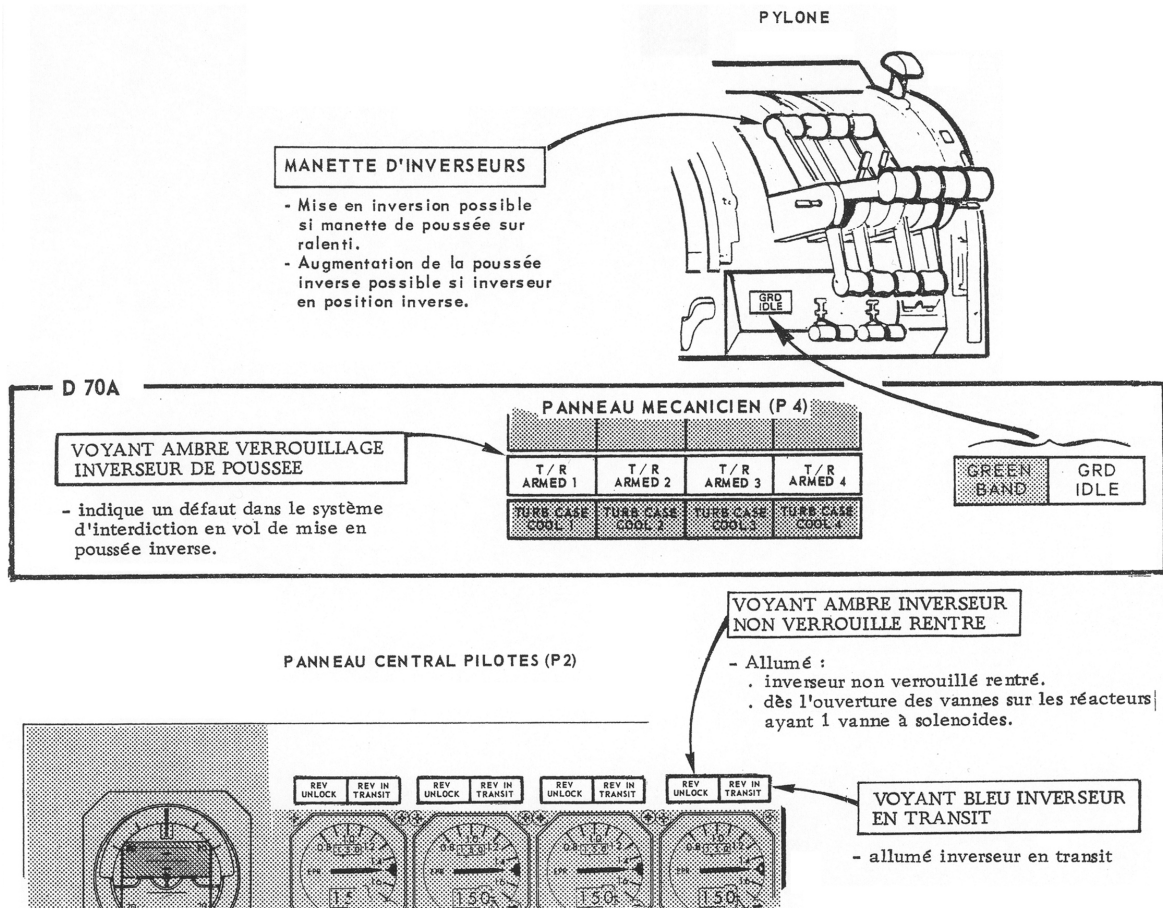
# **Réacteur** **INVERSEUR DE POUSSEE - Schéma**

Supposing that the unchecked connections were in good condition before the accident, the checks performed showed no malfunctions in thrust reverser n°1.
