# Report

Incident on **25 May 2001**  
at **Cayenne-Rochambeau Airport (French Guyana)**  
to the **Airbus A340-311**  
registered **F-GLZC**  
operated by **Air France**

**BEA**

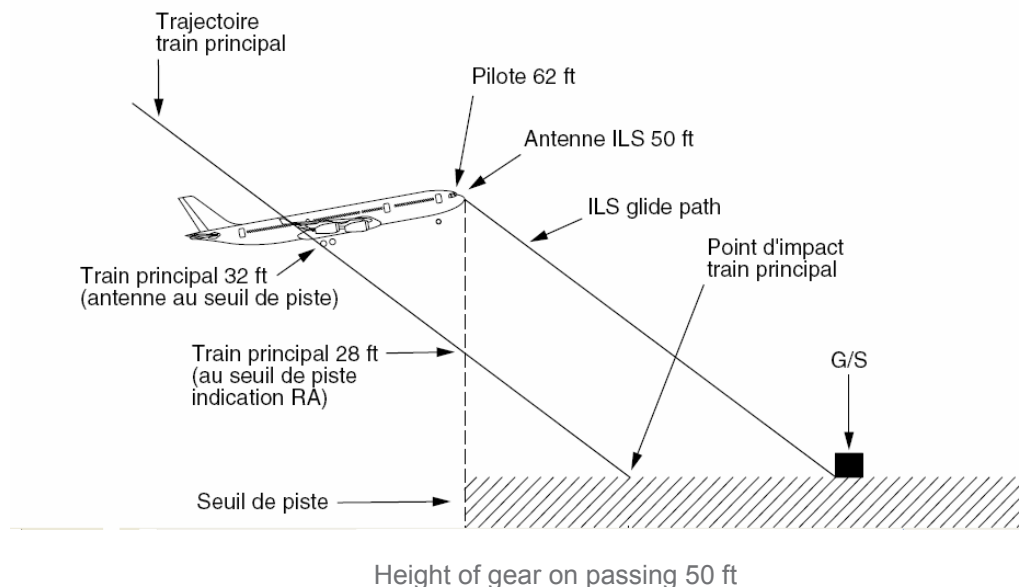
#### APPROCHE FINALE ILS (A340)

The airplane's attitude limit is  $10.1^\circ$  with the dampers compressed and the wings flat. Beyond this, the rear section of the fuselage touches the ground (see appendix 6).

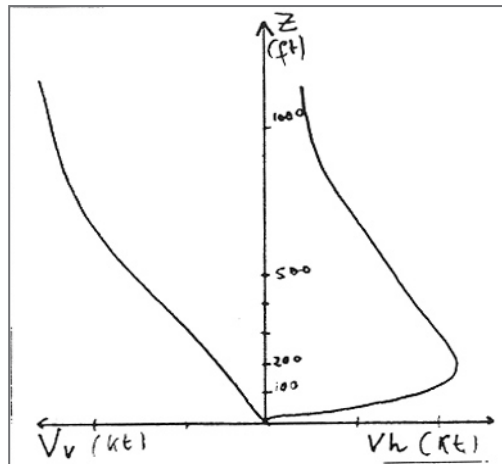
The vertical structure of a classic microburst is shown by the diagram below.

<sup>(15)</sup>The windshear encounter red by F-GLZC was of quite limited amplitude in comparison to the phenomena described in this appendix. Its specific feature was that it happened very close to the ground, which meant that there was no microburst.

It is notable that the maximum horizontal wind intensity is found very near the ground (between 100 and 300 ft), and that the more the altitude goes up, the more the draught becomes vertical (high intensity vertical downdraught  $V_v$ , horizontal speed  $V_h$  falling).
