Accident
on 22 June 2003
at Guipavas (21)
to the Bombardier Canadair
CL-600 2B 19
registered F-GRJS
operated by Brit Air

REPORT TRANSLATION
[f-js030622a](#)

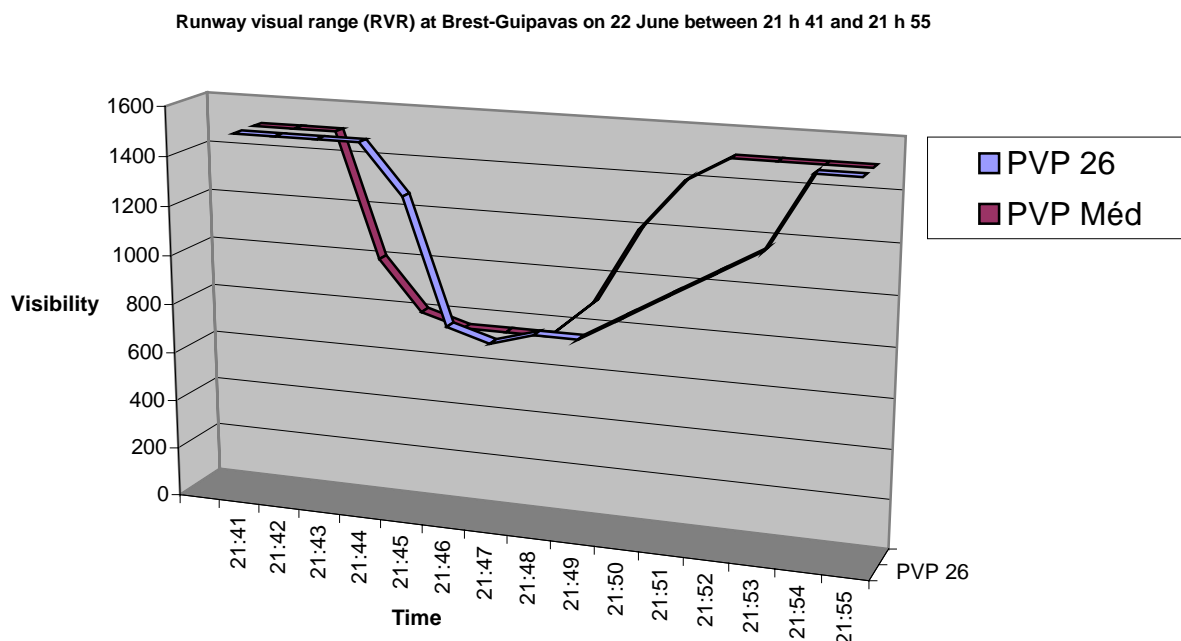
1.7.5 Evolution in Brest Runway 26-L RVR's during the approach

The rapid variation in the RVR's indicate the passage of fog banks. These indications nonetheless should be interpreted cautiously, since the location of the accident was over two kilometres from the runway threshold.

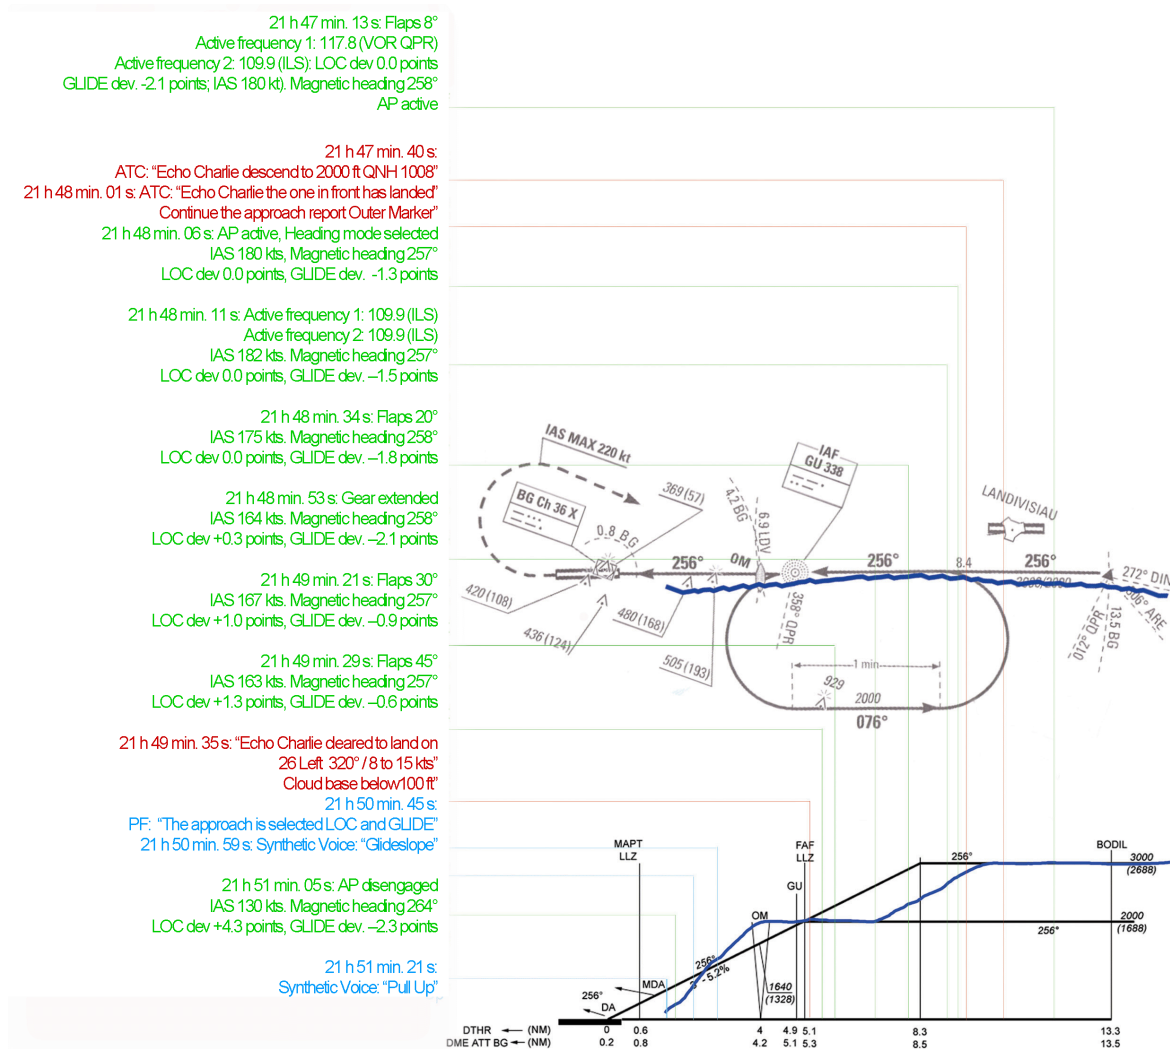
1.11.4 Approach track

Note: The wind information presented in the preliminary report was obtained from the FDR and has been removed from the present diagram due to its lack of precision (see para. 1.16.1).

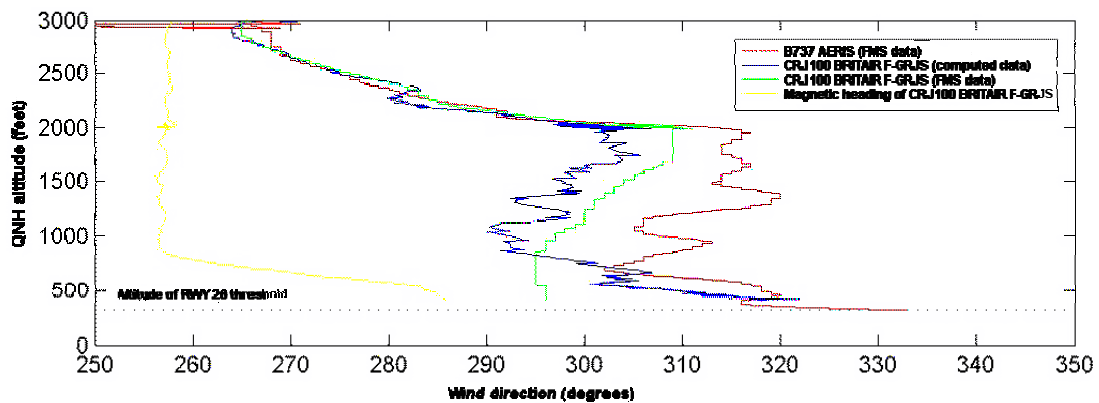
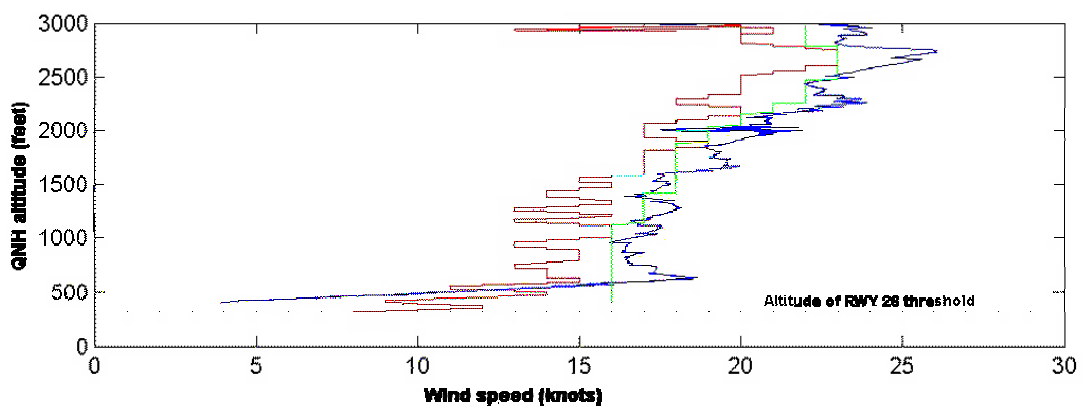
The various sources, despite some disparities, show that a wind rate was present between one thousand feet and the ground: the wind force went from a value of between 15 and 20 knots, to a value between 5 and 10 knots, and the wind direction was veering from west to north.

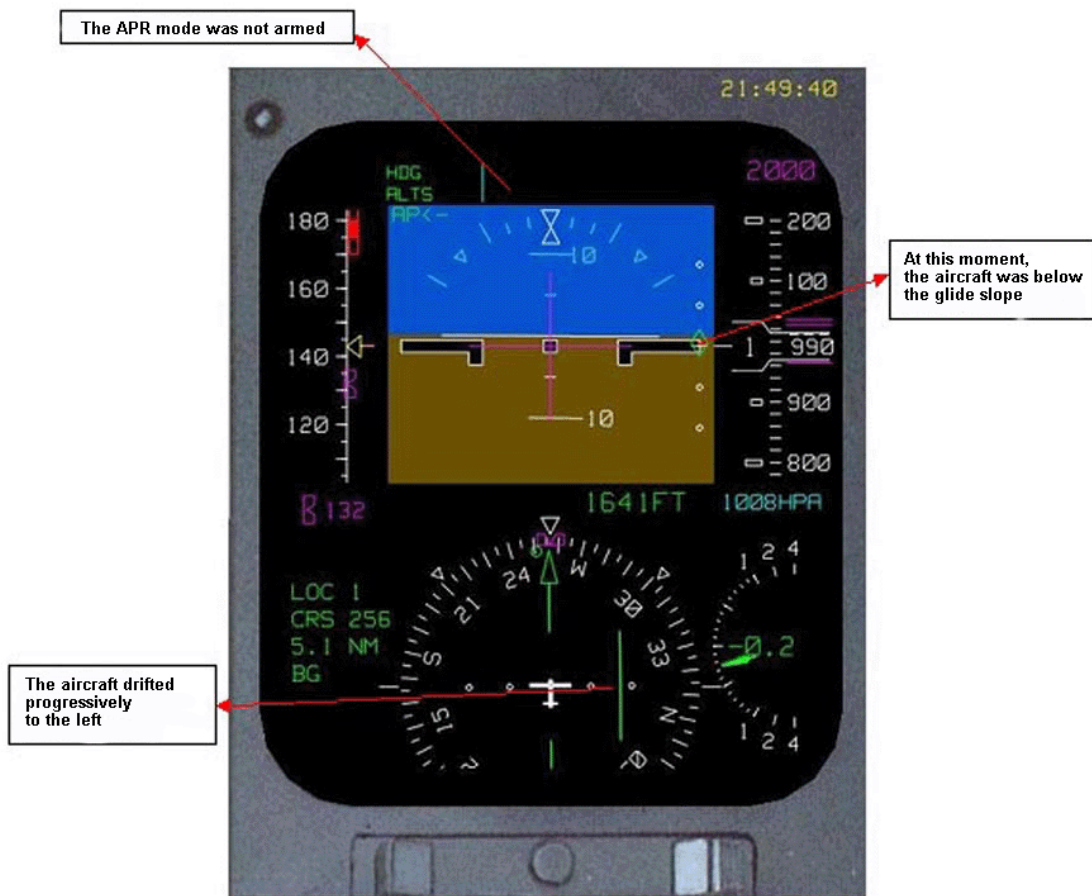
During these exchanges, the aeroplane passed down through the glide slope then passed back above. During this period, when the workload was very high, the crew did not detect the aeroplane's drift. For her part, the Controller indicated after the accident that she had looked repeatedly at the screen without seeing the aeroplane, probably because the latter was in an area where loss of radar contact was a known phenomenon.

Immediately after the end of these exchanges, sixteen seconds after the aeroplane passed through the glide slope, the Co-pilot said, "(...) we haven't got (*) approach (*)". These words are extremely difficult to hear and it has not been possible to reconstitute the whole sentence. The Co-pilot told the investigators that he had been out of the control loop while reading the checklist, configuring the aeroplane, and talking to Control. These words may mean that he was trying to analyze the situation, and the allusion to "approach" means that he was aware that the "APPR" mode was not armed. At that moment, the LOC display on the HSI attains right-hand stop. It will remain in this position until the ground impact.
