Report

Accident on **2 January 2009**
at **Molesmes (89)**
to the **Eurocopter EC135**
registered **F-HBMA**
operated by **Regourd Aviation**

BEA

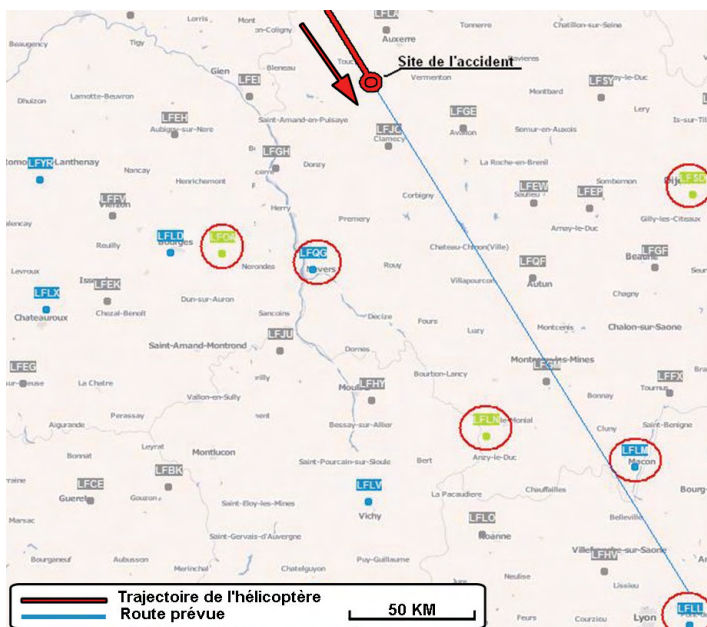
Positions of weather stations

METAR LFLI 021100Z 03007KT 4500 BR OVC003 M00/M01 Q1022 NOSIG=

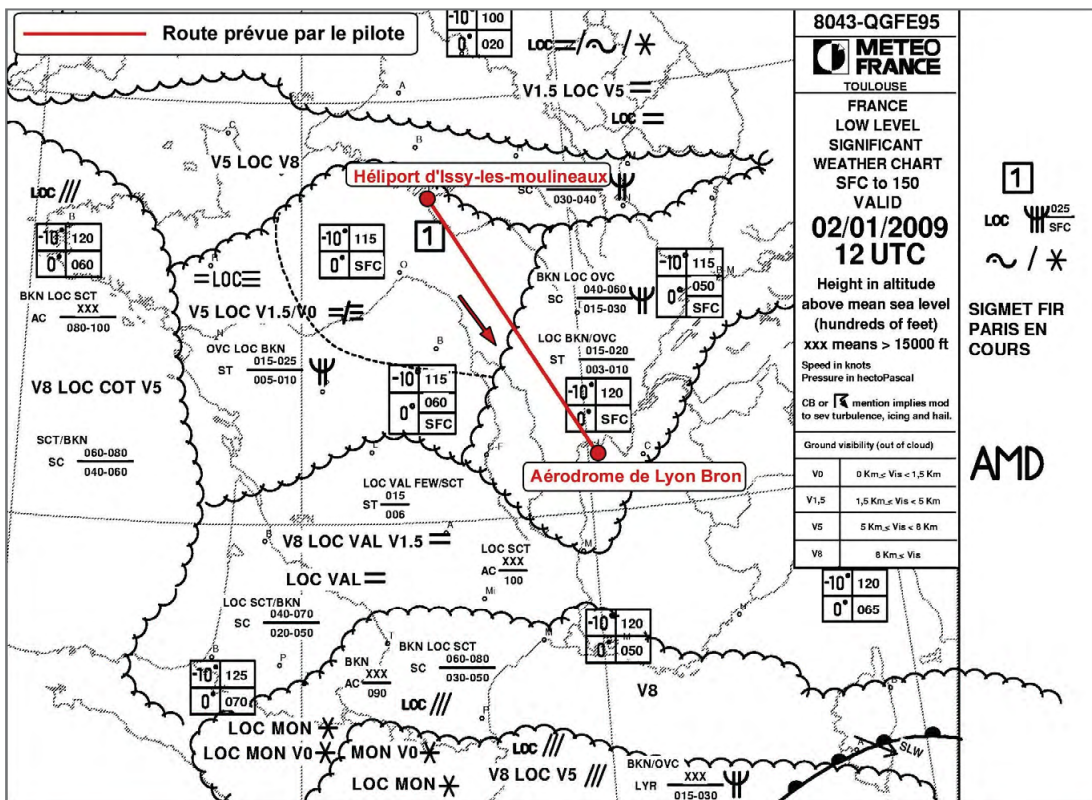
1.7.4 TEMSI chart France 12 UTC

Note: The pilot had a weather briefing including:

- the METARs for the departure and destination airfields as well as for certain airfields on the route
- the TAFs for certain airfields on the route but not the destination airfield,
- the TEMSI chart for France at 12 h 00, and wind and temperature charts for 12 h 00.

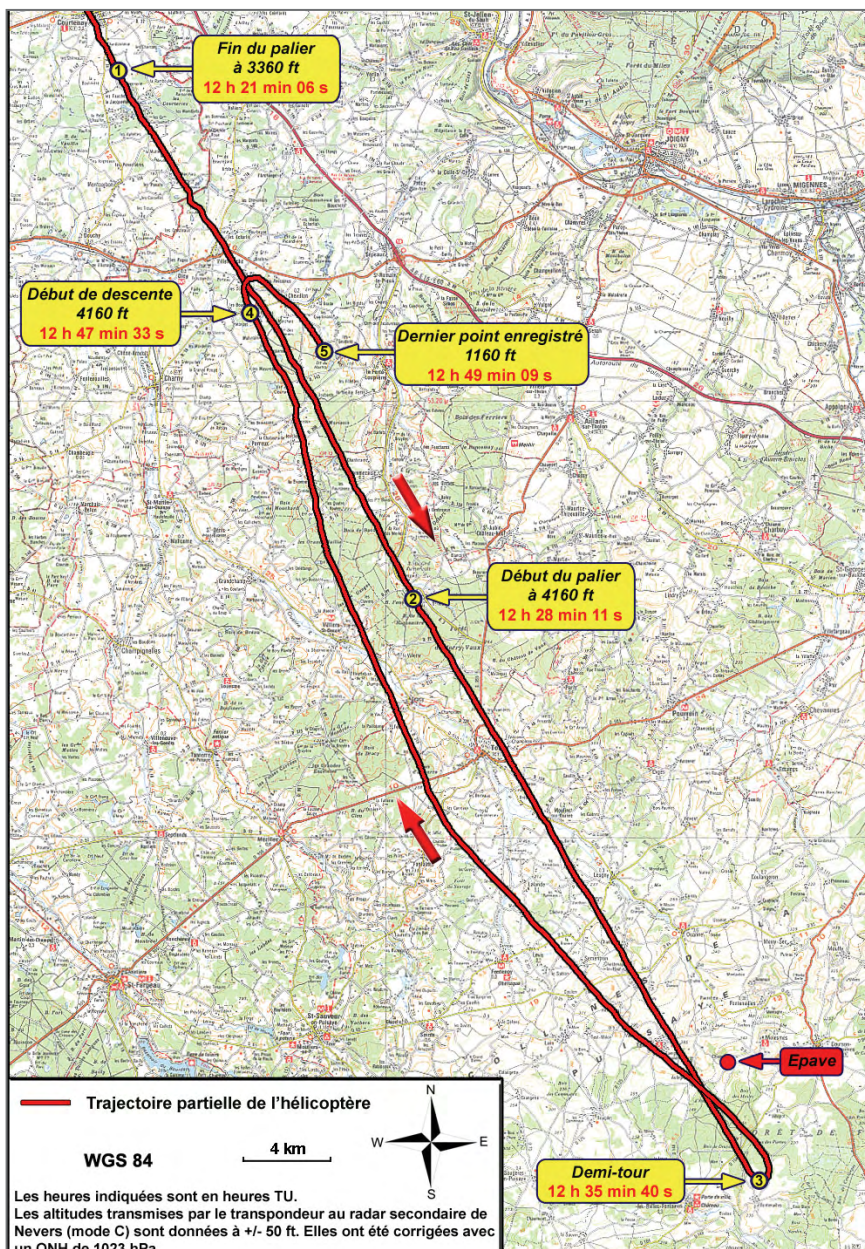
1.14.2 Examination of radar data

Data from the secondary radars at Palaiseau (91) and Nevers (58) was recovered. Only the partial trajectory from the Nevers radar, which was the most complete, was used and overlaid on an IGN map.

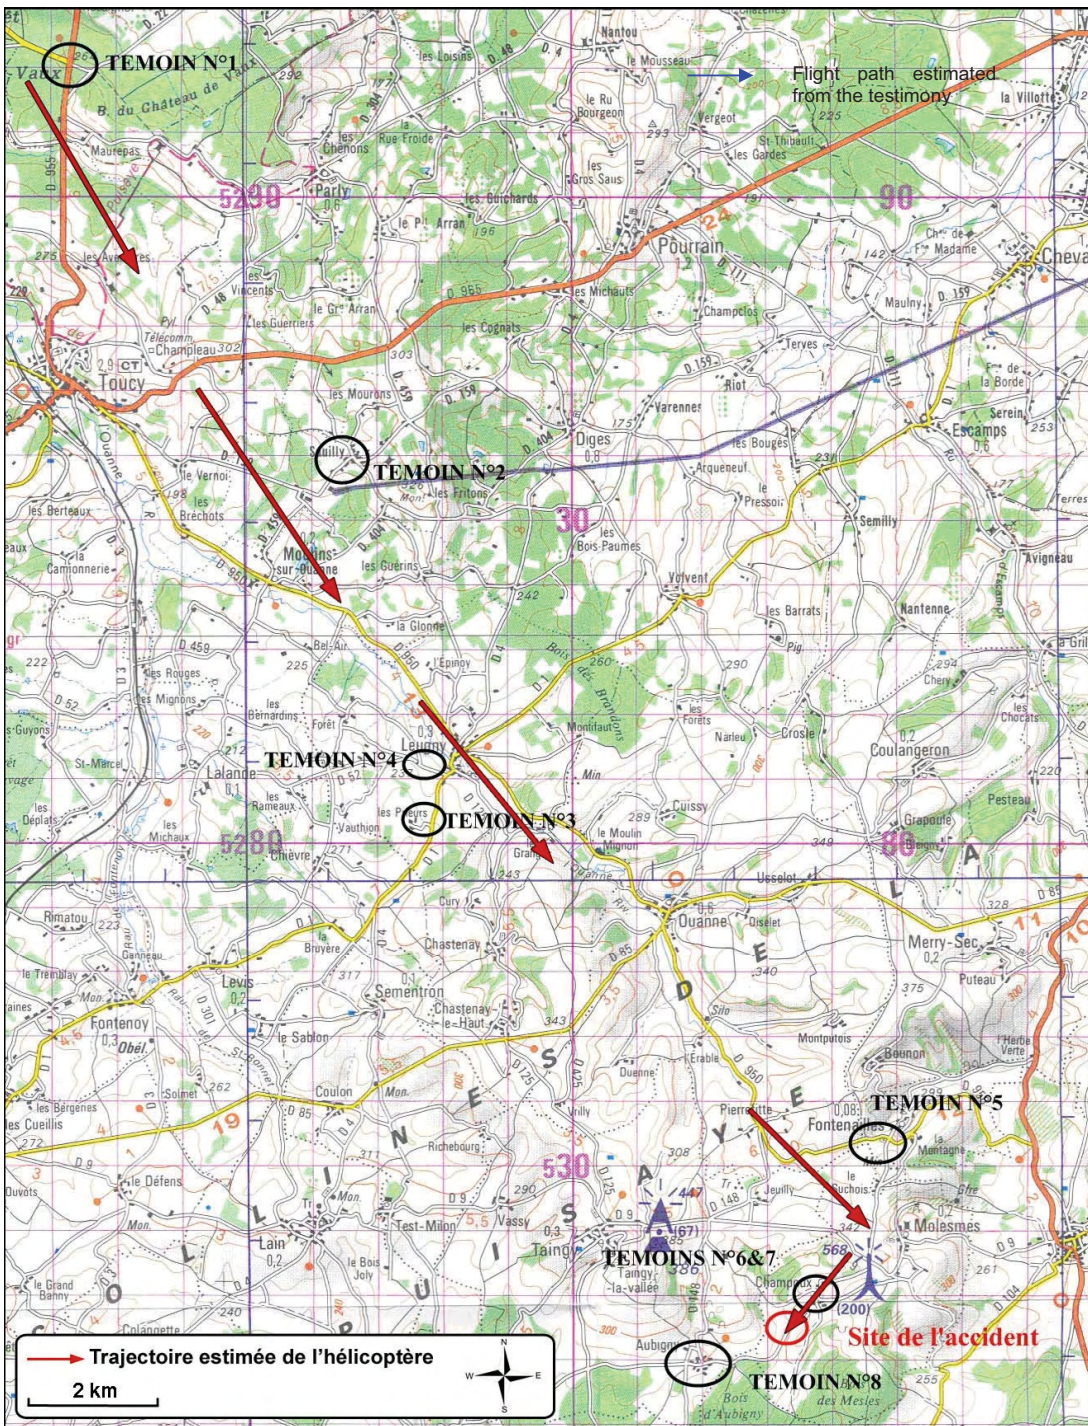
Eight eyewitnesses of the last ten minutes of flight before the accident were interviewed. The position of the witnesses is plotted on the chart below, which also shows the direction of flight of the helicopter and the estimated overflight position.
