Investigation Report on the Accident to

Ethiopian 409 – Boeing 737-800

Registration ET-ANB

25th January 2010

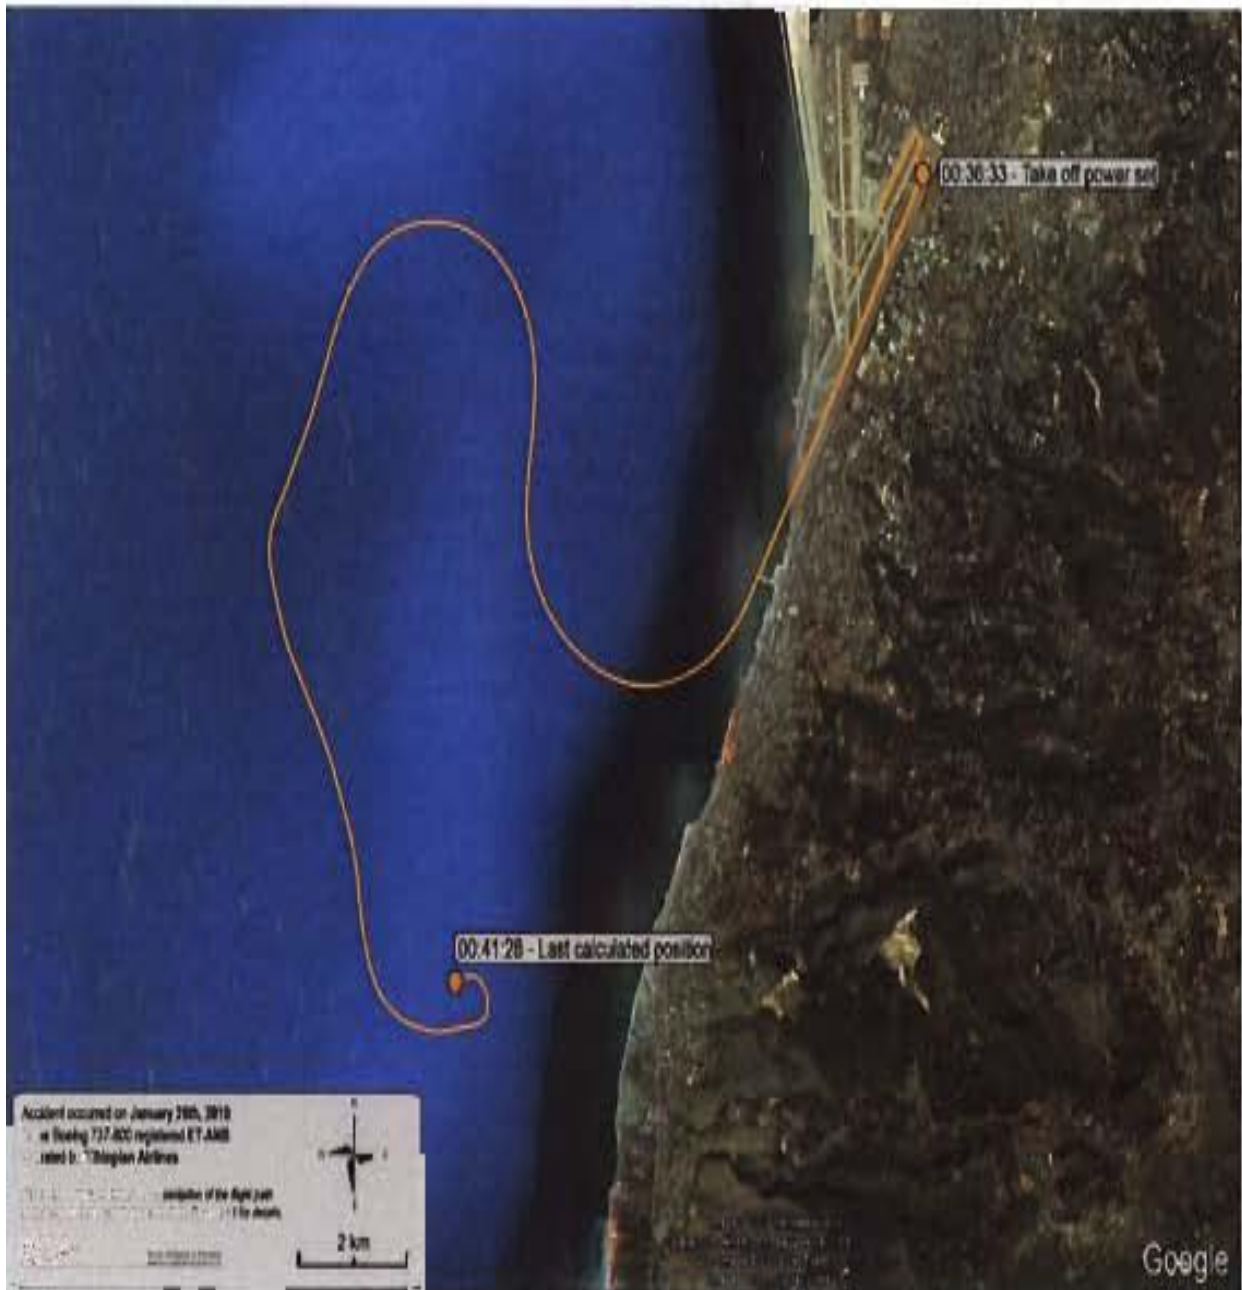
Figure 1: ET 409 horizontal tracks

The following two figures developed by the French Bureau d'Enquêtes et d'Analyses (BEA) reproduce the entire flight horizontal and vertical tracks as derived from the DFDR data:

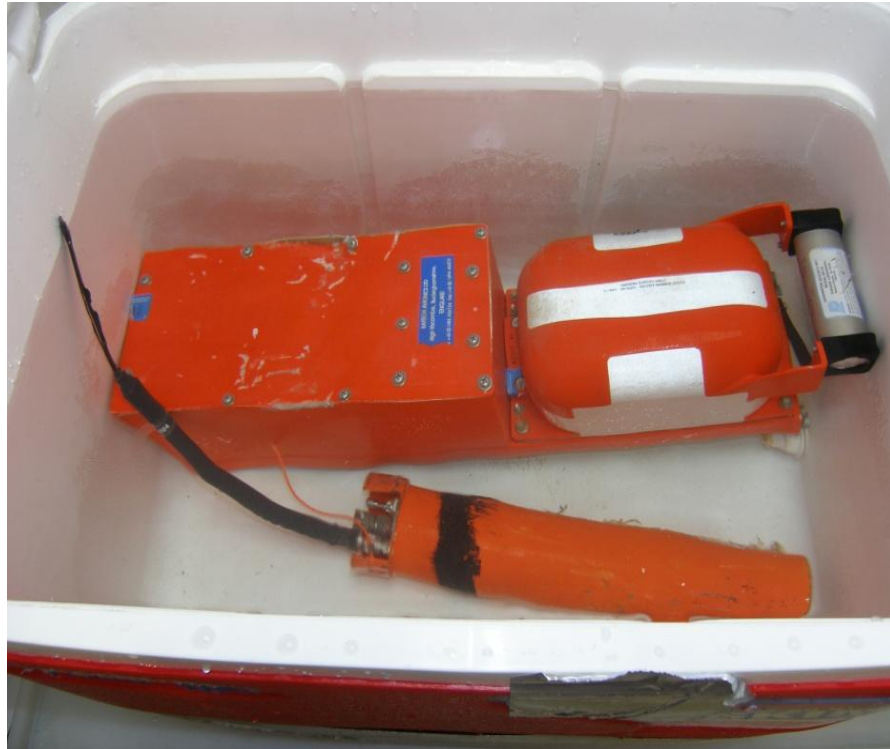
Figure 3: ET 409 DFDR

Flight performance parameters recorded by the DFDR included but were not limited to the following: pressure altitude; airspeed (computed); engine N1; pitch; roll; heading; AOA (Angle of attack – both left and right sensors); normal (vertical), longitudinal, and lateral acceleration (load factors); left and right elevator positions; left and right aileron positions; left and right trailing edge flap positions; rudder position; horizontal stabilizer position, stabilizer trim operations and stick shaker activation (both left and right stall warning systems). In addition, the DFDR recorded speed brake handle position, both left and right throttle resolver angles, autopilot engagement/disengagement, engine low oil pressure, and engine fuel cut signals. A graphical plot of essential parameters is included in this report as Appendix D.

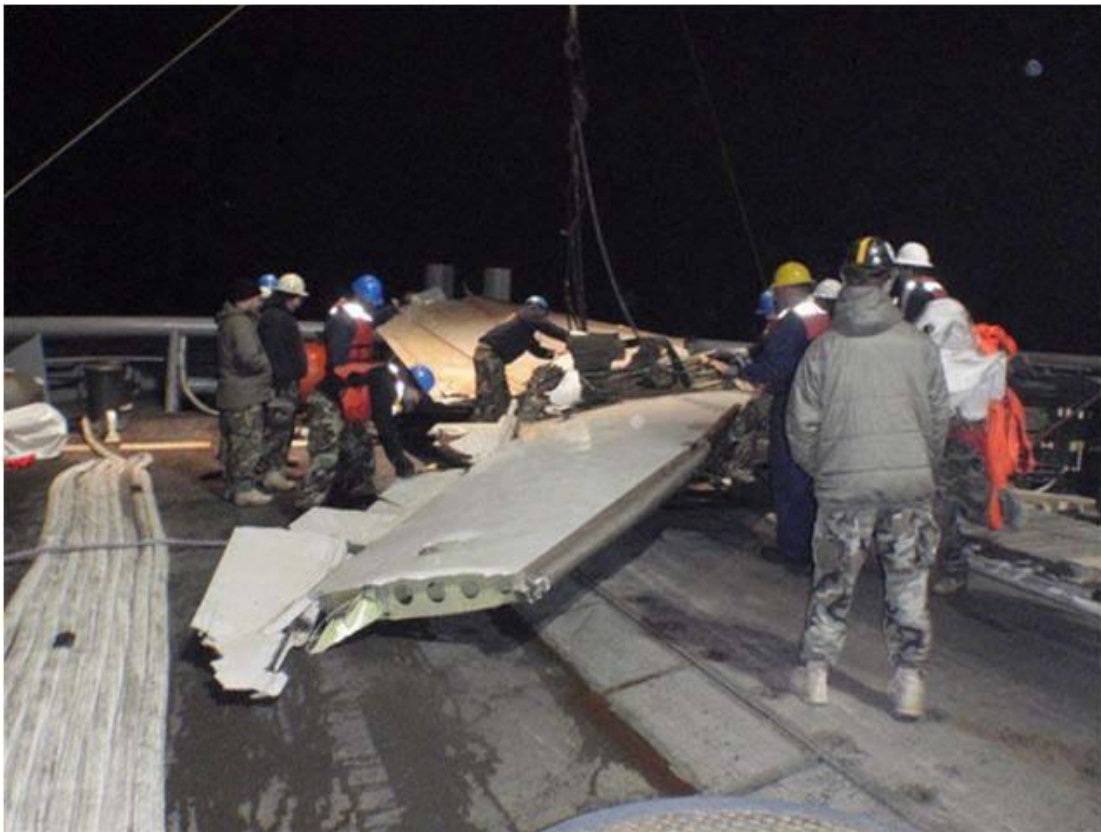
Figure 9: Recovery of the Stabilizer Section

The horizontal stabilizer section was recovered (during the search for the DFDR and CVR); this portion was relocated to Beirut Naval Station. The Airworthiness Group has recommended the removal of the Trim Tab section and sending it to the NTSB for further investigation. That recommendation was approved by the IC and the Trim Tab analysis is discussed in section 1.16 of this report with the full report attached as Appendix O.

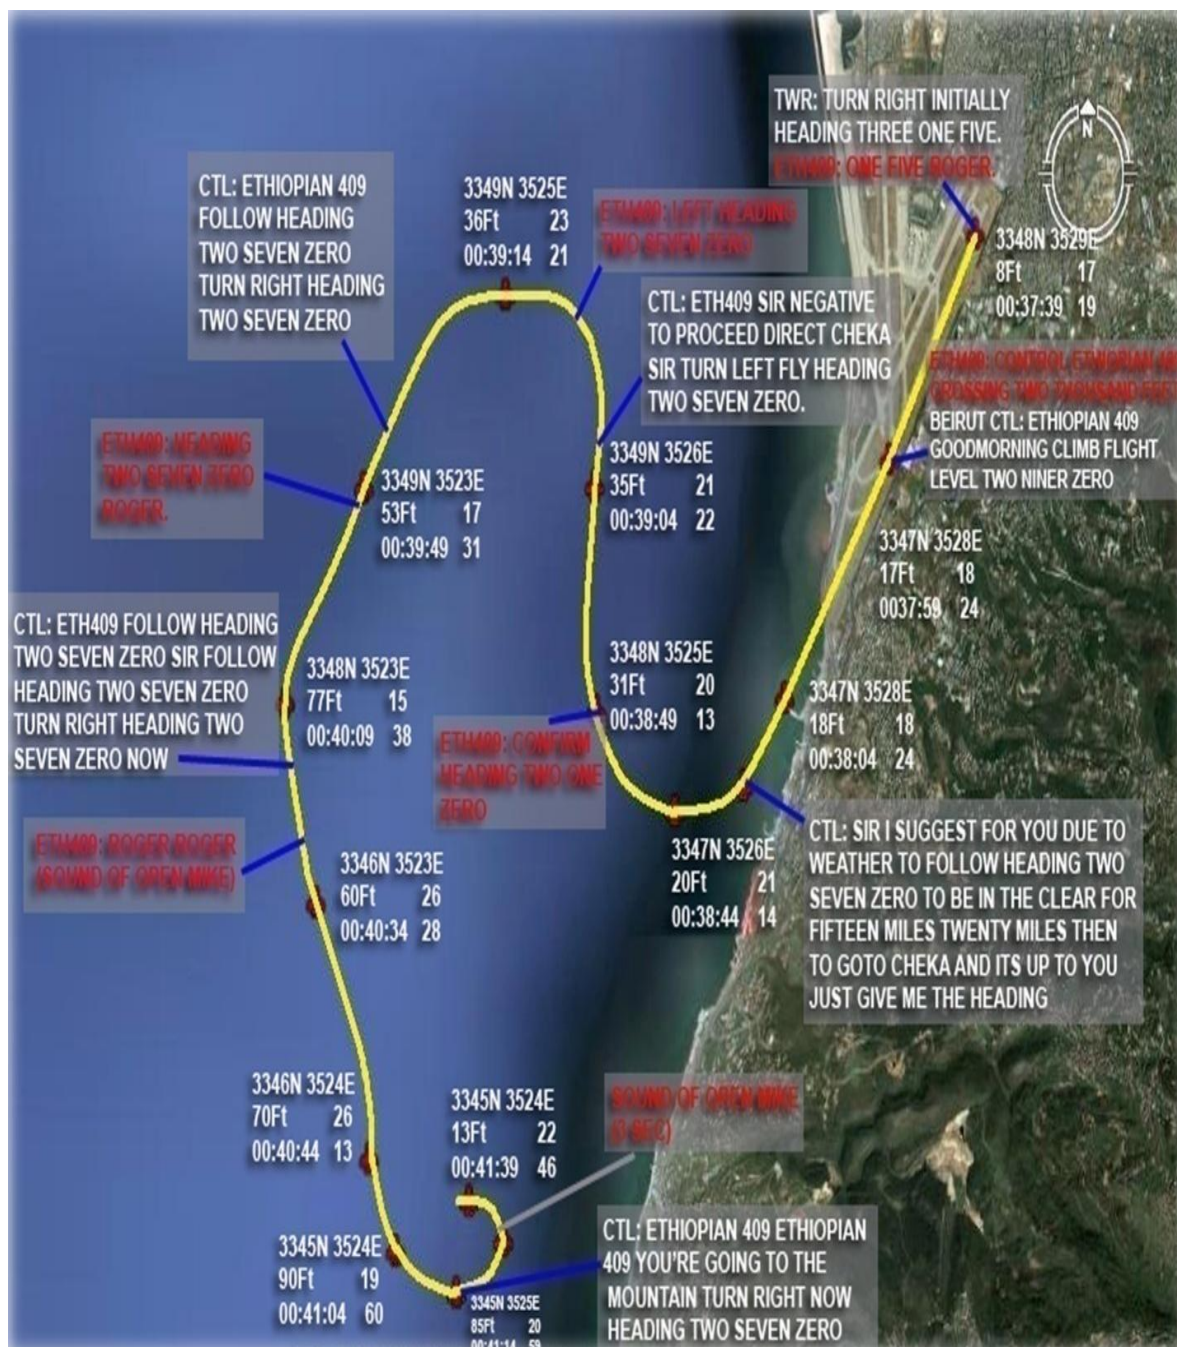
Figure 10: ET 409 Radar Tracks with ATC transcripts

Prior to the retrieval of the CVR and DFDR data, a reconstruction of ET flight path was carried out by the Lebanese CAA IT technician in synchronization with the ATC transcript data. This is shown in figure 10 below.

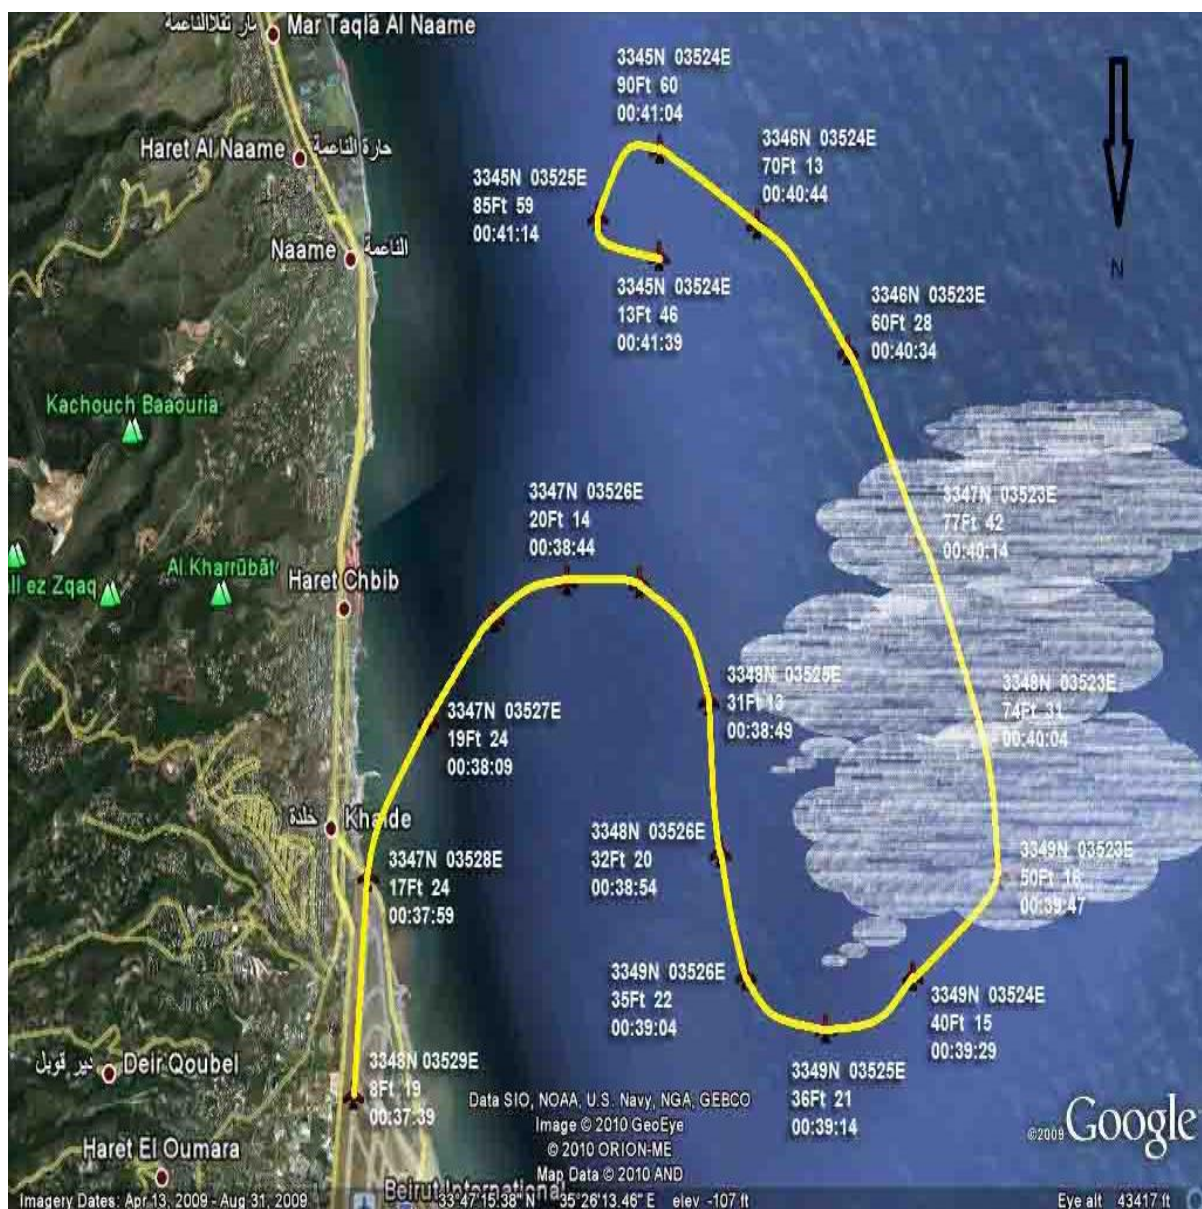
Figure 11: ET 409 Radar Tracks with cloud information

Further reconstruction of ET flight path was later on carried out by the Lebanese CAA IT technician in synchronization with the meteorological office at BRHIA and the ATC weather data. This is shown in figure 11 below.

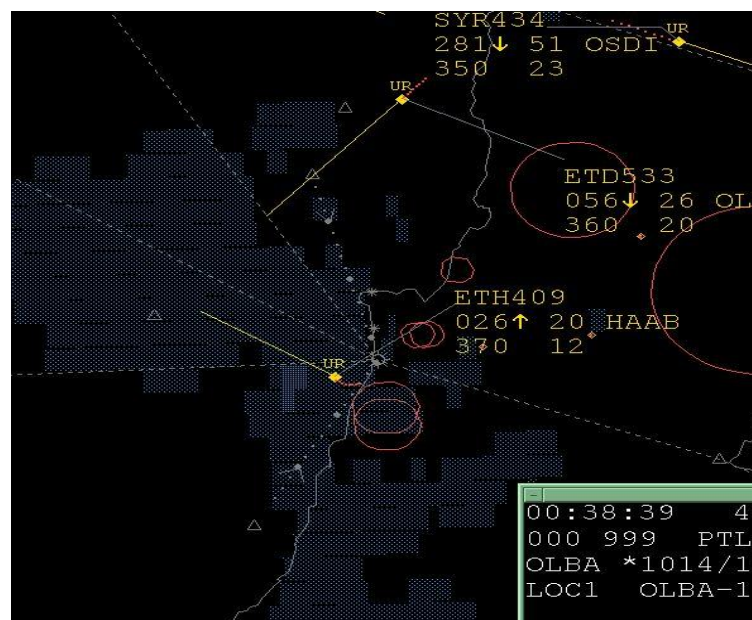
Figure 15: Radar Snapshot at 00:38:39

The Area controller was even trying to be more helpful and suggested to ET 409, “*due to weather to follow heading 270° to be in the clear for fifteen miles twenty miles then go to Chekka, and it is up to you just give me the heading*”. Thus, the controller suggested first an avoidance heading to the crew and then left it up to them to choose any other heading they felt comfortable with to avoid weather, as long as they advised him of that heading, since the responsibility for weather avoidance rests with the Flight Crew and their aircraft radar is definitely more accurate than the ATC radar in identifying weather and assessing the associated risks. Figure 15 in that report reproduces the snapshot of the radar picture displayed in front of the controller at the beginning of that transmission.

However, at that same time, the captain was having problems handling the aircraft, he turned beyond the selected/cleared heading despite the FD command and overbanked triggering “bank

angle” warnings. That situation might have been preoccupying the crew, and the controller offer most likely added to their workload, since they were concentrating on more serious issues and focusing their attention on what was going on at an aircraft handling level. This could explain why the crew initially misread the heading as 210°. Nevertheless, that situation couldn’t have been known to the controller.

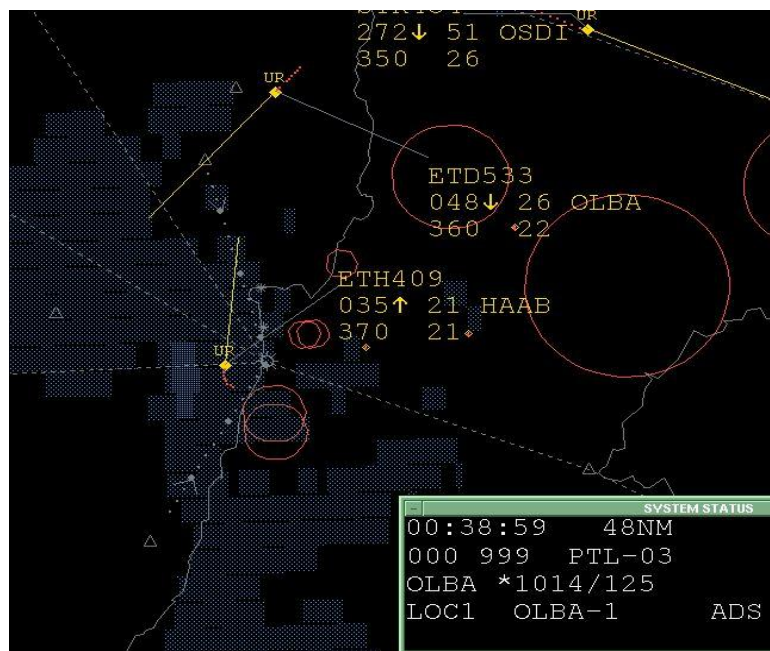
Figure 16: Radar Snapshot at 00:38:59

Therefore the ATC controller who thought that the aircraft, which was now more than 45° right of the cleared to heading, had misunderstood the Tower amended clearance to fly heading 315° v/s fly direct Chekka. So he immediately issued a clearance to turn left heading 270°, which was acknowledged by the crew. Figure 16 below reproduces the snapshot of the radar picture displayed in front of the controller when the aircraft reached a heading of 003°. The captain was heard on the CVR reading back in the cockpit the correct heading and the F/O was recorded setting it on the MCP and confirming his action as per the SOP call-out.

Beyond that point, the ATC controller was unaware of the problems the crew had to control the aircraft, especially that no particular call indicating such difficulties was received, and all the clearances issued to the crew were read back in a calm and relaxed voice, with the exception of the last non-standard “roger, roger” call back transmitted by the F/O one minute prior to the crash and the open microphone sound he got as a reply to the last instruction the flight crew could have heard around 20” prior to the crash.

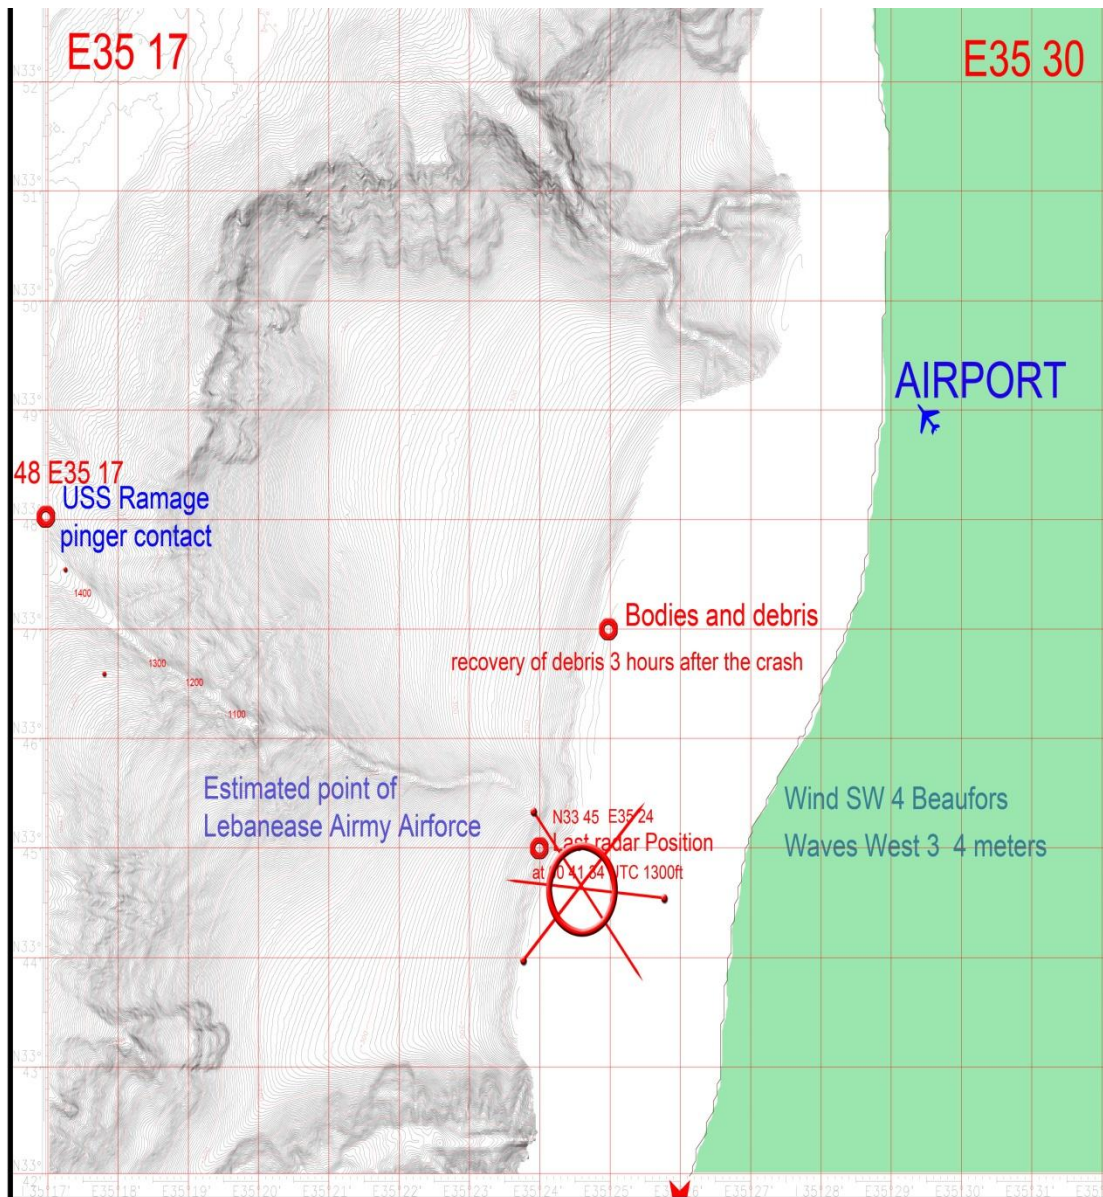
Attachment IV: Location of DFDR v/s Pinger Signal received by the USS Ramage

Finally, the controversy created by the signal picked by the USS Ramage was the result of the presence of a sea valley between the point where that signal was picked up and the point which was identified later by the French experts and where the wreckage was found. That allowed the sonar equipment on the USS Ramage to pick a signal which was 10 Km away through an adjusted sonar equipment (refer to Attachment IV).
