Report

Accident on **31 May 2010**
at "**Col des Bœufs**" (974)
to **the Robinson R22 helicopter**
registered **F-ORGB**

BEA

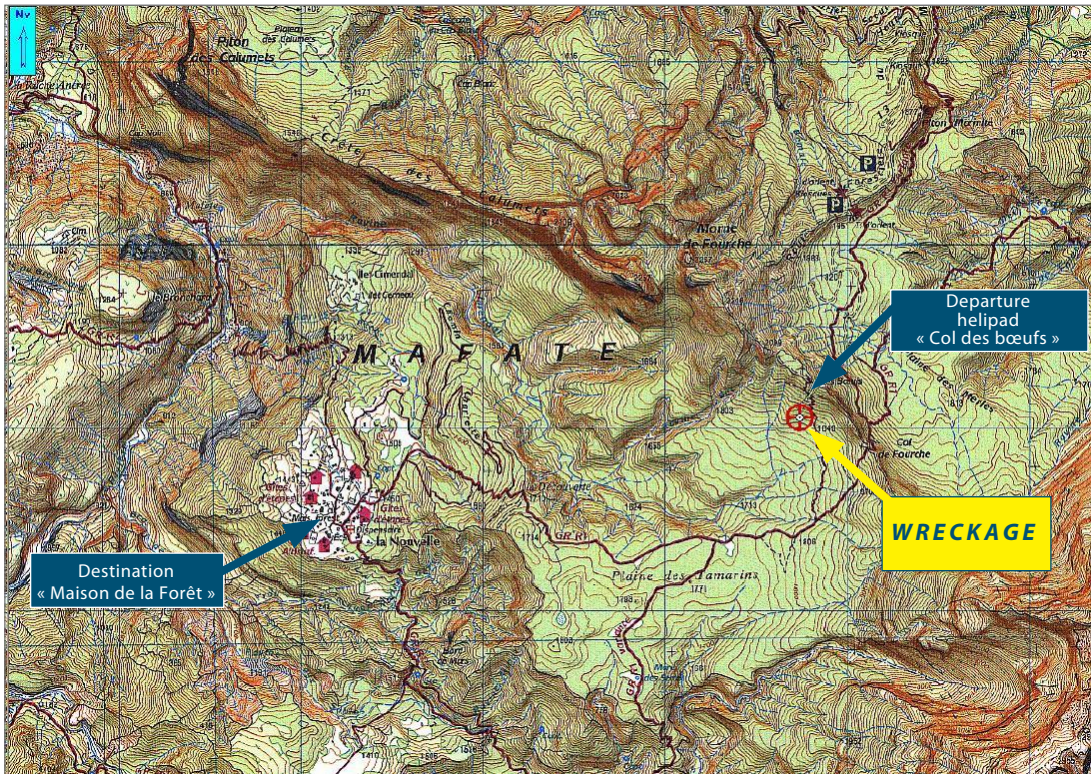
The pilot of the Robinson R22 took off from the commune of La Nouvelle in the Mafate cirque bound for the "Col des Bœufs" situated at 1,940 metres altitude to collect some packages. Three people from an electric company were on the col and were supposed to reach a house in the forest to undertake some work. The pilot that they contacted by phone offered to take them by R22 to the site of the house in the forest from the "Col des boeufs" after a first flight that he was scheduled to make. The pilot landed on the helipad at the "Col des boeufs" and began embarking the first passenger with the engine running. The pilot took off from a hover at about one metre, then flew rearwards before turning right on the slope. During this manoeuvre, the tail touched the ground on the slope and then the right skid got caught under a boulder. The helicopter crashed and came to a stop further below.

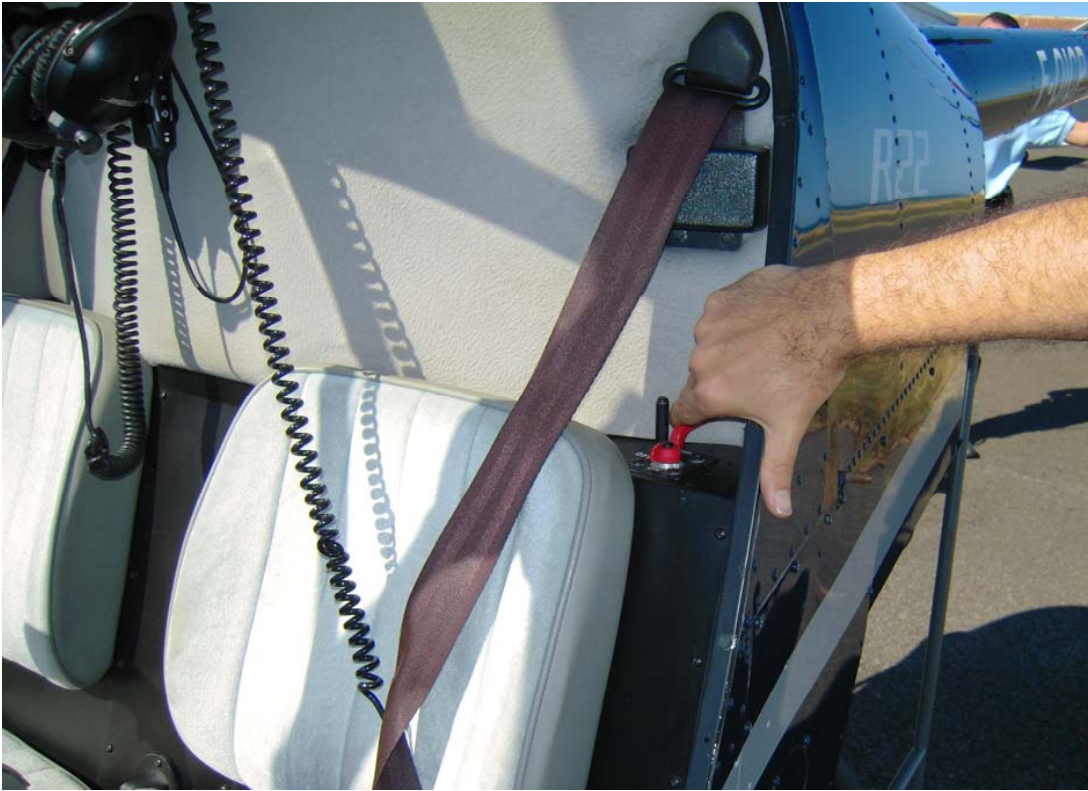
Position of the fuel cock observed in the wreckage

The fuel cock was observed to be in an almost closed position.

It was demonstrated that during boarding of a passenger via the side door, by grasping the side frame, it is possible to grab the fuel cock and turn it from the "ON" position towards a position close to "OFF".

The R22 is not equipped with an indicator light showing full or partial closure of the fuel cock. The only indication available to the pilot is the fuel pressure gage.

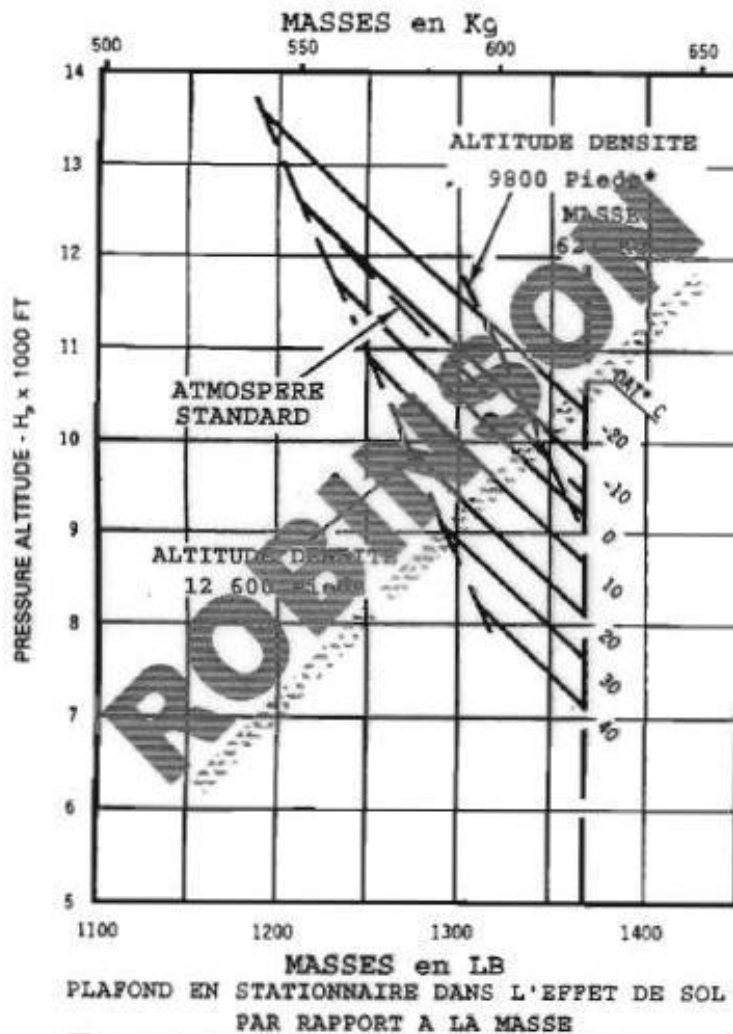
DANS L'EFFET DE SOL. PATINS A 2 Pieds
PLEIN GAZ ET REGIME A 103-104%
VENT NUL

At an altitude of 1,940 metres and a temperature of 17 °C, based on the "*in ground effect*" and "*out of ground effect*" takeoff performance graphs, the helicopter was within the limits of available power. However, during takeoff the pilot passed into "*out of ground effect*" and found himself at the limit of available power.
