# Report

**Accident on 5 September 2010  
at Anse-Bertrand (971)  
to the Cessna 208B registered F-OIXZ  
operated by Tropic Airlines**

Bureau d'Enquêtes et d'Analyses  
pour la sécurité de l'aviation civile

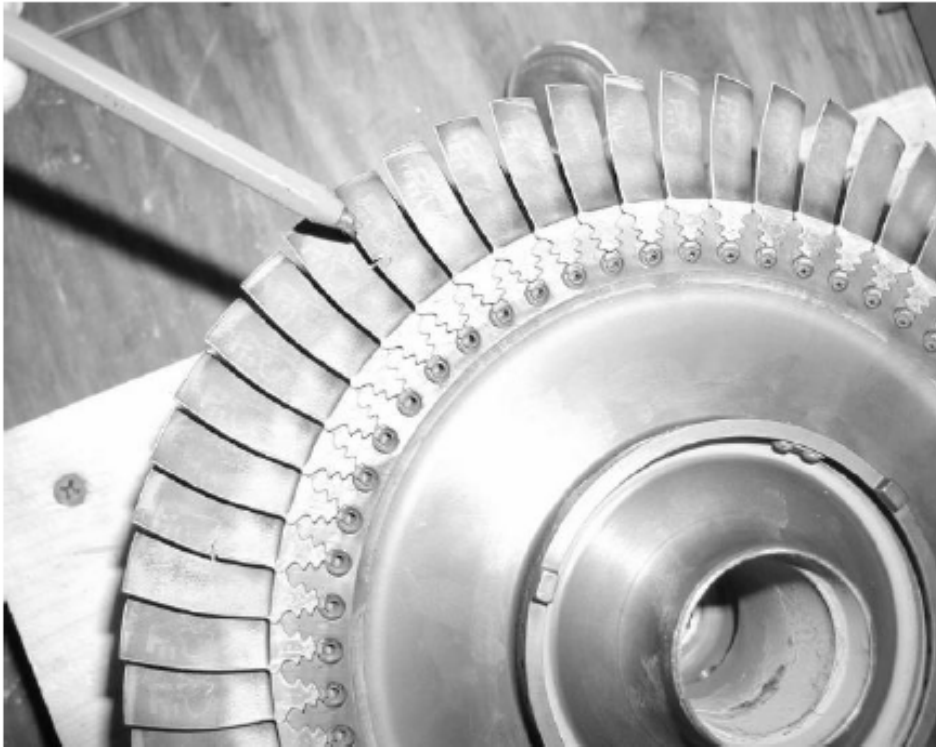
Figure 1

An example of CT Blades that were likely exposed to an overtemp condition are shown in Fig.1, these blades were in operation prior to being discovered during an H.S.I., cracking is evident on the trailing edge of some blades. Fig. 2 shows a CT disc assembly following a CT blade fracture event.
