Explosion of an oxygen pressure transducer

Aircraft	Bombardier CRJ700 registered F-GRZF
Date and time	1 July 2010 at around 7 h 25 ⁽¹⁾
Operator	BritAir
Place	Paris Charles de Gaulle Airport (95)
Type of flight	Scheduled public transport of passengers
Persons on board	Captain (PF), co-pilot (PNF)
Consequences and damage	Oxygen pressure transducer destroyed

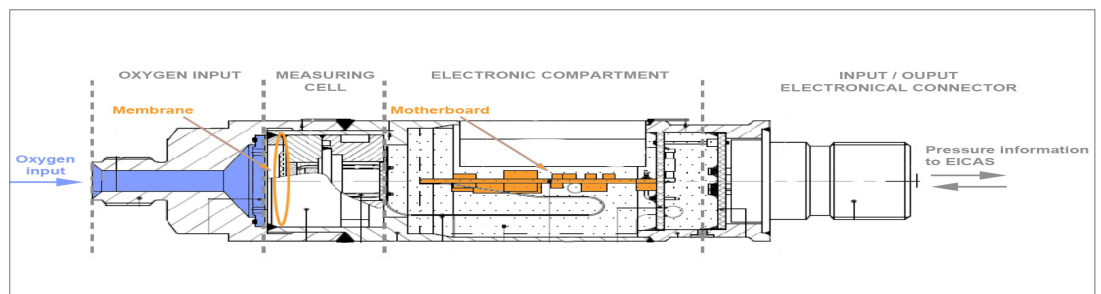
Description of the air pressure transducer.

This consists mainly of a high pressure fitting, a measuring cell, an electronics compartment and an electrical connector.

The oxygen puts pressure on a metal diaphragm that transmits the force to an incompressible fluid. The hydrostatic pressure of the fluid is then exerted on a piezo-resistive device that converts the pressure information into an electrical signal. This signal is then processed by the motherboard and then used to display the oxygen pressure on the EICAS.
