Tail strike on runway during night landing

Airplane	McDonnell Douglas MD-81 registered OY-KHP
Date and time	6 February 2010 at 18h25 ⁽¹⁾
Operator	Scandinavian Airlines System (SAS)
Site of accident	AD Grenoble-Isère (38)
Type of flight	Public transport of passengers Unscheduled international flight
Persons on board	Captain (PNF); Co-pilot (PF); 4 PNC; 127 passengers
Consequences and damage	Rear part of fuselage seriously damaged

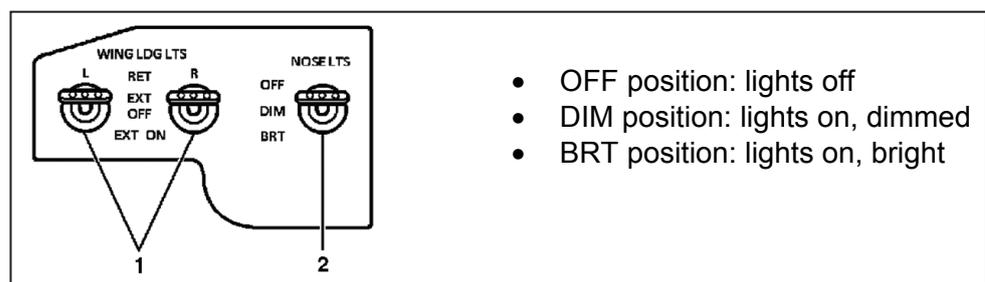
The nose wheel light switch has 3 positions:

- OFF position: lights off
- DIM position: lights on, dimmed
- BRT position: lights on, bright

According to the pilots' interview, SAS crews are encouraged to favour the "DIM" position for the lights, as the lights in "BRT" position undergo considerable wear and tear. Most night landings are carried out with lights in "DIM" position. However, the operating manual allows the crew to judge the level of lighting best adapted to external conditions.
