Fire on main left landing gear during taxiing after landing

Aircraft	ATR 72-200 registered EI-REJ
Date and time	19 April 2011 about 21 h 50 ⁽¹⁾
Operator	Air Contractors
Place	AD Paris Charles de Gaulle (95)
Type of flight	Scheduled international cargo transport
Persons on board	Captain (PF); Copilot (PNF)
Consequences and damage	Left main landing gear seriously damaged by fire

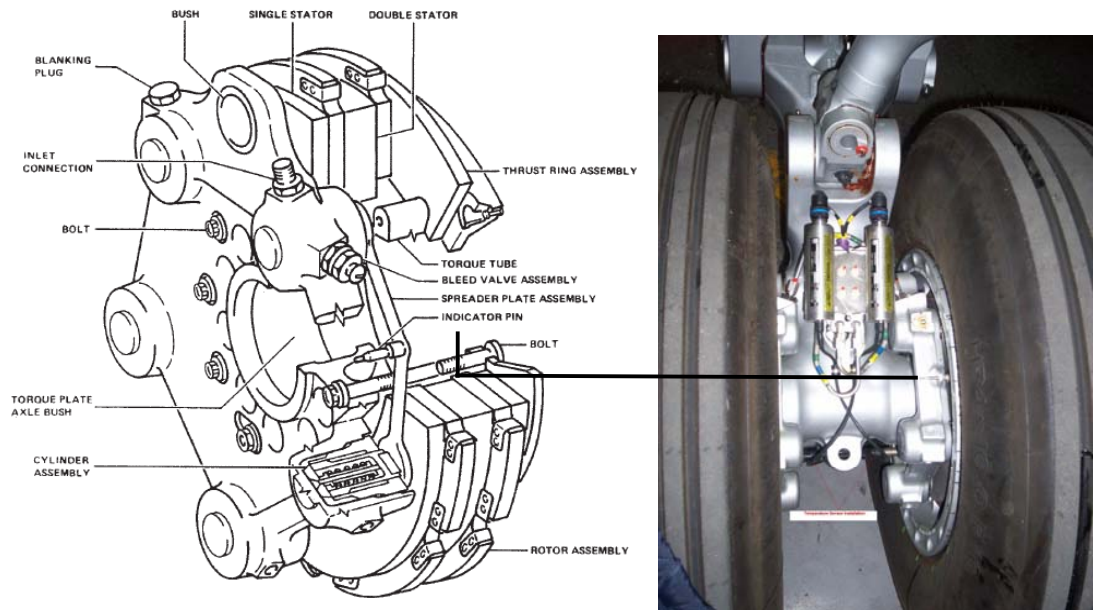
Figure 2: A brake block

Brake wear is assessed using an indicator pin located on the spreader plate. When the brakes are fitted on the wheels, the spreader plate is no longer visible and only the section of the indicator pin shown with an X in Figure 3 is visible. When this section is no longer visible, it means that the brakes have reached the wear limit.

Wear on brake block n°1 had exceeded the limit defined by the manufacturer. The spreader plate bearing the brake wear indicator was distorted before the accident and this distortion made it impossible to assess the real wear on the brake block, which appeared to be correct. The wear could not be detected⁽⁶⁾ during the daily maintenance checks. The equipment manufacturer indicated that this wear does not affect braking efficiency. However it did not specify if this wear could encourage a brake block piston malfunction.

The equipment manufacturer responsible for brakes designed a new spreader plate. Modifications were considered to avoid distorting the plate during normal operation of the aeroplane so that the wear indicator truly represented the condition of the brake block. This new model is currently being validated by the aeroplane manufacturer. Not having determined the cause of the brake block overheating as yet, the equipment manufacturer had not put in place corrective actions at the time of publication of this report.
