**FINAL REPORT ON ACCIDENT TO  
HELI- UNION COMPANY LTD.  
HELICOPTER SIKORSKY S76 C++  
NEAR YETAGUN IN ANDAMAN SEA  
ON 11.07.2011**

| 2. Aircraft type | : Helicopter SIKORSKY S76 C++ |
| 4. Registration | : F-HJCS |
| 6. Date & Time | : 11 July 2011 at 10 h 19 (local time) |

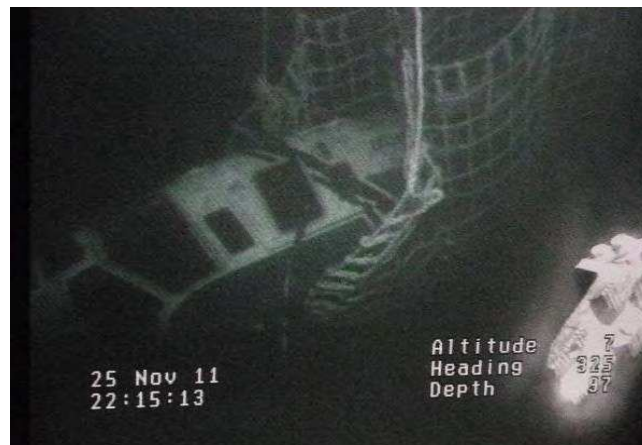
20 minutes later the helicopter wreckage was discovered. On 26 November, the rotorcraft was lifted out of water and loaded on board the vessel.

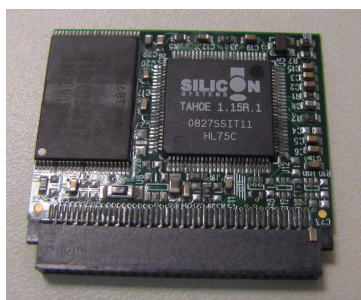
*Picture ref 1*

The CF card was extracted from the PCMCIA adapter and presented traces of corrosion (see picture ref 1).

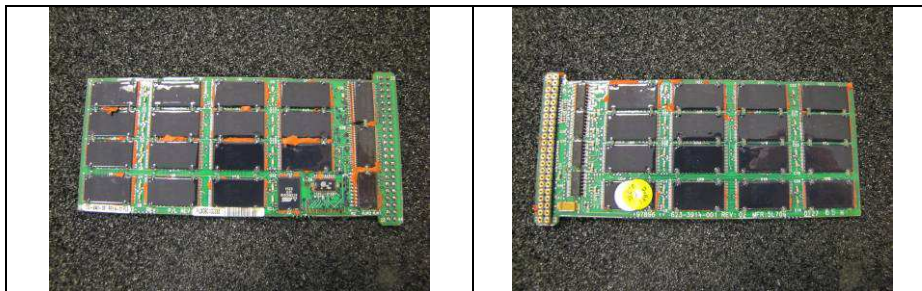
Board #1

The double memory board is in good condition and has been placed in an oven at 90°C for 48 hours and then at 40°C for drying.

Electrical checks were performed on the double boards outputs and resistive values were compared to reference tables provided by the manufacturer. The analysis of the few discrepancies observed concluded that the download could be attempted.

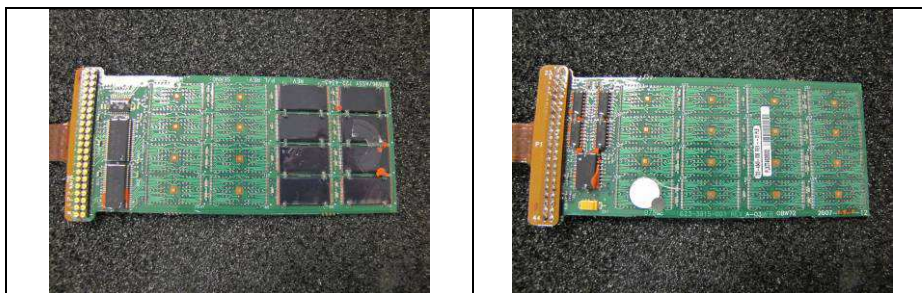
Board #2

The memory boards were connected with a BEA connector to the BEA 6025 chassis used as a playback system. The read out was performed using the manufacturer download equipment RPGSE. The file containing the cockpit voice data was downloaded successfully, but the file containing the flight data was partial.
