# Report

Serious incident on **22 July 2011**  
**in cruise at FL350, north Atlantic Ocean**  
to the **Airbus A340-313**  
registered **F-GLZU**  
operated by **Air France**

**BEA**

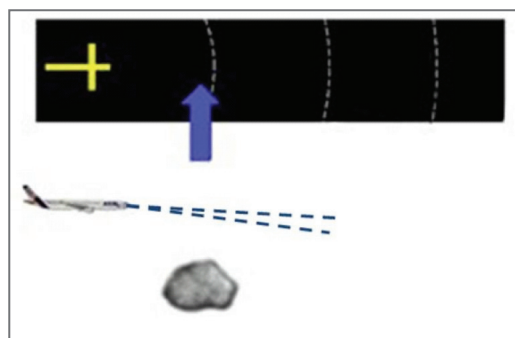
Figure 3 - Example of radar image

The tilt adjustment determines the zone scanned by the radar beam and consequently the echoes that are detected and displayed on the ND. Adjustment of the gain then enables the reflectivity of the precipitation encountered to be adapted. It should be noted that clouds situated in front of the aeroplane but not swept by the beam are not visible on the radar:

The adjustment of the weather radar was not the most suitable for detecting the convective zone crossed. Indeed, the ranges selected remained at 320 NM for a considerable time, whereas the airline's FCOM manual recommends 160 NM or 80 NM. This probably contributed to the crew's failure to detect the convective cell close to point 18N 060W.

It should be noted that choosing the 320 NM range on the ND may come from the practice of adapting the range to see the next waypoint on the ND. In the zones where the waypoints are distant from each other, this practice goes against optimal utilisation of the weather radar.

The tilt is adapted to the range of the ND. The manufacturer's Flight Crew Training Manual and the Air France FCOM A330/A340 manual recommend setting the range in cruise to 160 NM or 80 NM.
