## Vibrations, failure of the right main landing gear torsion link during landing roll

<b>Aircraft</b>	Boeing B737-300 registered G-CELD
<b>Date and time</b>	23 July 2011 at 8 h10 UTC <sup>(1)</sup>
<b>Operator</b>	Jet2.com
<b>Place</b>	Paris Charles de Gaulle Airport
<b>Type of flight</b>	Scheduled international transport of passengers
<b>Persons on board</b>	Captain; Co-pilot; 3 cabin crew; 128 passengers
<b>Consequences</b>	Right main landing gear damaged

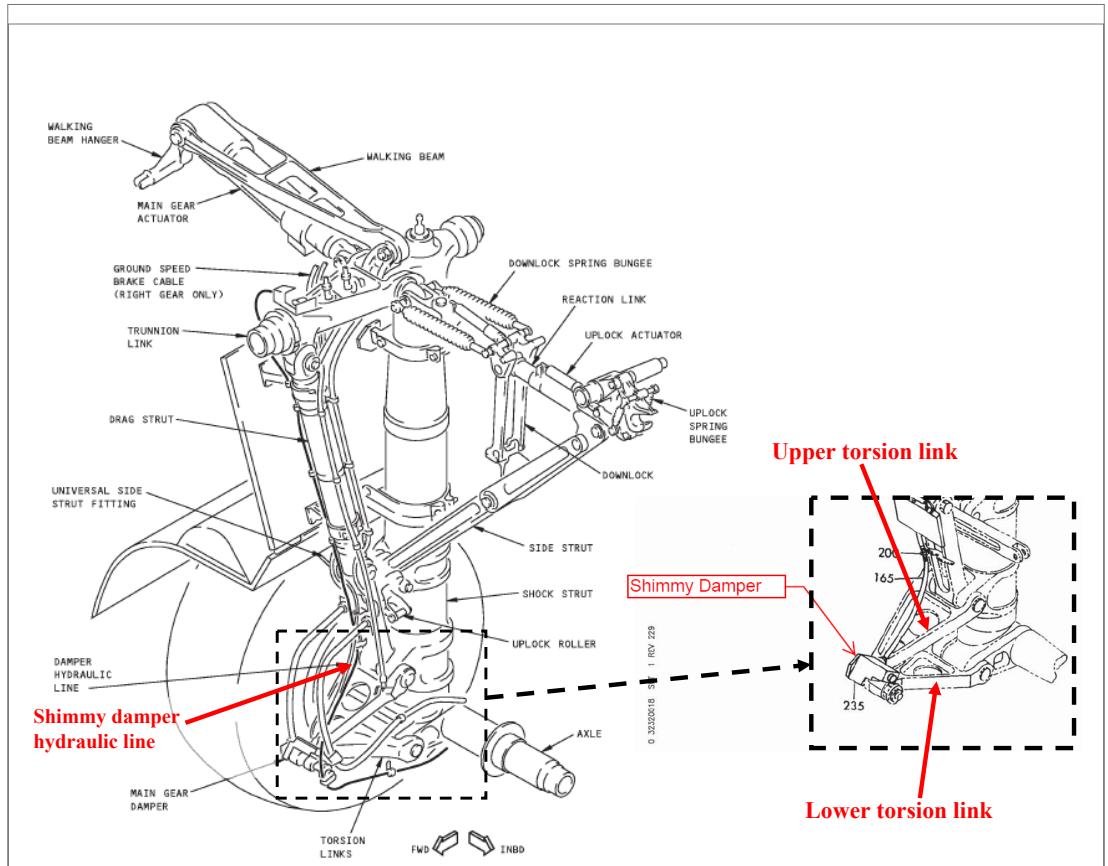
Figure 1 – Overall view of main landing gear

Three check valves enable hydraulic fluid to enter the damper. Rotating oscillation between the inner and outer cylinders of the main landing gear shock strut (see figure 1) is absorbed by the actuator piston. The movement of the actuator acts as a damper in order to counter vibrations. The rate of movement is regulated through a damping orifice.

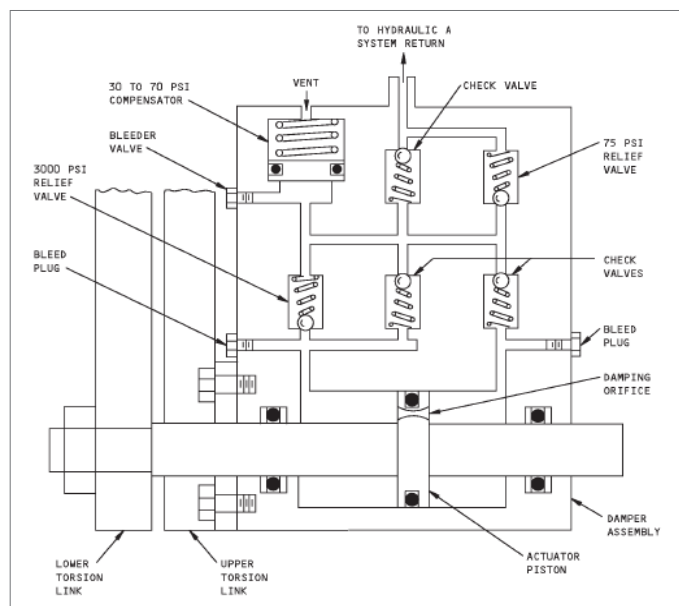
Figure 2 – Schematic of the shimmy damper

The shimmy damper was thus not supplied by the aeroplane's hydraulic system. It could not then function normally. During the landing, the vibrations caused by the high speed of the wheels and the heavy braking could not be damped down. The strong vibrations quickly weakened the lower torsion link until it failed suddenly.
