Report

Accident on **16 October 2012**
at **Lorient Lann Bihoué (56) Aerodrome**
to the **the Bombardier CRJ-700**
registered **F-GRZE**
operated by **Brit Air**

BEA

Bureau d'Enquêtes et d'Analyses
pour la sécurité de l'aviation civile

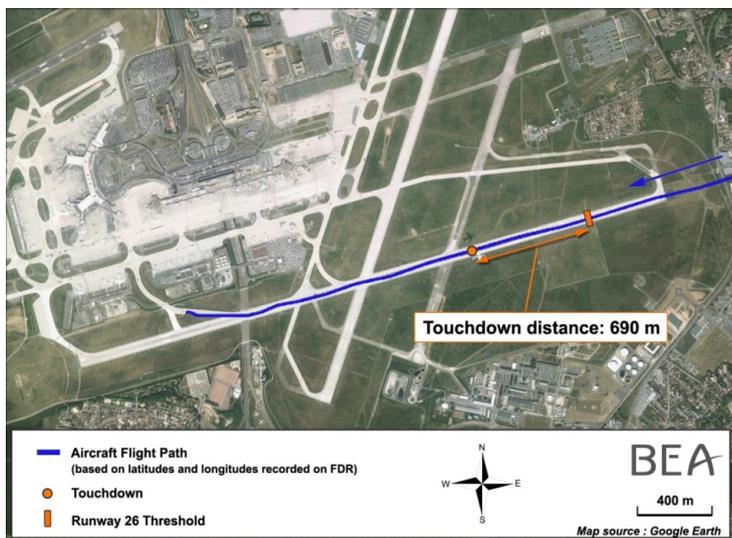
External environment	Runway for landing	Aeroplane configuration	Ground speed on touchdown	Distance of touchdown in relation to runway threshold
Flight N (PF=Captain)				
Night Visibility = 1800m Wind on passage over threshold = 150°/25 kt	Lorient Lann Bihoué runway 25	Flaps 30°	140 kt	1,130 m
VOL N-1 (PF=CDB)				
Daytime Visibility > 10km Wind on passage over threshold = 170°/5 kt	Paris Orly runway 26	Flaps 45°	121 kt	690 m

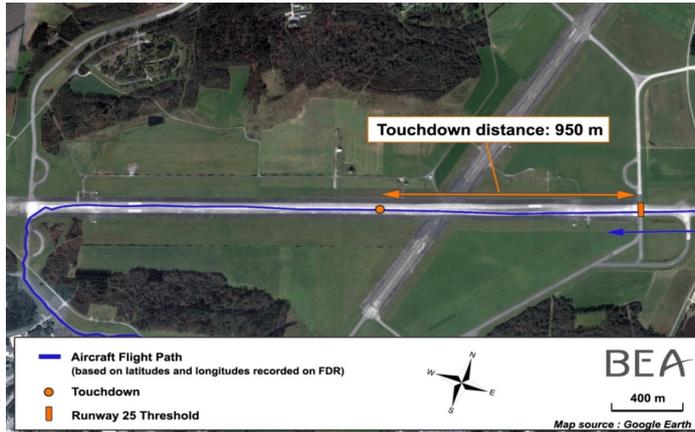
FLIGHT N-2 (PF=Copilot)

Daytime Visibility > 10 km Wind on passage over threshold =150°/18 kt	Lorient Lann Bihoué runway 25	Flaps 45°	123 kt	950 m
---	---	------------------	--------	--------------

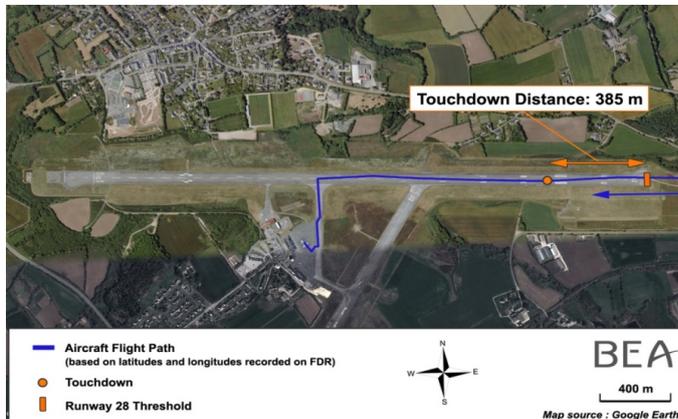
FLIGHT N-4 (PF=Copilot)

Daytime Visibility > 10 km Wind on passage over threshold =200°/4kt	Quimper runway 28	Flaps 45°	128 kt	385 m
---	-------------------------	------------------	--------	--------------

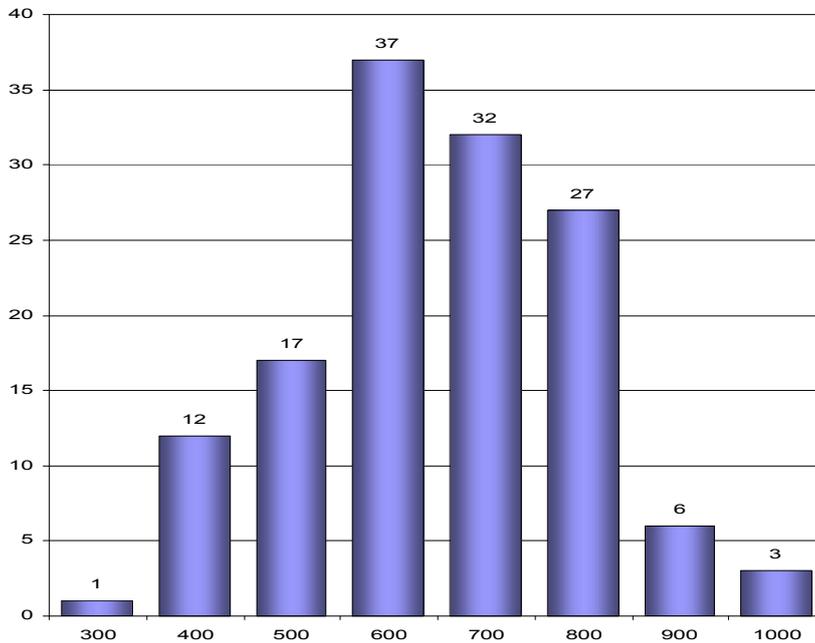
- Long landings in CRJ-1000 from May 2011 to December 2011 (Lyon Saint-Exupéry) runway 36 L (LDA: 4000 m)
