INTERSTATE AVIATION COMMITTEE
AIR ACCIDENT INVESTIGATION COMMISSION

FINAL REPORT
ON RESULTS OF INVESTIGATION OF ACCIDENT

Type of accident	Fatal accident
Type of aircraft	ATR72-201 aeroplane
Registration	VP-BYZ, Bermudas
Owner	BLF Limited
Operator	UTAir Aviation, JSC
Place of accident	1500 m from RWY 21 threshold; cross-track deviation about 400 m, Roschino aerodrome, Tyumen. Coordinates: N 57°09.440' E 065°16.000'
Date and time of accident	02.04.2012, 01:35 UTC (07:35 local time), day time

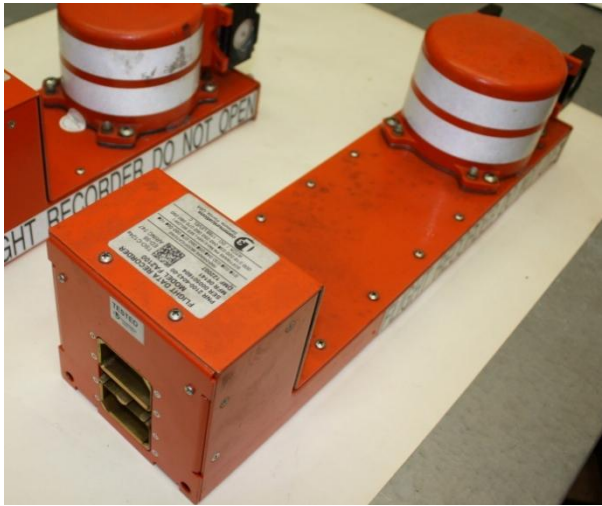
**Figure 7. Flight Data Recorder (FDR)
FA2100 SN000501604**

The FDR visual inspection determined that the case was not damaged. There was an identification label on the FDR case: **PNR 2100-4043-00, SER 000501604, MFR 06141, DMF 122007.**

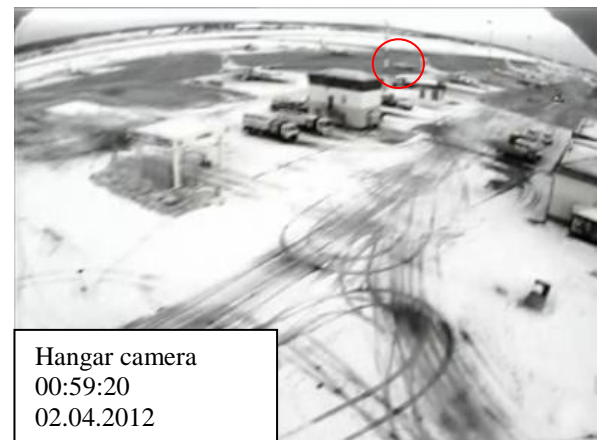
Figure 19. De-/anti-icing vehicle has arrived to the ATR 72 VP-BYZ A/C

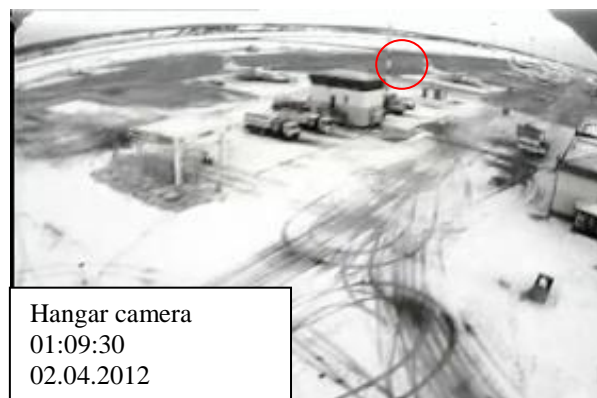
Figure 18. De-/anti-icing vehicle is leaving

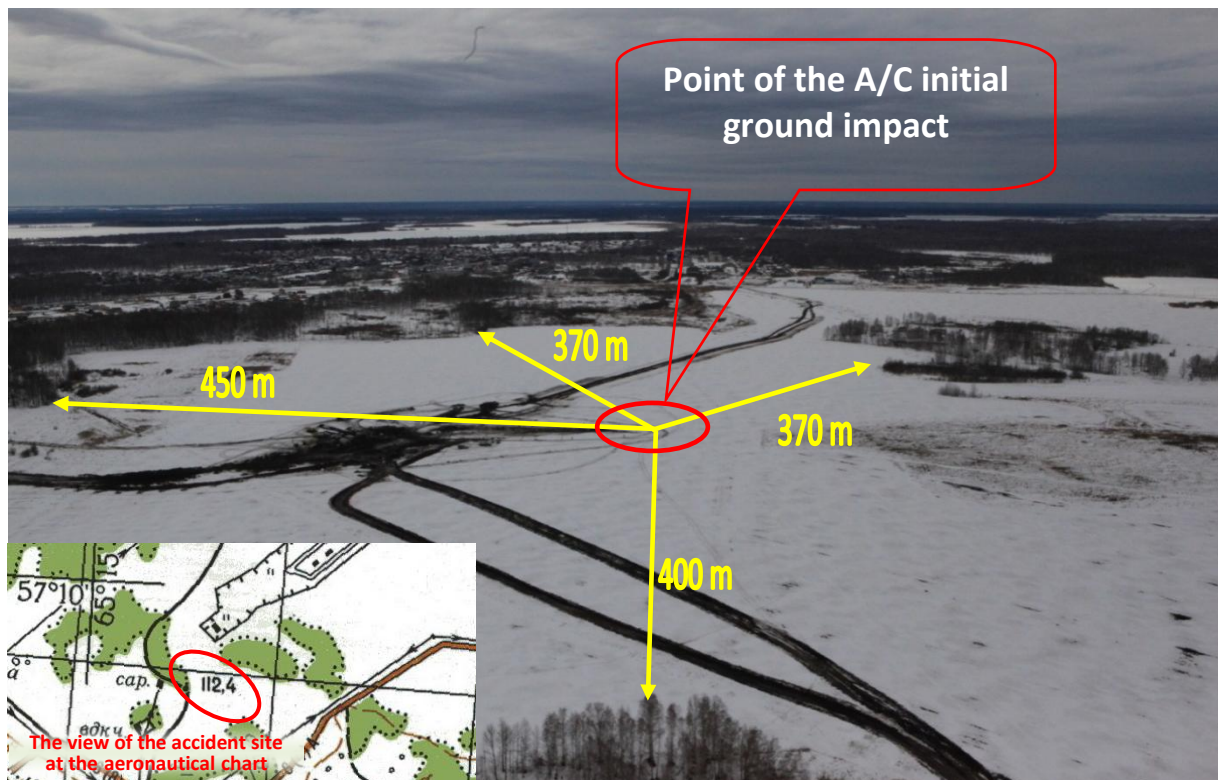
The Tyumen (Roschino) AP is located in the flat area and its RWY 21 exit threshold elevation is 103.9 m. The area where the accident occurred is a flat ground (at the moment of accident it was covered with snow, $H = 30\text{-}34$ cm) with some adjoining blocks of birch forest with trees' height of 15-20 m (Figure 29). The terrain elevation in the area of the accident is 110 m.

Figure 29. The accident site positioning with relation to the reference points

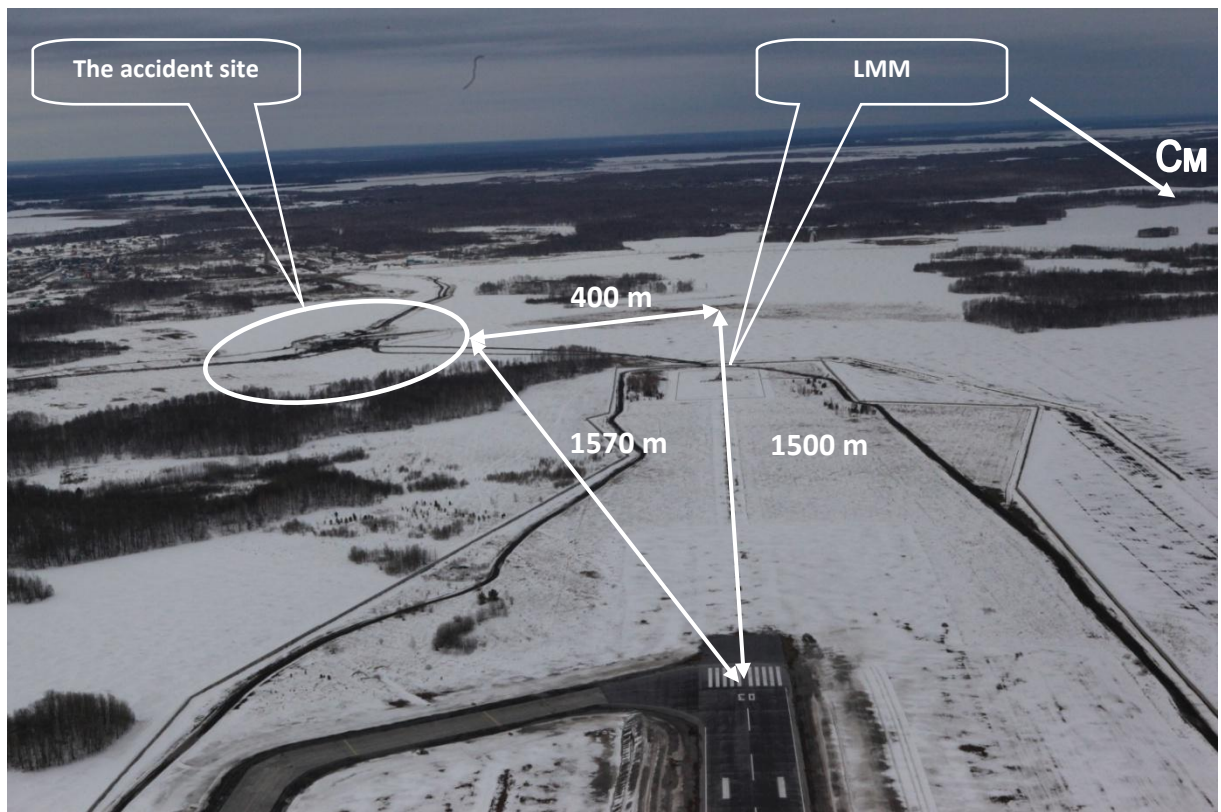
The accident site positioning with reference to the RWY is shown on Figure 30. The A/C center of mass's motion direction on impact was $MH \approx 90^\circ$. The A/C debris are located within about ≈ 190 m along the A/C motion direction and within about ≈ 50 m edgewise.

The A/C ground collision occurred at distance ≈ 1500 m from the RWY 03 threshold along the RWY centerline, with lateral deviation to the left ≈ 400 m of the RWY centerline. The point of initial impact coordinates are: N $57^\circ 09.440'$ E $65^\circ 16.000'$.

Figure 30. Airscape view of the accident site with reference to RWY with takeoff heading MH = 214°

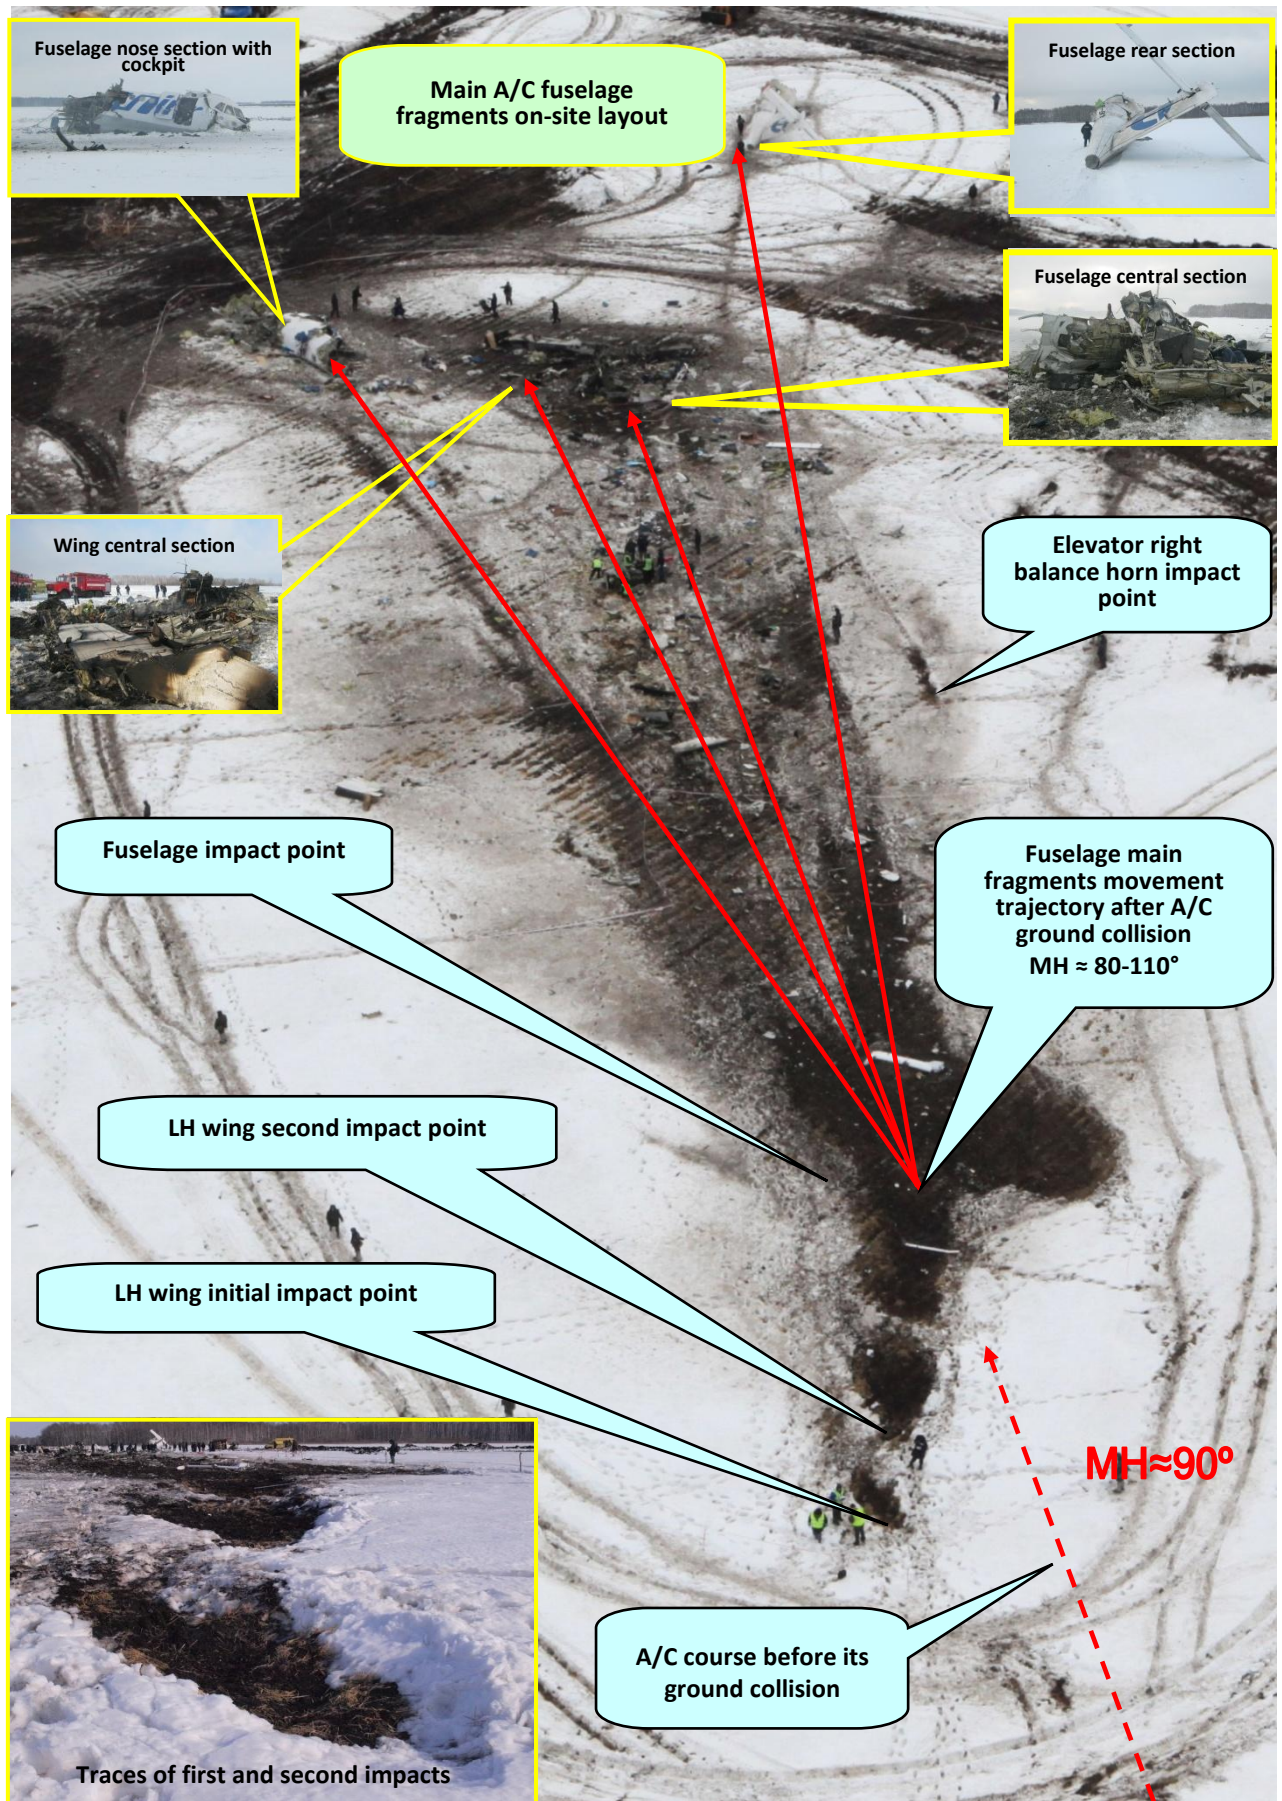
Figure 32. Airspace view of the accident site

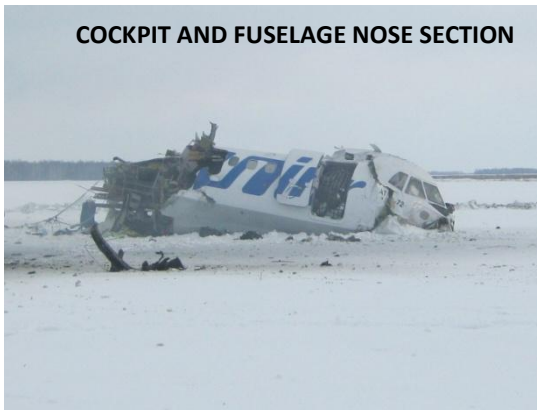
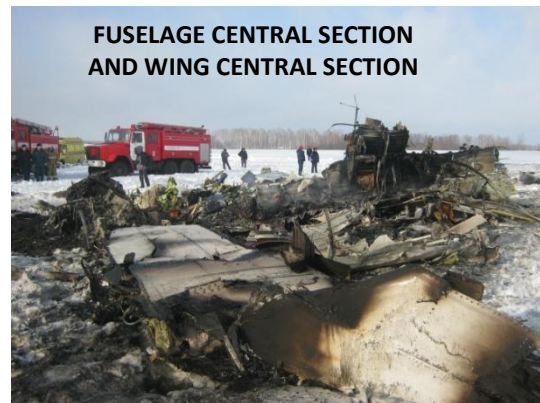
Figure 34.

At the point with coordinates N 57°09.428' E 65°16.020' the A/C fuselage hit the ground that resulted in the fuselage breaking into three major parts (cockpit with the fuselage nose section [further FNS], fuselage central section [further FCS] with wing central section, and fuselage rear section [further FRS]) that continued their travelling within the sector from 80° to 110°.

Cockpit with FNS was located at 134 m from the A/C initial impact point. The fuselage major damage, namely deformation, are along the fuselage LH side, and this evidences that the A/C collision first occurred with the fuselage left nose section. This is also evidenced by the absence of the left door that was found about 50 m before the FNS. The FNS did not show any evidence of fire.

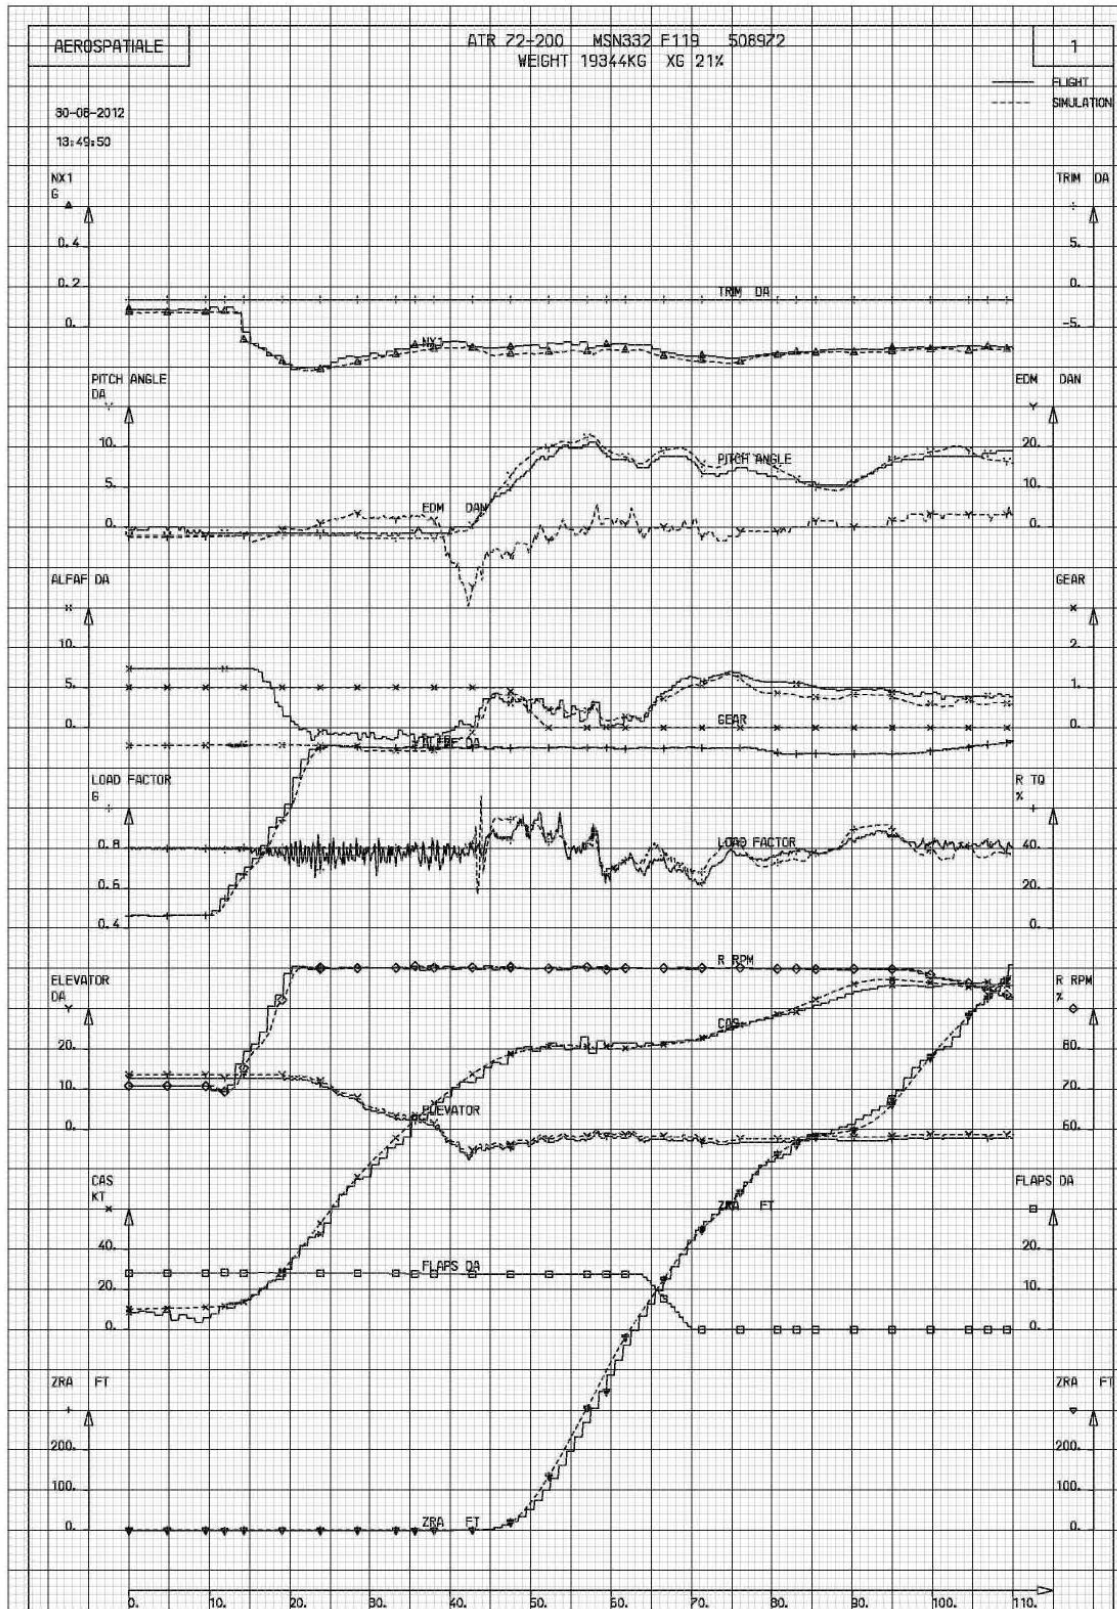
To calibrate the parameters and estimate the consistence of the simulation, the DFDR data available from the previous flight (Flight UTA119, from Surgut to Tyumen) was used. The simulation was based on the takeoff weight and CG data from the load and trim sheet. The SAT was +6°C at the time of departure, i.e. there could be no contamination. The simulation revealed a good consistency of the simulated and recorded parameters (see Figure 41), thus validating the simulated aircraft motion during the takeoff run and takeoff. The simulation also revealed that before the rotation there was practically no forces on the control columns. During the rotation the control column forces were about 20 daN and then went to near zero after the climb pitch angle was established, which means the aircraft was stabilized.

Figure 41. Simulation compared to FDR, Flight UTA-119

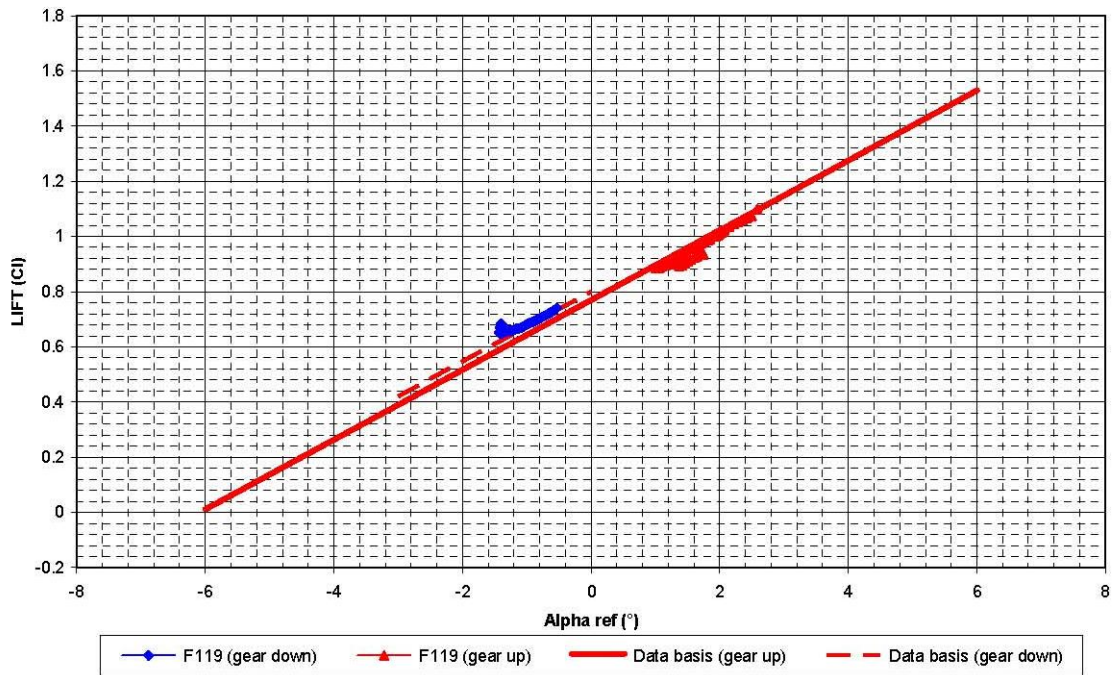
The simulation revealed that the actual drag and lift of the aircraft (Flight UTA-119) with flaps 15° (landing gear up and down) and flaps 0° (landing gear up) are well consistent with the aerodynamic data basis (Figure 42 and Figure 43).

Figure 42. Takeoff simulation Flight UTA-119 (Flaps 15°)

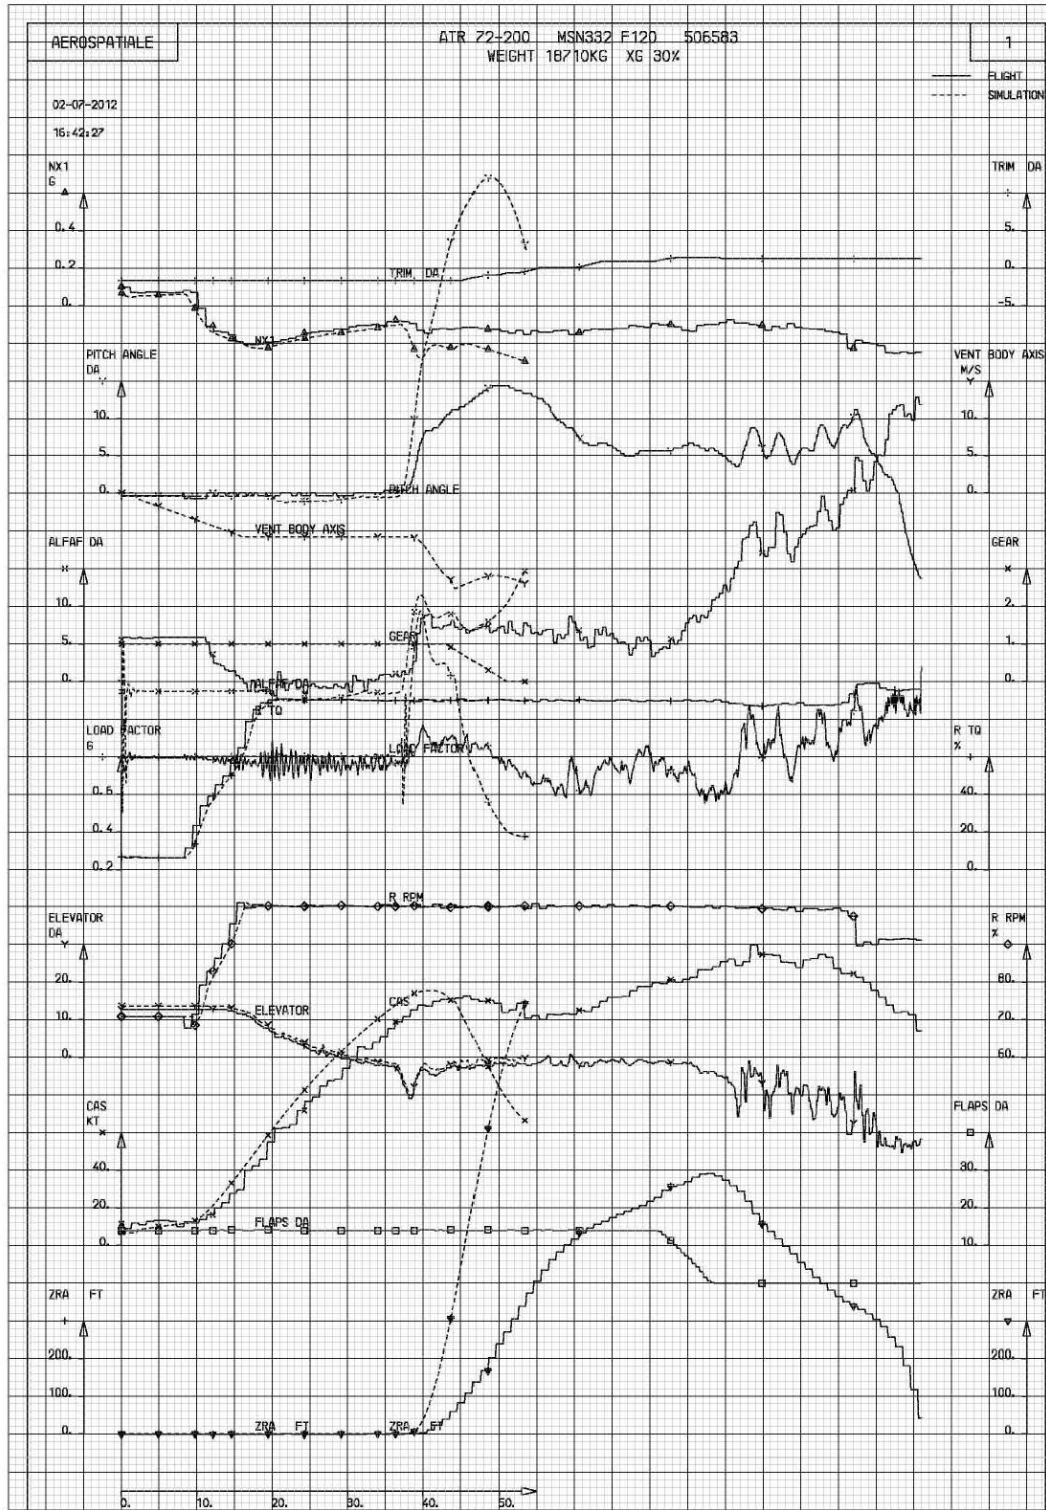
Figure 44. Simulation compared to FDR Flight UTA-119 – without extra drag and lift

The accident flight simulation (Flight UTA-120) showed that with the actually realized deflection of the flight control surfaces, engine thrust and the aerodynamic data basis, the simulation did not match the DFDR parameters (Figure 44).

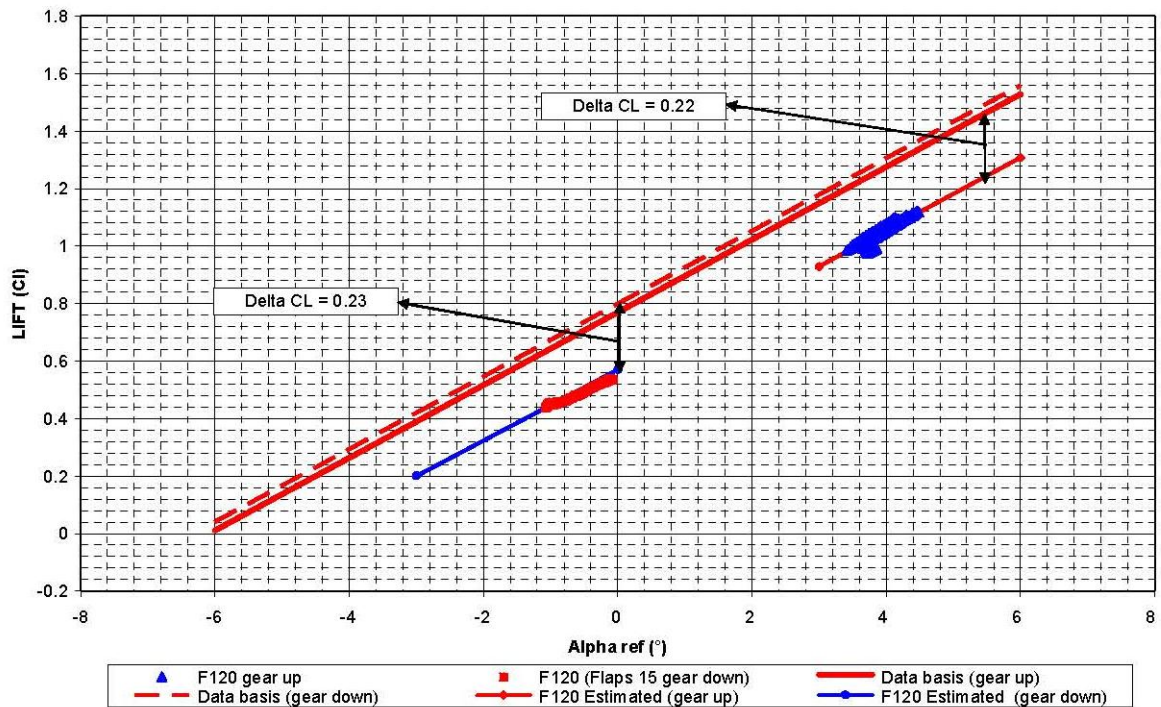
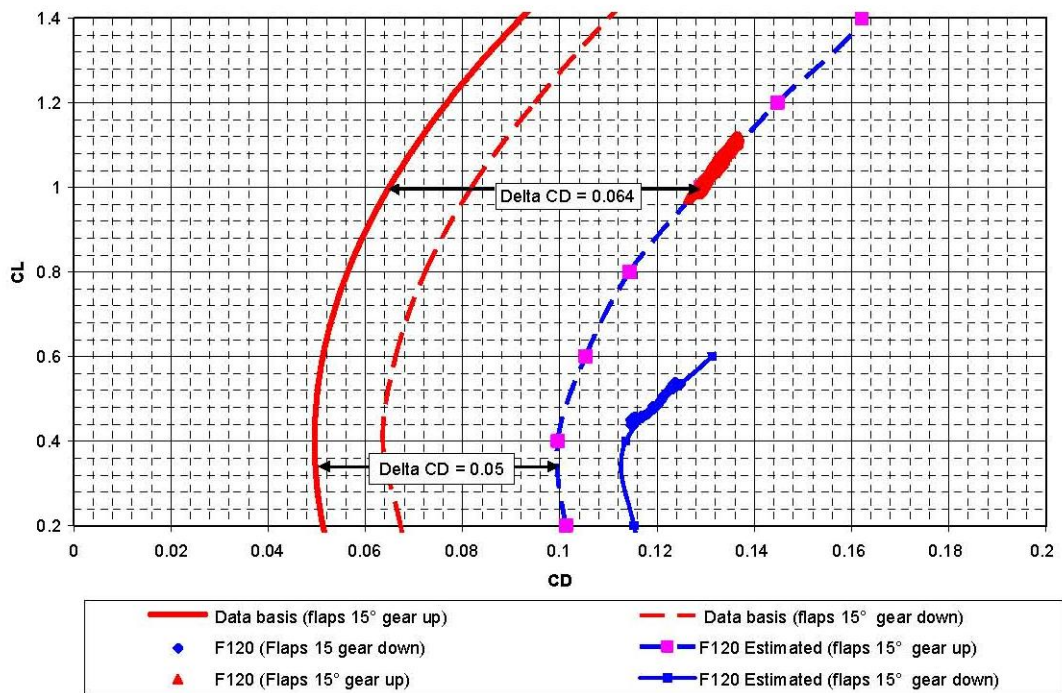
Figure 46. Takeoff simulation Flight UTA-120 (Flaps 15°)

The simulation revealed that during the takeoff run at angle of attack near 0° , a loss of lift and an increase of drag were $\Delta CL_0 = -0.23$ and $\Delta CD_0 = 0.05$ (Figure 46). The graph analysis shows that at that phase of flight CL was reduced by approximately 25%, while drag was doubled. Further after the landing gear retraction the loss of lift remained more or less constant, while the drag increased with angle of attack, providing a $\Delta CD_0 = 0.064$ (Figure 46). After the flaps retraction the loss of lift still remained almost constant, while the drag increasing was $\Delta CD_0 = 0.05$ (Figure 47).

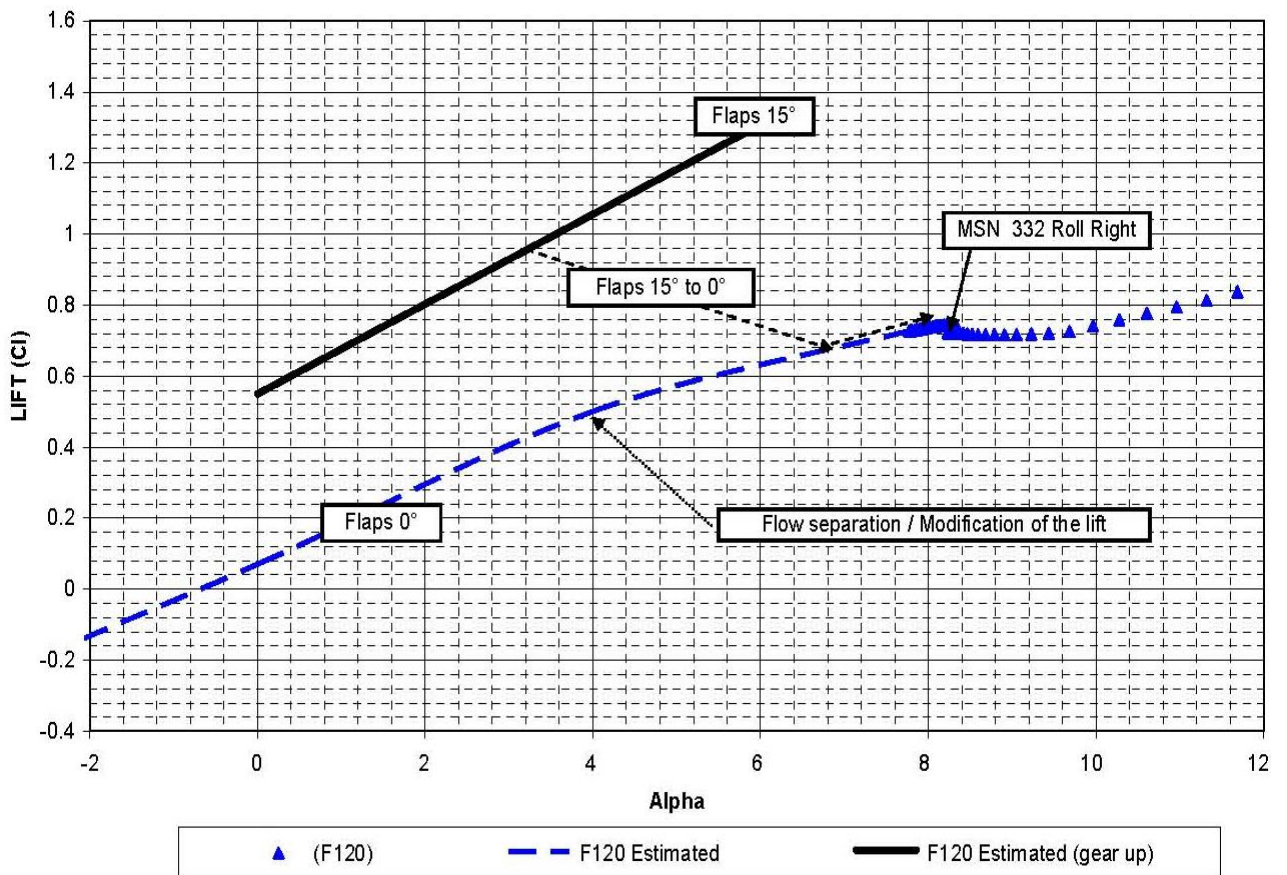
Figure 49. Simulation of Flight UTA-120 (flaps 0°)

Another conclusion drawn in the course of the simulation was that having the actual aerodynamic parameters it was impossible, after the flaps retraction, to obtain the lift required to continue flight at the current speed. It could be drawn from Figure 49 that the AOA increase cause stall before reaching the required CL. Thus, it was impossible to recover without setting flaps 15°.

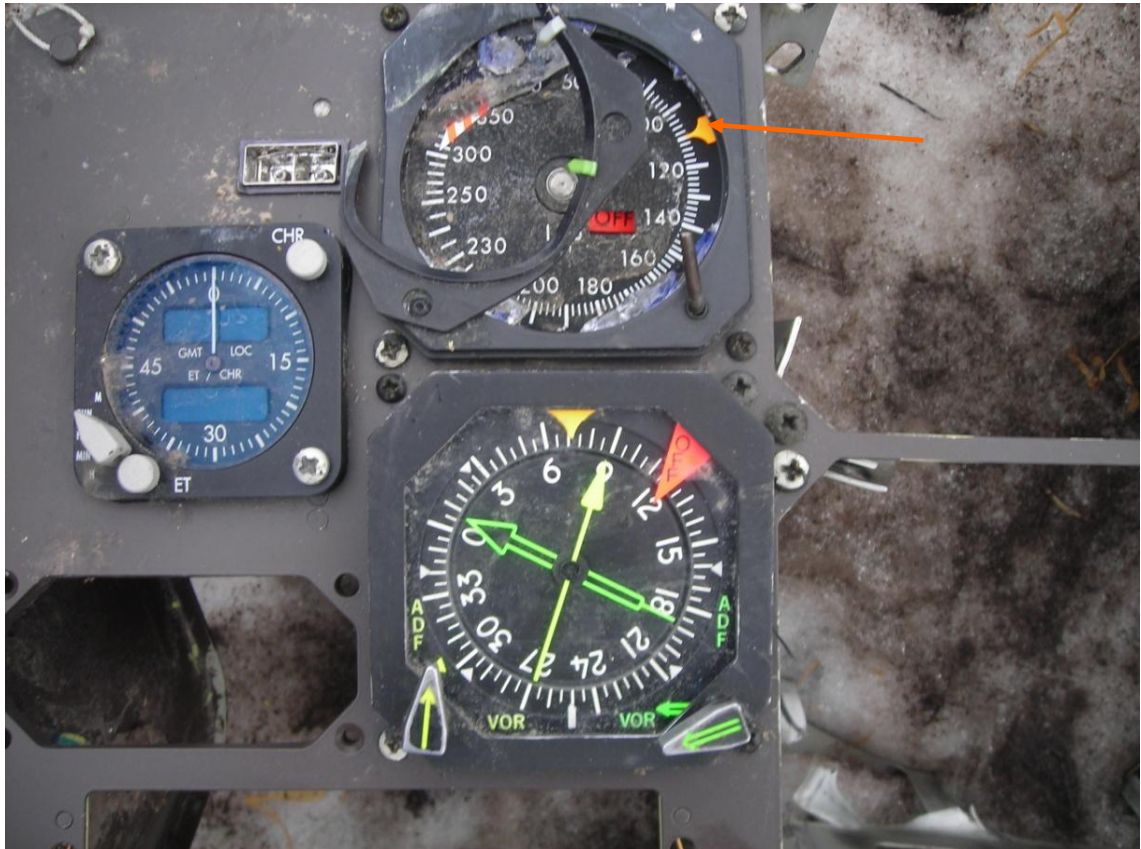
Figure 57. PIC instrument panel

All the crew further actions also confirm that they were not aware of the danger of aircraft takeoff with non-removed ground icing. The value of takeoff safety speed (V_2) was set on the airspeed indicator for normal conditions but not for flight under the conditions of possible icing. During the inspection of the PIC's and F/O's instrument panels it was revealed that the V_2 bugs were set at 111 kt. According to FCOM this speed value corresponds to takeoff normal conditions for the actual weight. For takeoff under possible icing conditions this value would be equal to 115 kt.

After the takeoff the crew performed flaps retraction, being guided by the white bug (minimum flight speed with retracted flaps for normal conditions, 132 kt, TOW 18730 kg), but not to the red bug of minimum flight speed with retracted flaps under possible icing conditions (160 kt for TOW 18730 kg).
