Report

Accident on **29 March 2013**
at **Lyon Saint-Exupéry Airport (France)**
to the **Airbus A321**
registered **SX-BHS**
operated by **Hermes Airlines**
chartered by **Air Méditerranée**

BEA

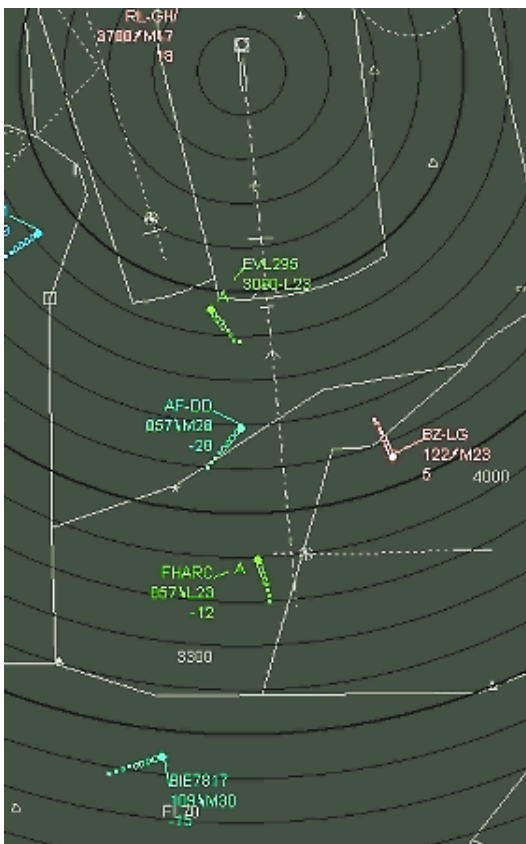
Radar vectoring of SX-BHS and of preceding aeroplane (AF-DD)

- **AF-DD at 5,700 ft at a ground speed of 280 kt**

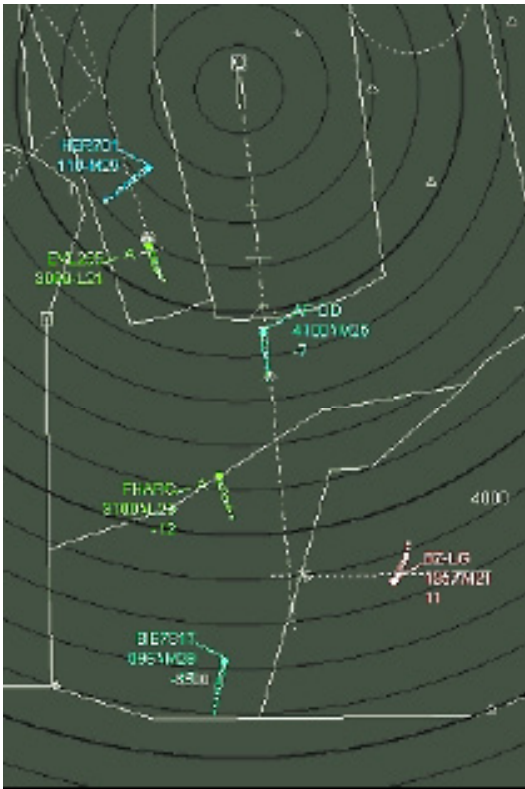
- AF-DD is 10 NM from the threshold of 36R, aligned on the LOCALIZER at 4,100 ft with a ground speed of 250 kt (Radar). At that moment the QAR recording indicates a CAS of 220 kt.

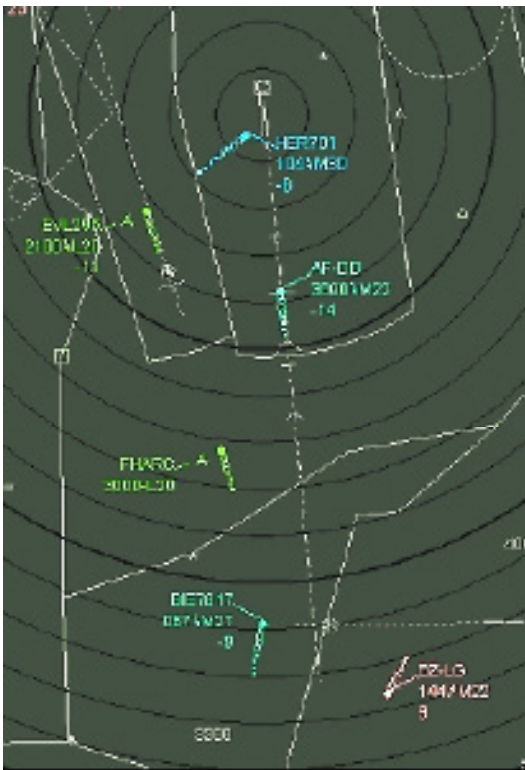
- AF-DD crosses FAP (6.9 nm/ 3,000 ft) at 3,000 ft at a ground speed of 220 kt (radar) CAS = 182 kt (QAR)

- BIE7817 at 22 nm from threshold at 8,700 ft at a ground speed of 270 kt (radar) CAS = 227 kt (FDR)

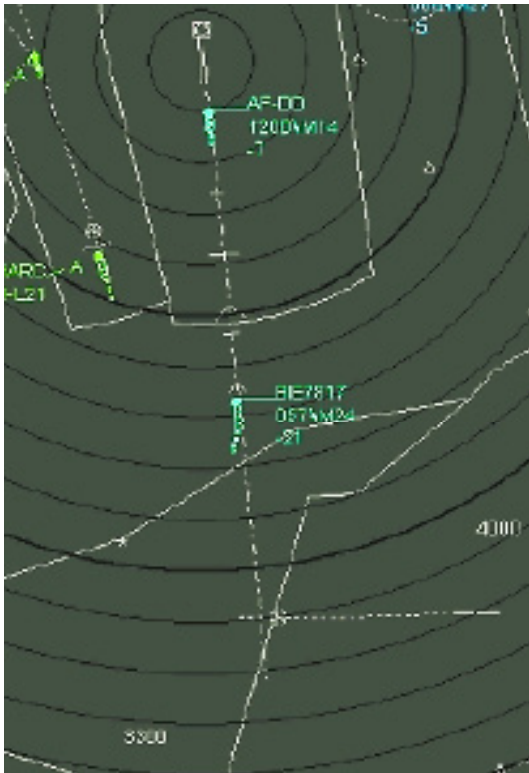
BIE7817 at 5,700 ft at a ground speed of 240 kt (radar). CAS = 217 kt (FDR)

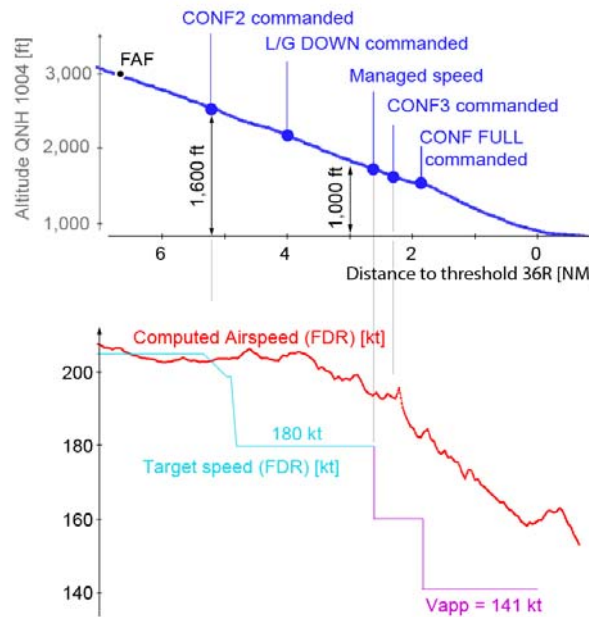
During the event, passing through about 2,400 ft QNH in descent (1,600 ft AAL), the crew selected the CONF2 configuration. They selected a target speed of 180 kt but the air speed (CAS) did not drop and remained stable at about 204 kt. The crew selected landing gear extension 15 seconds later, passing through 1,400 ft AAL. The CAS fell and reached 198 kt when passing through 1,000 ft AAL. During this sequence, the aeroplane was subjected to a significant drop in tailwind.

The results of the calculations show that, under the event conditions, the progressive drop in the tailwind penalises the reduction in aeroplane air speed (CAS) more than a constant strong tailwind. This result is mainly due to the fact that in constant wind conditions CONF 3 can be engaged earlier.

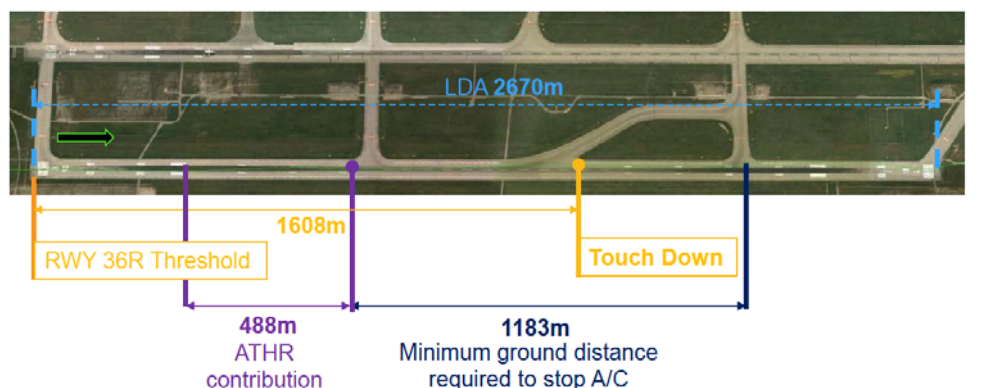
Contribution of the A/THR anomaly to the extension of the air phase in the worst case scenario

The results show that the increase in N1 contributes to a 5 kt increase in calibrated airspeed on passing 50 ft radio altitude. An increase of the vertical speed of about 300 ft / min is also observed.

- ❑ the distance between passing 50 ft and the touchdown point is increased by +130 to +500 metres;**
- ❑ the calibrated airspeed (CAS) at touchdown is increased by +4 to +9 kt.**

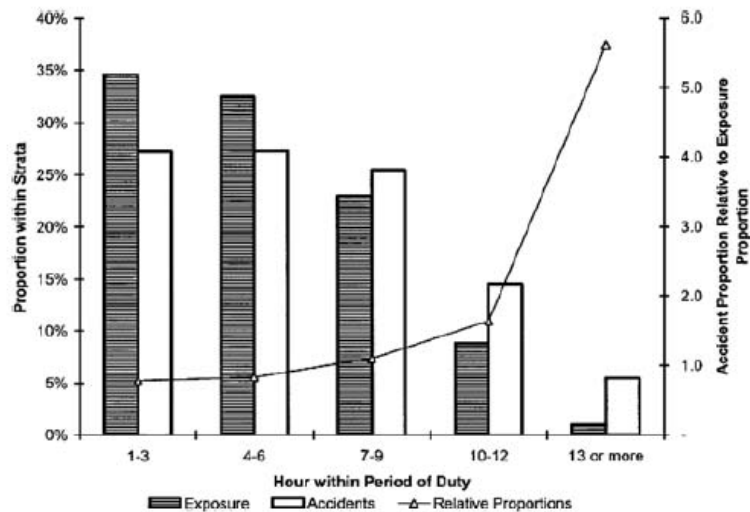
Relative proportion of exposure to accidents as a function of the period of duty (Goode 2003)

However, the flight duty period (14h50) is consistent with a significant increase in the risk of accidents and fatigue usually felt by crews. Several studies have demonstrated a relationship between the flight duty period and the drowsiness and fatigue felt (Bourgeois-Bougrine et al. 2003b, Powell et al. 2007, Powell et al. 2008), the frequency of air safety reports (ASR) in regional airlines (Cabon et al. 2012) and the frequency of accidents (Good 2003). A study conducted in the USA showed that 20% of accidents related to human factors occurred after ten hours of flight duty (Good 2003). Reduced to the relative amount of flying hours, this study reveals a slight increase in risk of accidents between ten and twelve hours of flight duty (relative risk, RR = 1.65) and a very significant increase beyond thirteen hours of activity (RR = 5.6). The relative risks are shown in the following graph in relation to the duty hours (RR in order on right).

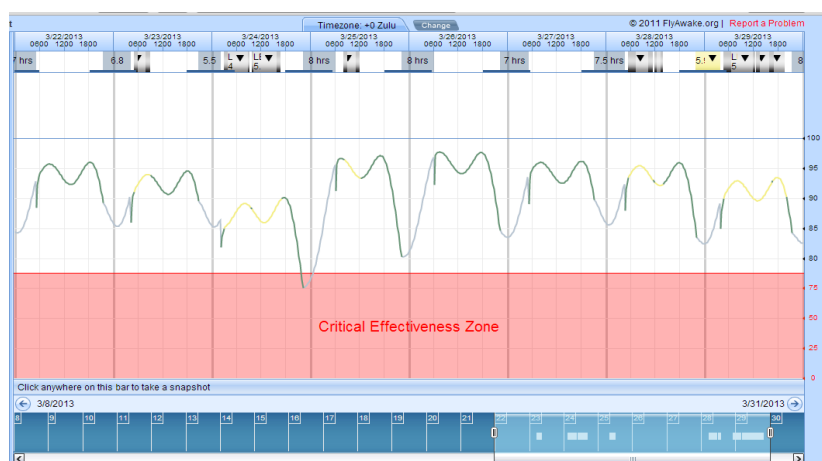
L'analyse des activités aéronautiques au cours des 2 mois précédents a révélé une intrusion dans la zone critique 6 jours avant l'accident survenu le 24/03/2013 au soir (figure 7). Cette période a été suivie par un vol de retour sur Valence le 25/03/2013 et 2 jours de repos sans vol. Le 29/03/13, jour de l'accident a été la journée avec le plus d'heure de vol et de temps de service en vol au cours de la période étudiée.

Figure 7. Modélisation de la fatigue (inverse de l'effectiveness) de l'OPL au cours des 10 jours précédents l'accident

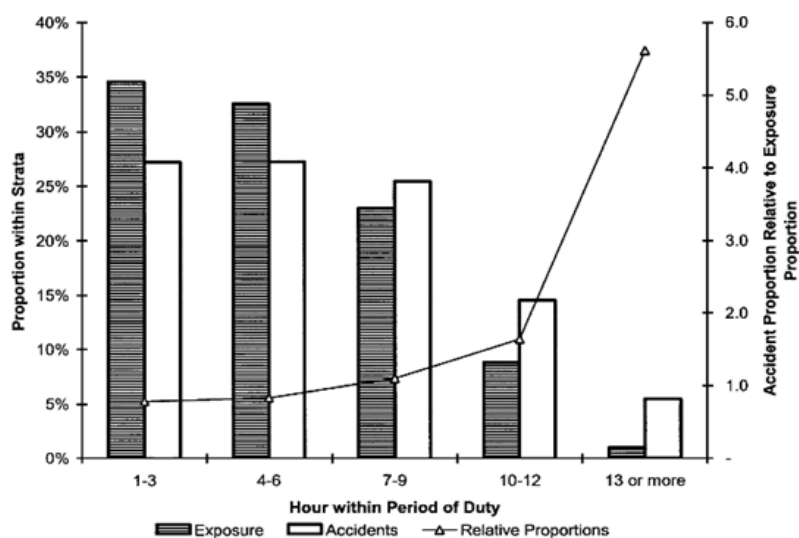
L'équipage a cumulé un temps de service d'environ 14 h 30 au cours de cette journée. Plusieurs études ont mis en évidence une relation entre le temps de service en vol et la somnolence ressentie, la fatigue ressentie (Bourgeois-Bougrine *et al.* 2003b, Powell *et al.* 2007, Powell *et al.* 2008), la fréquence des rapports sécurité des vols (*Air safety reports*, ASR) dans des compagnies aérienne régionales (Cabon *et al.* 2012) et la fréquence des accidents (Good 2003). En particulier, dans une étude réalisée aux Etats Unis, sur plus de 1 million d'heure de vol, il a été mis en évidence que 20% des accidents liés aux facteurs humains, survenaient au-delà de 10 h de services en vol (Good 2003). Ramené à la quantité relative d'heure de vol, cette étude révèle une légère augmentation du risque d'accident entre 10 et 12 h de service en vol (risque relatif, RR= 1,65) qui devient très significative au-delà de 13 h d'activité (RR = 5,6) (figure 8).

Figure 8 : proportion relative d'exposition aux accidents en fonction du temps d'activité (Goode 2003)

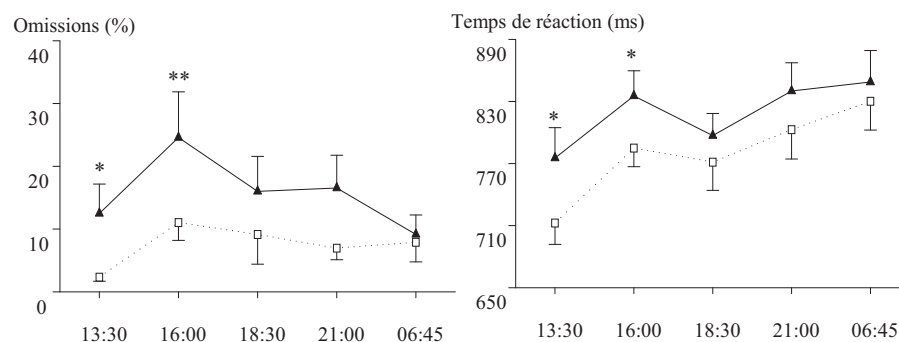
Après un vol de 3 h 30 en monomoteur, Sauvet *et al.* (2009) ont observé un score d'hypovigilance altéré immédiatement et 2 h 30 après la fin du vol (figure 9). Dans son analyse, validée par un groupe d'expert, Moebus (2008) recommande que la période de repos entre deux vols soit égale à au moins un tiers de la durée du dernier vol et que des conditions adéquates au sommeil puissent être proposées aux pilotes qui souhaitent faire une sieste.

Figure 9 : Evolution de performance à un test de vigilance avant (□) et après (▲) un vol de 3 h 30 (10h00 a.m. à 1 h 30 p.m.) * différence entre les valeurs observées à la même heure * $p < 0,05$, ** $p < 0,01$ (Sauvet *et al.* 2009).

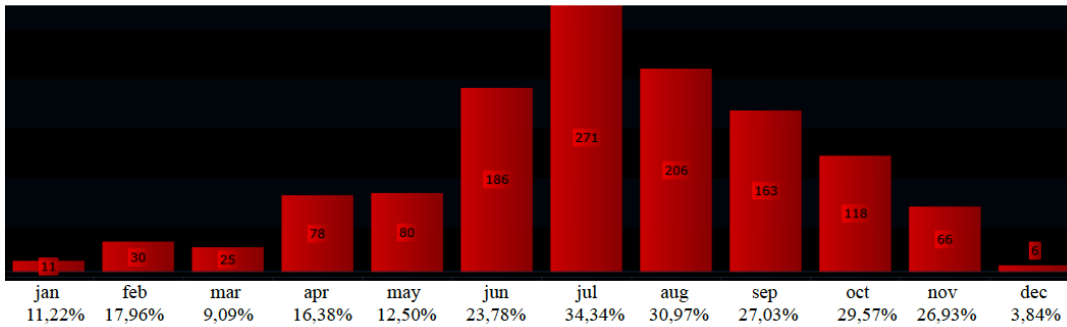
DUAL INPUT

Dual input is characterized when the deflection between the two sidesticks is greater than 0.5°.

The report indicates the following suggestions: *“The bad and possible hazardous habit of the dual input must be addressed to the crews. The numbers appear to be great but the fact that the parameter is set at only ½ degree displacement increases the numbers due to inadvertent movement of the side stick during normal operations (mike button etc.). A reevaluation of setting the parameters to a more realistic figure for every day operations may be considered”.*

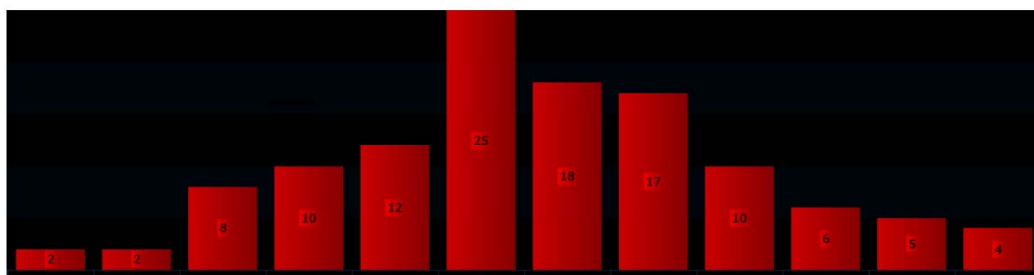
Unstabilized Approches

January	February	March	April	May	June	July	August	September	October	November	December
2,04%	1,19%	2,90%	2,10%	1,87%	3,19%	2,28%	2,55%	1,65%	1,50	2,04%	2,56%

The report indicates the following suggestions: *“An increase of the stabilization height to 1000’ regardless of meteorological conditions will reduce the rates as previous experience has shown. Crews must be made aware that a “rushed” high energy approach has more dangers than benefits from gaining 1 or 2 minutes less flying time. Crews that show a repetitive tendency must be called and made aware of this fact”.*

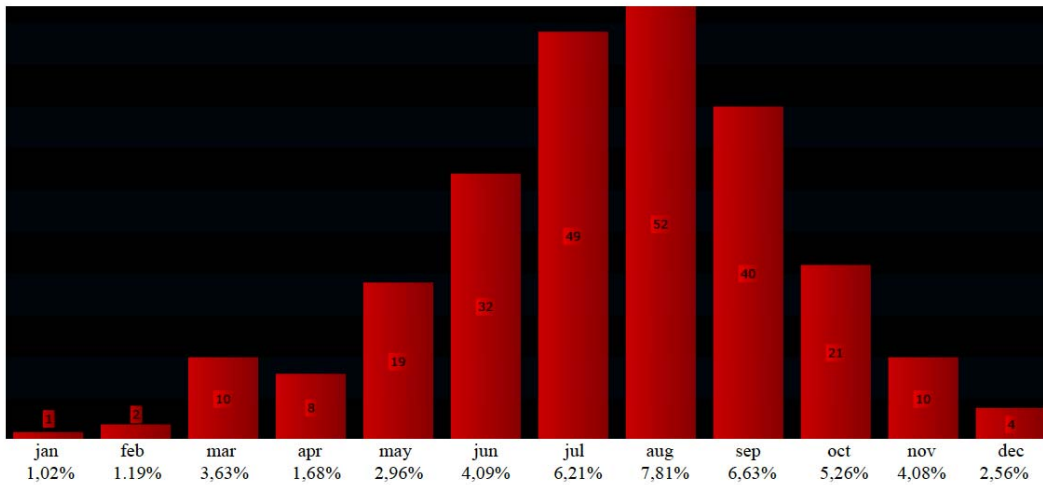
LONG TOUCHDOWN

The late A/THR reductions during landing and long flares are not mentioned in the report.

The report indicates the following suggestions: “Crews should be made aware that « eating » the runway in order to achieve a smooth landing is not a safe practice. Further analysis to follow so as to see if these events are from specific crews”.
