**Accident on 4 March 2013
just after takeoff from Annemasse (France)
to the Beechcraft Premier 1A
registered VP-CAZ**

BEA

Stall after takeoff in icing conditions, collision with the ground, fire

Aircraft:	Beechcraft Premier 1A Model 390 registered VP-CAZ
Date and time:	4 March 2013 at 7h39 ⁽¹⁾
Operator:	Private
Site:	Near Annemasse aerodrome, in the commune of Cranves-Sales (74)
Type of flight:	General aviation
Persons on board:	One pilot and two passengers
Consequences and damage:	Pilot and one passenger killed, one passenger injured, aeroplane destroyed

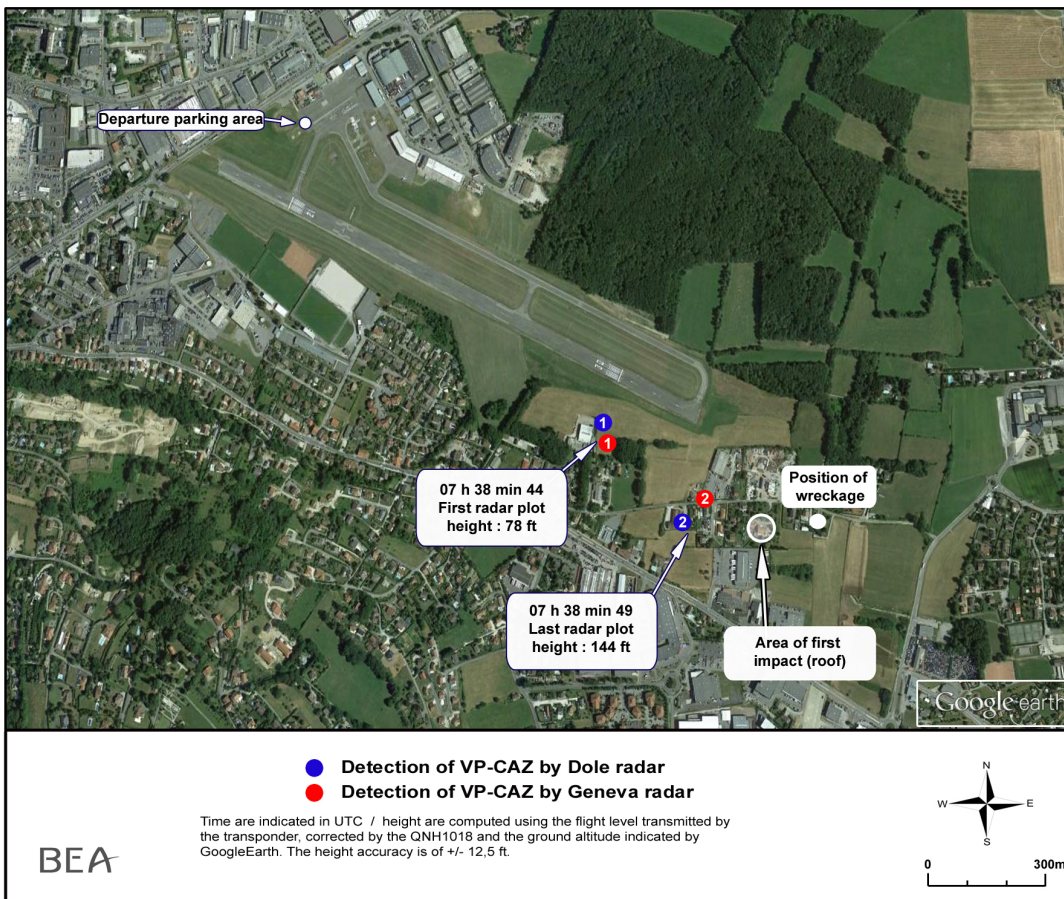
Figure 1 - Radar plots and position of the wreckage

At about 7 h 38 min 44, the aeroplane was detected by the Dole and Geneva radars at a height of about 80 ft above the ground (points ① on figure 1).

At 7 h 38 min 49 the aeroplane was detected by the radars at a height of about 150 ft above the ground (points ② on figure 1).

At 07 h 38 min 52, the main landing gear struck the roof of a first house. The aeroplane then collided with the ground. During the impact sequence, the three landing gears and the left wing separated from the rest of the aeroplane. The aeroplane slid along the ground for a distance of about 100 m before colliding with a garden shed, a wall and some trees in the garden of a second house. The aeroplane caught fire and came to a stop.

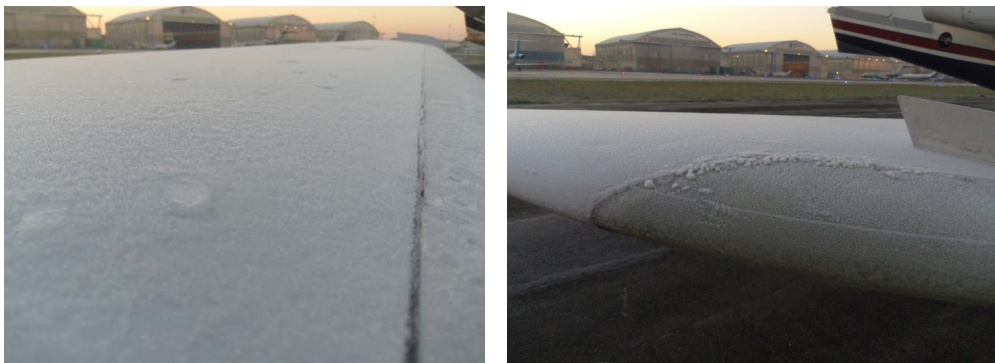
Figure 9 - Roughness on a wing contaminated by frost

For this, a visual and/or hands on surface check must be carried out by the captain. It is intended to detect the presence of roughness on the surfaces or different sensations to those of the skin of the aircraft, in particular on critical surfaces such as the wings and the horizontal stabiliser. The wings photographed below are those of a Beechcraft Premier 1A which had parked all night outside at Le Bourget airport in meteorological conditions similar to those that prevailed at Annemasse on 4 March 2013. Rime ice, showing roughness in several places, had been deposited over the whole wing surface, without any previous precipitation.
