Comparative audio analysis

Title: Result of cigarette and propagation tests

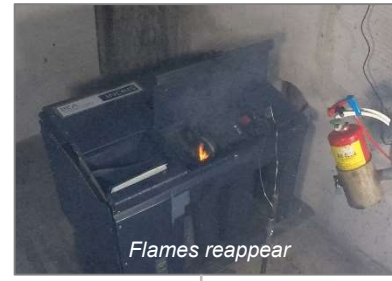
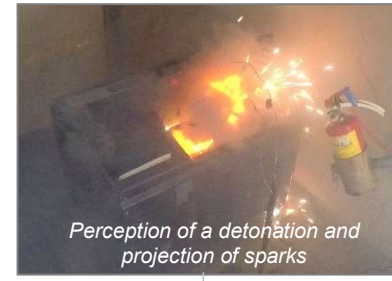
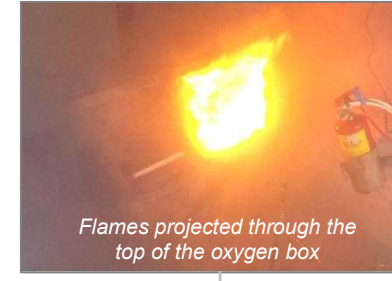
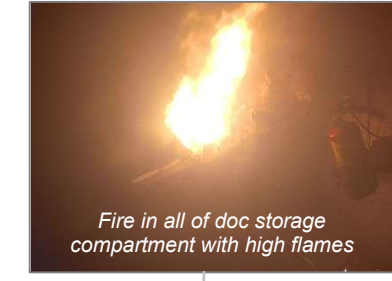
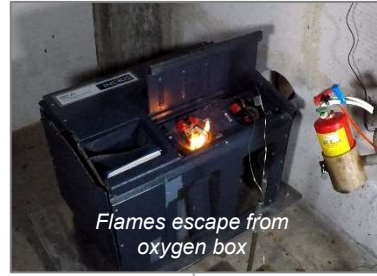
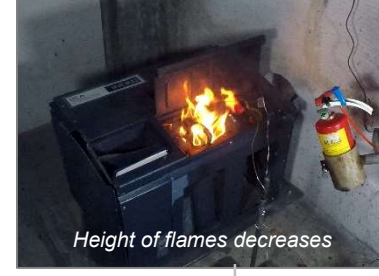
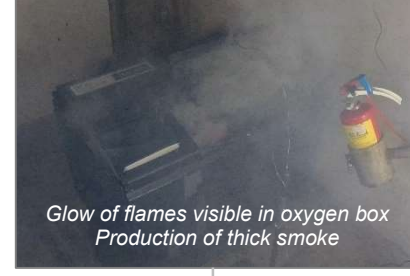
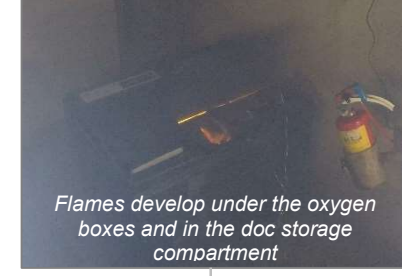
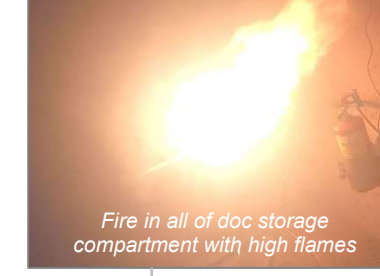
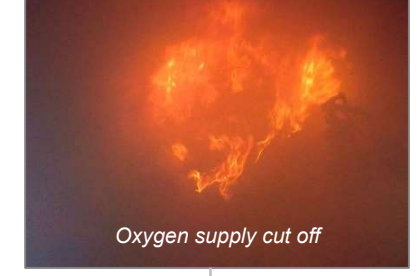
4 ___ Spectrum and waveform of audio recording of "Propagation_01" test

- Page #4 shows the waveform of the audio recording (GOPRO camera sound band) during the "Propagation_01" test and the associated sequence of images. Smoke and flames could be seen coming out of the oxygen box 5 s after the remote lighting of a cotton pad placed in the bottom of the oxygen box. The mask hose was probably pierced 18 s after the start of the fire. This was shown by a broadband noise followed 1s later by a sound runaway. The fire that followed the piercing of the hose spread rapidly to the surrounding elements. The leaking noise suddenly stopped for 0.5 s - without any action by the test operators - 50 s after the mask hose was probably pierced. This short interruption in the leak preceded a detonation, the resumption of the leak and the enrichment of the fire.

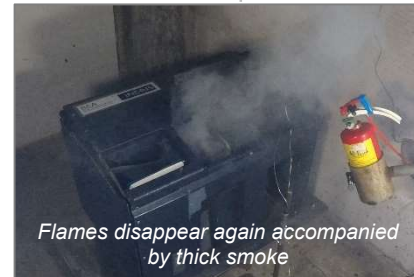
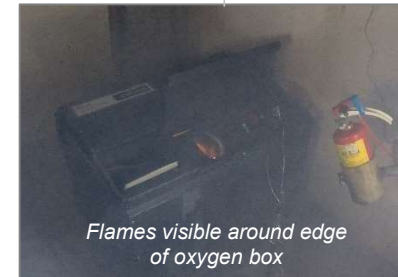
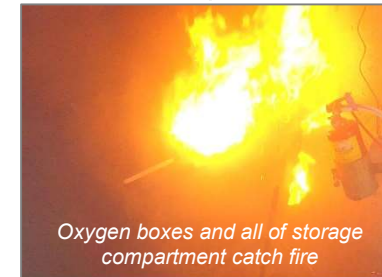
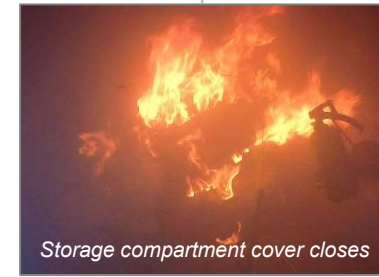
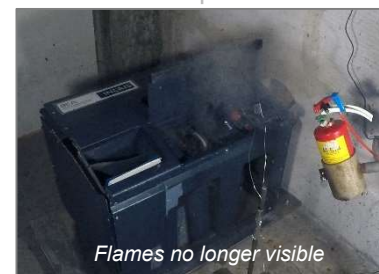
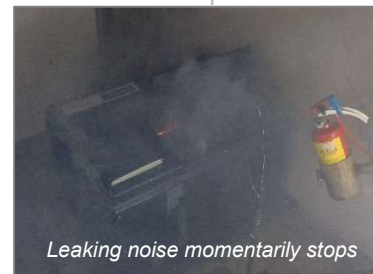
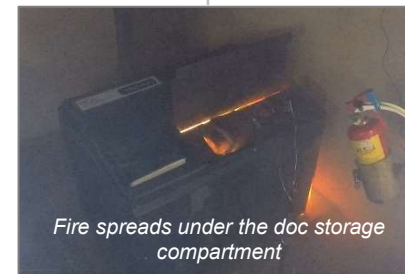
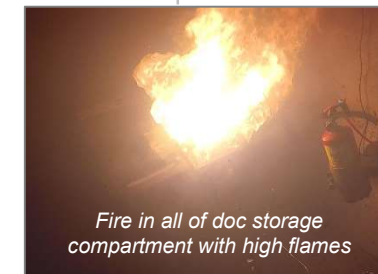
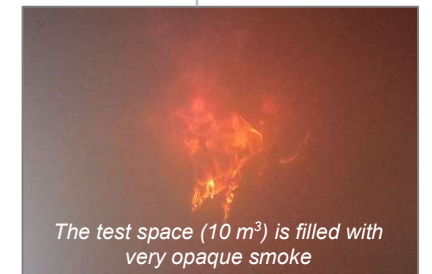
5 ___ Spectrum and waveform of audio recording of "Propagation_02" test

- Page #5 shows the waveform of the audio recording (oxygen mask microphone signal and CAM signal) during the "Propagation_02" test and the associated sequence of images. Smoke and flames could be seen coming out of the oxygen box 6 s after the remote reactivation of the cotton pad fire in the bottom of the oxygen box⁴. The mask hose was probably pierced 13 s after the reactivation of the fire. It was preceded over the same period by cracking noises picked up by the oxygen mask microphone. The probable piercing of the hose produced a broadband noise. The sound runaway described for the previous tests was not perceived. The fire that followed the piercing of the hose spread rapidly to the surrounding elements. The leaking noise was continuous until the oxygen supply of the test set-up was cut off.

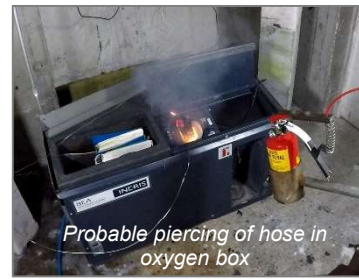
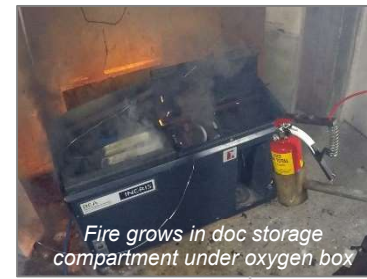
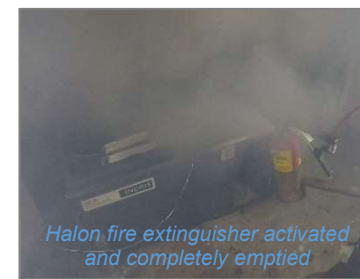
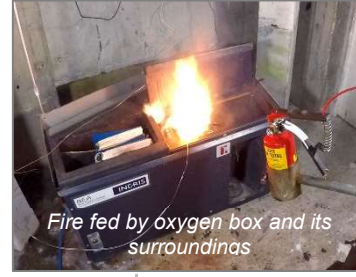
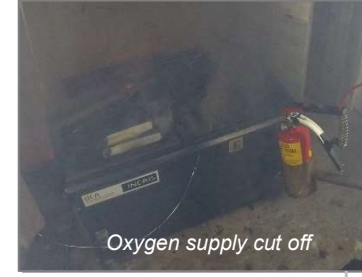
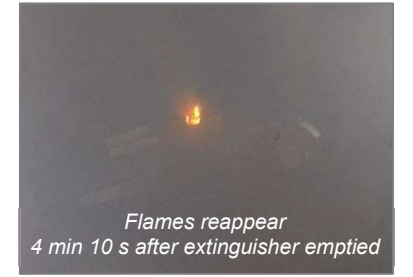
6 ___ Spectrum and waveform of audio recording of "Propagation_03" test

- Page #6 shows the waveform of the audio recording (oxygen mask microphone signal and CAM signal) during the "Propagation_03" test and the associated sequence of images. Smoke and flames could be seen coming out of the oxygen box 7 s after the remote lighting of a cotton pad placed in the bottom of the oxygen box. The mask hose was probably pierced 14 s after the start of the fire. It was preceded over the same period by cracking noises picked up by the oxygen mask microphone. The probable piercing of the hose produced a broadband noise followed 0.5 s later, by a sound runaway. The fire that followed the piercing of the hose spread rapidly to the surrounding elements. Cutting off the oxygen supply - which preceded the use of the fire extinguisher - stopped the leaking noise.
