## Sequences/scenarios of actions on oxygen mask and mask storage box

## SU-GCC – CVR event sequence (first oxygen activity noise / co-pilot's mask)

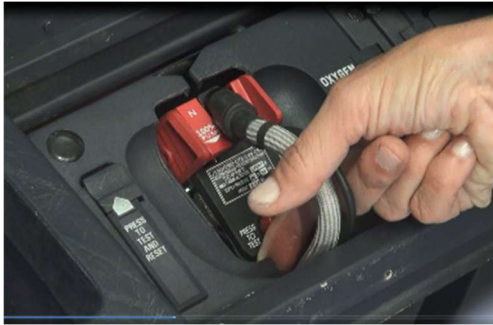
An MXP801 oxygen mask storage box equipped with an MF20-534 mask was supplied with 5-bar compressed air. The following actions were carried out:

- Seq.0 / Reproduction of the before flight oxygen system test procedure.
- Seq.1 / The mask EMERGENCY knob was pressed (2.6 s) after door was opened.
- Seq.2 / The mask EMERGENCY knob and the PRESS TO TEST pushbutton on the box door were simultaneously pressed (2.6 s).
- Seq.3 / The PRESS TO TEST pushbutton on the box door was pressed (2.6 s) with the mask knob in the EMERGENCY position.
- Seq.4 / With the mask knob in the EMERGENCY position, the door of the oxygen mask storage box was opened (2.6 s).
- Seq.5 / With the mask knob in the EMERGENCY position, the door of the oxygen mask storage box was opened and supplied with air for 2.6 s.

**Result:** from an audio point of view - and in these test conditions - the actions on the oxygen assembly, whether it be pressing the EMERGENCY knob to carry out a mask test or pressing the PRESS TO TEST pushbutton on the box, or both, produce an audio event which differs in terms of the duration of the transient noise at the end of the oxygen flow (transient noise release) and the noise of bleeding of the system (reverberation). The acoustic signature of the leak produced during sequences 2, 3 and 4 was identical.

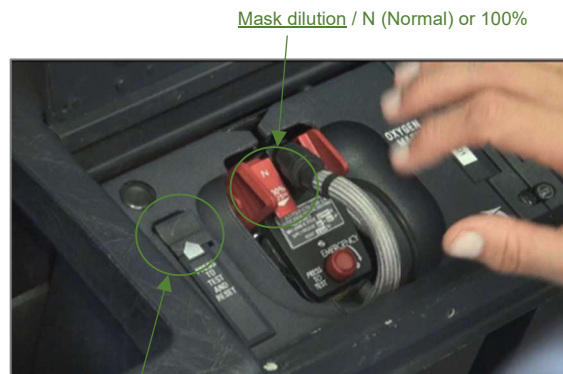
## Comparison\_\_\_\_Signature differences - Mask dilution set to 100% then normal

Box test control

Door Press To Test PB / pushbutton to obtain a temporary oxygen flow and to RESET after opening the oxygen box

**Test procedure:** The Press To Test pushbutton on the left door of the oxygen mask storage box was pressed and held, and then released.

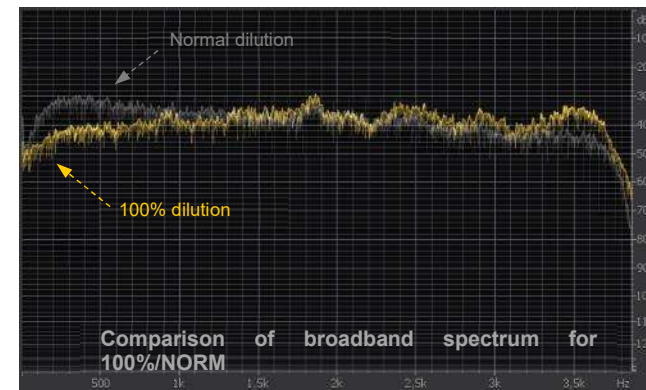
**Comparison \_\_\_\_\_ Spectrum of oxygen mask and storage box handling sequences**

**Test conditions:** the test sequences were carried out on an assembly composed of an MXP801 box and an MF20-534 mask. The assembly was supplied with air at 5 bar (an additional test on another model of box and mask gave different duration values).

Note: tests 8a (regulator set to NORMAL) and 8b (regulator set to 100 %) produced the same data in terms of the duration of the transient noise and reverberation (bleeding noise).
