# Oxygen fire in cockpit study - Accident to the A320 registered SU\_GCC on 19 May 2016

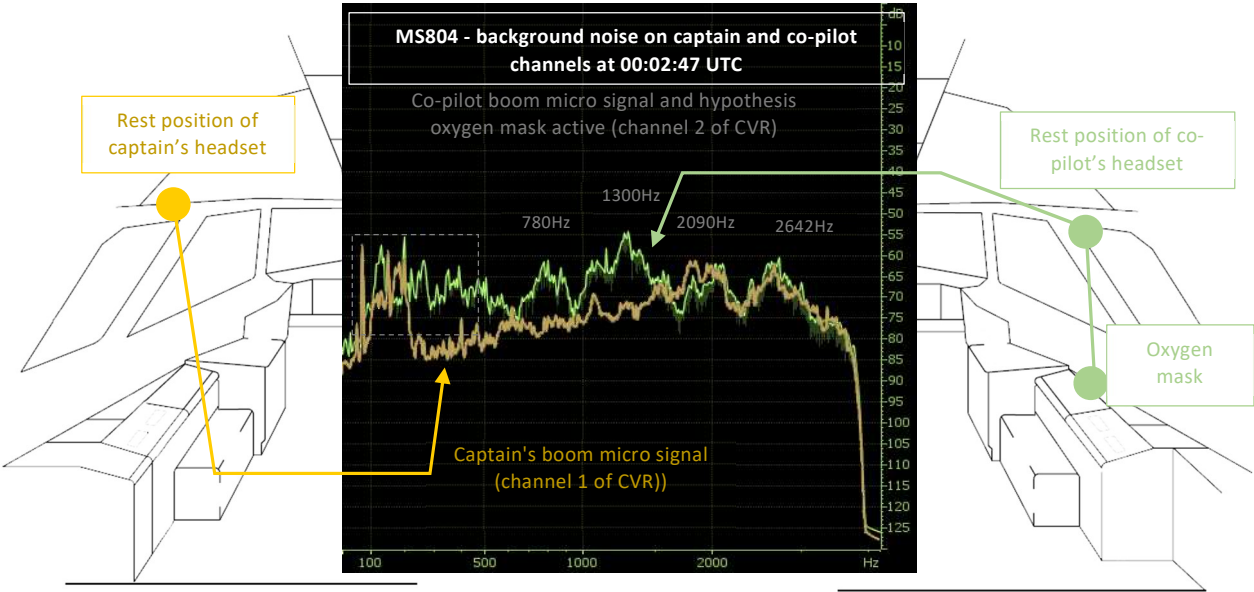
Figure 19: comparison of noise spectrum picked up by captain’s and co-pilot’s boom mikes

The sound picked up by the oxygen mask microphone had an acoustic signature consisting of the emergence of five characteristic noise bumps. The appendix Sound pick-up by the oxygen mask microphone presents the comparison made with a series of audio samples taken from the BEA’s audio database. The spectral view below shows the comparison between the signal recorded by the captain’s CVR channel and that recorded by the co-pilot’s CVR channel.

The low-frequency noise bump (from 100 to 500 Hz) and the four broadband bumps (780 Hz, 1300 Hz, 2090 Hz and 2642 Hz) confirmed that the microphone of the co-pilot’s oxygen mask was active.

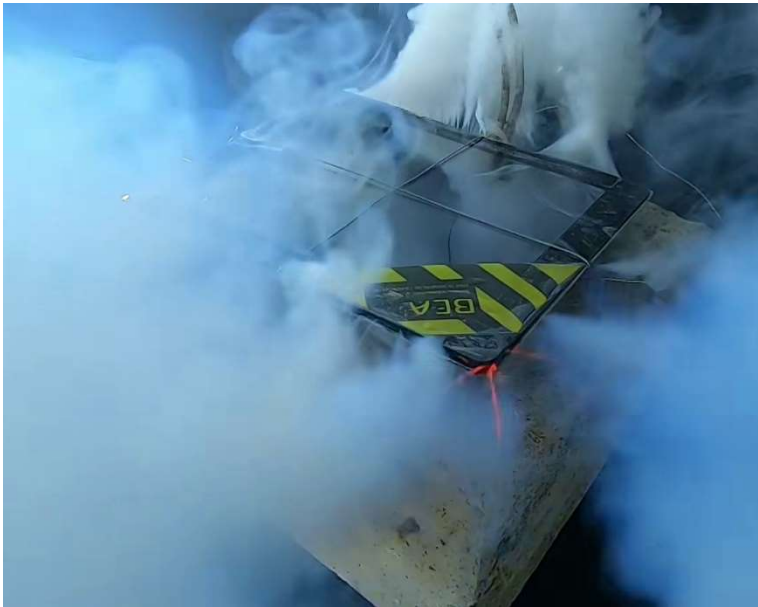
**Figure 24: example of release of smoke during thermal runaway of battery (Lithium\_Battery\_04 test)**

During the tests, the thermal runaway of the batteries was visually characterised by a sudden release of thick white smoke. No sudden loud sound (snapping, detonation) was produced; only a whooshing sound or hiss could be heard during the ejection of gases. The ejection of incandescent particles was often observed during these tests, but the combustion of these particles proved to be very rapid and insufficient to spread the fire to the environment. The runaways were all preceded by the release of smoke over several minutes.

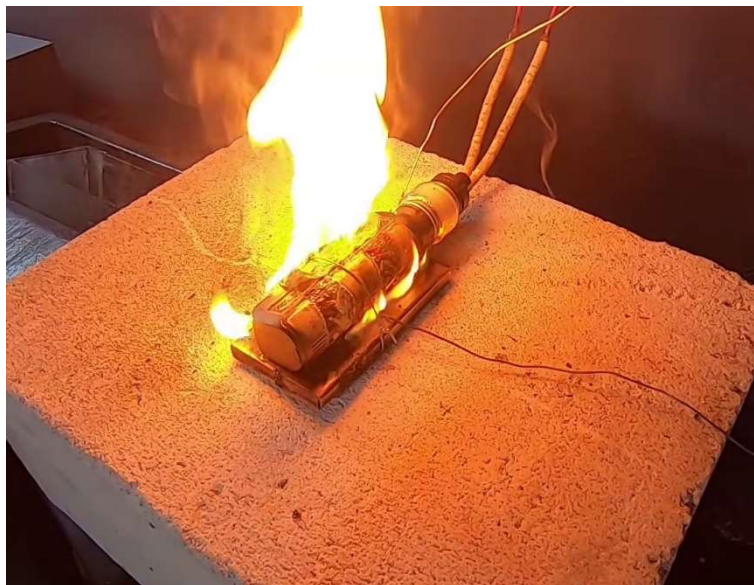
**Figure 26: visible flames during Lithium\_Battery\_07 test**

The appearance of flames was observed only once, during a test carried out on an electronic cigarette in the free field (Lithium battery\_07 test). It is likely that the fire broke out due to the presence of adhesive tape affixed<sup>31</sup> to the body of the cigarette, which burst into flames during the test.

In the conditions of the tests, only one element external to the electronic cigarette (adhesive tape) probably contributed to the outbreak of fire after the thermal runaway of the battery.

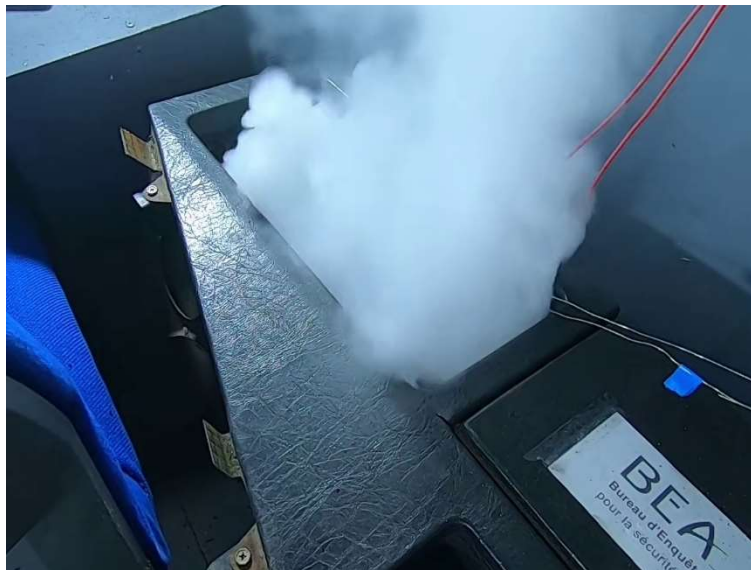
**Figure 27: release of smoke during Lithium\_Battery\_05 test**

During the tests carried out on the equipment placed in the document storage compartments, no outbreak of fire was observed. Only the release of dense white smoke was seen.

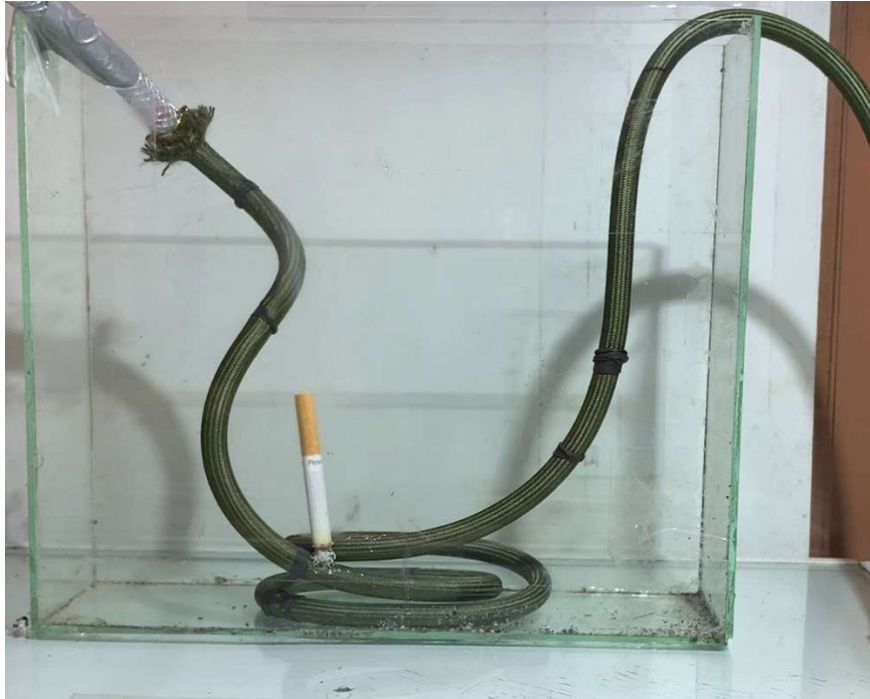
**Figure 29: open-air test (source: BEA)**

The cigarette went out after about ten seconds. The braided outer protection of the hose and its core (a flexible silicone tube) were not damaged or impaired.

Thus, in the test conditions, a glowing cigarette placed in an open-air enclosure in contact with a pressurised oxygen hose did not damage the system or start a fire. The absence of damage is consistent with the certification, which requires equipment manufacturers to use fire-resistant materials to limit the outbreak and spread of fires.

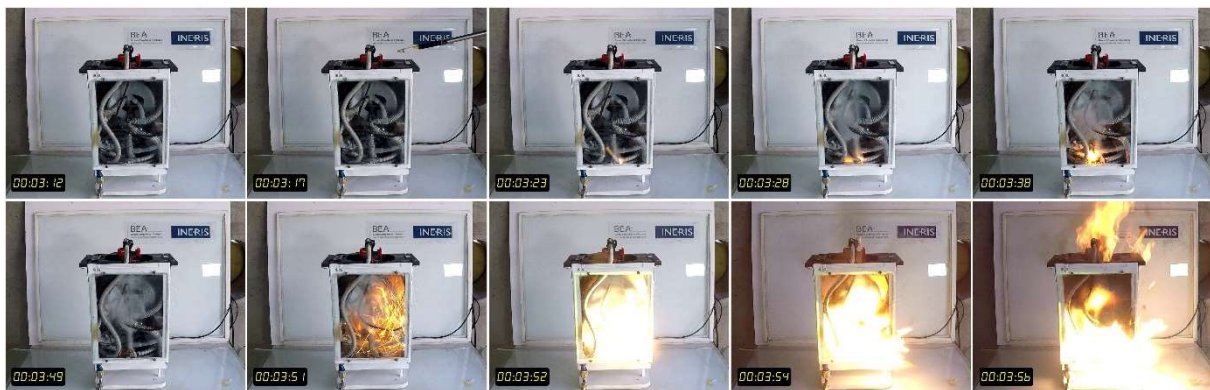
Figure 33: cigarette\_03 test - video sequence (source: BEA)

Cigarette\_03 test: crackling noises for 28 s were audible on the recording, corresponding to the combustion of the hose casing. The subsequent piercing of the hose produced a broadband noise. 1 s later, the mask ignited, causing a sound runaway. The mask microphone stopped working 6 s after the mask ignited.

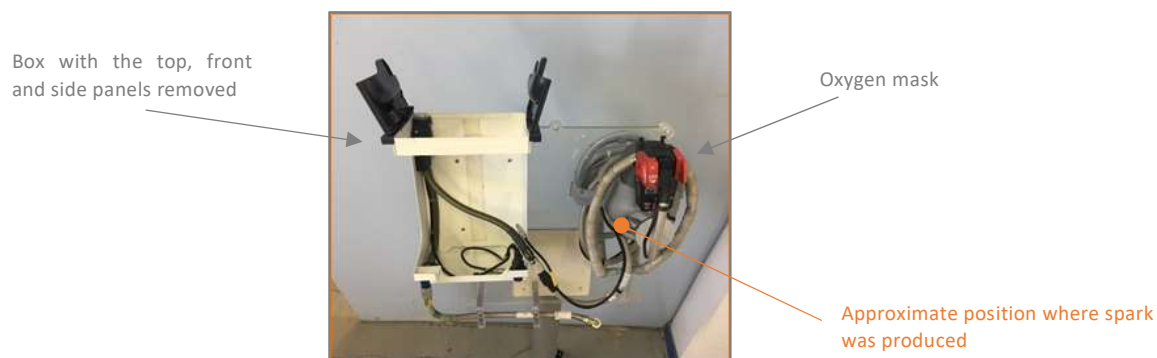
**Figure 37: insertion of device in hose of oxygen mask (source: BEA)**

During the first test, immediate damage occurred inside the hose (appearance of a moving glow in the tube); the hose was punctured and the fire spread to the surrounding area 42 s after the spark was created.

In the second test, no immediate internal damage was detected; the hose was punctured and the fire spread to the surrounding area 30 s after the spark was created.

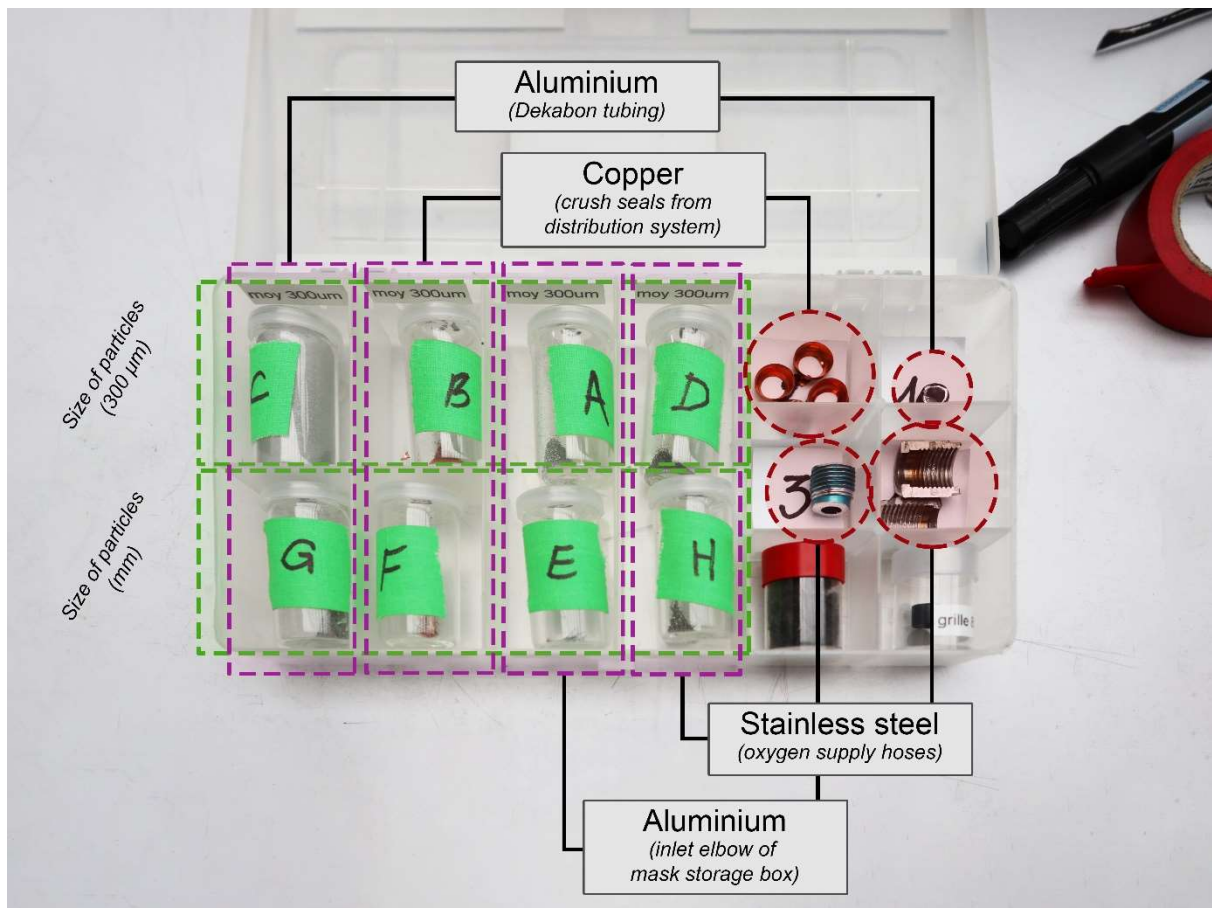
**Figure 41: particles used (source: BEA)**

A total of 76 tests were carried out. No particle impact ignition or increase in temperature were observed during the tests.

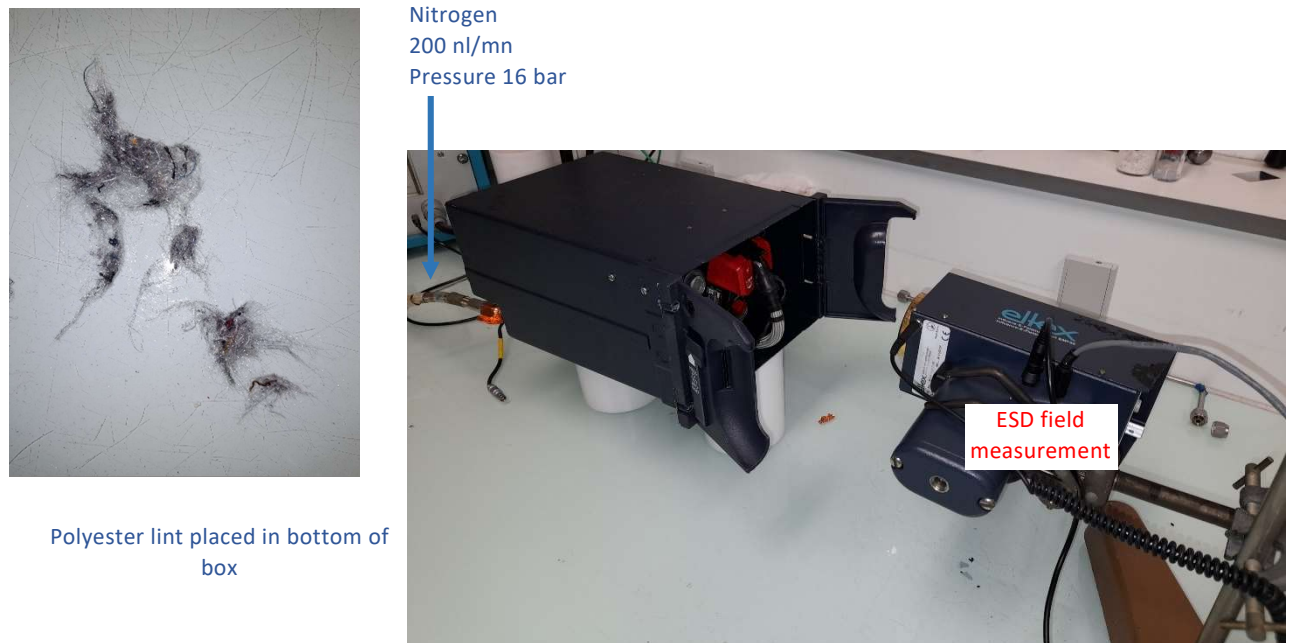
**Figure 44: measurement of electrostatic fields created on accumulated synthetic debris at bottom of storage box (source: INERIS)**

The maximum voltage observed was 255 V; this voltage was too low to generate an electrostatic charge likely to produce sparks capable of igniting dust or metal particles. In an explosive environment, the formation of dangerous sparks is considered for a value greater than 2 kV.

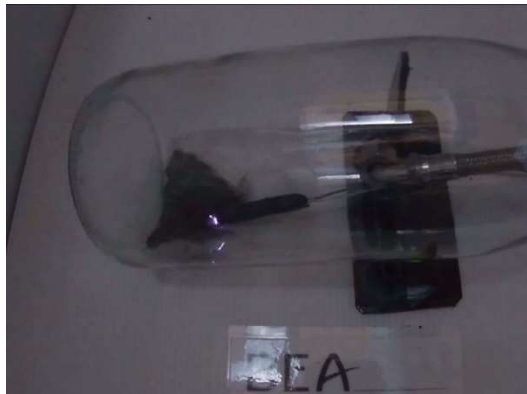
A second test was carried out on dust taken from the bottom of oxygen mask storage boxes in three aircraft. Several attempts were made to ignite the dust by producing a spark in the middle of the pile of dust. No incipient ignition was observed.

**Figure 47: aeroplane dust (source: BEA)**

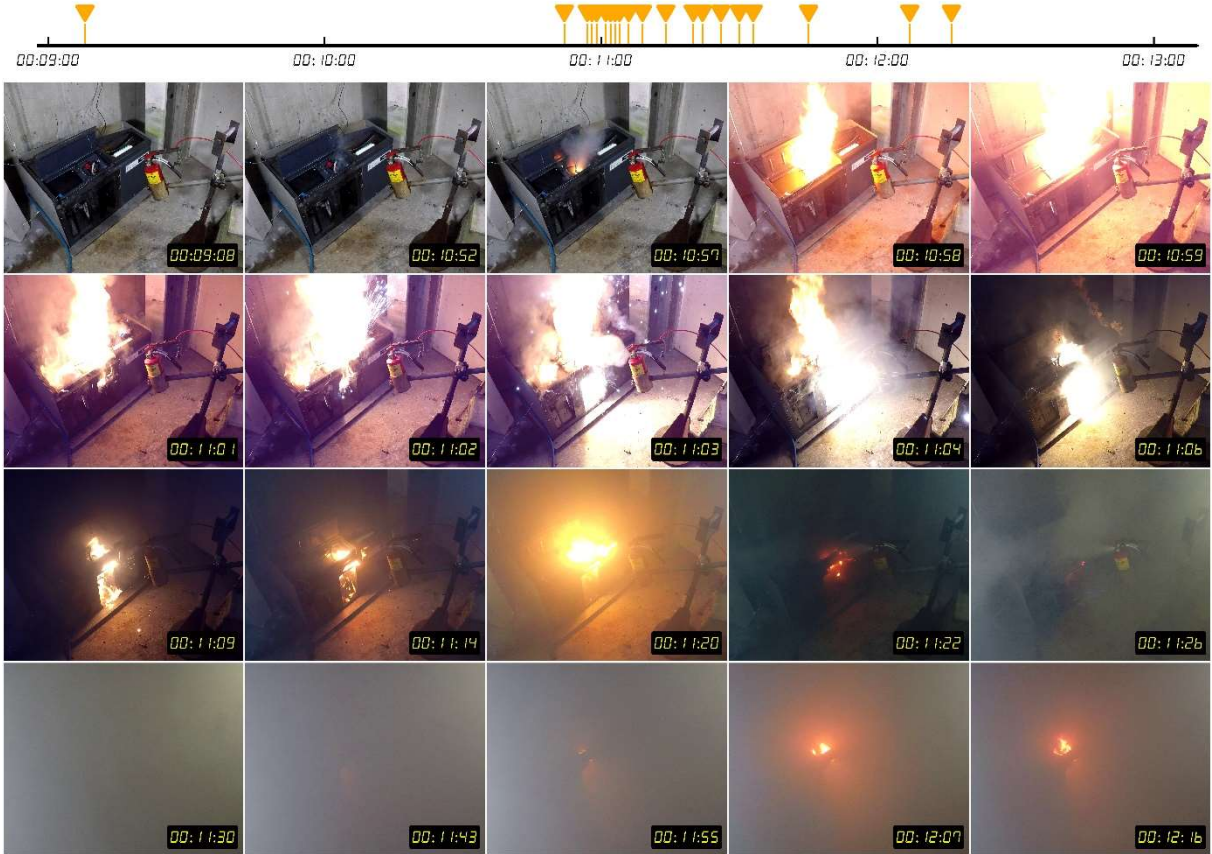
Audio elements: the piercing of the mask hose 13 s after the reactivation of the fire was preceded by crackling noises (picked up by the microphone on the oxygen mask). The piercing of the hose produced a broadband noise (leaking noise). The mask microphone stopped working 5 s after the hose of the oxygen mask was pierced.

The fire that followed the piercing of the hose spread rapidly to the surrounding components. No sound runaway or interruption in the leaking sound was observed.

Figure 55: Propagation\_02 test - video sequence (source: BEA)

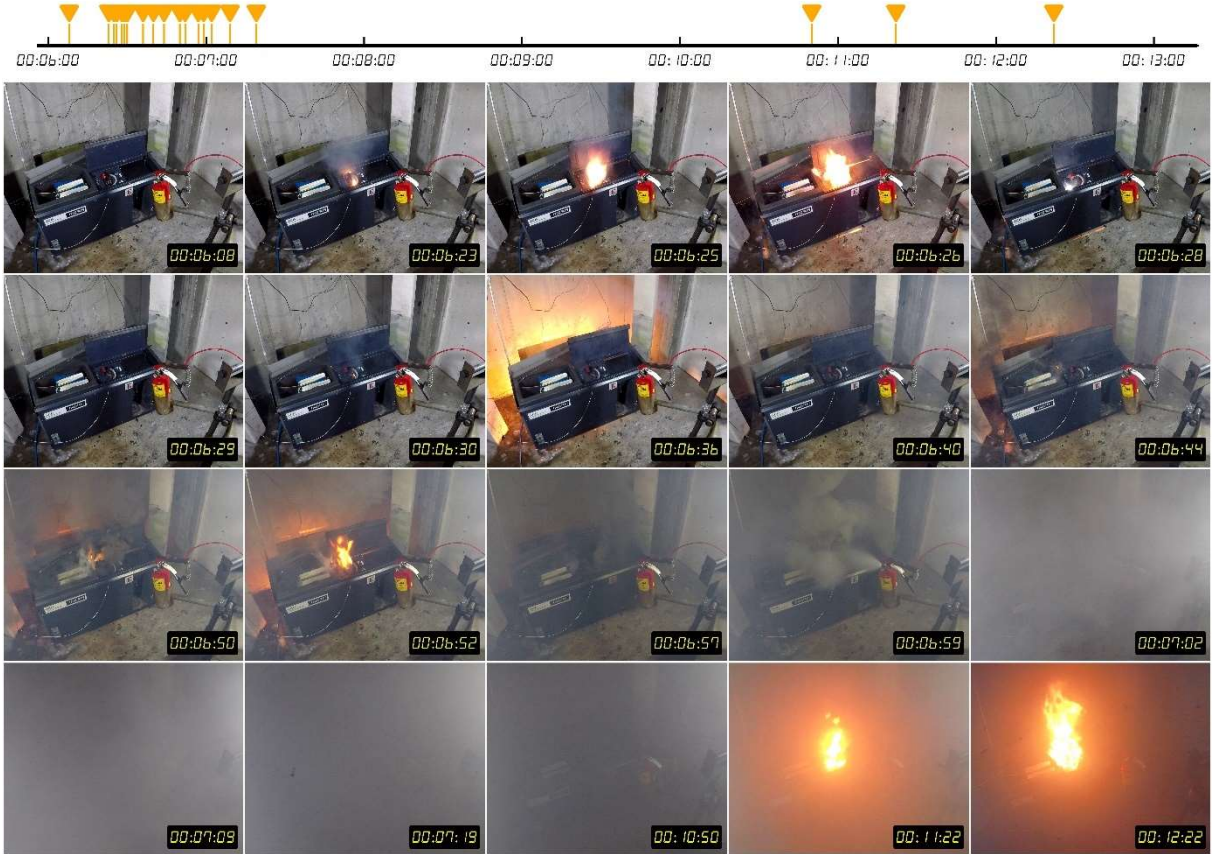
minutes (at 10:50). No flames or red glow were visible; crackling noises were present and smoke escaped from the mask storage box. Flames reappeared in the vicinity of the mask storage box four minutes after the activation of the fire extinguisher.

Audio elements: the piercing of the mask hose 14 s after the fire was started was preceded by crackling noises (picked up by the microphone of the oxygen mask). When the hose was pierced, there was a broadband noise (leaking noise) followed 0.5 s later by a sound runaway. Cutting off the oxygen supply - which preceded the use of the extinguisher - interrupted the leaking noise.

Figure 56: Propagation 03 test - video sequence (source: BEA)

During the test, the fire was concealed in the lateral compartment. The technique of fighting the fire with a halon fire extinguisher could not be applied. It is recommended to aim at the base of the flames, and if necessary, when the flames are inaccessible, to perforate the vertical wall of the compartment and slide the nozzle of the extinguisher into it before activating it. As the extinguisher was activated from the outside, it was not possible to accurately direct the extinguishing jet onto the flames, which may explain why the fire started up again after several minutes.

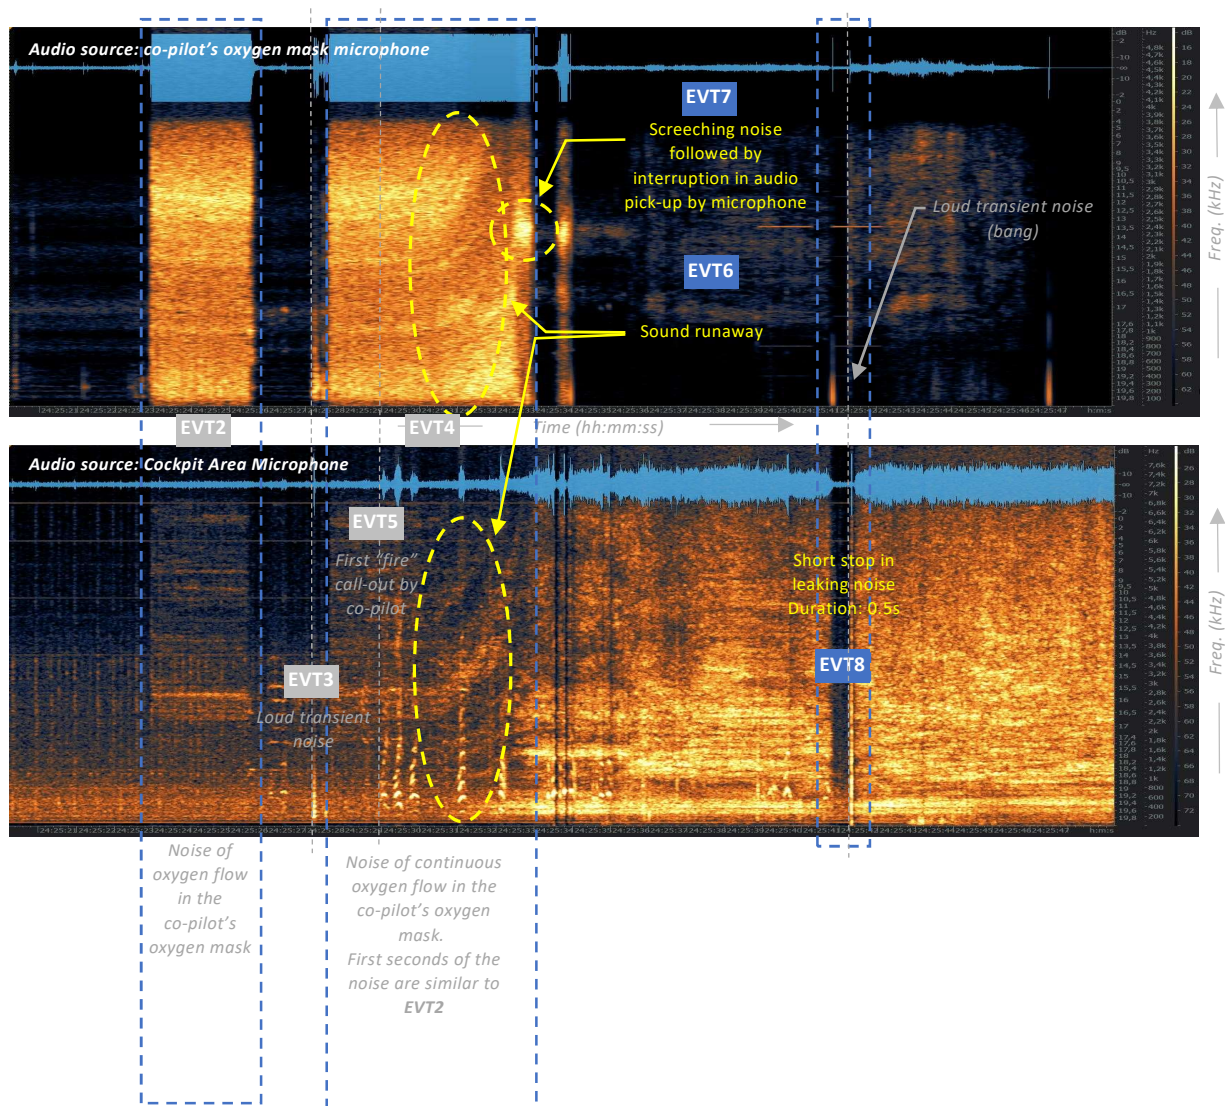
- no crackling noise was present in the mask microphone recording;
- a sound runaway could be heard on the co-pilot mask microphone and CAM channels at 00:25:31 (EVT6);
- a screeching noise preceded the loss of the co-pilot mask microphone signal at 00:25:33 (EVT7);
- a momentary interruption (510 ms) in the oxygen leaking noise occurred at 00:25 :42 (EVT8).

**Figure 57: part of spectrum - waveform - flight MS804 (source: BEA)**
