# CONCORDE ACCIDENT

25 JULY 2000

## THE OCCURENCE

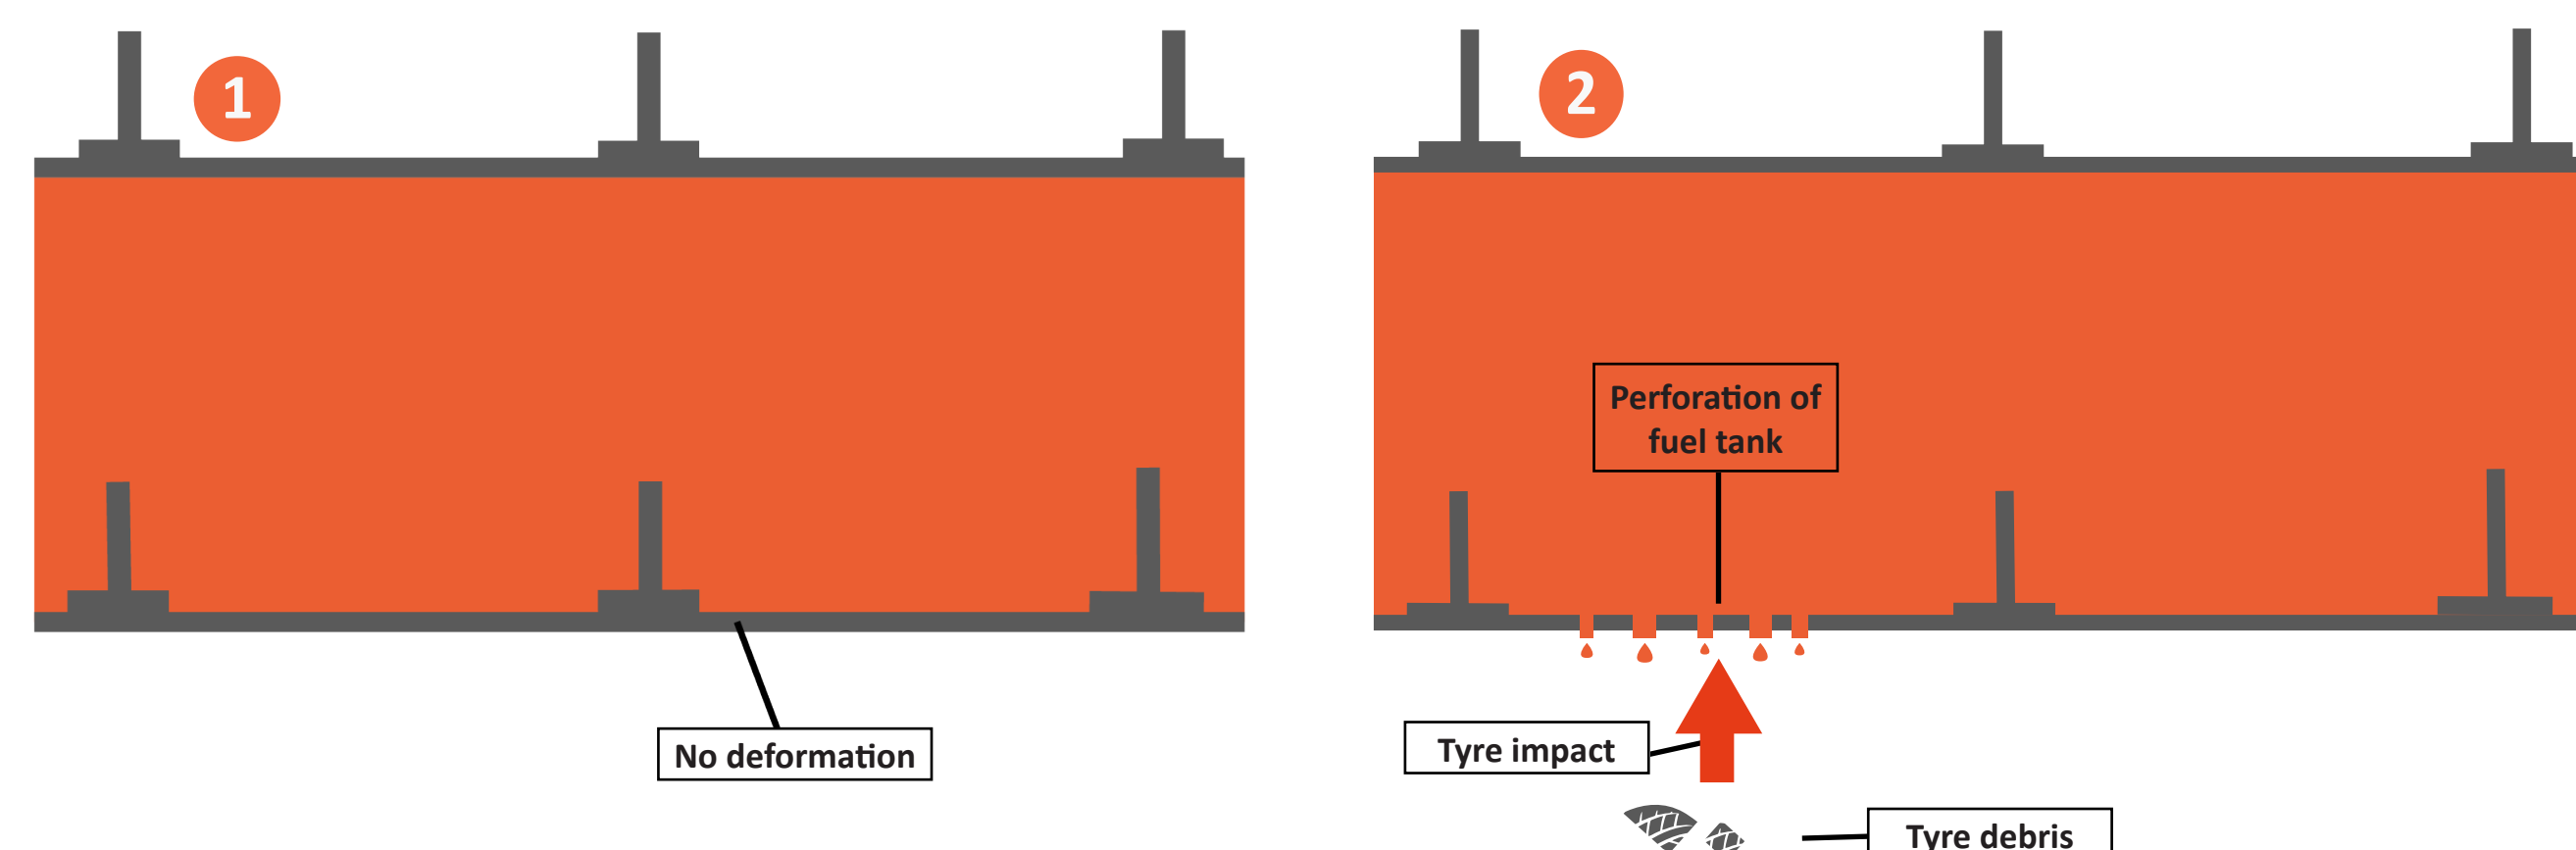
- Two tyres burst with separation of tread during take-off
- Engine damaged, fuel tanks perforated, hydraulic system lost, landing gear jammed
- Emergency landing without casualties
- Tyre inspection procedures reinforced

Photo (viewed from above) of damage to the left wing of F-BVFC, following the penetration of wheel No 5 debris

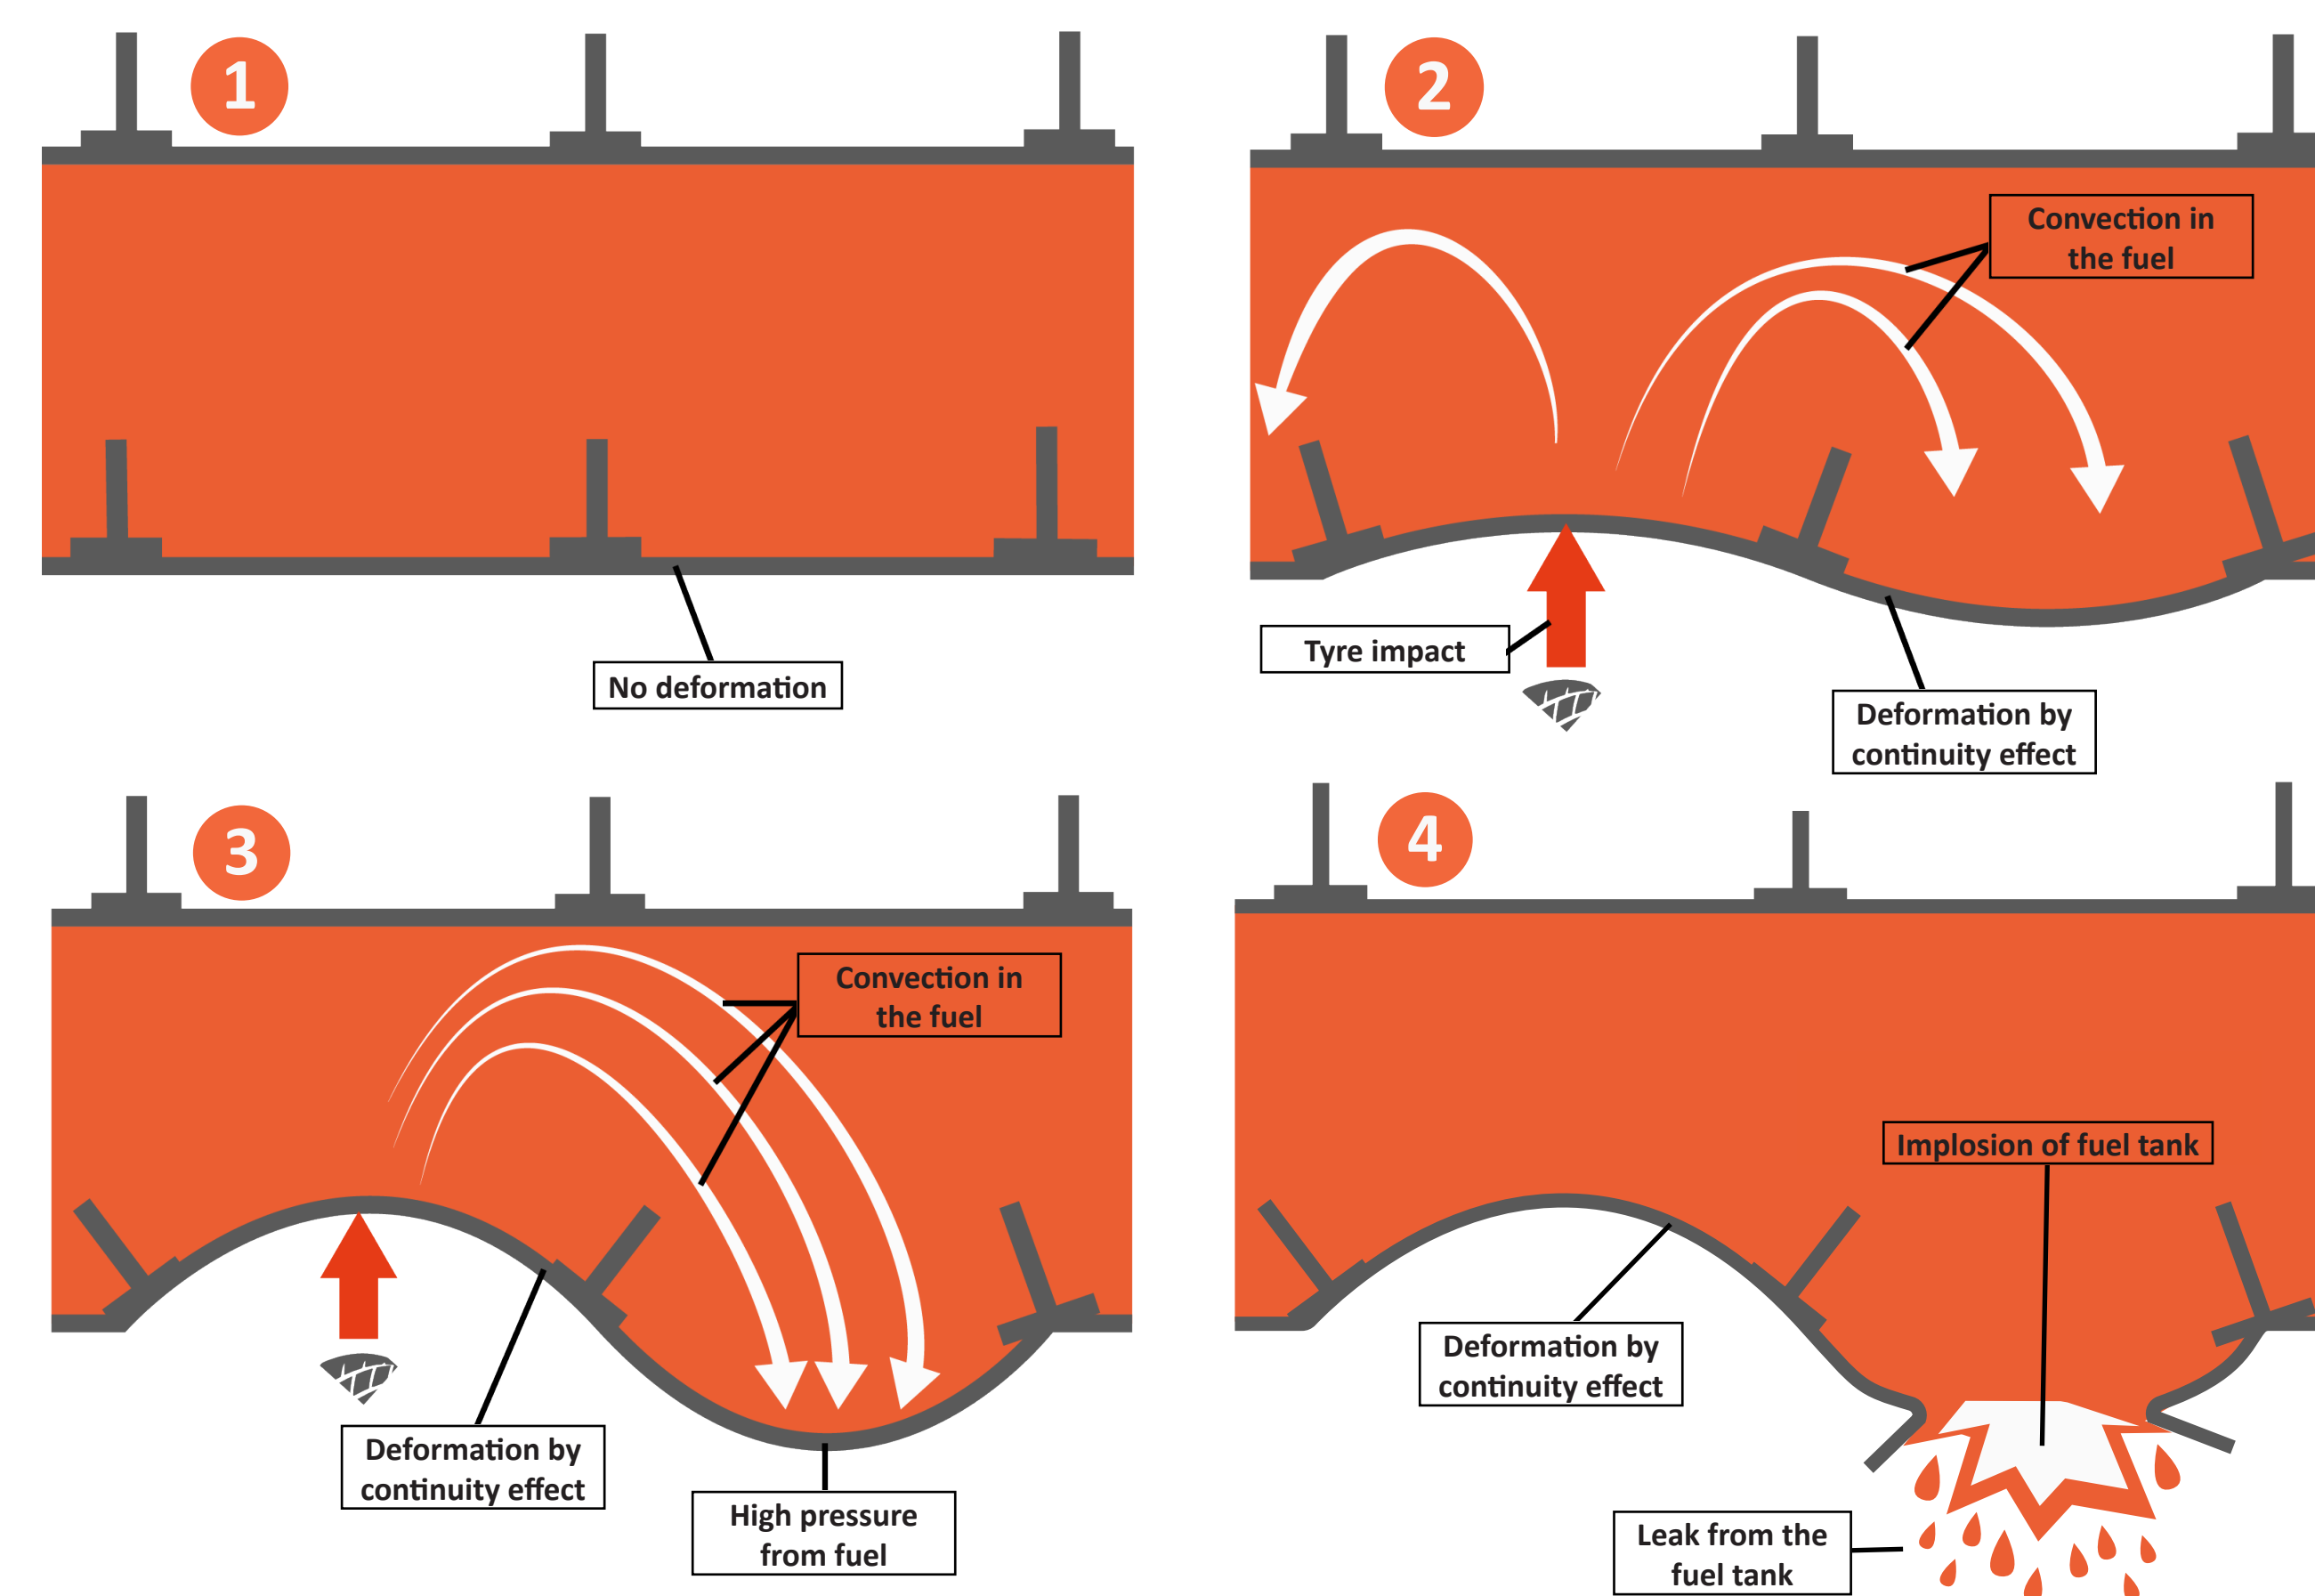
This piece of tyre struck the underside of the left wing, level with fuel tank No 5. The impact was so violent that it deformed the wall, creating a hydrodynamic shock wave inside the full tank. This internal overpressure caused the tank's structure to collapse from the inside, and a breach at the weakest point of the tank's structure.

- Tyre burst due to a metal strip on the runway
- Fuel tank perforated by shock wave, fire, loss of engine power, landing gear and flight controls jammed
- 113 fatal injuries
- Concorde flights suspended, technical and structural modifications, new certifications, resumption of flights

Part of tank No. 5

In early 2001, Kevlar liners were introduced into the fuel tanks to prevent leaks following structural damage, and the Concorde's were equipped with new radial tyres.
