# ERMENONVILLE ACCIDENT

3 March 1974

BEA

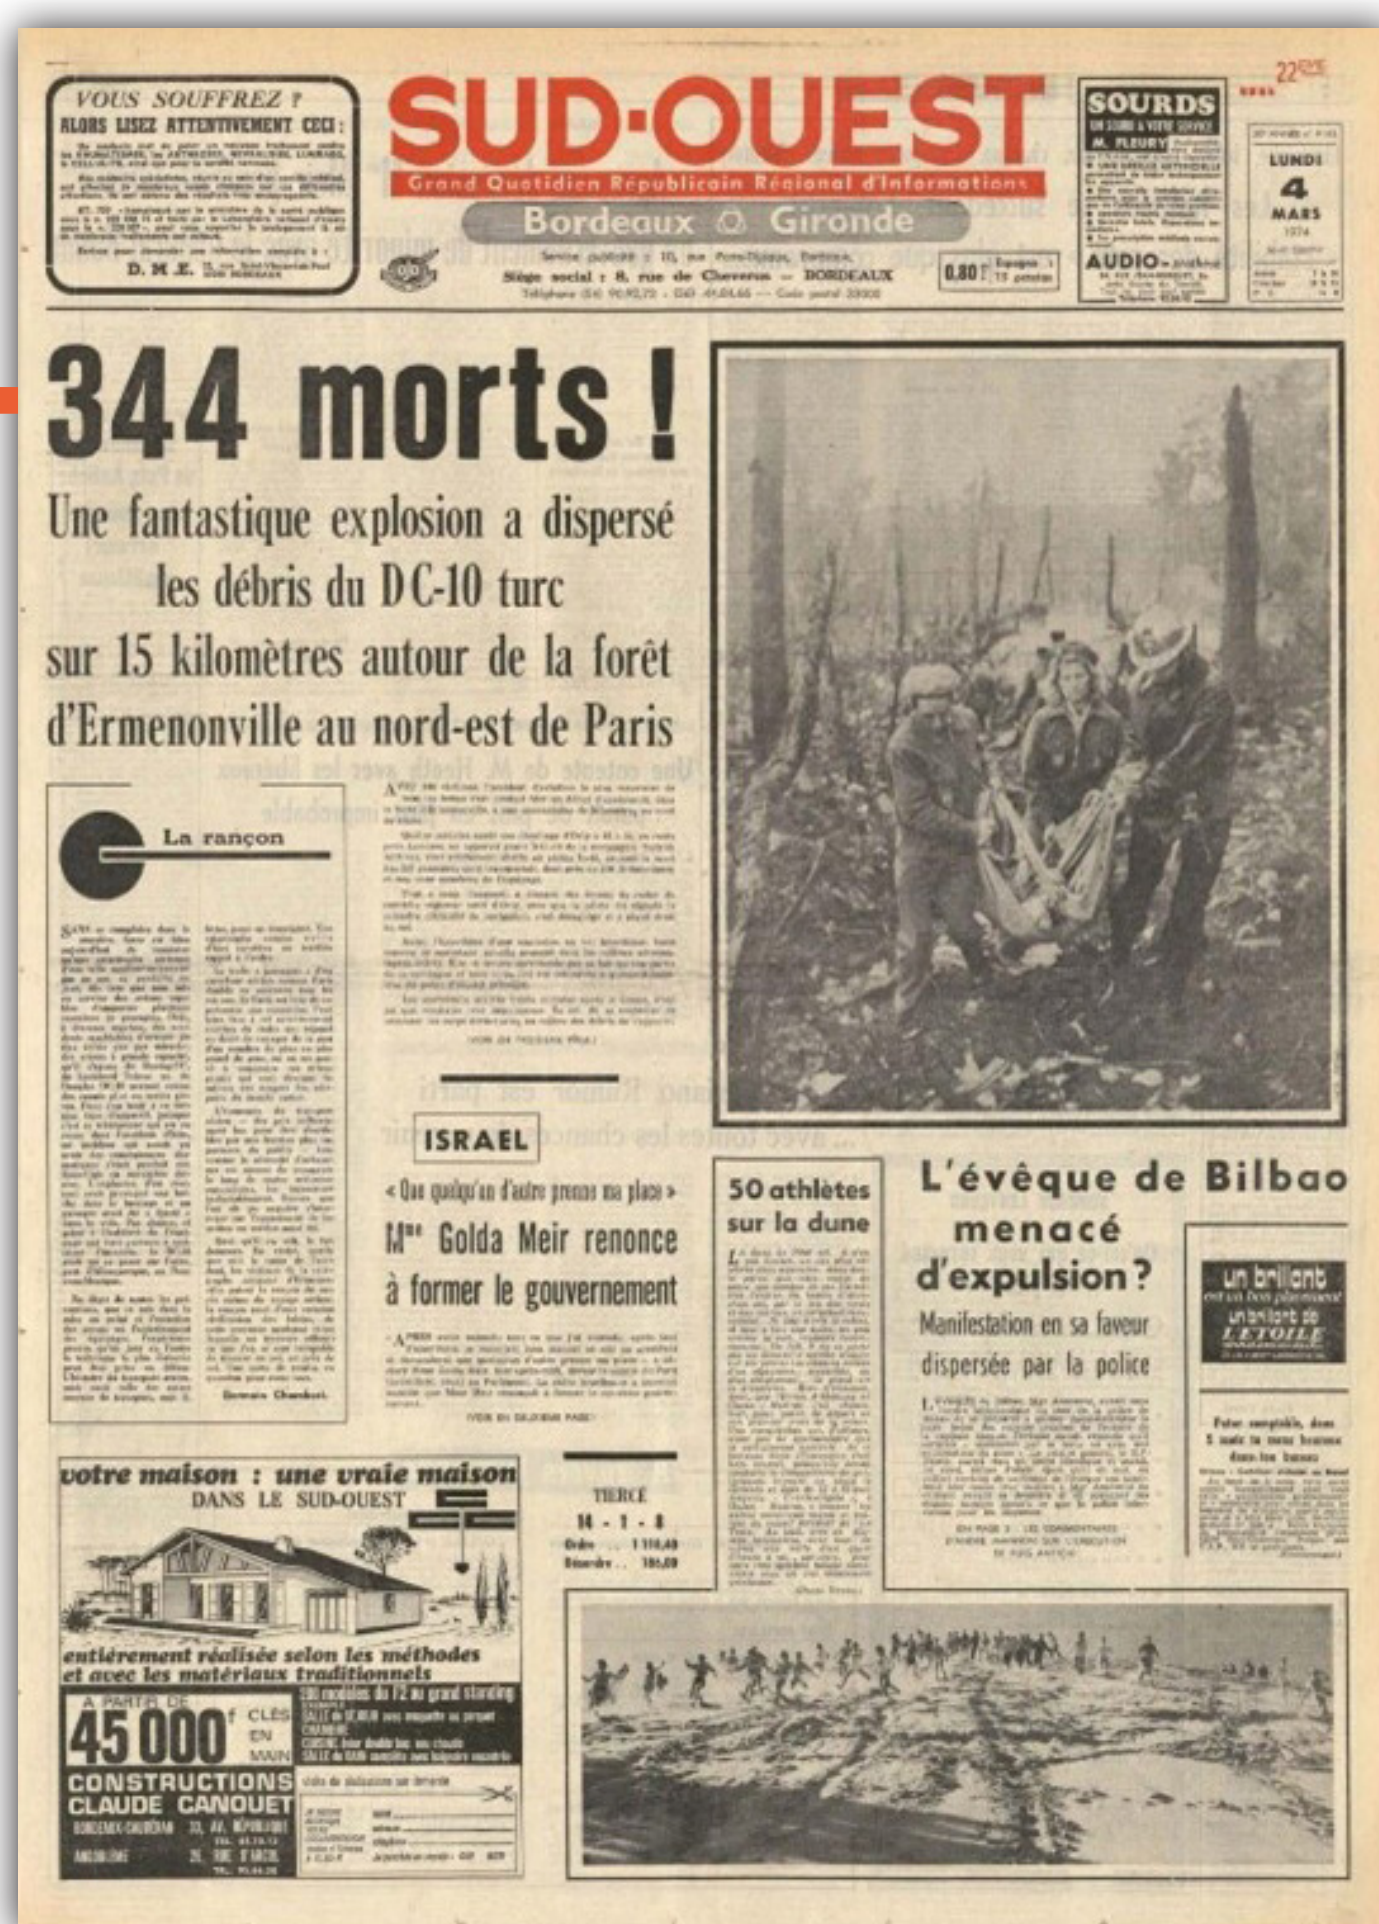
The wreckage was found in the *Bosquet de Dammartin*, in the heart of Ermenonville forest, not far from Senlis situated 37 km north-east of Paris.

The aeroplane had cut a 700-metre long by 100-metre wide swath through the forest.
