TECHNICAL REPORT

**Accident on 23 July 2020
at Bâle-Mulhouse airport (Haut-Rhin)
to the PIPER - PA-28RT-201T
registered HB-PNP**

Examination of wreckage

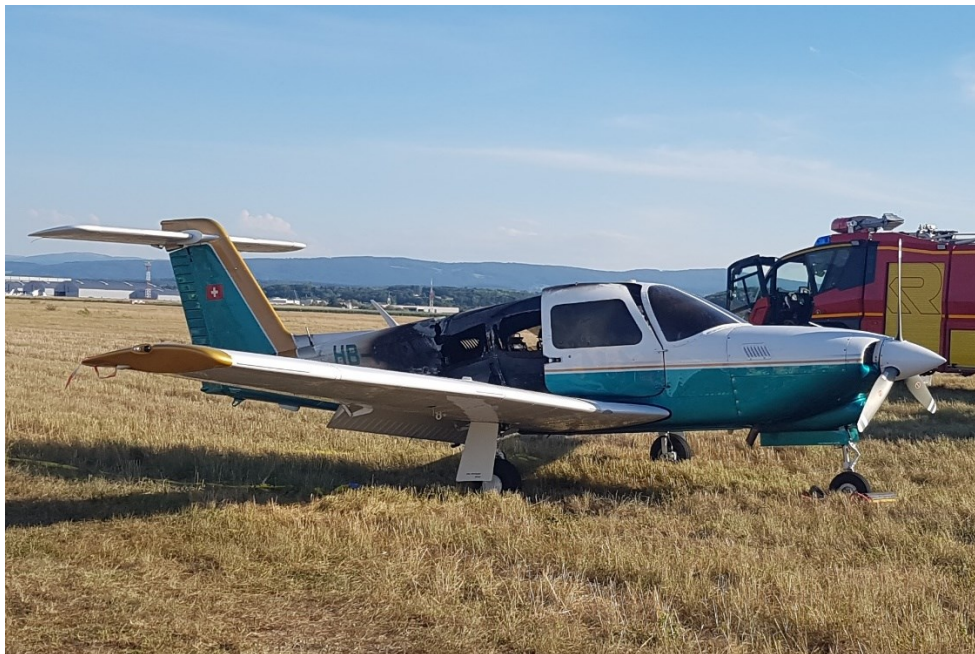
Figure 1: Aeroplane at the edge of the runway at Bâle Mulhouse airport on the day of the accident
Source: BEA - photo taken day of accident

- The outer surface damage was concentrated on the right side of the aeroplane, on the rear section of the luggage hold and around the rear right passenger window (**Figure 1**).
- The interior of the cockpit was covered with soot, extending from the instrument panel to behind the luggage hold. The seats were partially burnt (**Figure 3** and **Figure 4**).

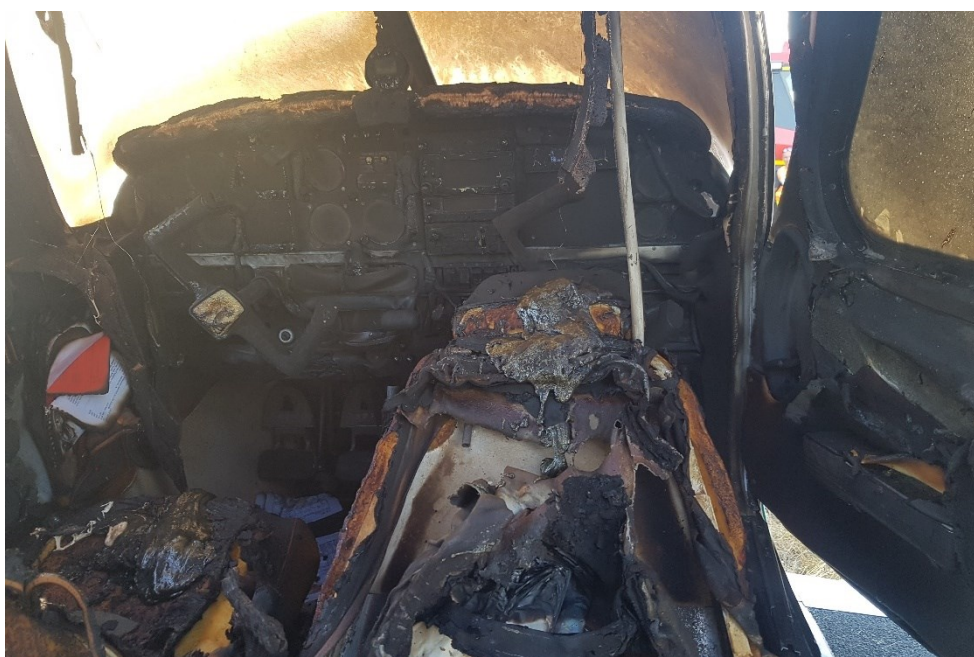
Figure 4: Instrument panel
Source: BEA - photo taken day of accident

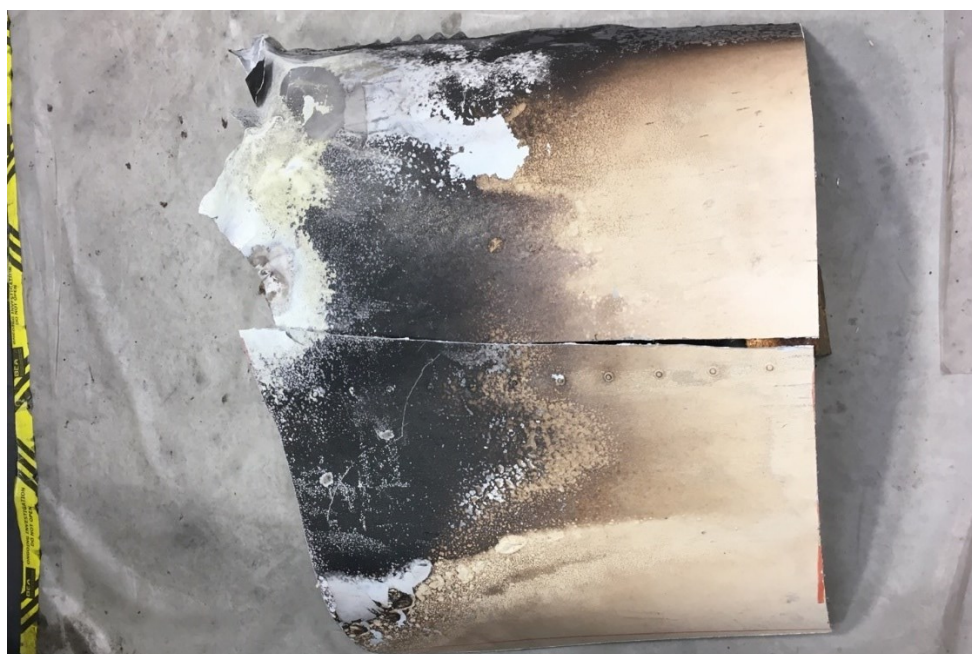
Furthermore, the external paint was damaged on the rear right side and part of the rear upper surface of the fuselage. The degree of damage varied according to the area of the airframe. This variation in damage reflects the spread of the hot smoke in the cockpit. The paint was more damaged at the rear, aft of the luggage hold and on the right side.

Figure 10: Area where the external paint on the sheet was damaged or destroyed
(upper part of the aeroplane)
Source: BEA

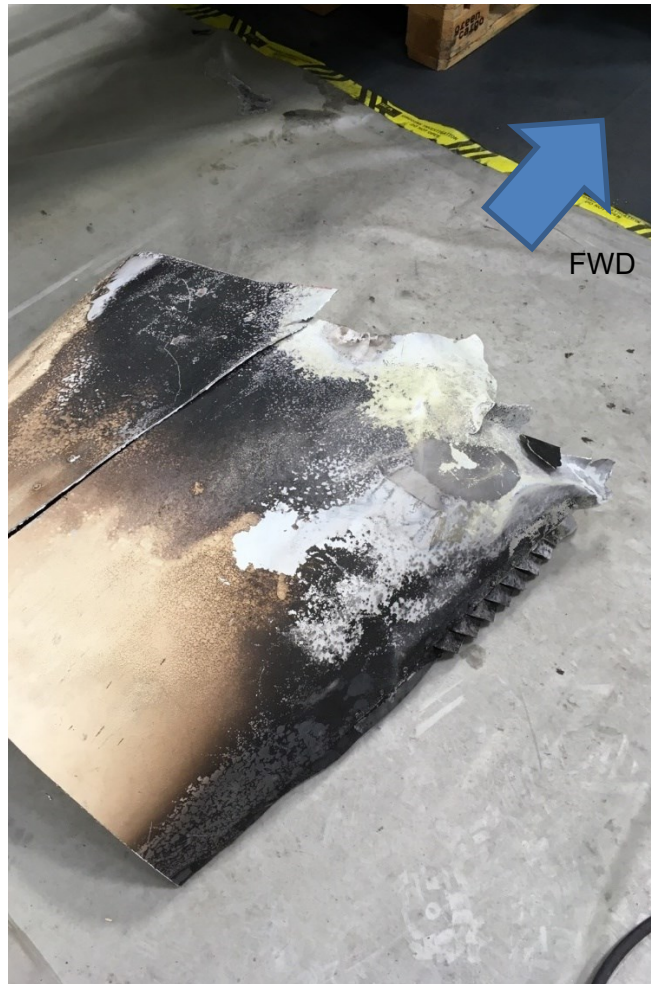
Figure 11: Area where the external paint on the sheet was damaged or destroyed (upper part of the aeroplane)
Source: BEA

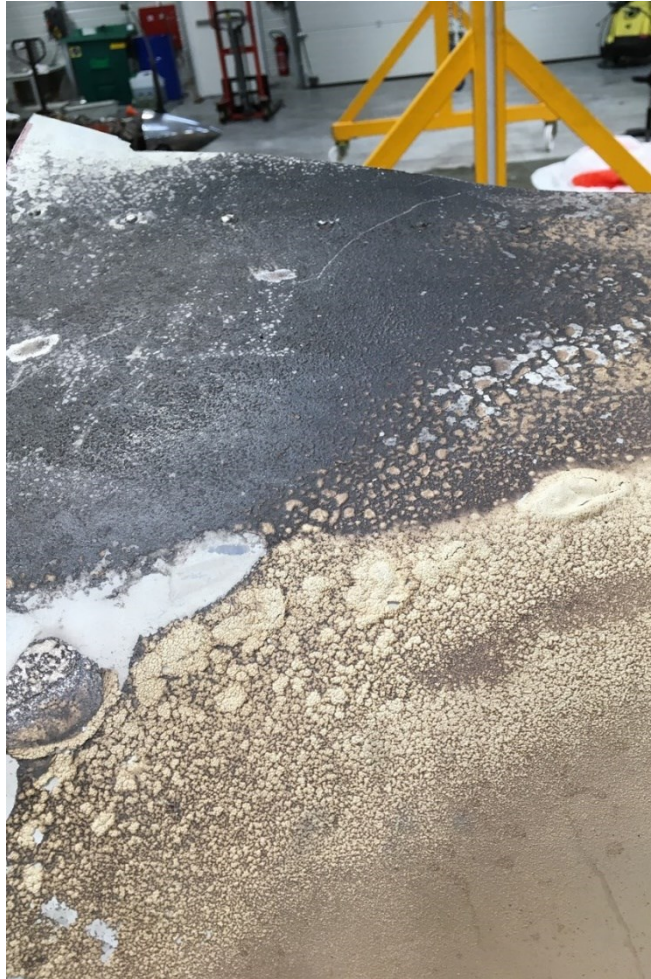
Figure 12: Detail of condition of external paint
Source: BEA

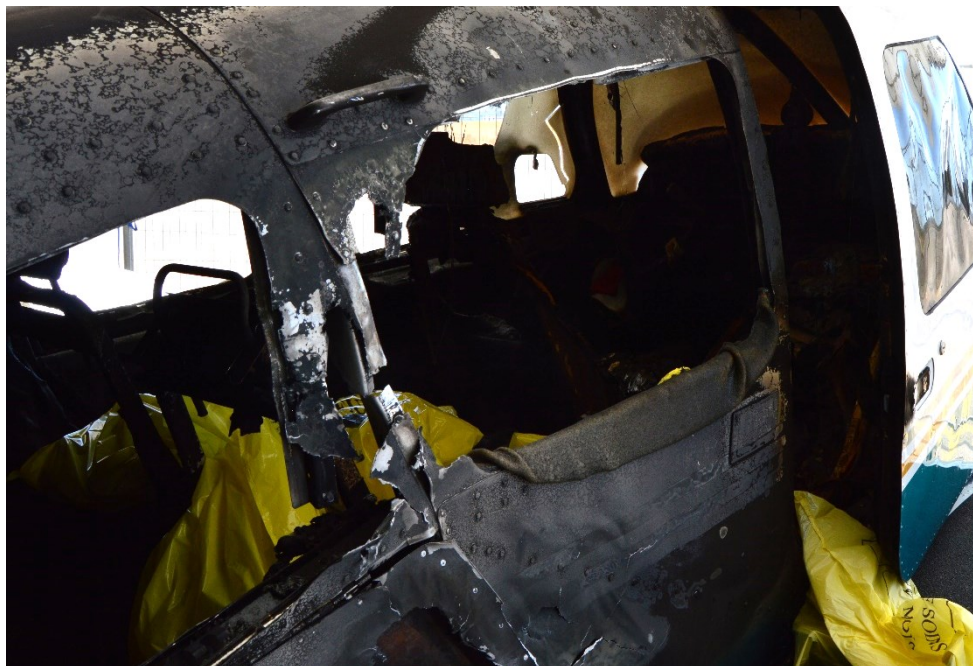
On the right side, the two rear glass panels had melted (**Figure 14**). The glass panel of the right door was complete but deformed.

Figure 14: Glass panels on right side
Source: BEA

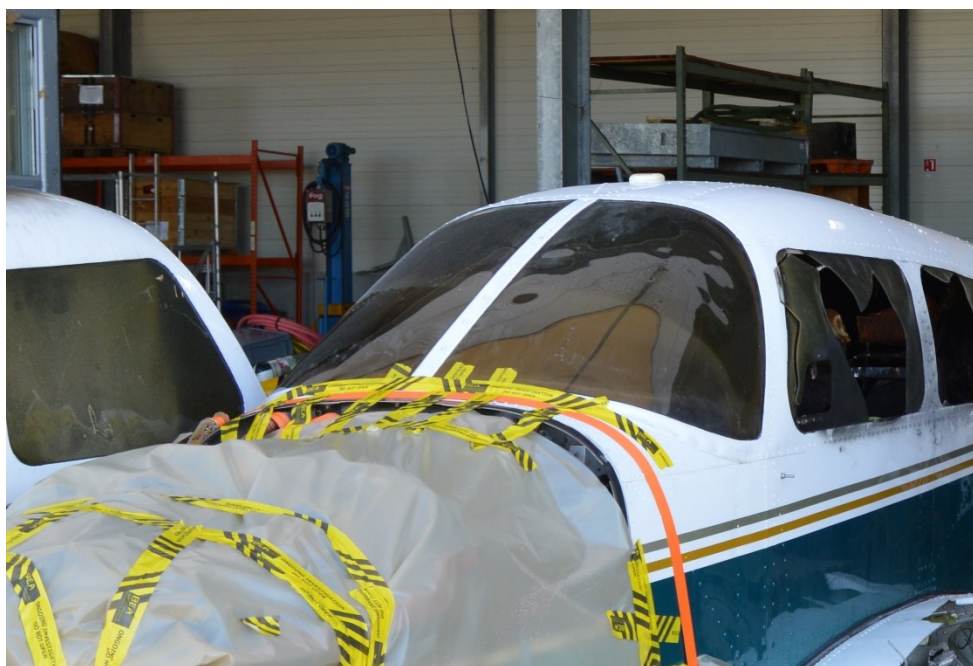
The aeroplane's windshield was complete and not deformed (**Figure 15**).

Figure 15: Windshield
Source: BEA

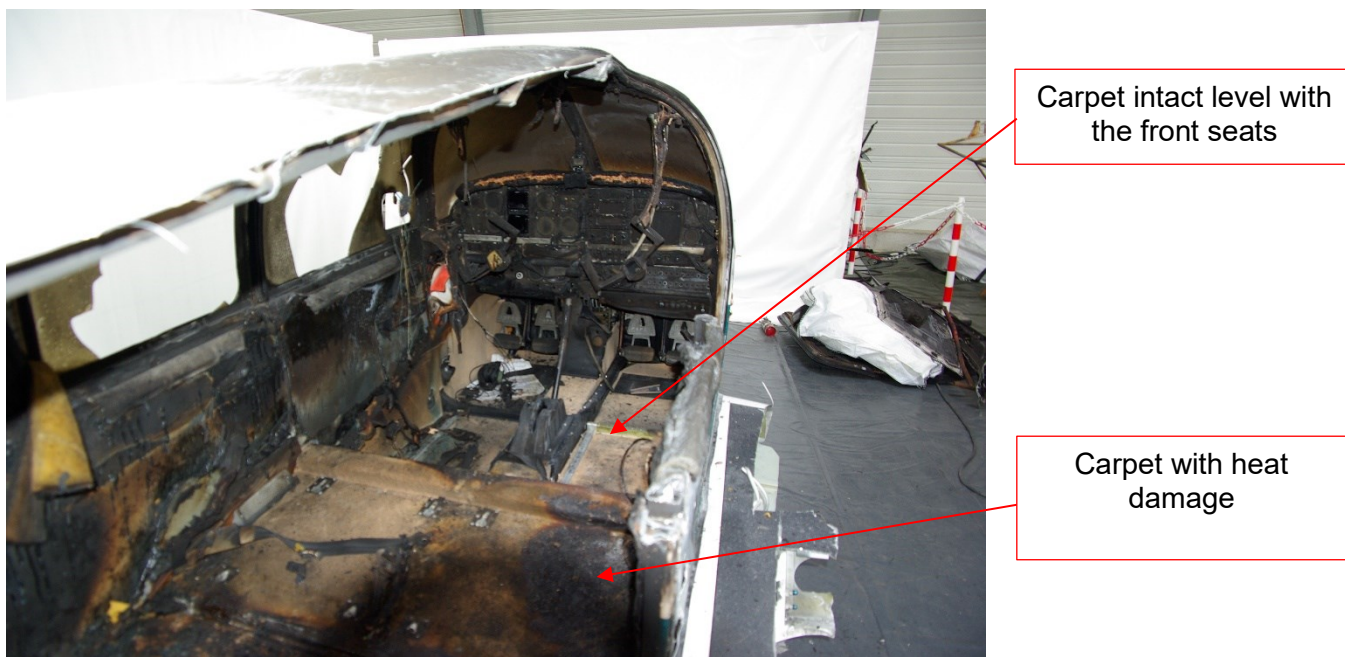
The cockpit was characterized by substantial damage to the side skin panels, the overhead skin panels and the instrument panel. This damage was the result of contact with smoke (**Figure 17** to **Figure 19**), and reflected the movement of the smoke in the aircraft due to the circulation of air. This damage particularly consisted of the melting or deformation of the plastic panels.

On the floor, the carpet at the base of the seats still had its normal colour (**Figure 17**). This carpet had heat damage at the base of the rear right seat, next to the door (**Figure 17**).

Figure 17: Cockpit after cutting the fuselage and removing the seats
Source: BEA

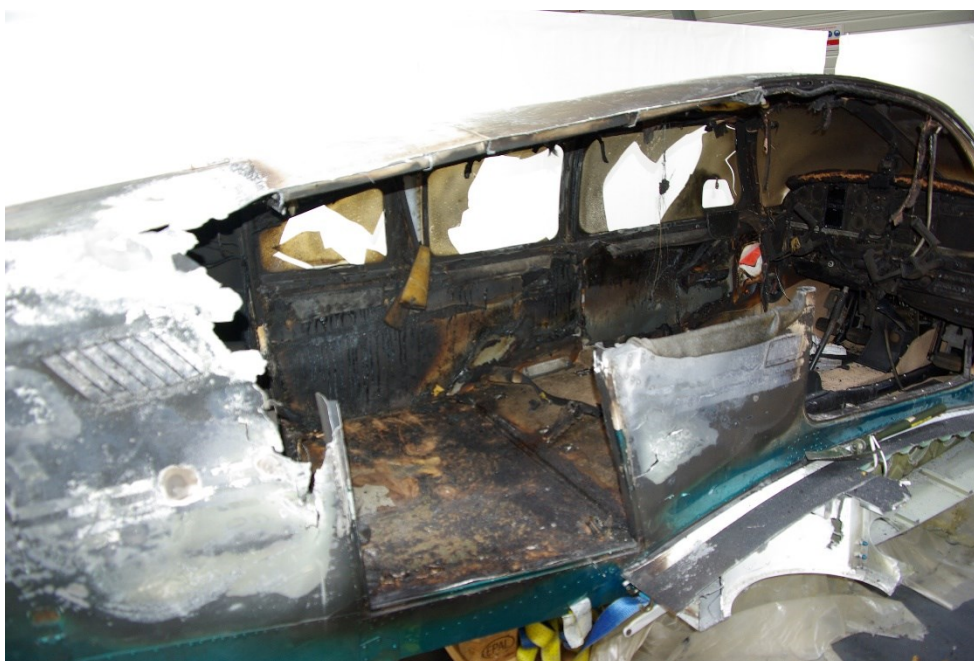
Figure 18: Cockpit after cutting the fuselage and removing the seats
Source: BEA

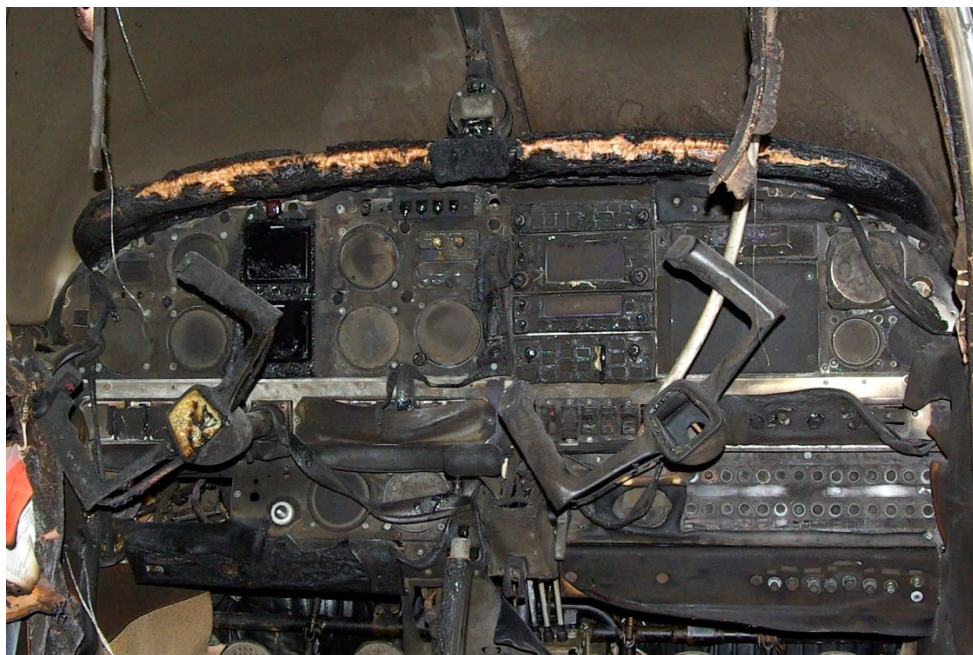
The plastic skin on the instrument panel had partially melted and was deformed. The instrument faces were covered with soot (**Figure 20**).

Figure 20: Instrument panel
Source: BEA

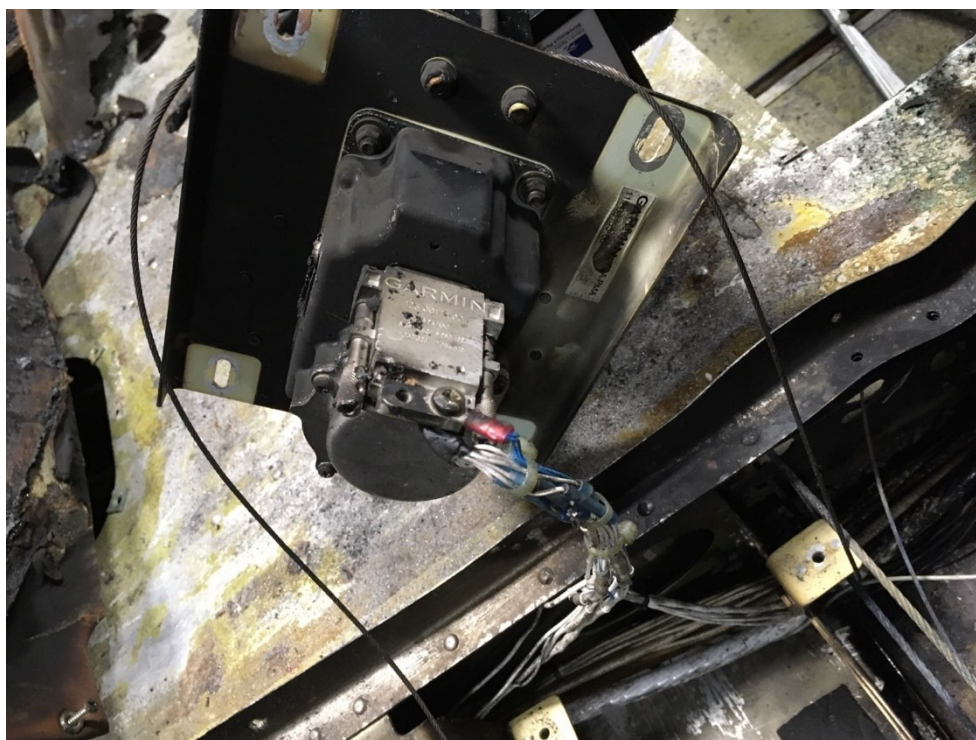
The servocontrol was still in position on the floor (**Figure 28**). It showed no substantial damage. Its electrical connections and the associated conductors were whole, no singularity was observed (**Figure 29**).

Figure 29: Electrical connections of servocontrol
Source: BEA

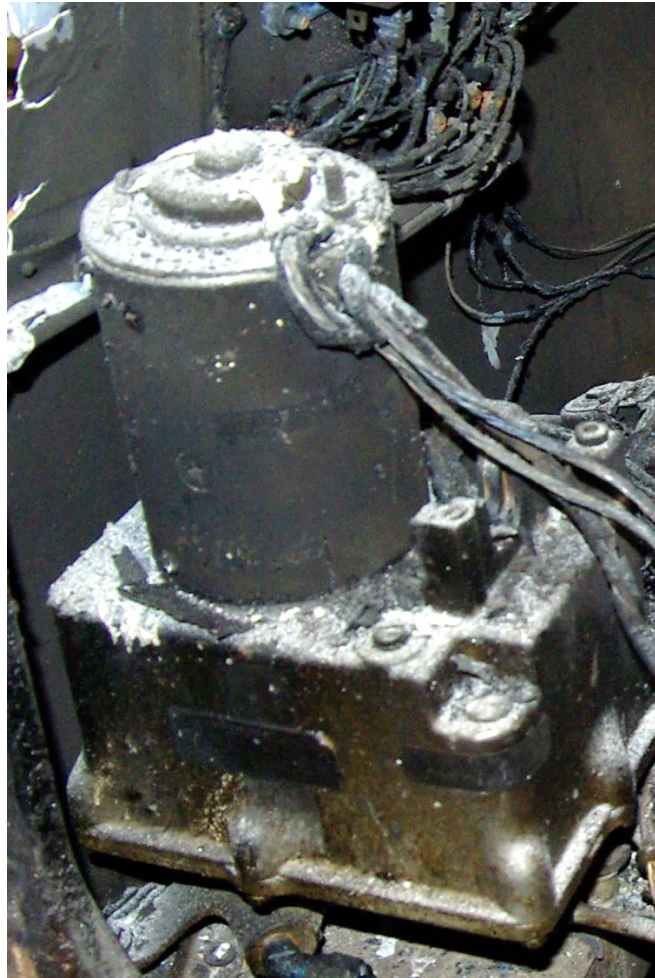
On the right side, the hydraulic pump was in position and nominally screwed to the floor (**Figure 30**). Three conductors were associated with the hydraulic pump. These conductors were continuous (an earthed conductor secured to the aeroplane's floor and two conductors attached to adjacent contactors). Their insulation was destroyed, very probably by the high temperature. Despite the insulation being destroyed, the core of these conductors remained flexible. These observations did not indicate an electrical problem on these components.

Figure 30: Hydraulic pump
Source: BEA

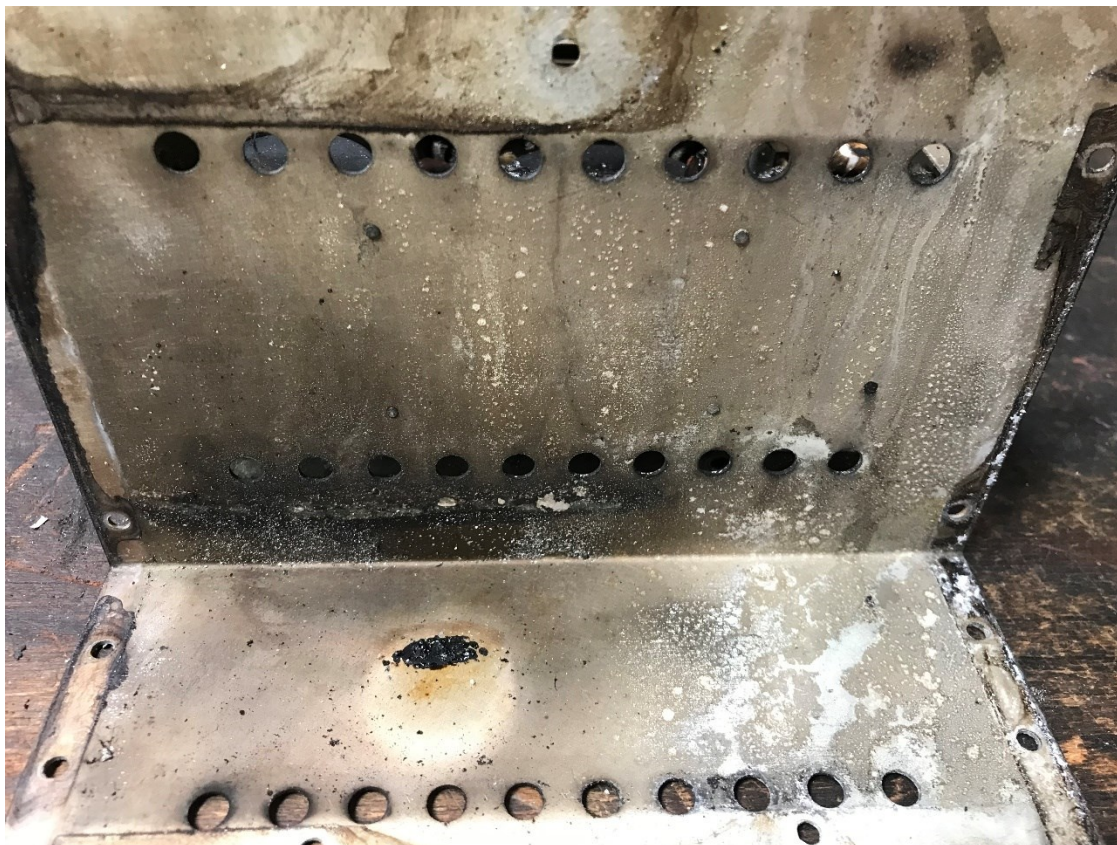
Figure 35: Inner surface of 12 V - 24 V converter casing

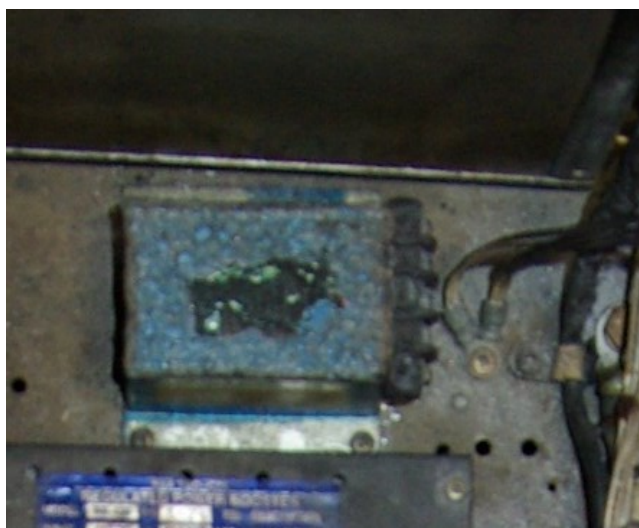
- The circuit breaker (different from the circuit breakers equipping the rest of the electrical system) was in position on the aircraft floor (**Figure 36**). The equipment had damage on its upper surface due to its exposure to an excessive temperature (**Figure 37**). This circuit breaker was not electrically connected to the aircraft.

Figure 36: Circuit breaker in position on the cockpit floor and not electrically connected

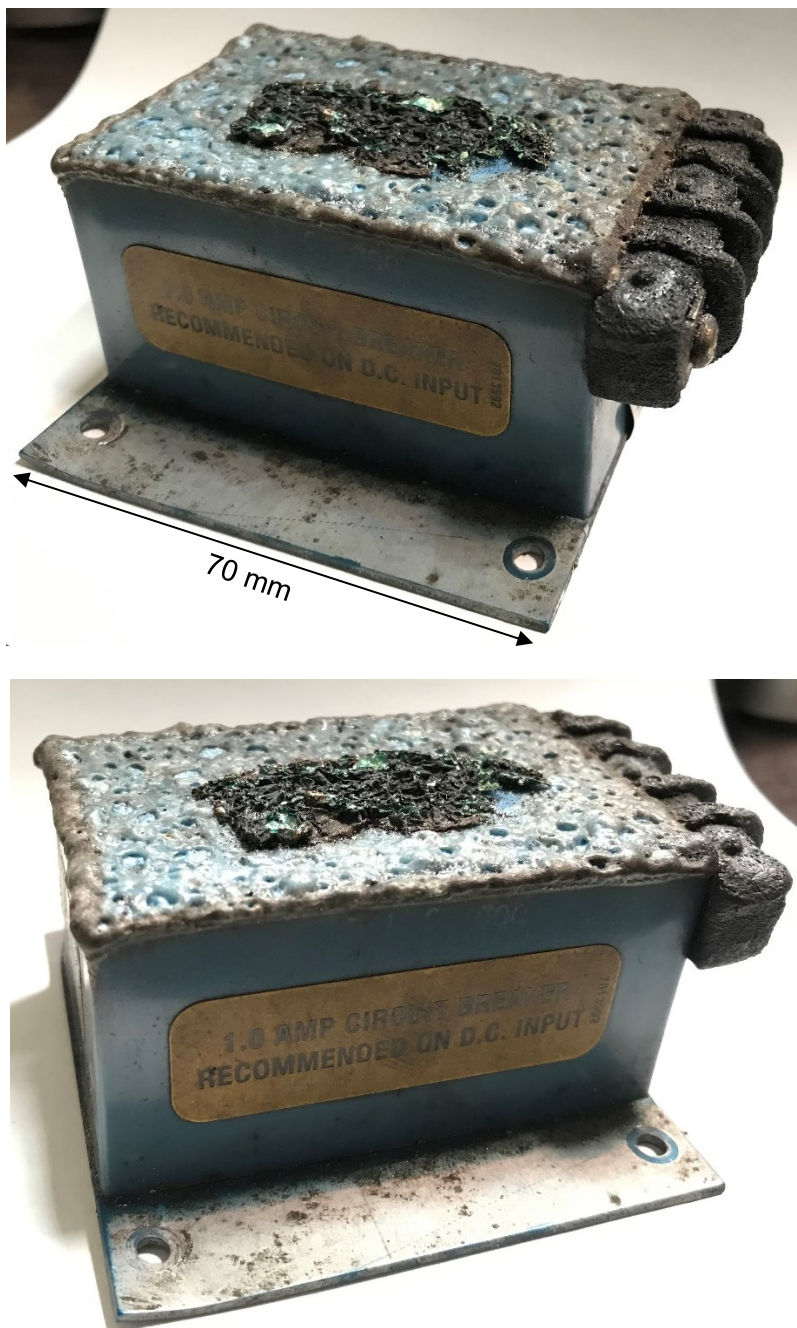
Figure 37: *Circuit breaker*
Source: BEA

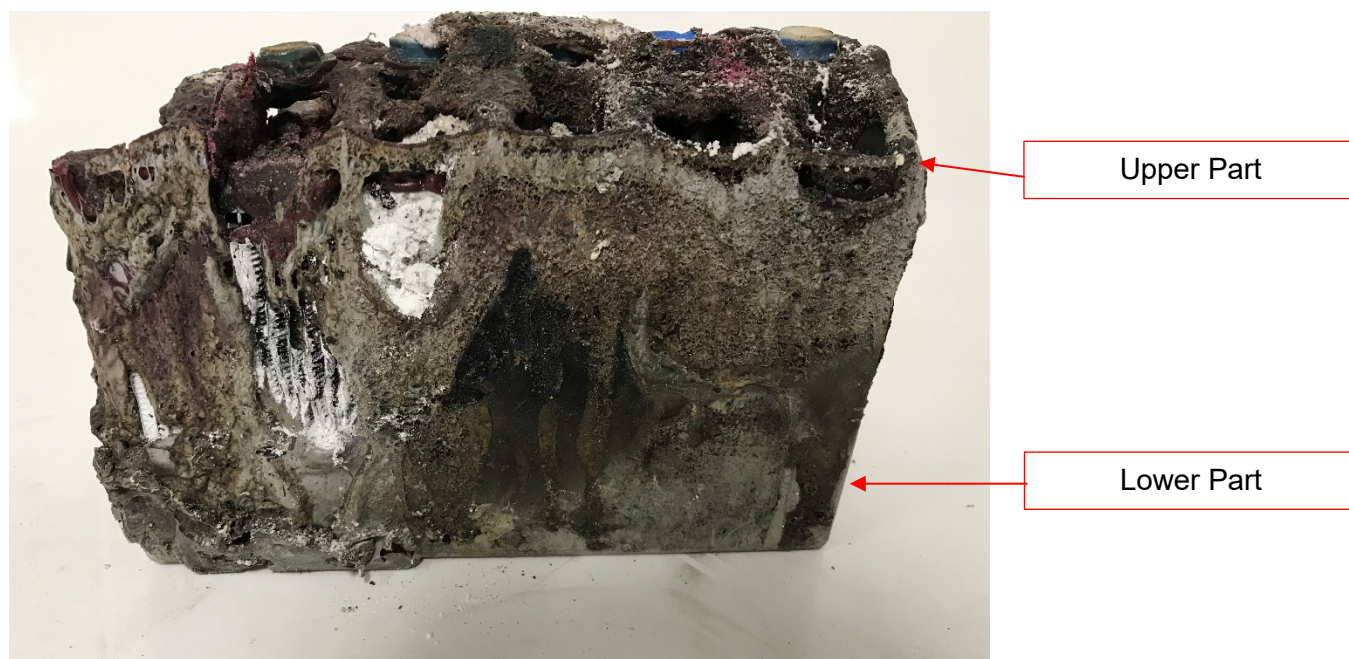
The appearance of the upper part and lower part of the battery was not homogeneous (**Figure 48** and **Figure 49**):

Figure 49: Lateral face of battery
Source: BEA

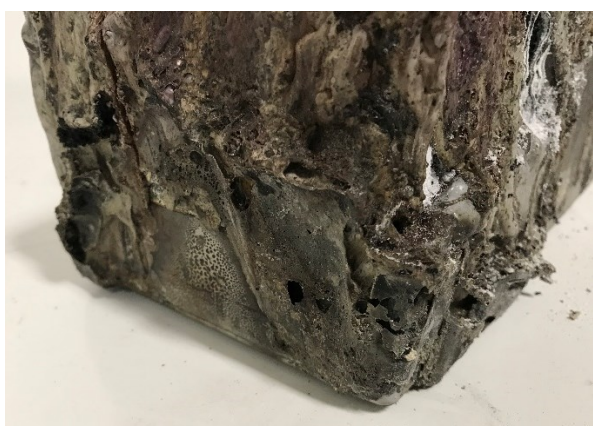
In the lower part of the battery, a contrast was observed between the sector on the negative terminal side and the sector on the positive terminal side (**Figure 50** and **Figure 51**). There was more damage on the positive terminal side.

Figure 50: Lower part of battery,
positive terminal side
Source: BEA

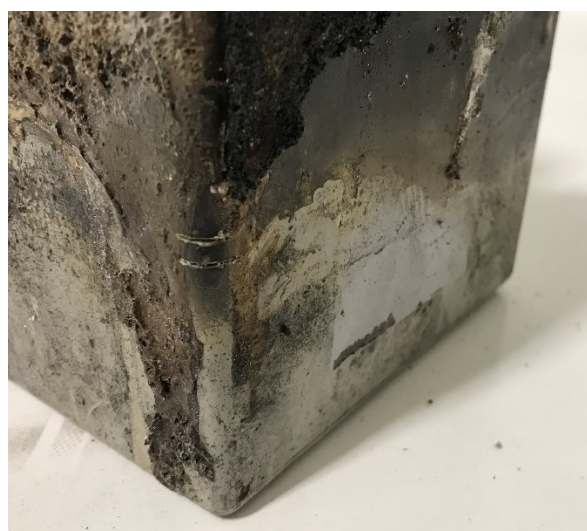
Figure 51: Lower part of battery,
negative terminal side
Source: BEA

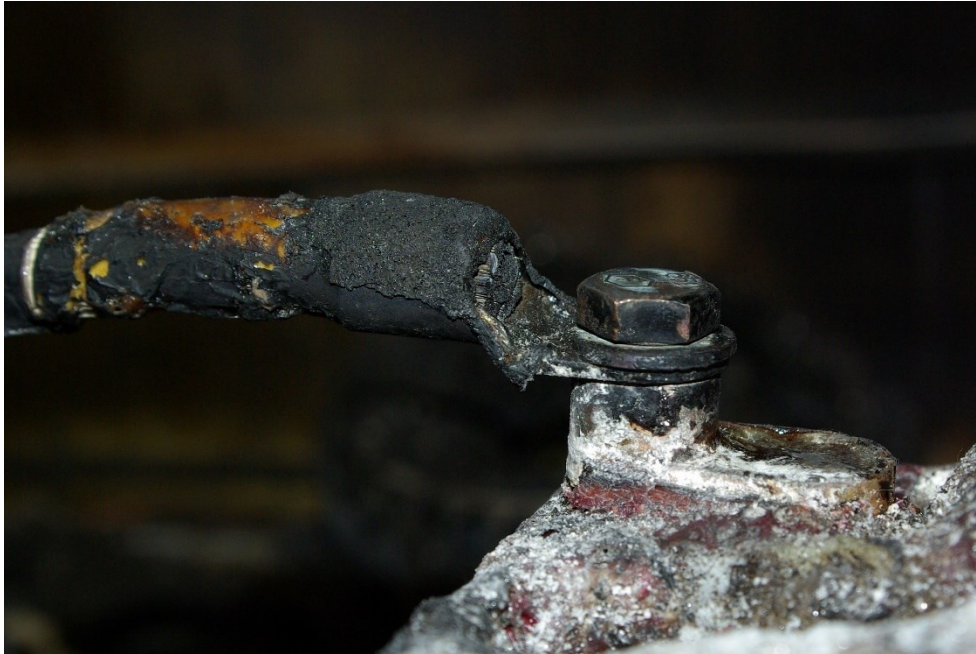
The negative terminal of the battery was still in position. The associated conductor was attached to this terminal (**Figure 52**). It was not possible to check the torque value. Due to the temperatures reached during the accident, this torque value would not have been usable and representative.

Figure 52: Negative terminal of battery

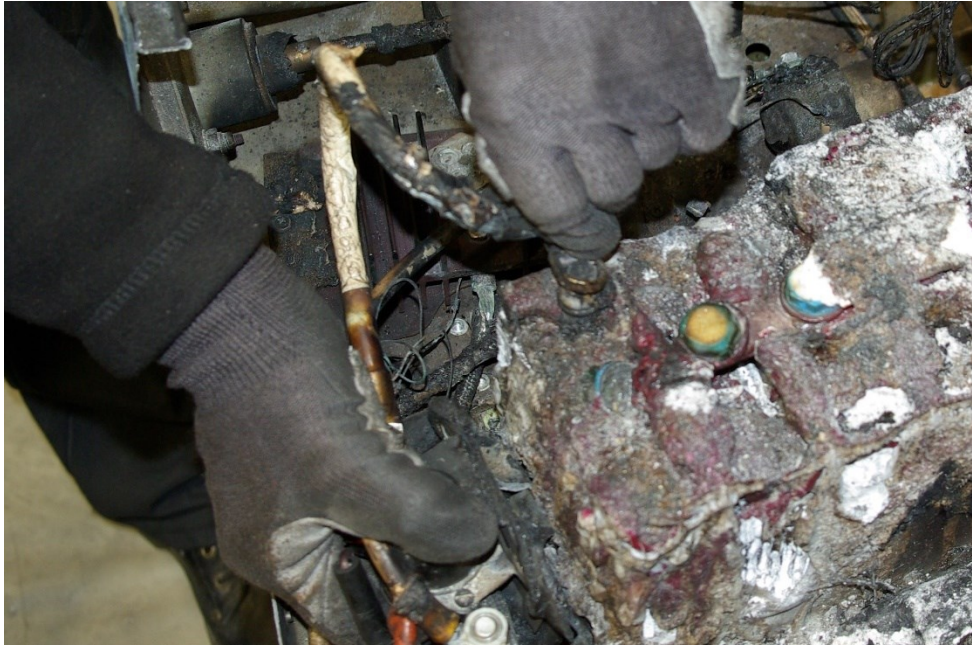
When repositioning this conductor on the positive terminal of the battery, it was observed that substantial force was required and that the end of the conductor, on the battery side, was under high stress loadings (**Figure 55**). The stress loadings created can very probably be explained by the rigidity and length of the conductor (large section, diameter varying between 9.1 and 9.9 mm) and by the shape which had to be imposed on it to ensure its connection with the battery terminal.

Figure 55: Repositioning of conductor on positive terminal of battery
Source: BEA

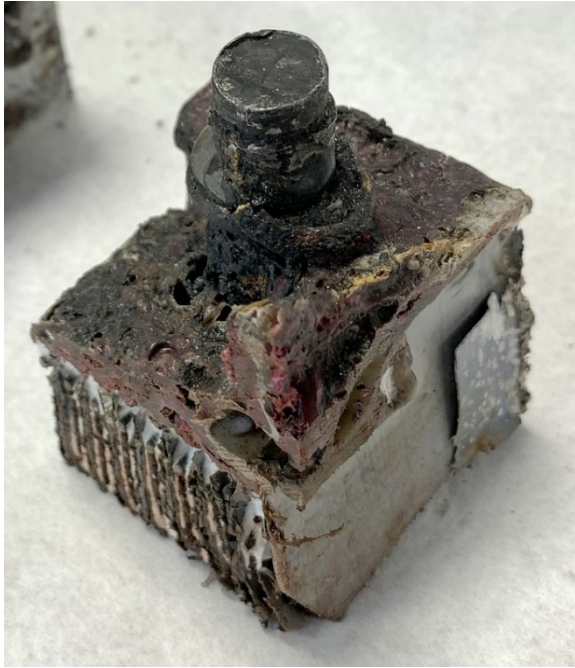
Figure 57: Positive terminal of battery
Source: BEA

The positive terminal of the battery was partially destroyed (**Figure 53**). Signs of melting were observed level with this terminal. The associated conductor was no longer connected. Part of the terminal was still integral with the end of the conductor and had therefore separated from the battery (**Figure 54**).

The positive and negative terminals of the battery were removed for a detailed examination in the BEA laboratory (**Figure 57** and **Figure 58**).

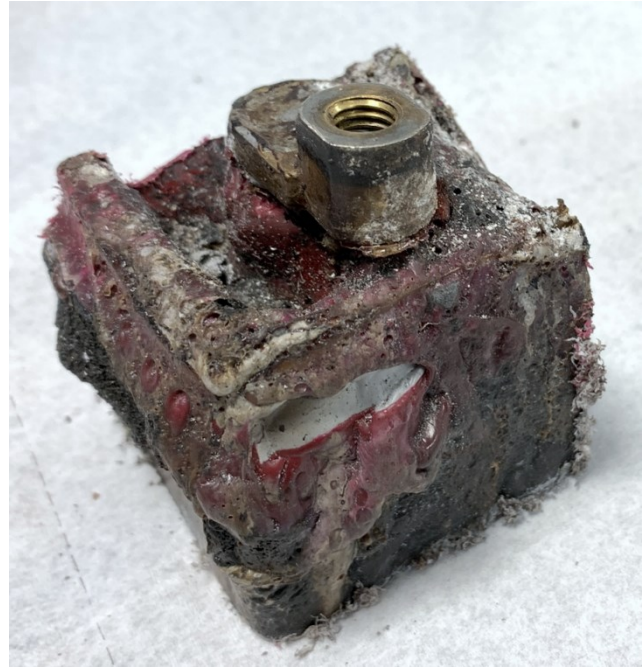
Figure 58: Negative terminal of battery
Source: BEA

There was no damage on the negative terminal. The various components were in position. The soldered connection was intact (**Figure 59**).

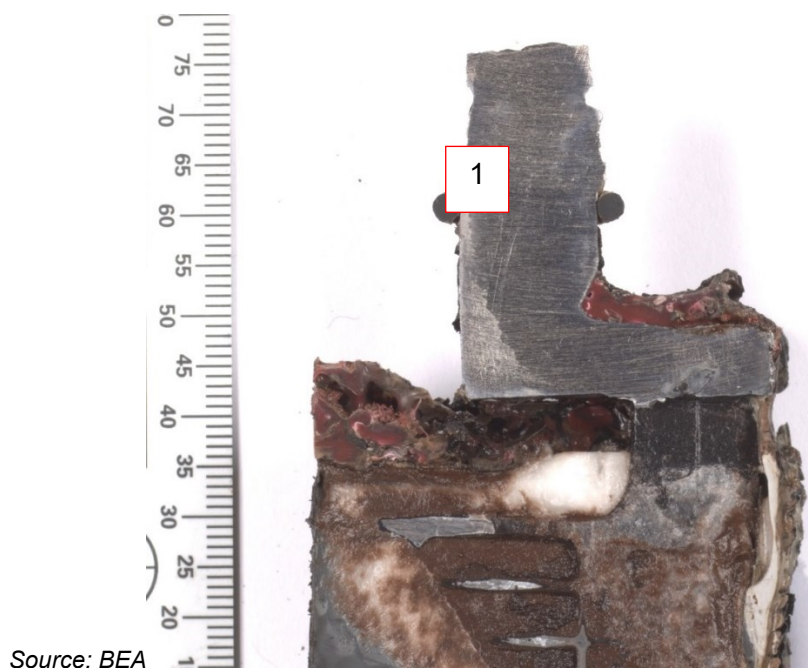
Figure 61: Cross-section of positive terminal

- the solder which normally makes components 1 and 2 integral with each other (**Figure 56**) was not in its normal place. The solder seemed to have run downwards (**Figure 60, Figure 61 and Figure 63**);
- the epoxy sealant was no longer present;
- arc type damage was observed in one of the section planes, level with the connection between the terminal and the battery cells (**Figure 62 and Figure 64**);
- item 2 had stayed connected to the conductor.

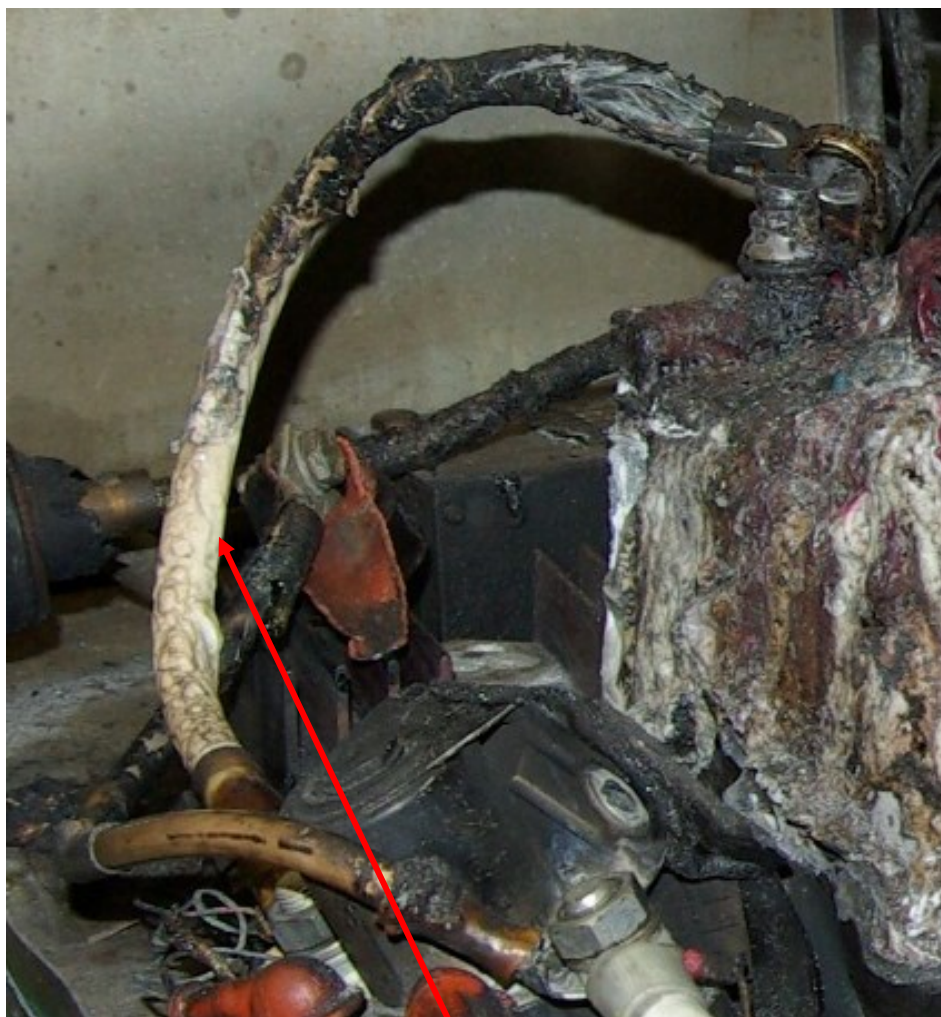
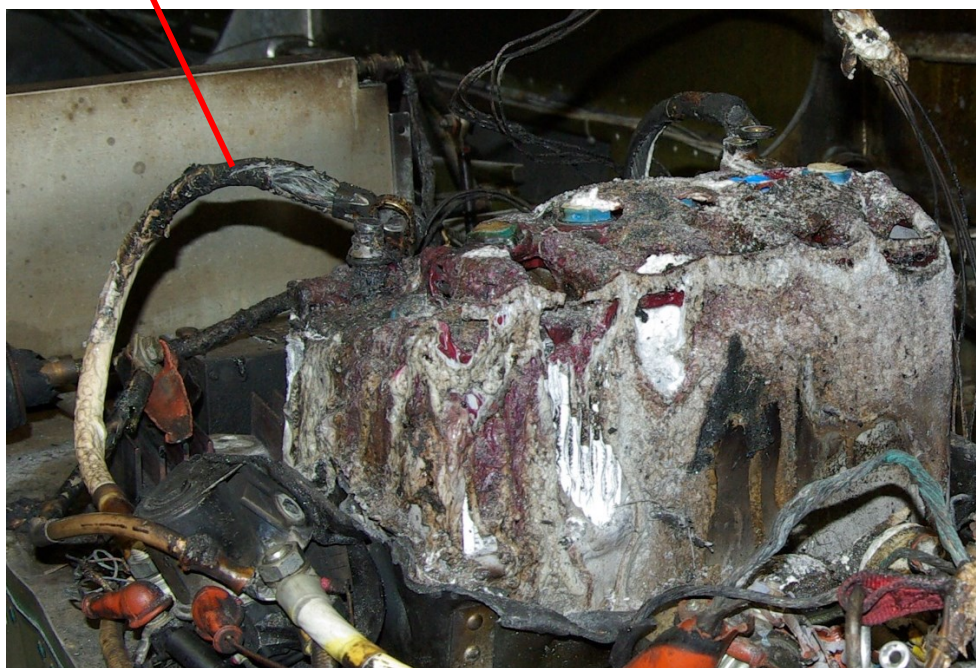
Figure 65: Conductor associated with positive terminal of battery
Source: BEA

The conductor showed signs of overheating, principally on its insulation (Figure 65). The destruction was greater on the part of the cable on the battery terminal side.

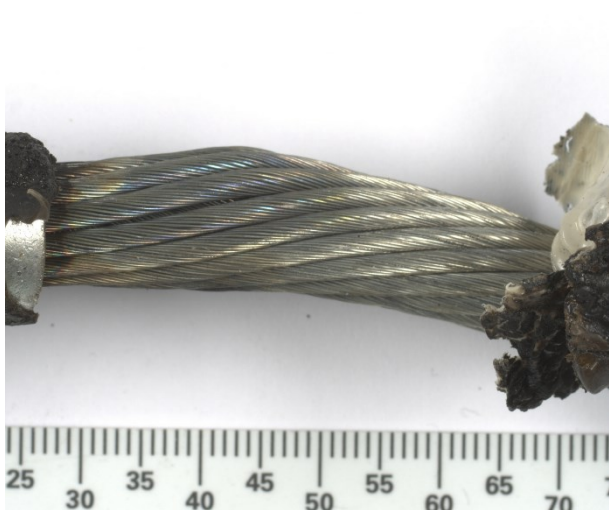
Once the insulation had been removed, a bluish colouring could be seen on the conductor over a length of around 30 mm starting from the lug normally attached to the positive terminal (**Figure 67**). This was very probably a sign of overheating. In the same area, there was also a deformation of the strands making up the cable (**Figure 68**).

Figure 67: Bluish colouring of conductor (overheating of conductor)
Source: BEA

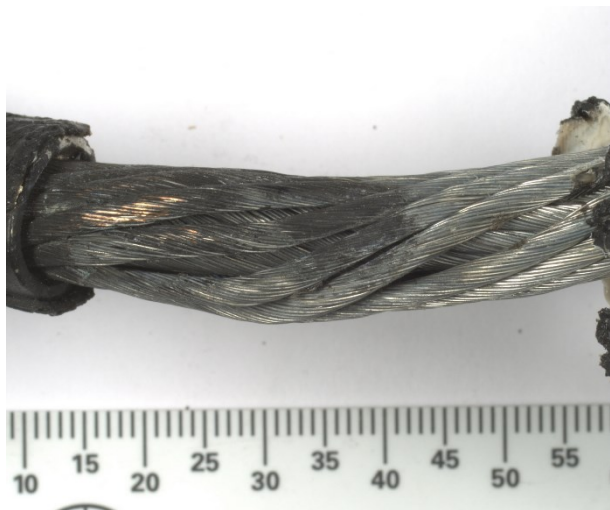
Figure 68: Deformation of strands making up conductor
Source: BEA

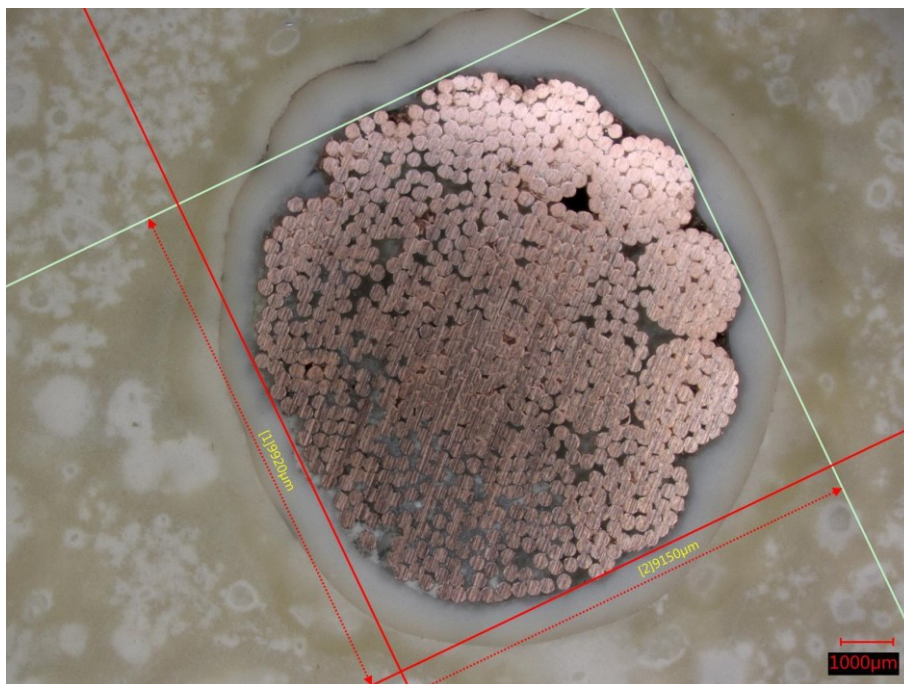
A cross-section was made in an area of little cable damage. The diameter of the cable was measured by image analysis (**Figure 69**). As the cable was not perfectly circular, its diameter varied between 9.1 mm and 9.9 mm.

Figure 69: Cross-section of conductor
Source: BEA

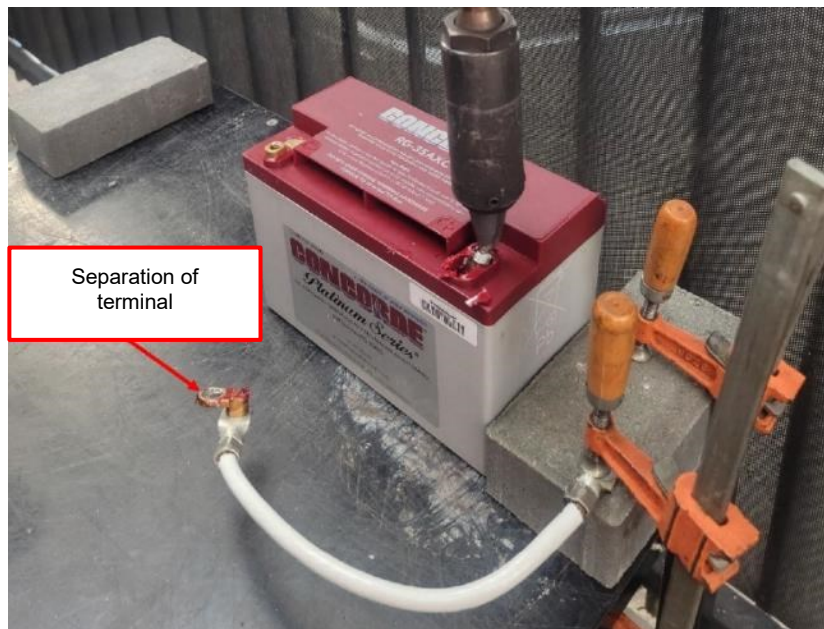
Parts 1 and 2 of the terminal separated after a period of around 6 minutes. This separation was not associated with a flame. The damage was concentrated on the terminal.

Figure 71: Separation of parts 1 and 2 of terminal
Source: Concorde Aircraft Batteries

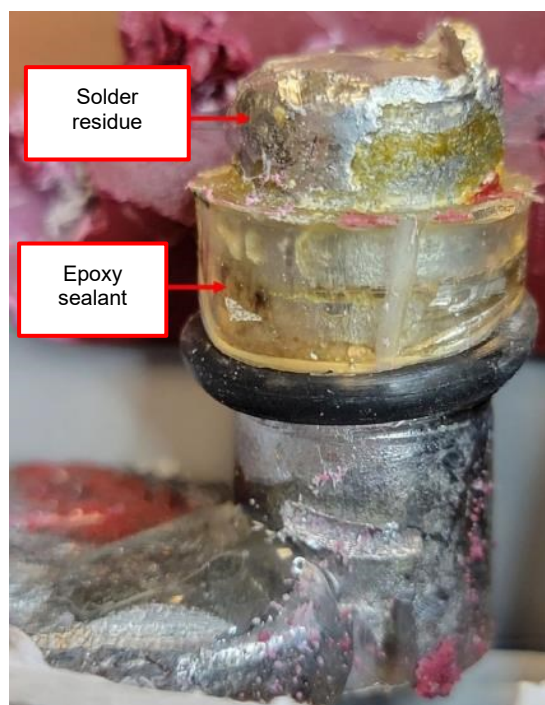
The detailed examination of the terminal found that the solder had melted. The epoxy sealant was still present however.

Figure 72: Detail of terminal after test
Source: Concorde Aircraft Batteries

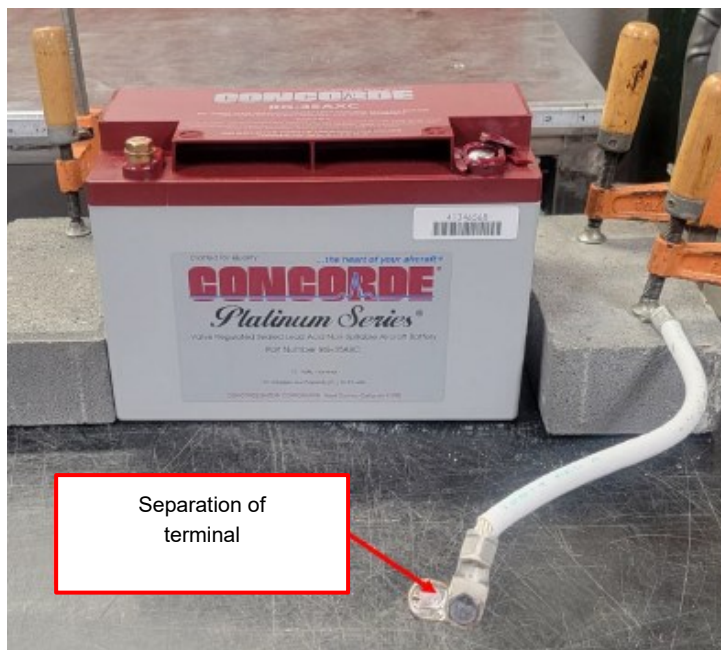
Parts 1 and 2 of the terminal separated after a period of around 2 minutes. This separation was not associated with a flame. The damage was concentrated on the terminal.

Figure 74: Separation of parts 1 and 2 of terminal
Source: Concorde Aircraft Batteries

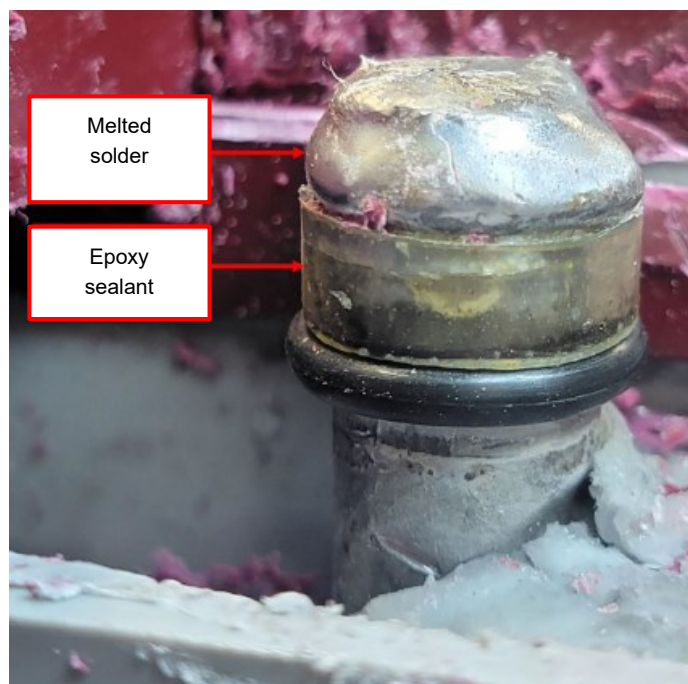
The detailed examination of the terminal found that the solder had melted. The epoxy sealant was still present however.

Figure 75: Detail of terminal after test
Source: Concorde Aircraft Batteries

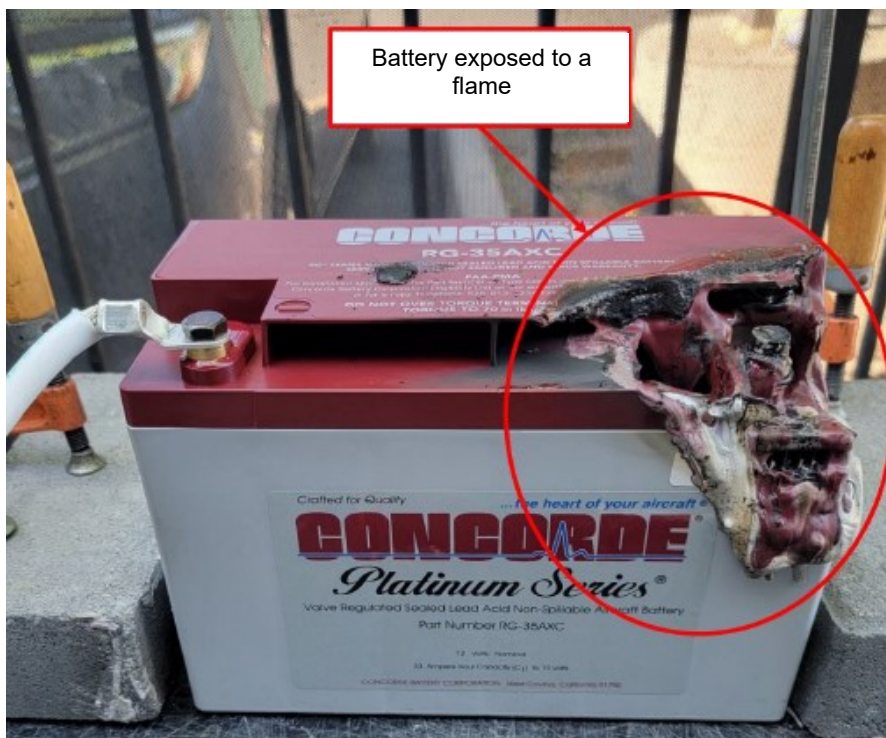
Parts 1 and 2 of the terminal separated after a period of around 2 minutes.

Figure 76: Separation of parts 1 and 2 of terminal
Source: Concorde Aircraft Batteries

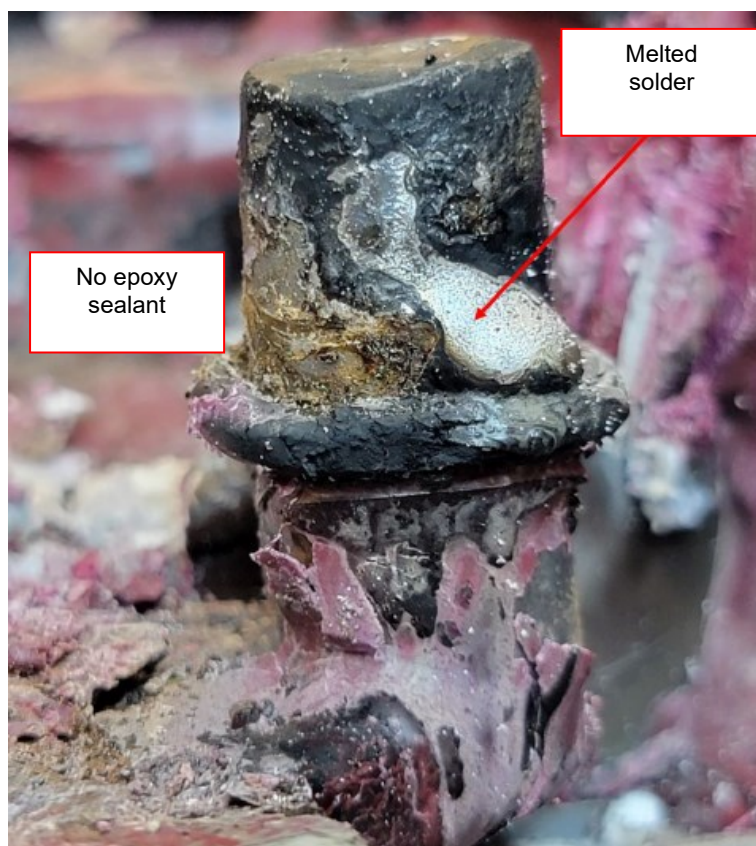
The detailed examination of the terminal found that the solder had melted. The epoxy sealant was no longer present.

Figure 77: Detail of terminal after test
Source: Concorde Aircraft Batteries
