TECHNICAL REPORT

**Accident on 23 July 2020
at Bâle-Mulhouse airport (Haut-Rhin)
to the PIPER - PA-28RT-201T
registered HB-PNP**

Examination of wreckage

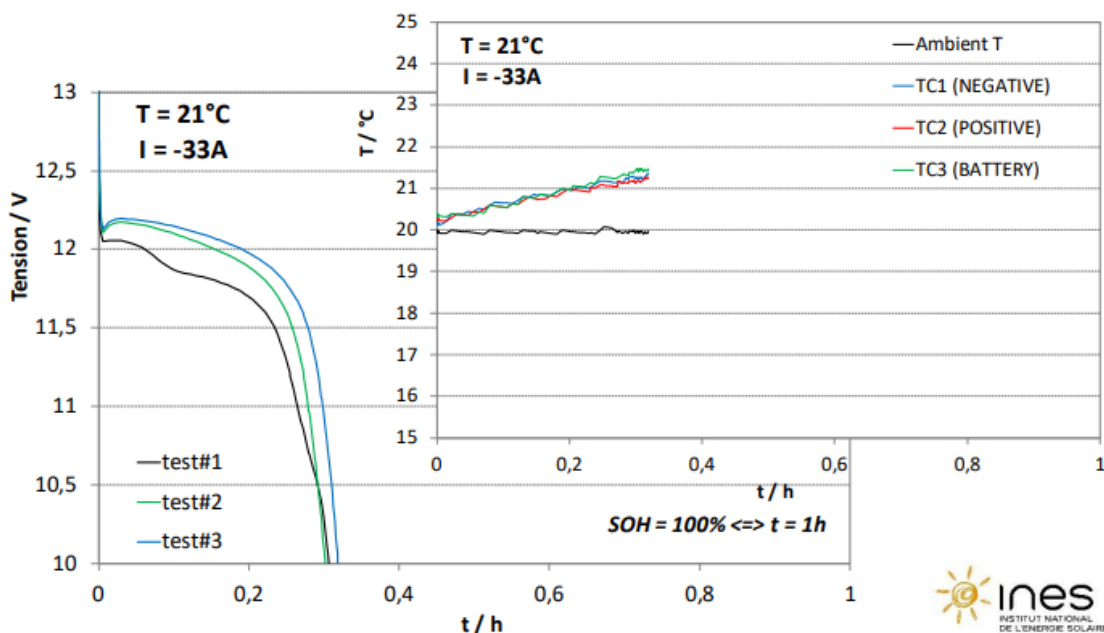
Figure 82: Data acquired during three battery discharge operations

The three battery discharge tests defined the battery capacity as between 10 and 10.5 Ah, i.e. a SoH of between 30 and 32%. A significant difference can therefore be noted between this value and the value defined on 28 April 2021 of 81.6%. This difference seems to indicate early ageing of the battery between 28 April 2021 and the date of examination at the CEA. The removal of the battery and its storage without charge before the date of examination at the CEA was probably a contributory factor.

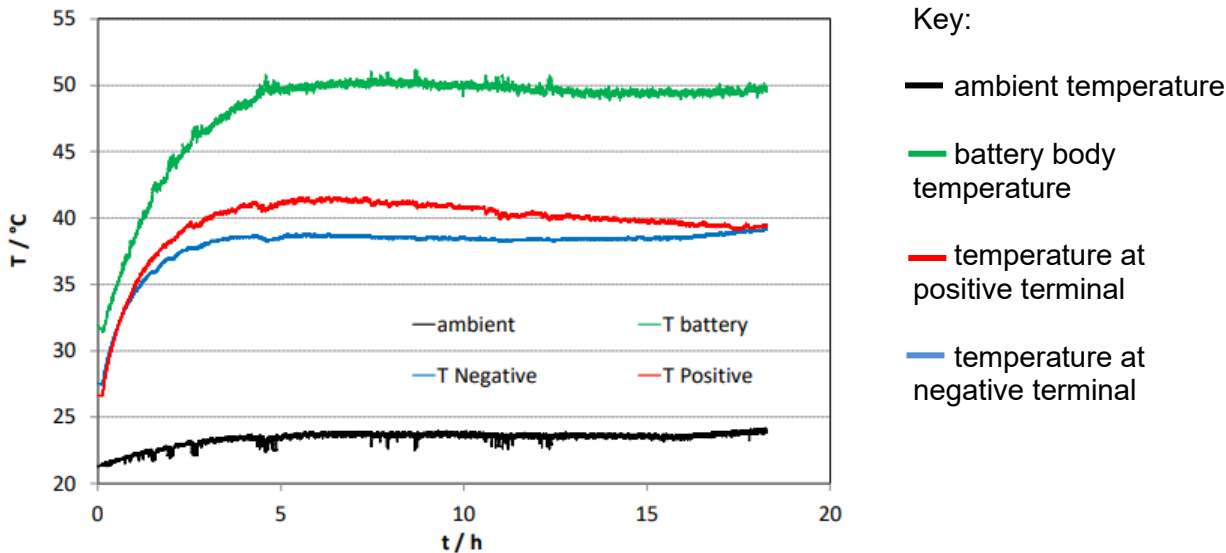
Figure 88: Temperature measurements during test
Source: INES CEA

- the battery voltage remained in the specified limits of use;
- the temperature of the battery's "body" increased to around 50°C;
- the temperature at the battery's terminals increased to around 40°C.

According to the CEA experts, these results show that the application of such a current on a battery with a lower electrolyte saturation of the separator could initiate a violent thermal runaway process. If this happens, the temperature will rise further.

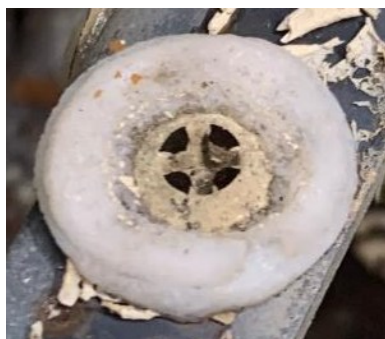
- softening temperature: during the tests carried out, softening started at around 450°C;
- melting temperature/destruction by thermal effect: destruction was observed at a temperature of between 480 and 500°C.

Softening of insulating washer

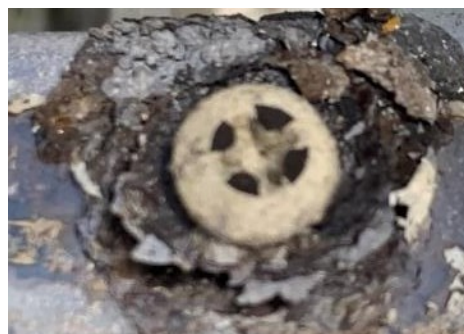
Destruction of insulating washer

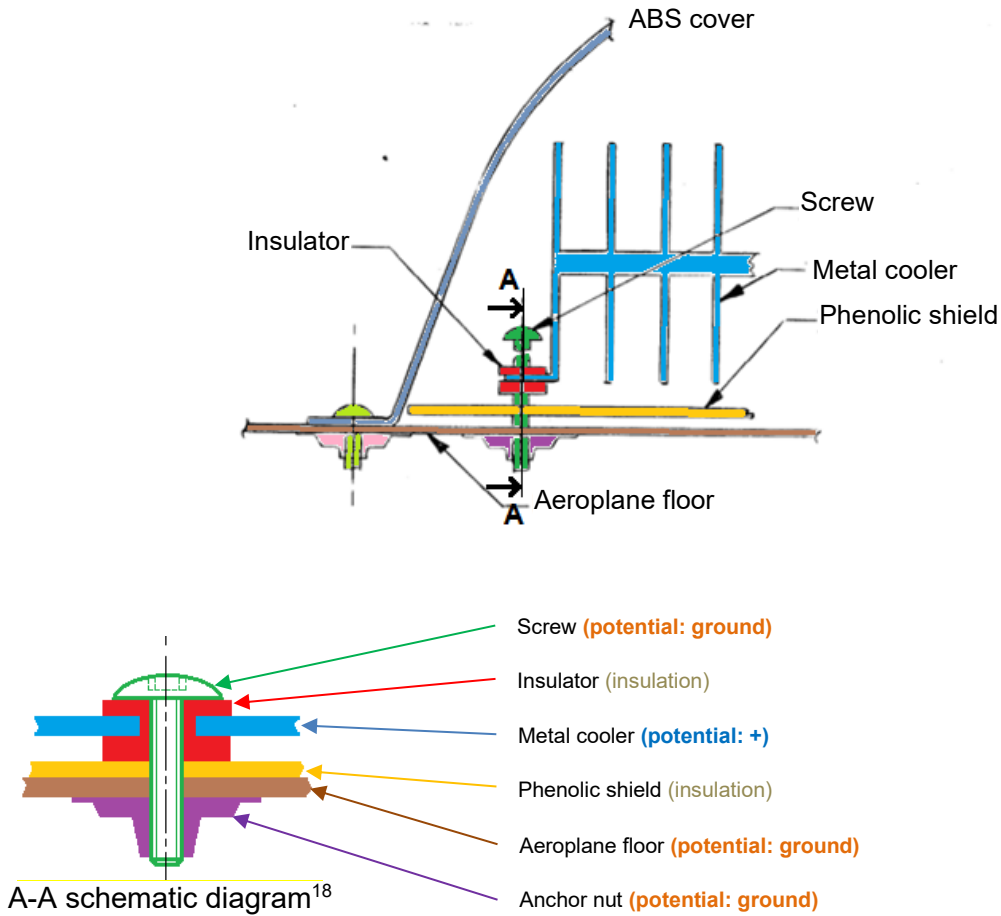
Figure 94: Diagram of assembly of cooler on aeroplane floor

This diode device is composed of a metal cooler, secured to the floor of the aircraft at four points. A detailed diagram of how it is assembled to the aeroplane floor is given in **Figure 94**.

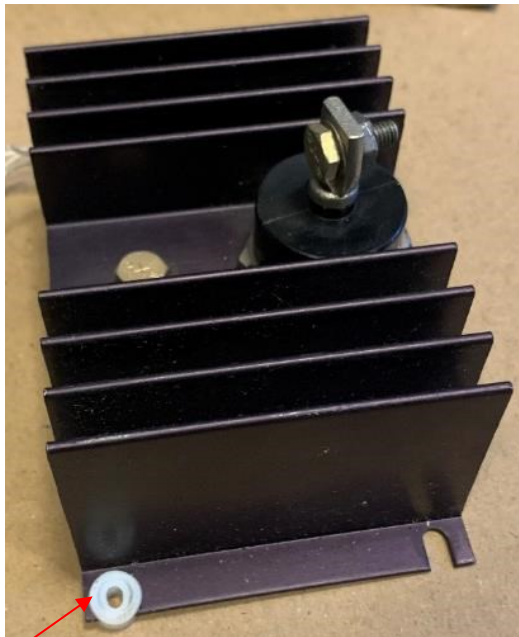
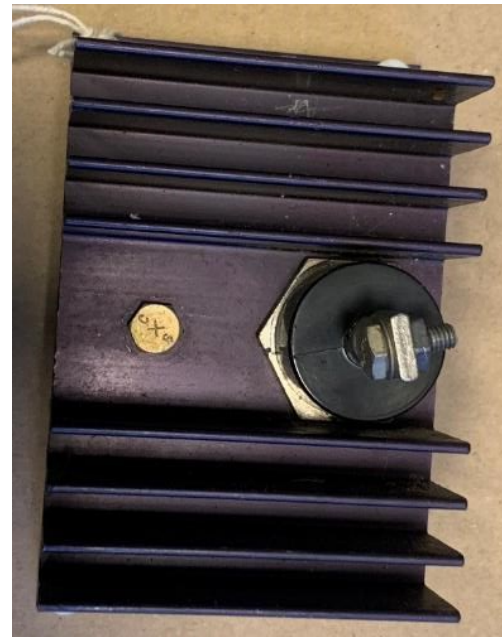
Figure 95: Diode device supplied by Concorde Aircraft Batteries to the BEA¹⁹
Source: BEA

¹⁹ When this item was received by the BEA, it was observed that an insulating washer (normally four) was missing.

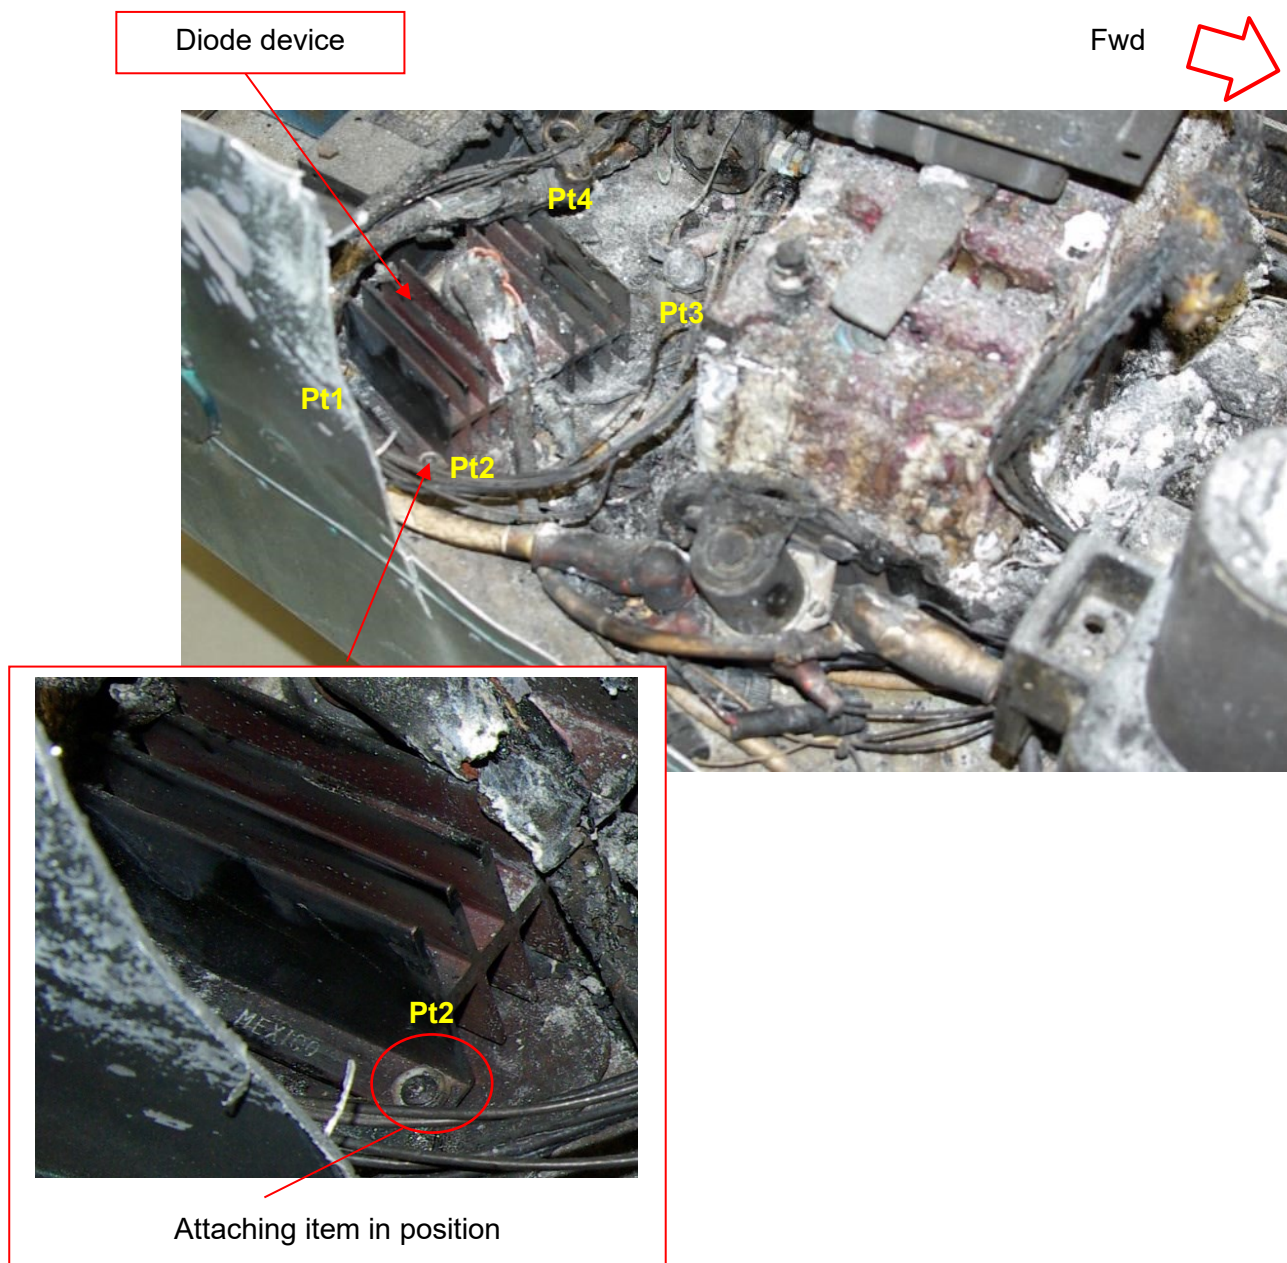
Figure 98: Diode device in position on aeroplane floor
Source: BEA

- In one of its corners, the metal cooler had thermal effect damage which had resulted in the melting of the alloy of which it is composed (**Figure 101**). The associated attaching screw and insulating washer were no longer present. However, the three other attaching screws were in position (**Figure 98**)²¹.

²¹ To simplify understanding in the rest of the document, the metal cooler attaching points are arbitrarily numbered Pt1, Pt2, Pt3 and Pt4 as shown in **Figure 98**.

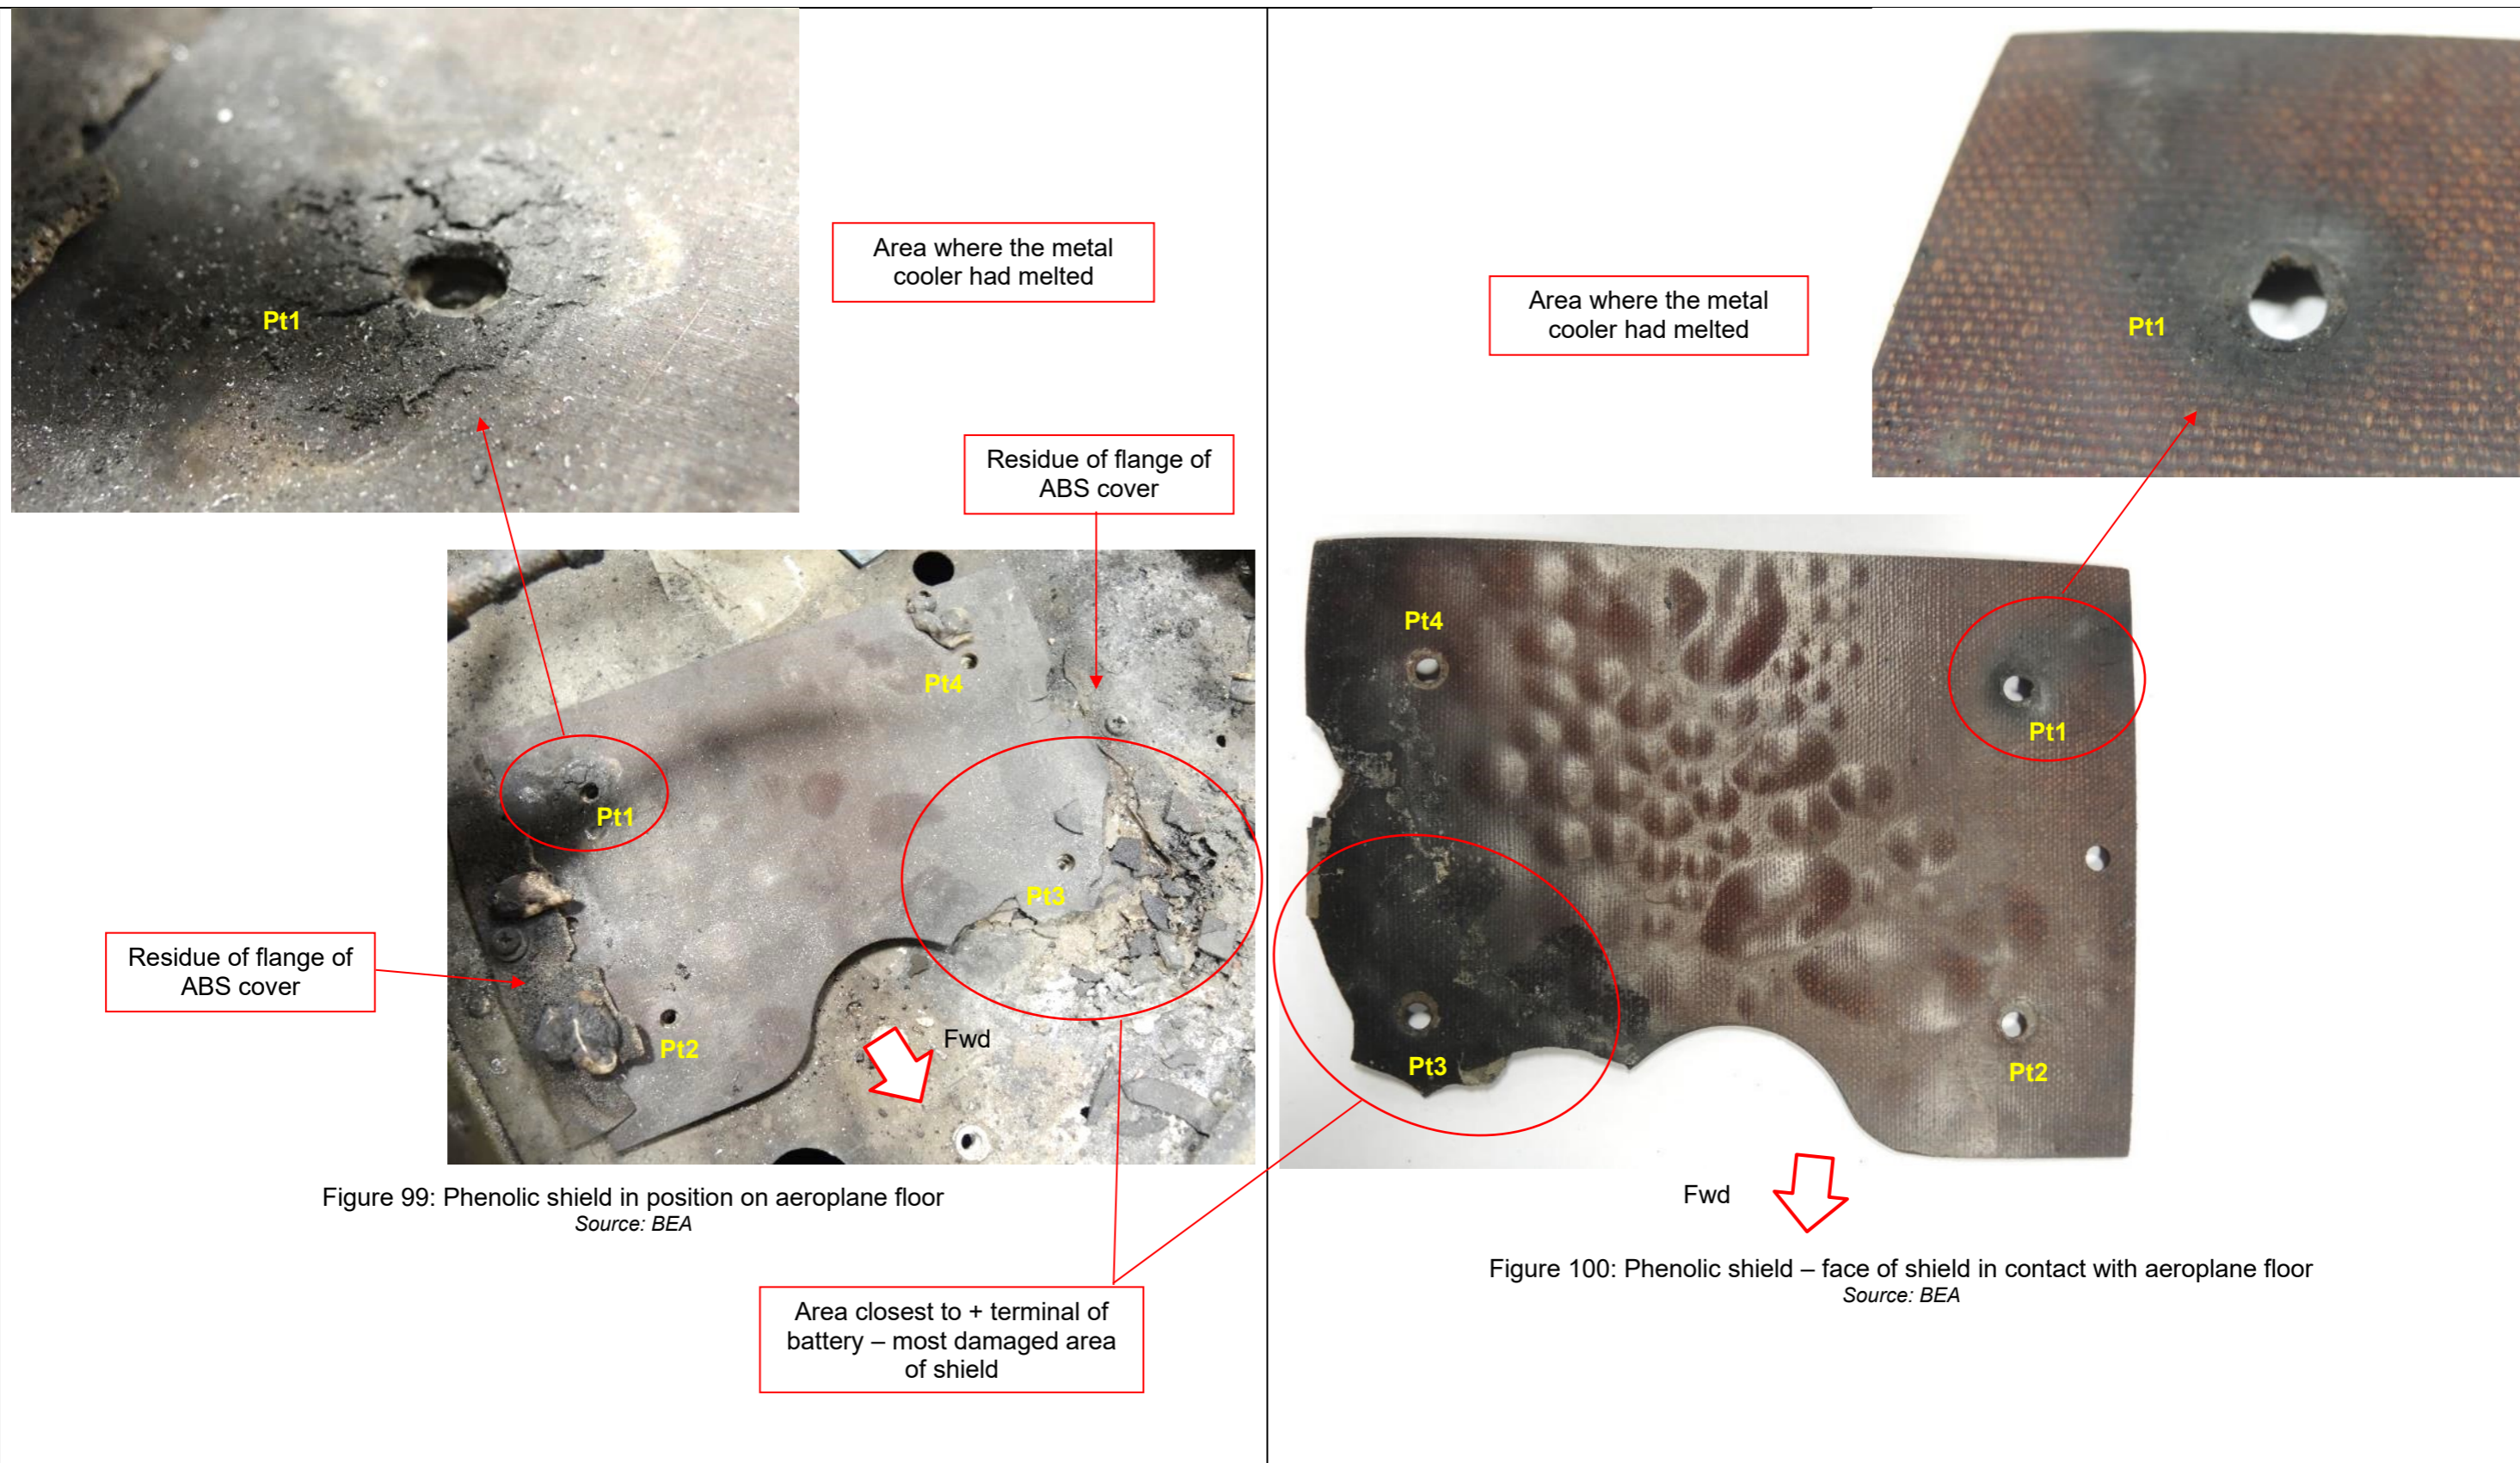
Figure 99: Phenolic shield in position on aeroplane floor
Source: BEA

- The phenolic shield was in position under the metal cooler (**Figure 99**). The shield was blackened around the attaching point in line with where the metal cooler had melted (attaching point arbitrarily numbered Pt1) (**Figure 99** and **Figure 100**). The shield was also partially burnt in line with the front left corner (around the attaching point arbitrarily numbered Pt3), situated the closest to the positive terminal of the battery.

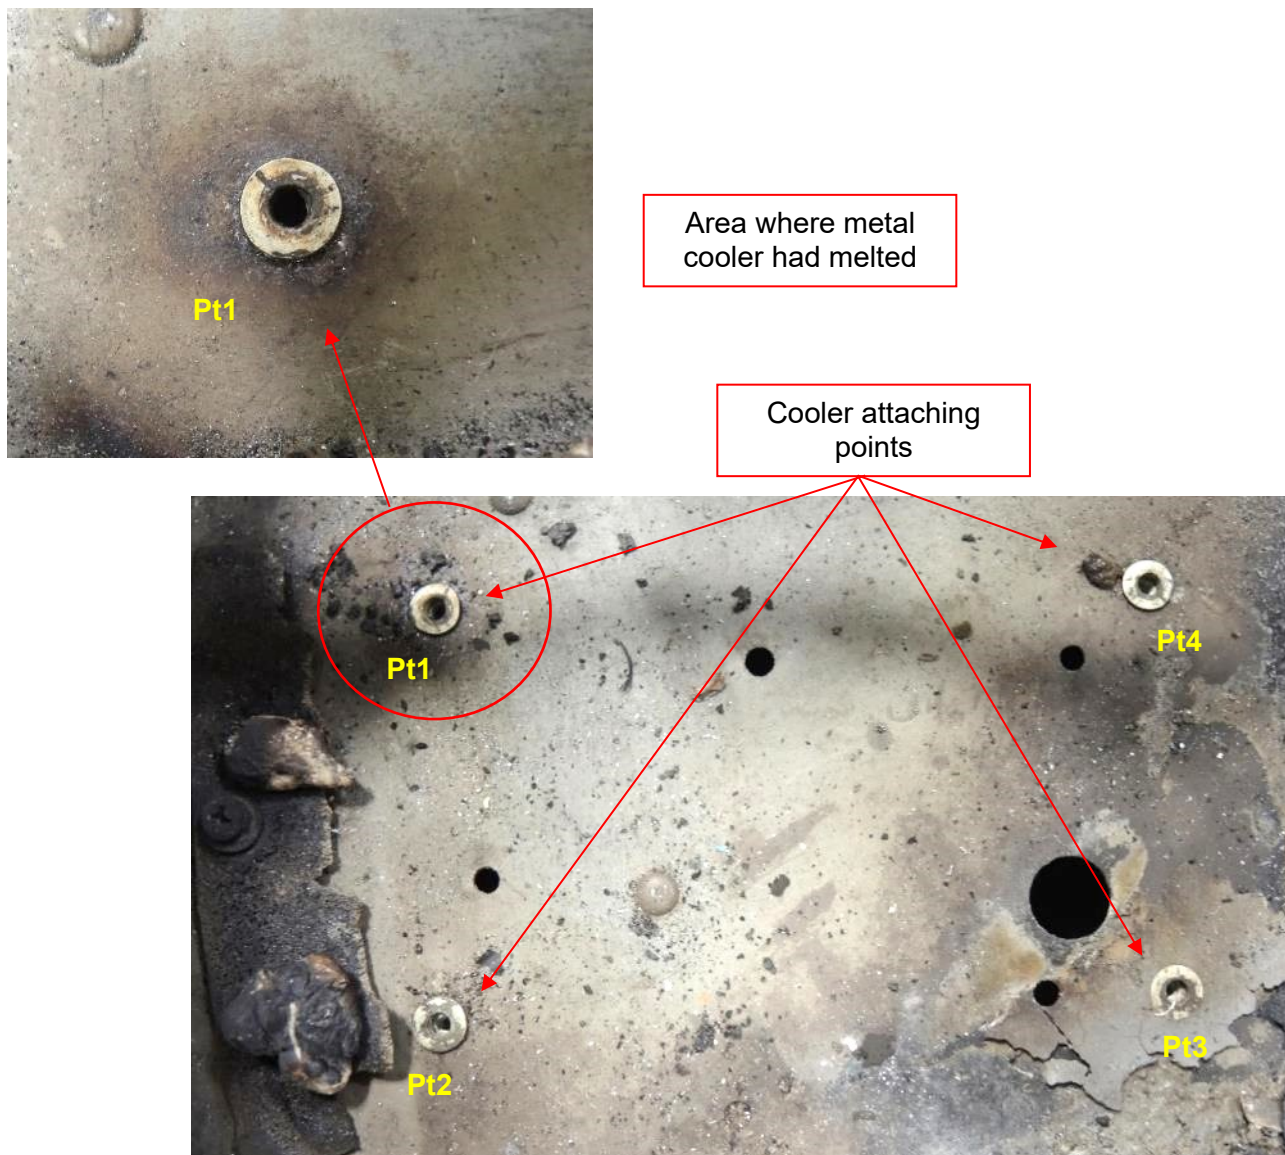
Figure 101: Aeroplane floor under diode device
Source: BEA

- The aluminium alloy plate making up the aeroplane floor was blackened around the attaching point of the melted part of the cooler (attaching point arbitrarily numbered Pt1) (**Figure 101**). The anchor nut holding the attaching screw also had a darkened appearance (**Figure 102**). This darkening was not observed around the three other attaching points (Pt2, Pt3 and Pt4).

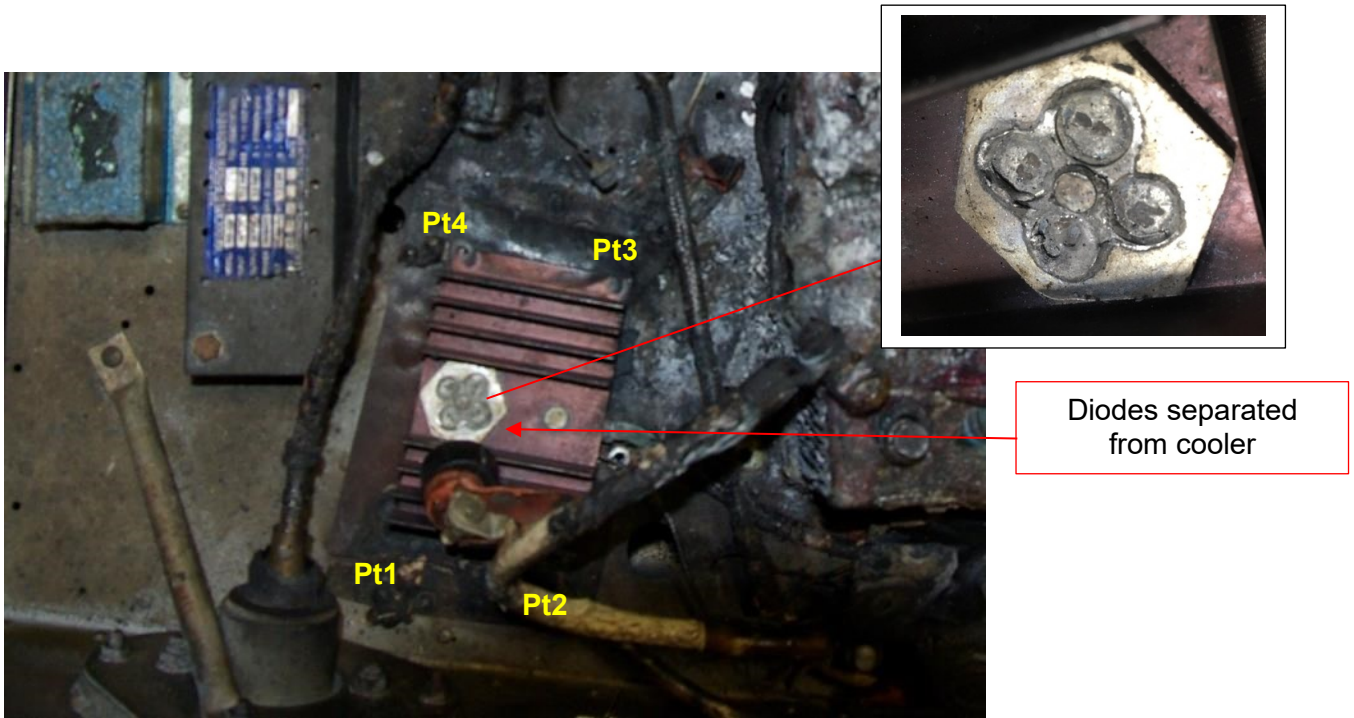
Figure 103: Diodes and its cooler
Source: BEA

- The diode assembly had separated from the metal cooler after the melting of the brazed areas (**Figure 103**);
- The conductor coming from the alternator was correctly connected to the diode device (**Figure 104** and **Figure 105**). However, the core of the conductor was oxidised and showed "swelling" level with the lug fixed to the metal cooler.

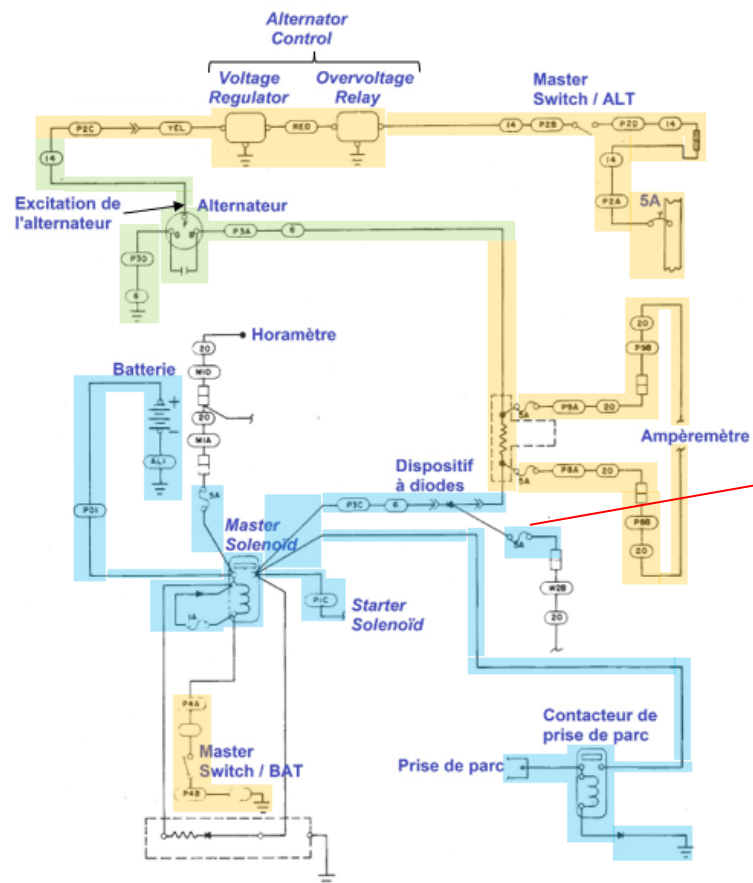
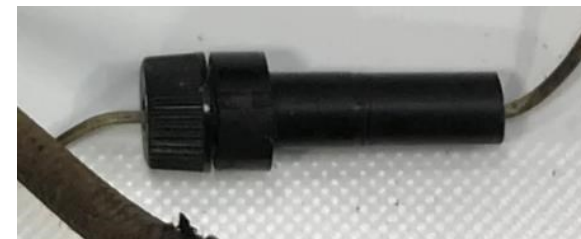
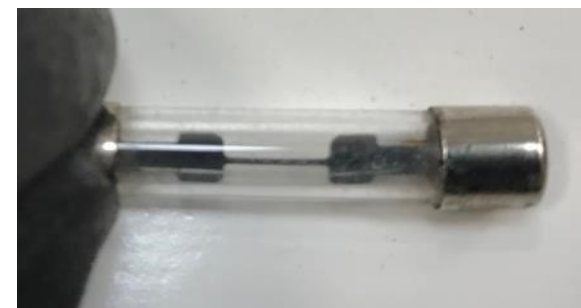
Figure 106: 5A fuse associated with diode device
Source: BEA

- The 5A fuse, connected to the diode device, was in position and whole (**Figure 106**). The associated fuse holder was intact and undamaged.

The fuse holder (item 4) (**Figure 134**) was whole, with the fuse in place and whole (**Figure 106**).

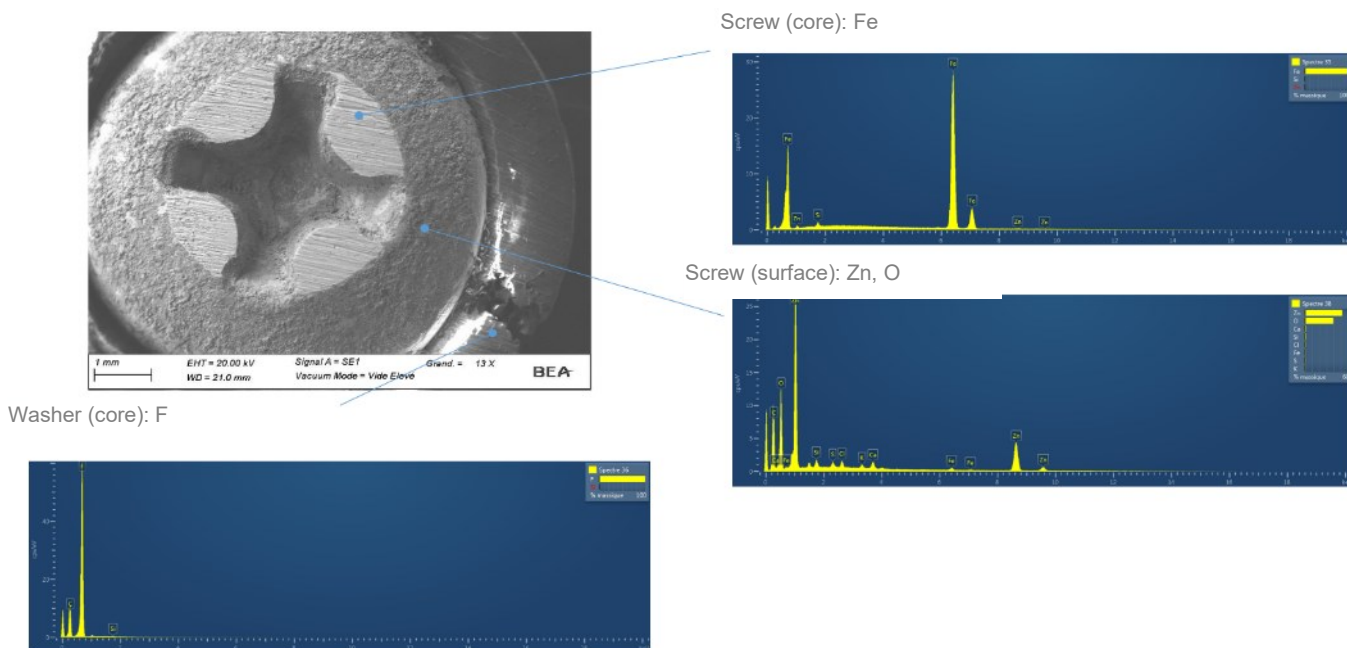
Figure 108: EDS analysis of materials making up screw and washer

The screw was found to be made of galvanised unalloyed steel (Fe in the core and Zn on the surface). The washer showed a fluorine (F) peak (**Figure 108**).

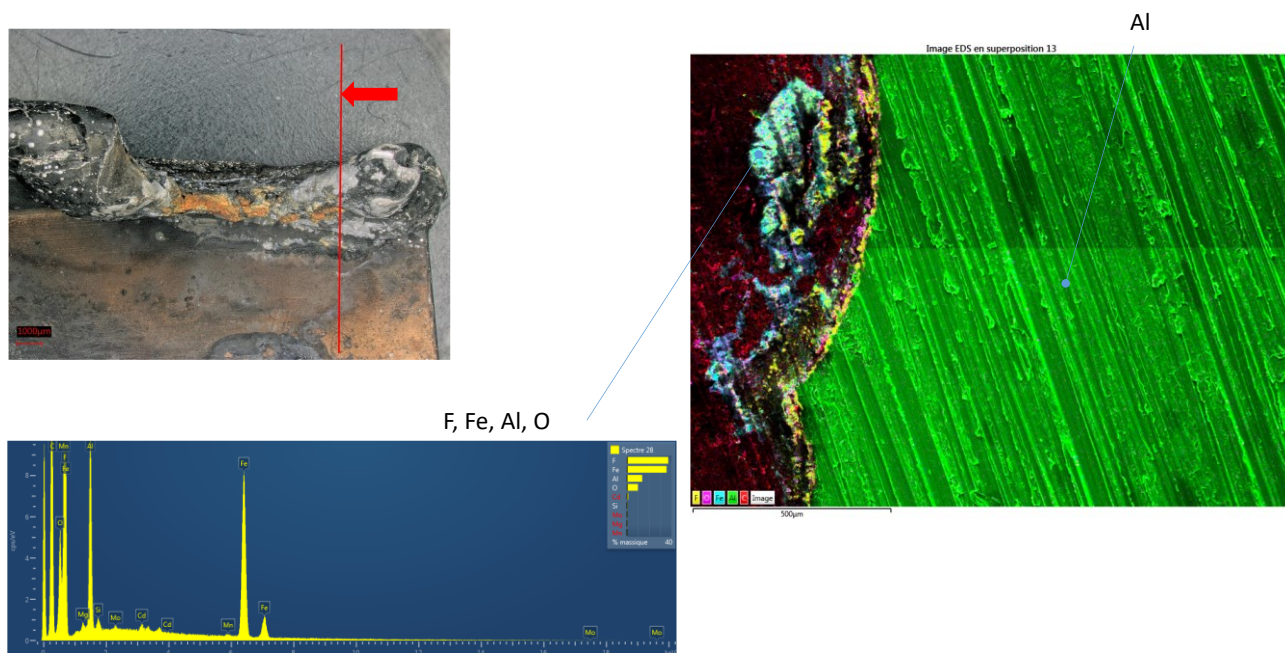
Figure 109: EDS analysis of section of melted area – presence of Fe and F on surface
Source: BEA

The EDS analysis of the successive sections found the presence of iron (Fe) and fluorine (F) in significant quantities in the melted area, as illustrated in **Figure 109**. The aluminium (Al) is the material making up the cooler.

The steel screw and washer composed of fluorine were therefore present when the overheating occurred, leading to them melting.

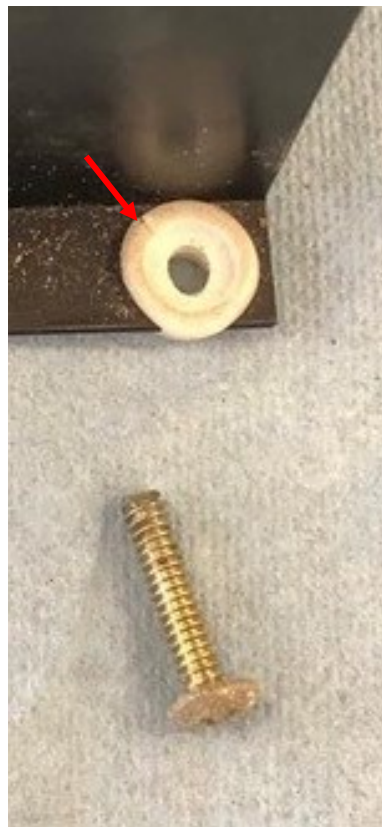
Figure 112: Cracked upper flange of insulating washer
Source: maintenance workshop for HB-PPB

The diode device of this aeroplane was removed and the insulating washers examined. The upper flange of two of the four washers was cracked (**Figure 111** and **Figure 112**).

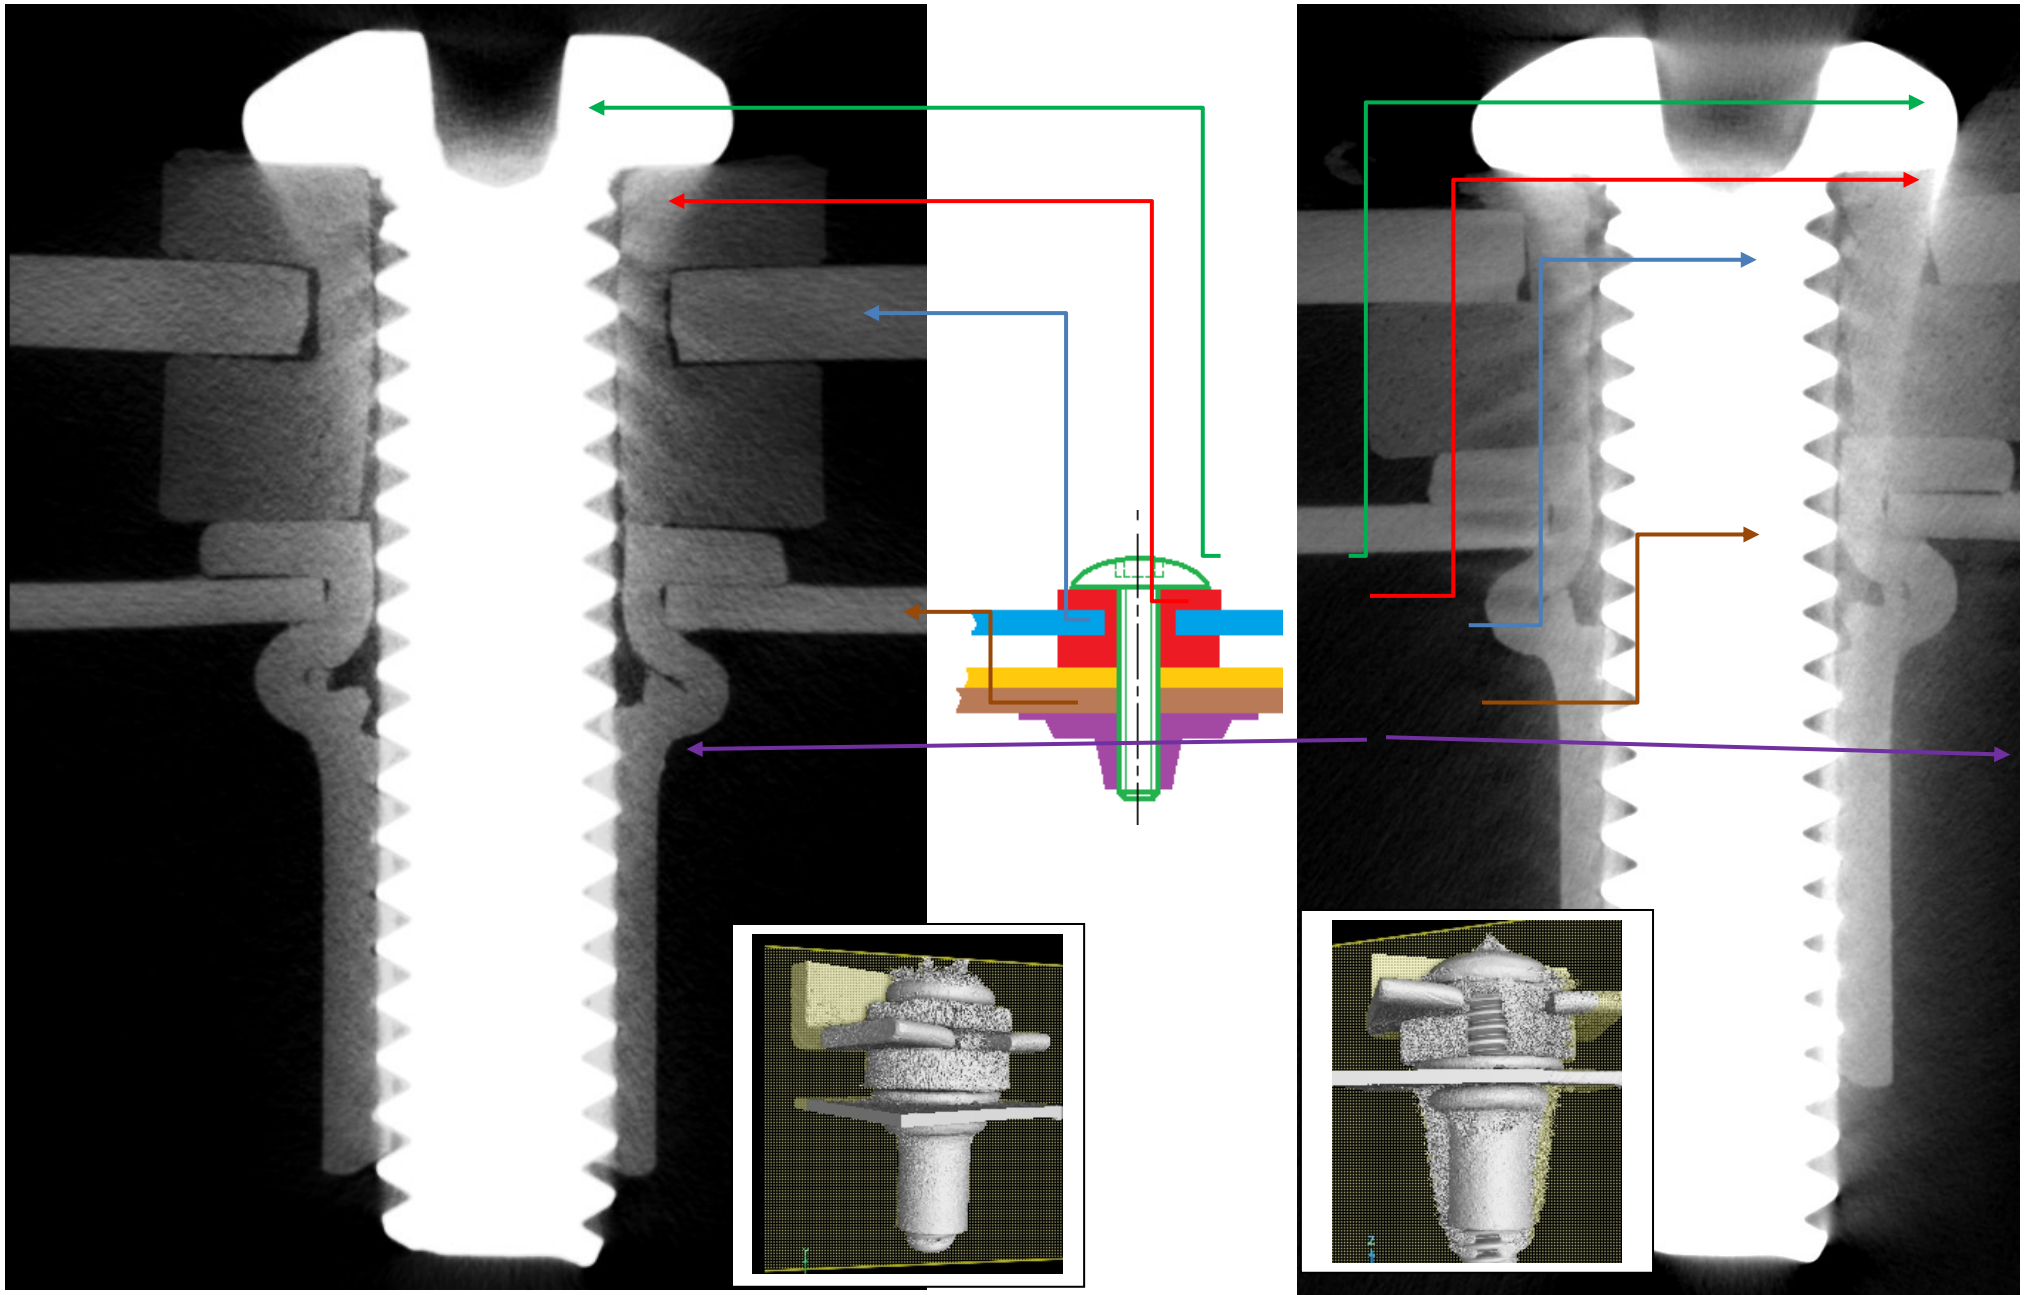
Figure 114: Nominal assembly
Source: BEA

The two figures below show a tomographic view of an assembly that can be considered “nominal” (only the phenolic shield is not in place) (**Figure 114**) and an assembly with a damaged insulating washer (**Figure 115**).

With the “nominal” assembly (**Figure 114**), it can be seen that the metal cooler is correctly insulated from the attaching screw.

In the other assembly (**Figure 115**), it can be seen that the insulating thickness between the screw head and the metal cooler is clearly reduced, but there is no mechanical contact between the two metal parts.

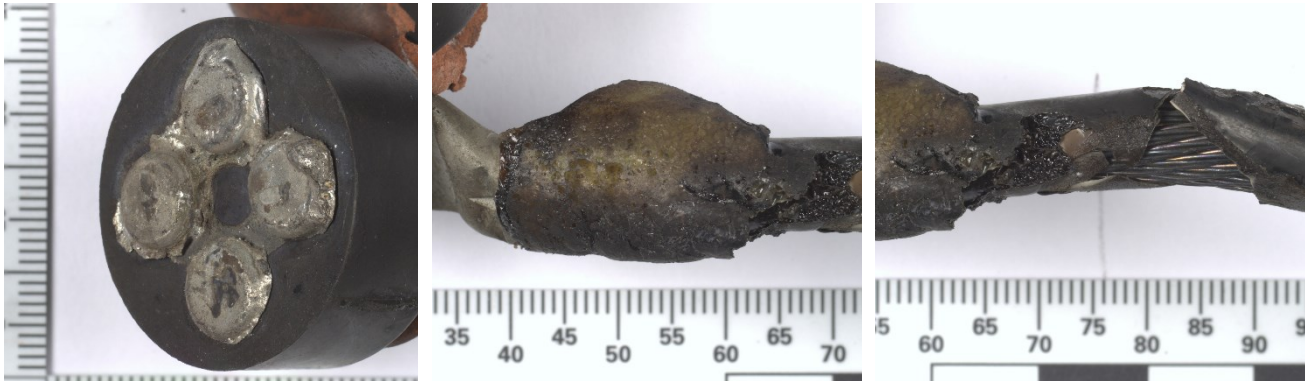
Figure 116: diode and its conductor
Source: BEA

The conductor leading to the master solenoid had signs of overheating, in particular at the insulation (**Figure 116**).

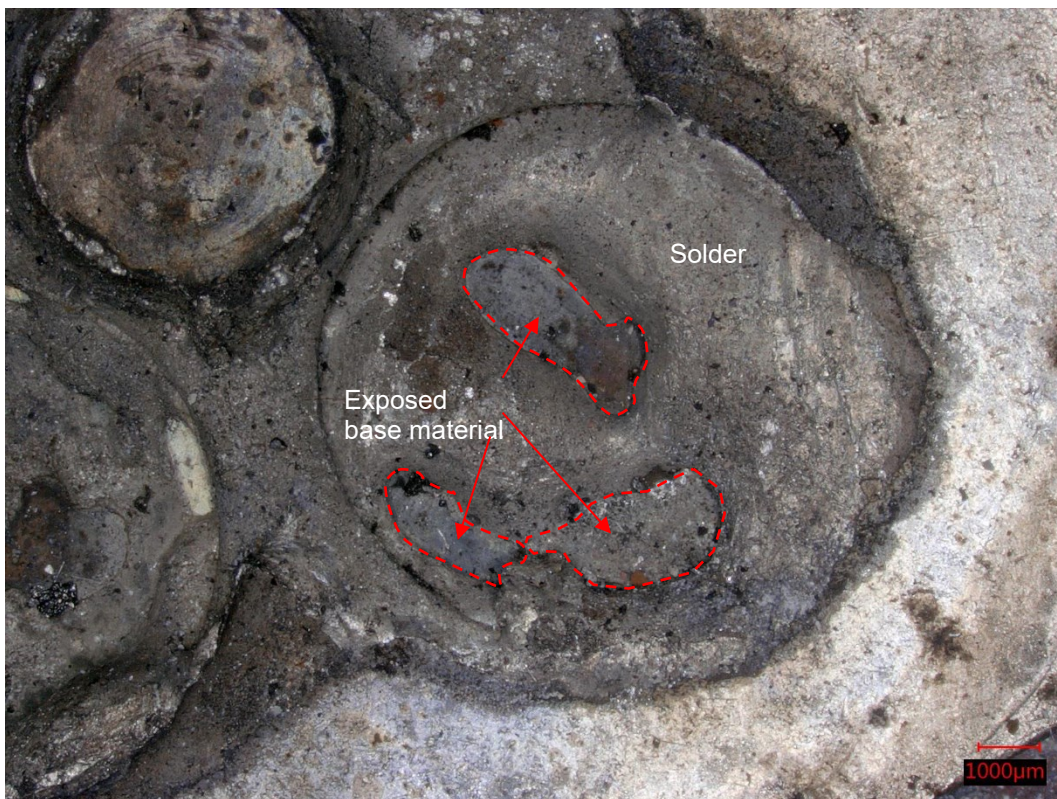
Figure 117: high-magnification photo of diode solder
Presence of areas without solder
Source: BEA

A high-magnification visual examination of the separation area was carried out in the BEA laboratory. The surfaces normally in contact had areas where the solder was absent. These areas showed exposed base material. The separation of the diode was very probably the result of a rise in temperature of the solder leading to the separation of the two soldered surfaces and locally exposing the base material.

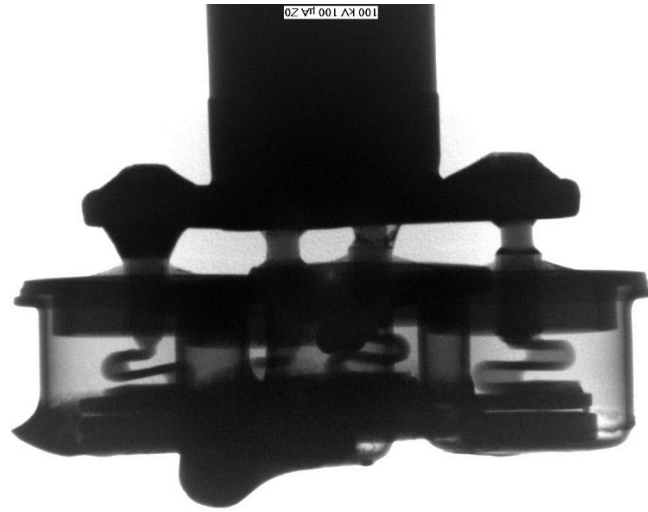
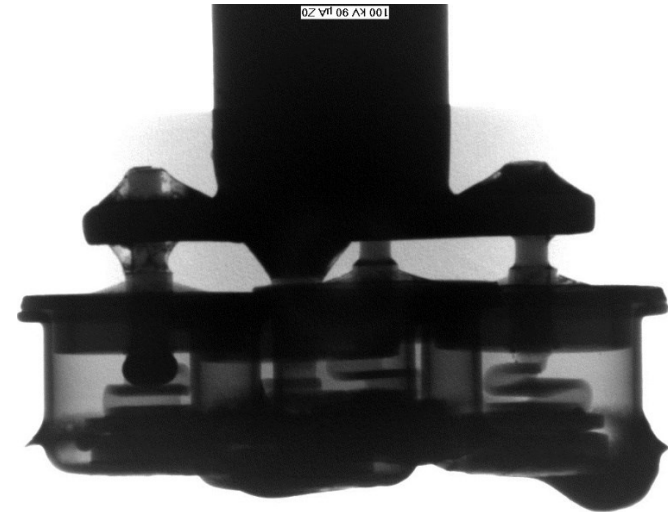
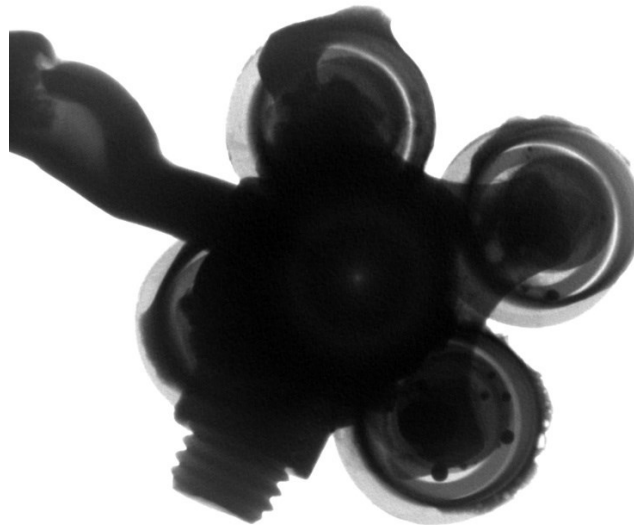
Figure 118: X-ray observations of diode device
Source: BEA

An X-ray examination was carried out (**Figure 118**). It showed:

- the presence of each cell;
- the visually undamaged content of each cell.

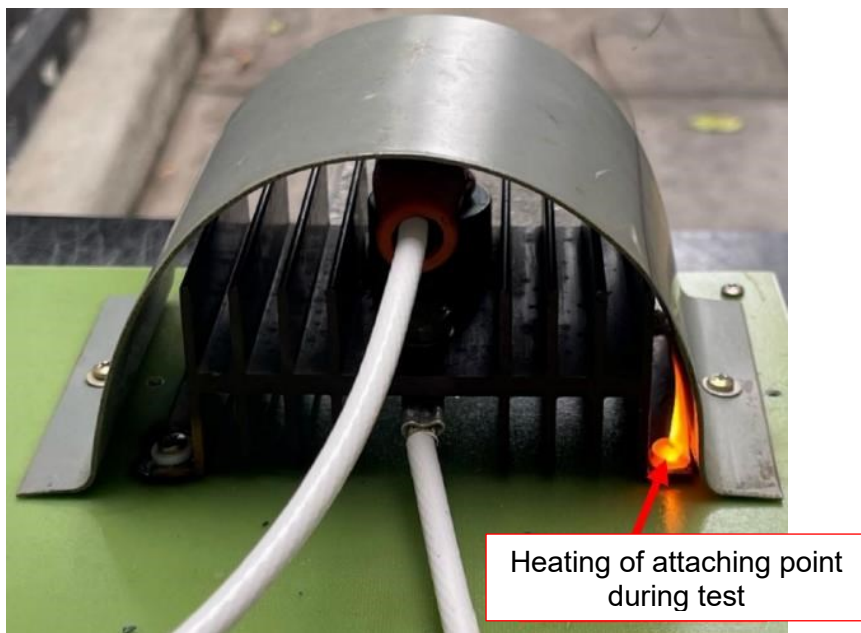
Figure 124: ABS cover in position with attaching point subject to intense heat
Source: Concorde Aircraft Batteries

This test consisted of reproducing test 3 with the ABS cover in position. The cover was positioned when the colour of the attaching point indicated intense heat (**Figure 124**).

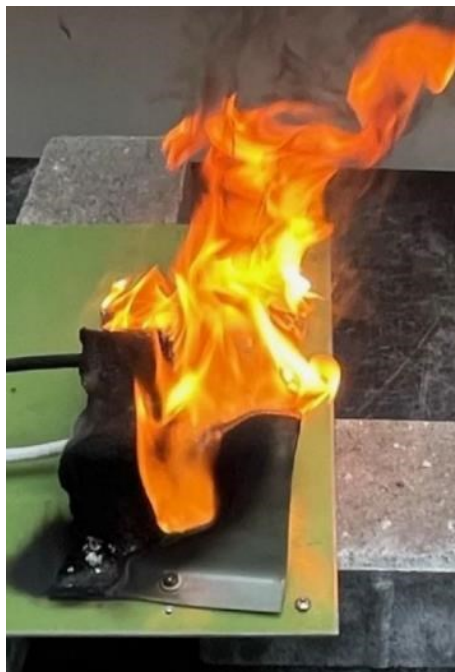
Figure 125: Burning ABS cover
Source: Concorde Aircraft Batteries

The ABS cover burst into flames around 20 s after it had been put in position. The cover was destroyed after 13 min (**Figure 125** and **Figure 126**).

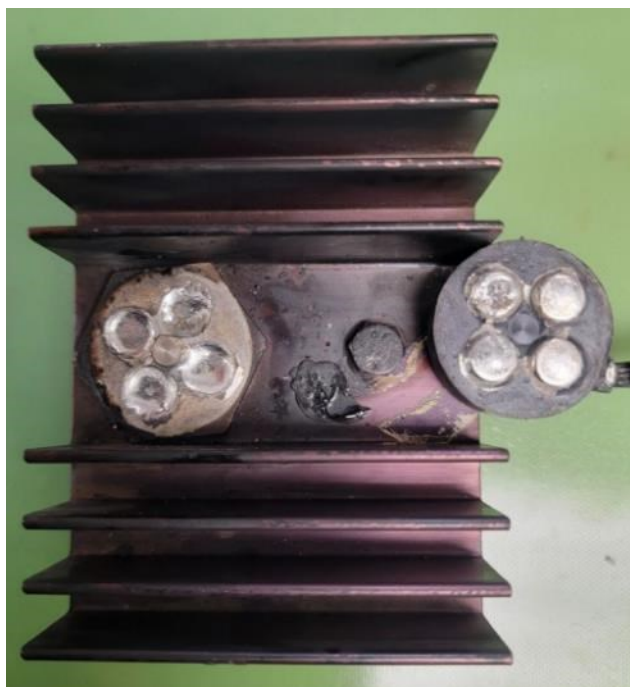
Figure 127: Separation of diode bridge from metal cooler
Source: Concorde Aircraft Batteries

The diode device separated from the metal cooler after around 8 min of exposure to the flame (**Figure 127**). This separation was identical to that observed on HB-PNP.

After this separation, the diodes were in a short-circuit as was the case for the diodes of HB-PNP.

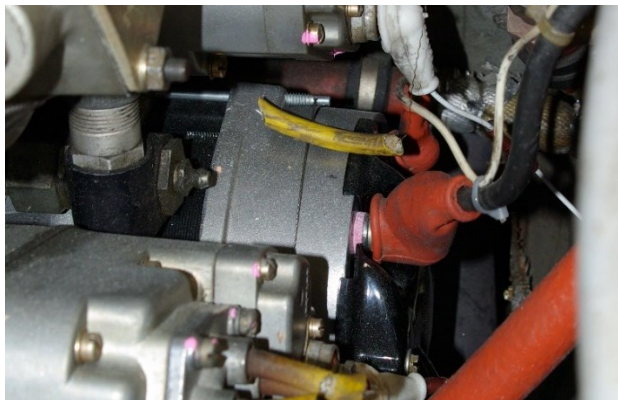
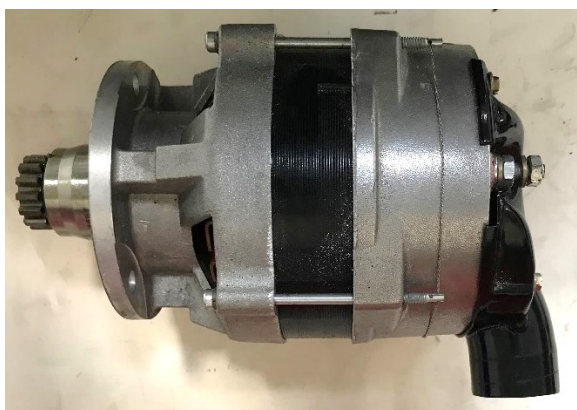
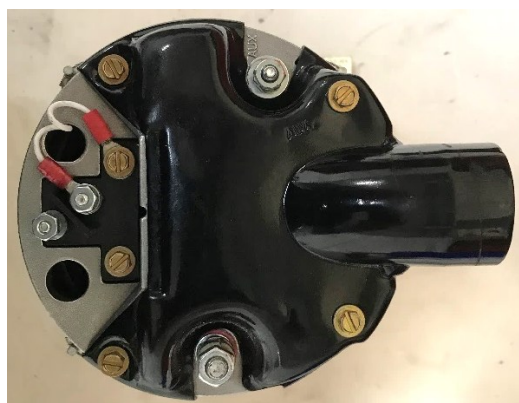
Figure 128: Alternator
Source: BEA

The components in the engine compartment (see **Figure 39**) were in position. The conductors were attached and undamaged (**Figure 128**).
