TECHNICAL REPORT

**Accident on 23 July 2020
at Bâle-Mulhouse airport (Haut-Rhin)
to the PIPER - PA-28RT-201T
registered HB-PNP**

Examination of wreckage

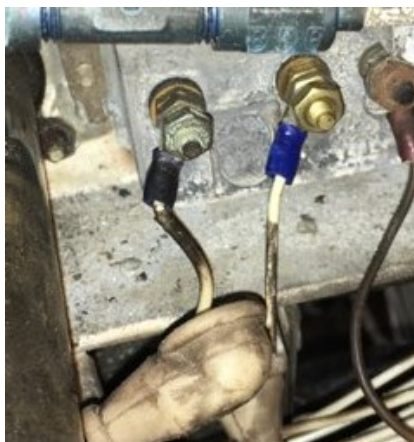
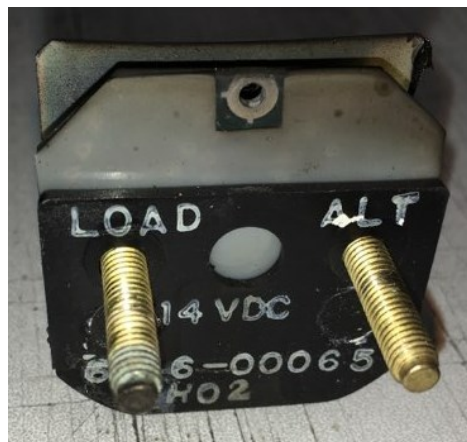
Figure 129: Ammeter
Source: BEA

The components on or behind the instrument panel (see **Figure 39**) were in position, some were covered with soot. The conductors were not damaged, only the outer surface of their insulation was sometimes blackened due to contact with the smoke (**Figure 129**, **Figure 130** and **Figure 131**).

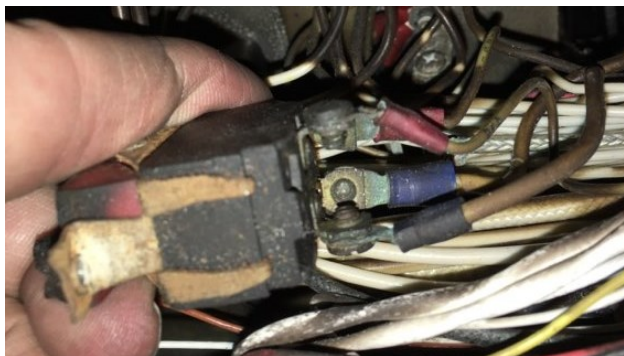
Figure 130: Master switch (BAT/ALT)

Conductors connected to master switch, located behind instrument panel

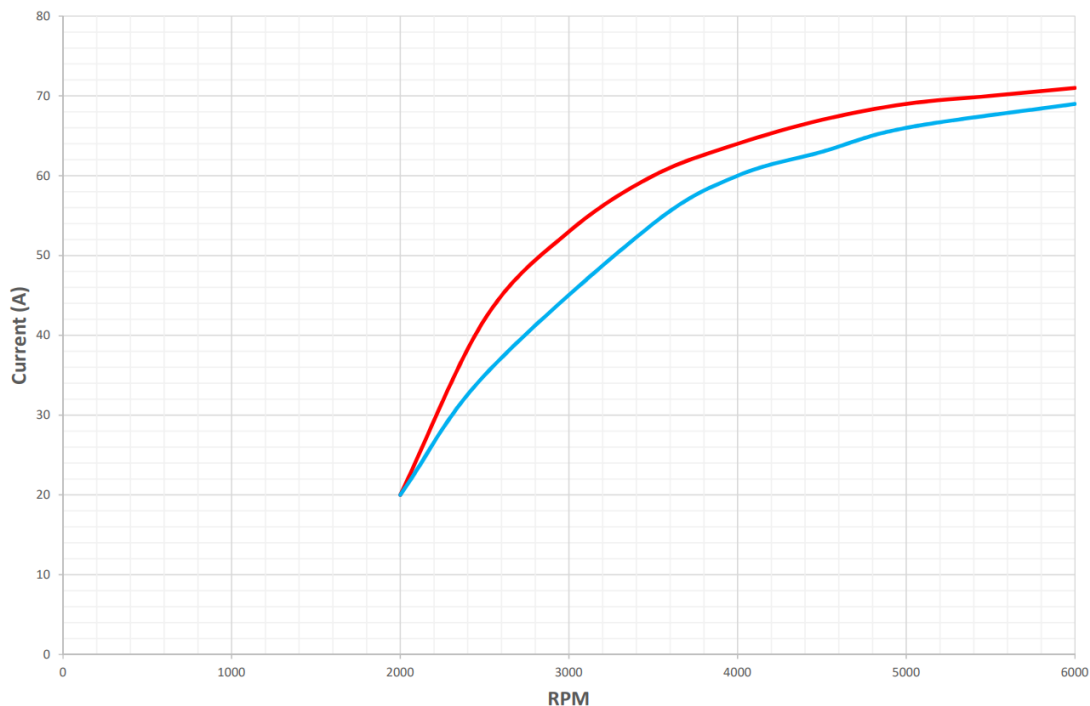
Figure 132: Measurements made during alternator test

The alternator was tested at the ENAC at Castelnaudary, in the presence of the BEA. This test consisted of applying a nominal voltage to the terminal of the inductor winding in order to produce the highest possible output current at a given speed. The test bench automatically varied the speed from a few hundred to a few thousand revolutions per minute. As the alternator output voltage attempted to rise, the test bench added more load (increased current draw) to maintain the target voltage setpoint, which in the case of a 12 V alternator is 14 V DC. The data was collected automatically during the test and was used to produce an output curve of current versus rotor speed.

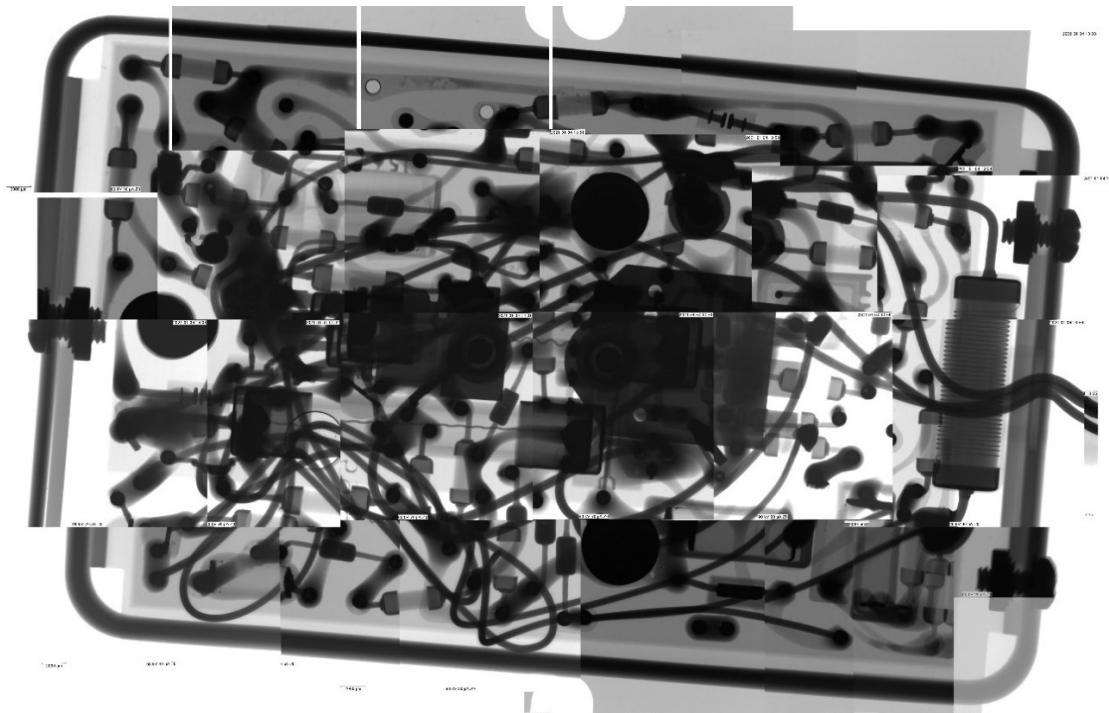
Figure 133: Reconstructed view of alternator control

Before being tested, an X-ray examination of the alternator control was carried out by making detailed observations of small area by small area. A reconstructed view of the equipment made up of the various detailed images is shown in **Figure 133**. This examination did not reveal any internal damage.

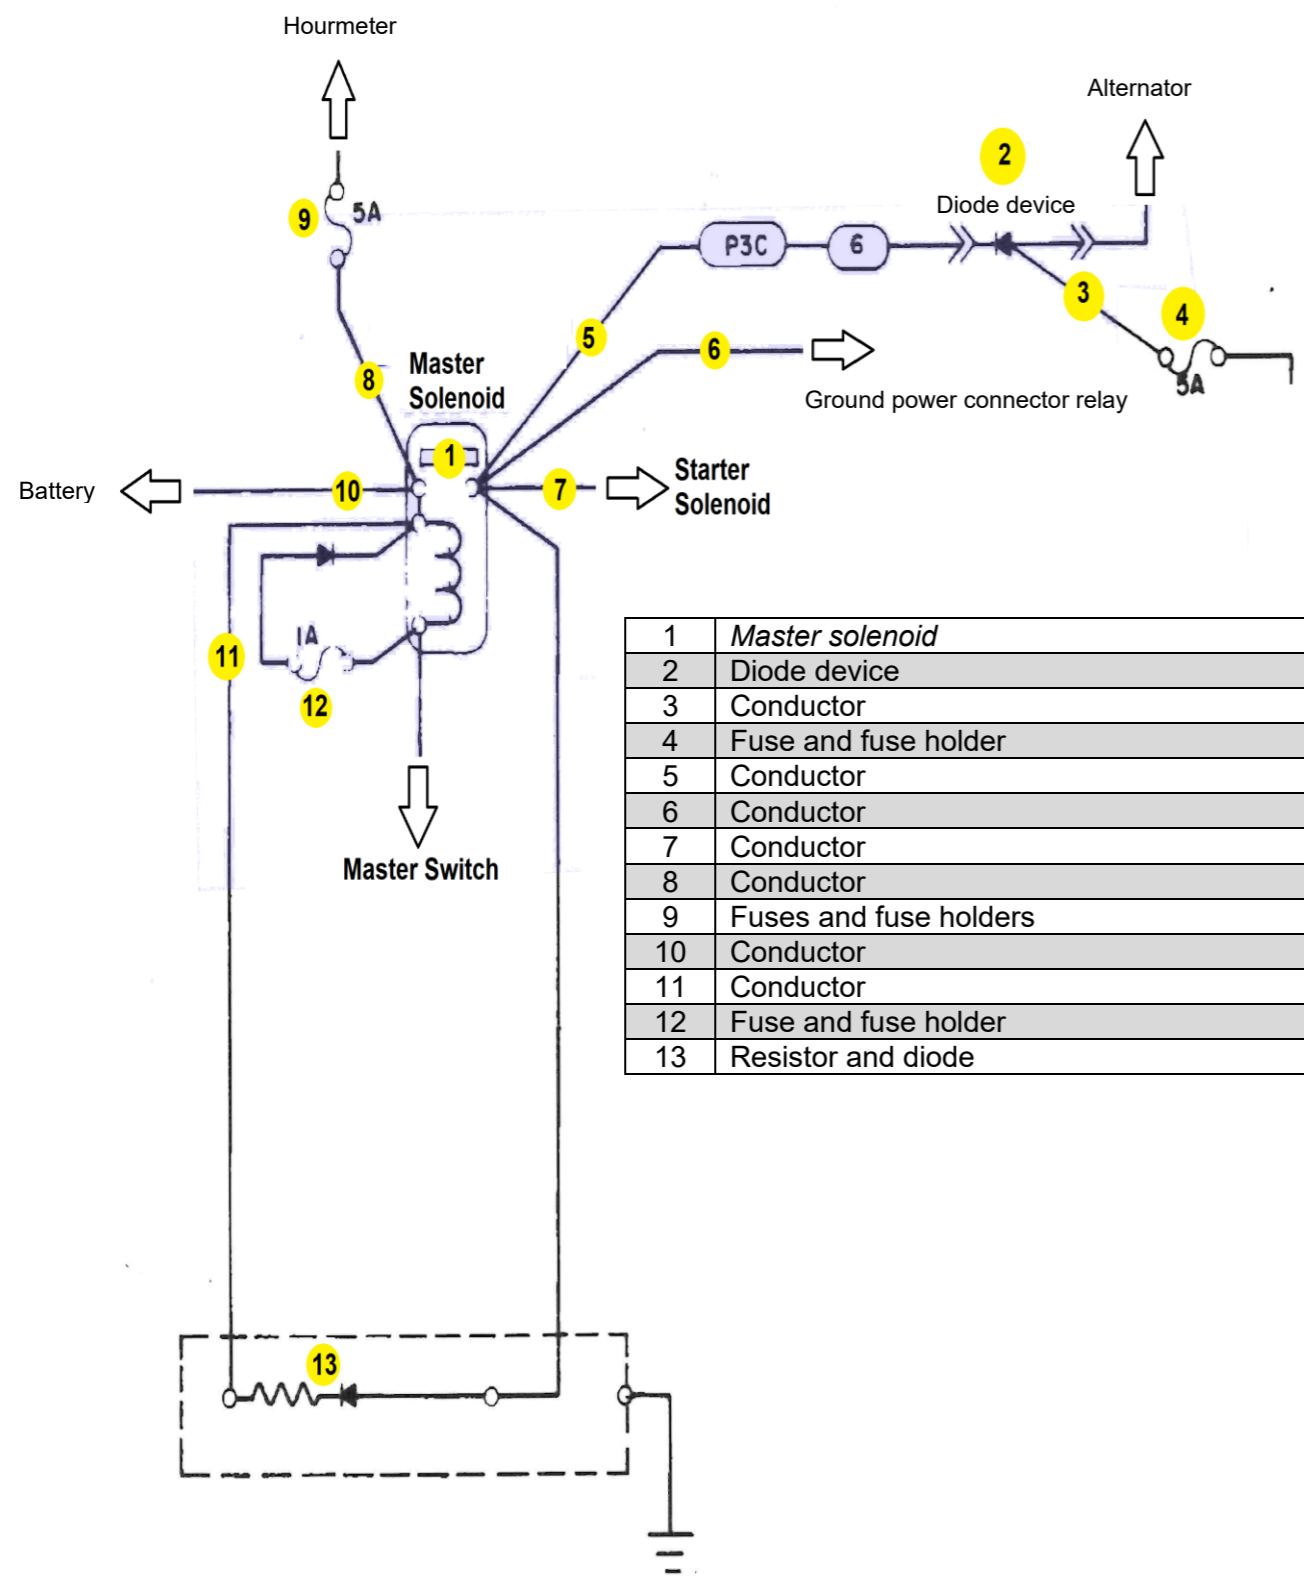
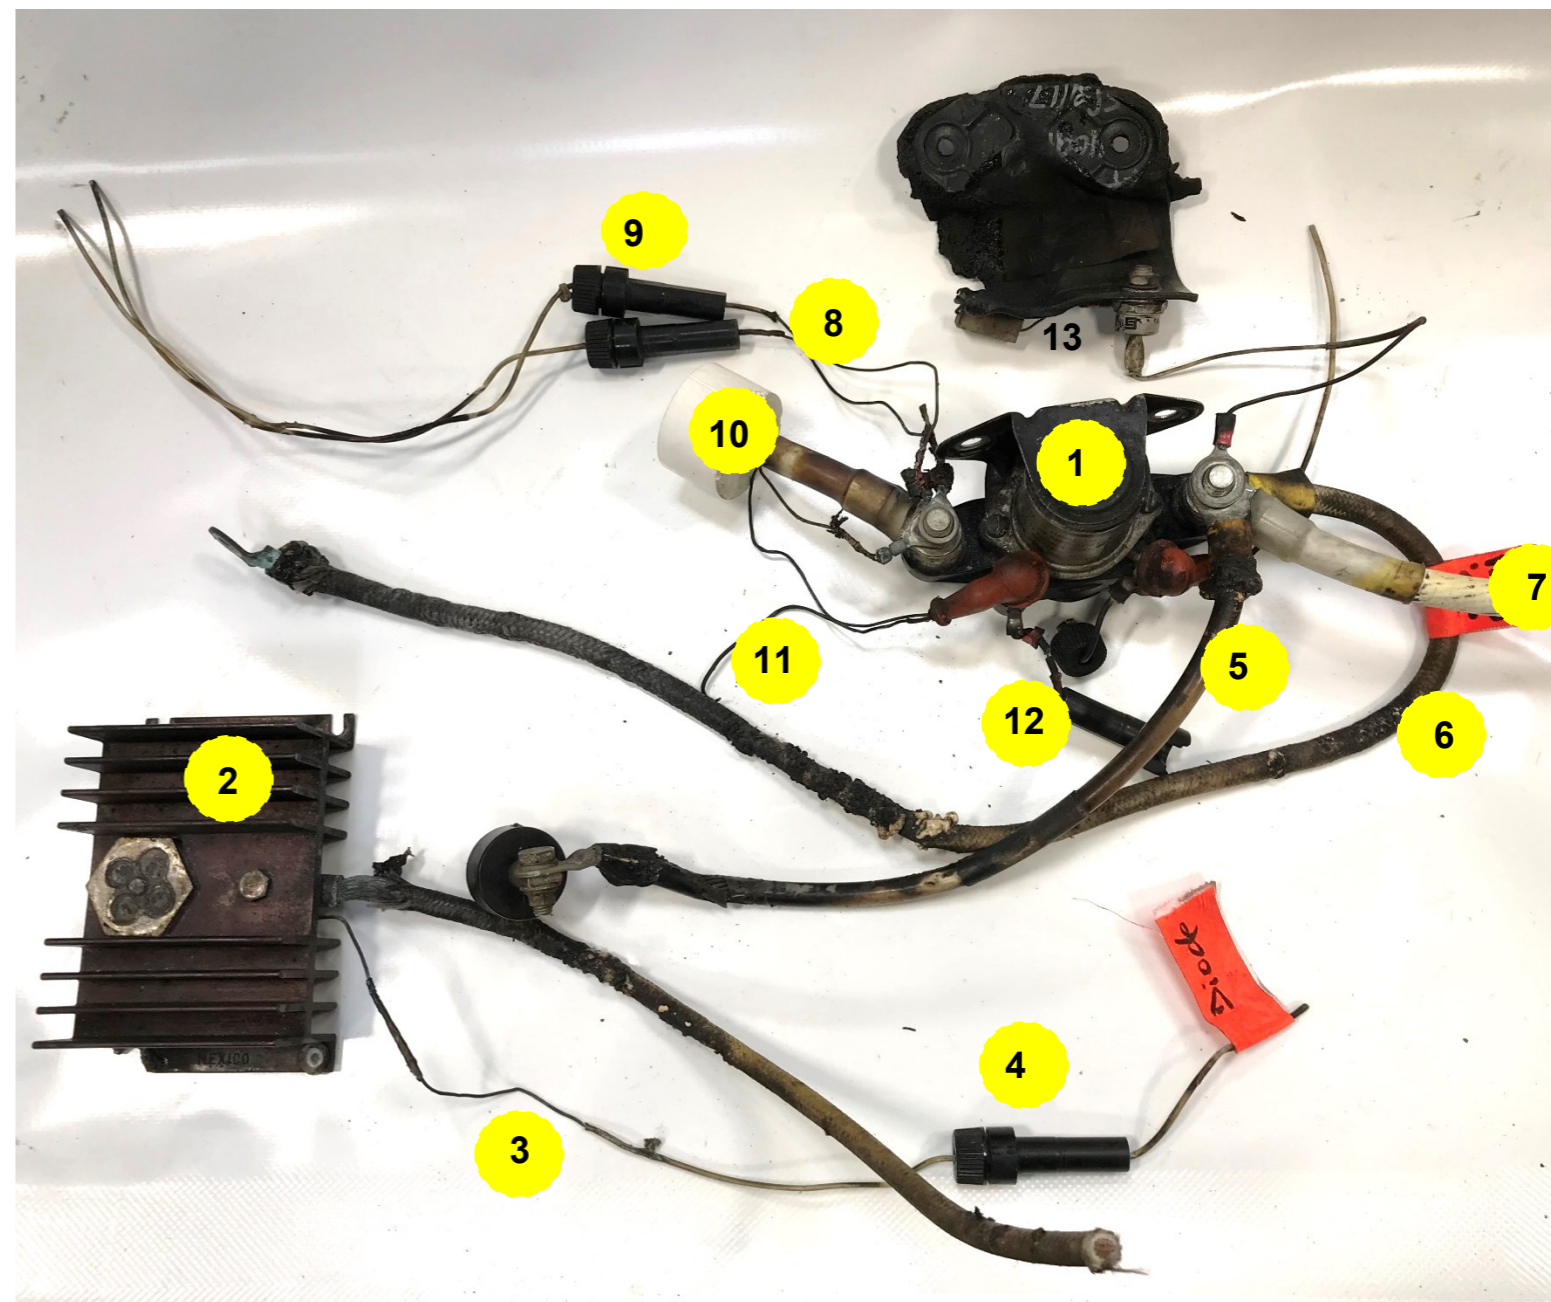
Figure 134: Reconstruction of electrical system associated with master solenoid
Source: BEA

Figure 134 shows the reconstruction of the electrical system associated with the master solenoid.

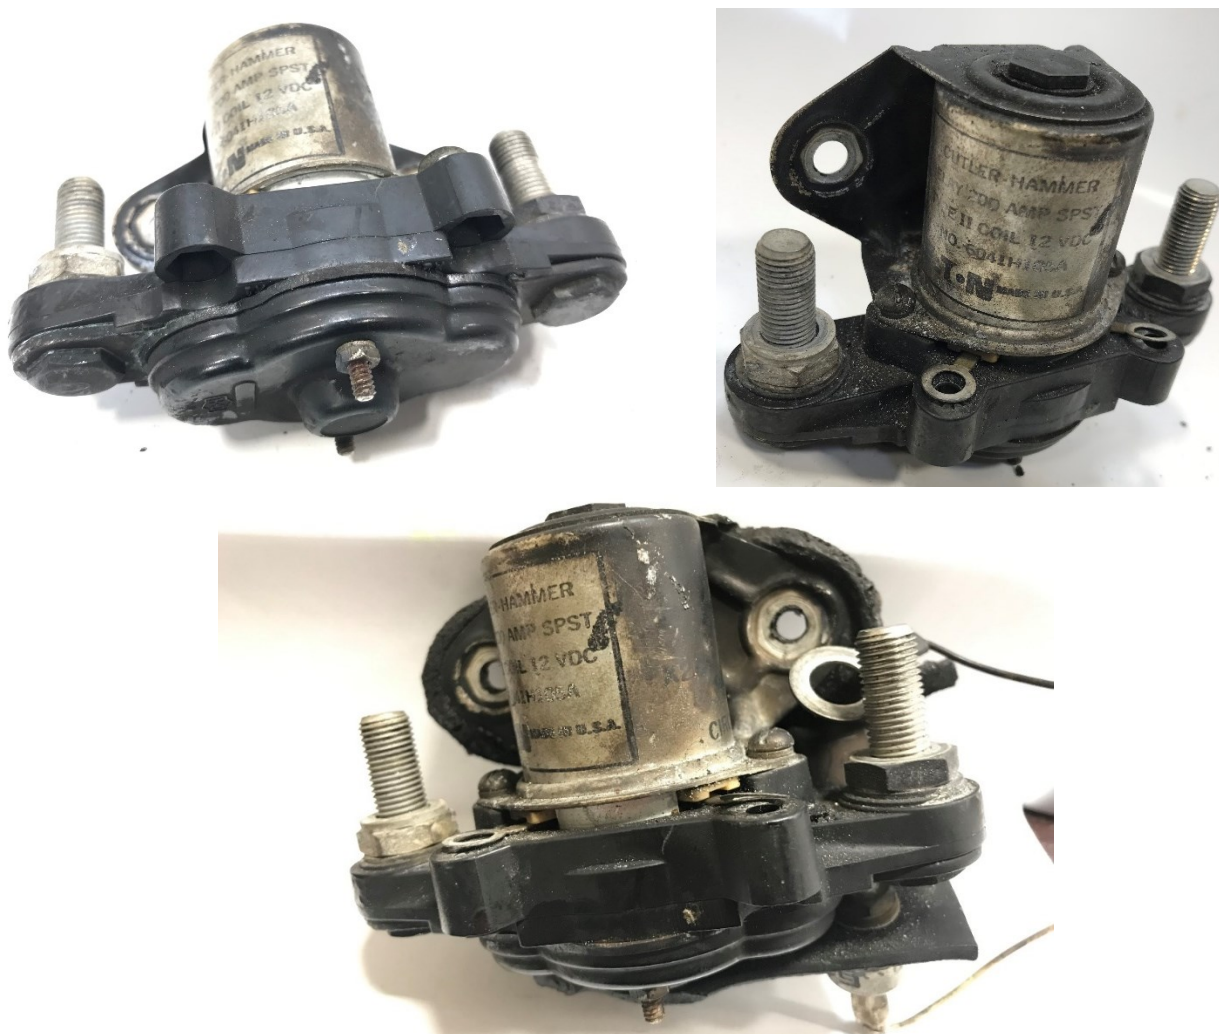
Figure 135: Master solenoid
Source: BEA

The outer surface of the master solenoid was black in colour due to exposure to high temperatures and smoke (**Figure 135**).

The master solenoid was tested at the BEA. The test consisted of repeatedly electrically controlling the master solenoid and systematically checking for its activation and deactivation. The test was carried out at room temperature. No malfunction was identified. This component was functional.

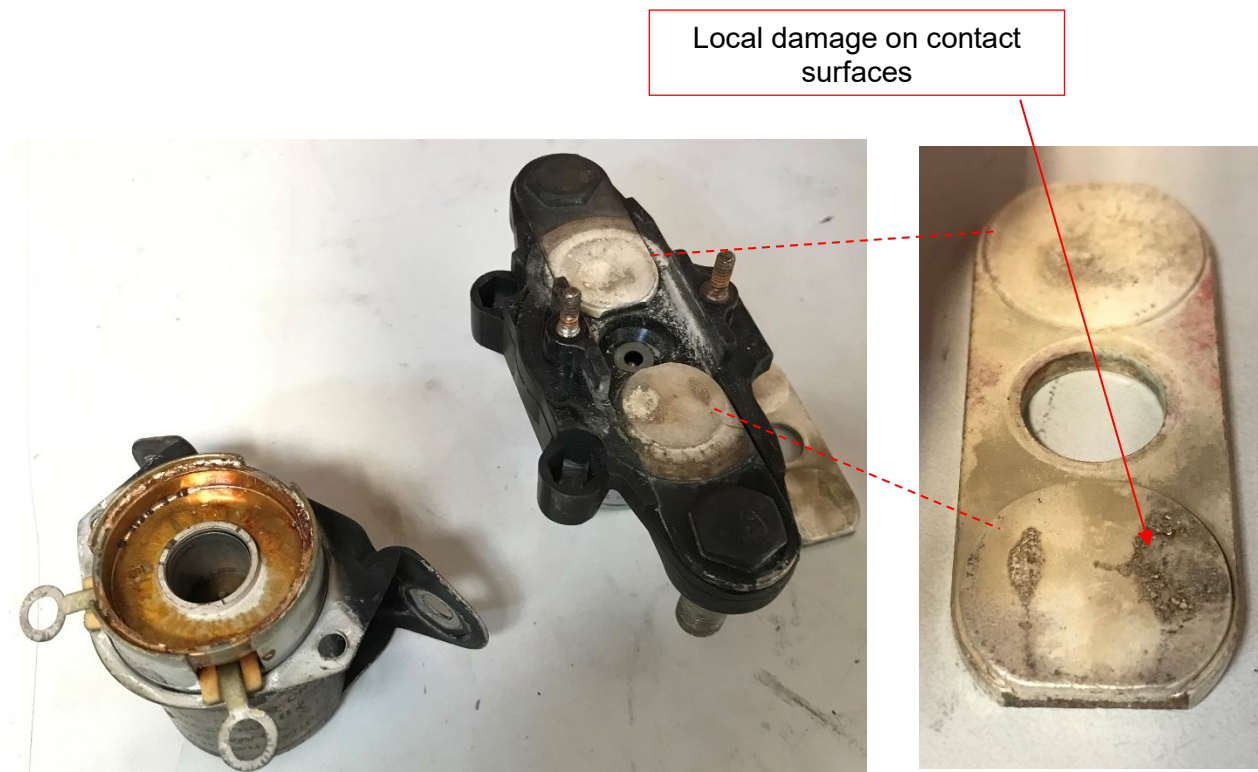
Figure 136: Master solenoid disassembled in the BEA laboratory

The master solenoid was then disassembled in the BEA laboratory²² (**Figure 136**). The internal components of the master solenoid were in position, without significant damage. Damage to the contacts through which the electrical connection is made was noted. This damage corresponded to local melting of the material, due to the occasional presence of electric arcs. This type of damage is common on this type of equipment. This damage did not affect the functionality of the equipment.

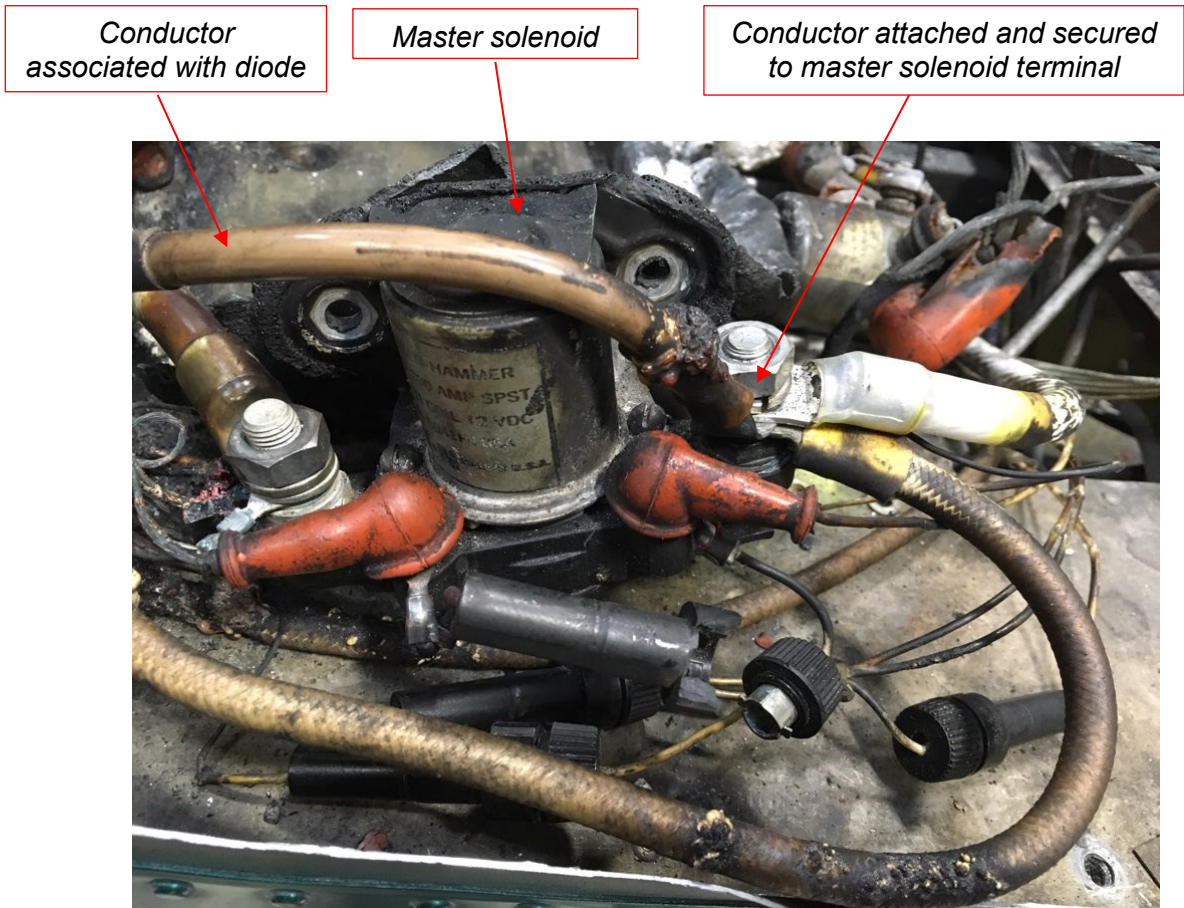
Figure 137: Assembly on aircraft
Source: BEA

The insulation of the conductor (item 3) (**Figure 134** and **Figure 137**) was destroyed over several centimetres level with the diode device.

The conductor (item 5) (**Figure 134**) between the diode device and the master solenoid, was in position, secured to the terminal of the latter (**Figure 137**). The external protection, located between the lug on the master solenoid and the conductor, had partially melted (**Figure 138**).

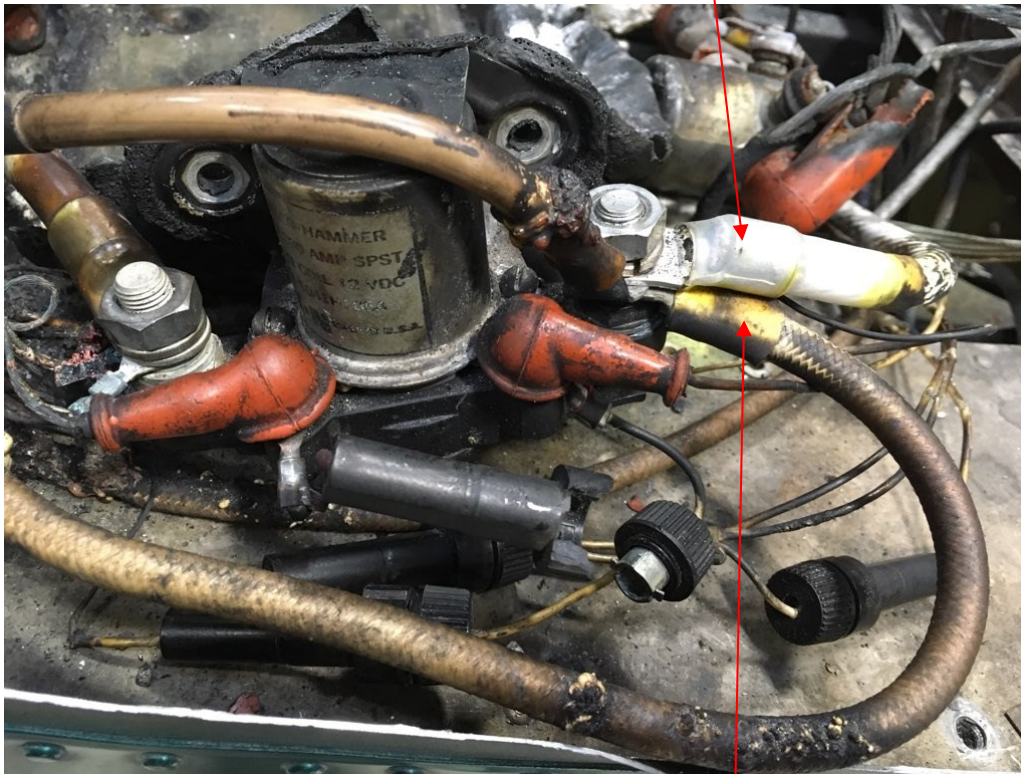
Figure 139: Assembly on aircraft
Source: BEA

The conductor (item 6) (**Figure 134**) between the ground power connector relay and the master solenoid was in position, secured to the latter (**Figure 139**). This conductor showed no substantial damage.

The conductor (item 7) (**Figure 134**) between the starter solenoid and the master solenoid was in position, secured to the terminal of the latter (**Figure 139**). This conductor showed no substantial damage.

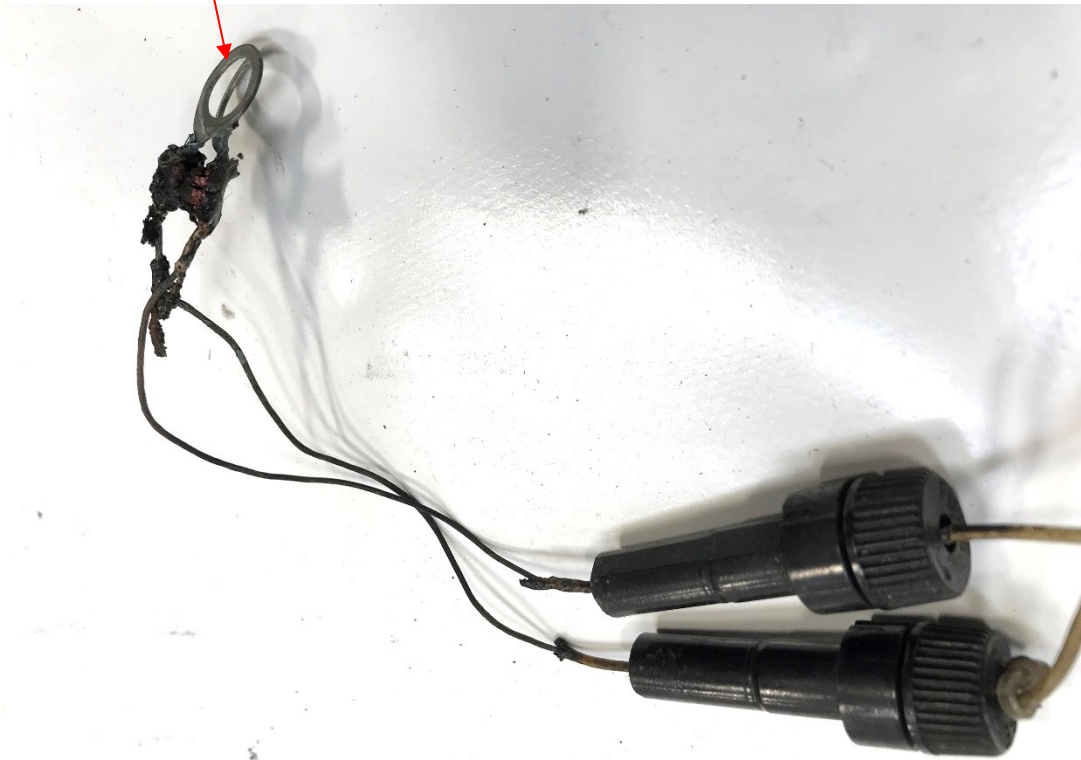
Figure 140: Conductor (item 8) and fuse holders (item 9)
Source: BEA

The conductors (item 8) (**Figure 134**) were attached and secured to the master solenoid terminal. The conductor insulation was destroyed between the master solenoid and the fuse holders (**Figure 140**).

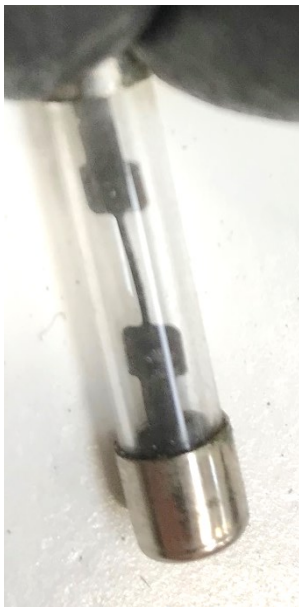
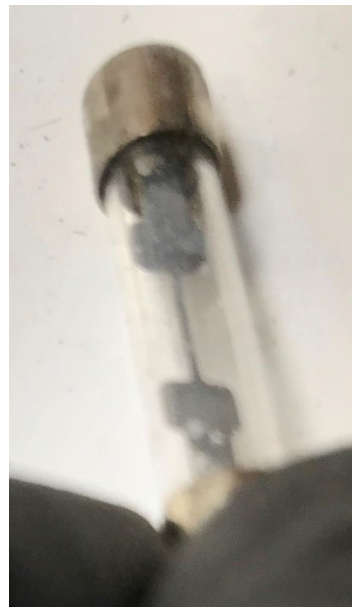
Figure 141: Fuses (item 9)
Source: BEA

The fuse holders (item 9) (**Figure 134**) were whole, with the fuses in place and whole (**Figure 141**).

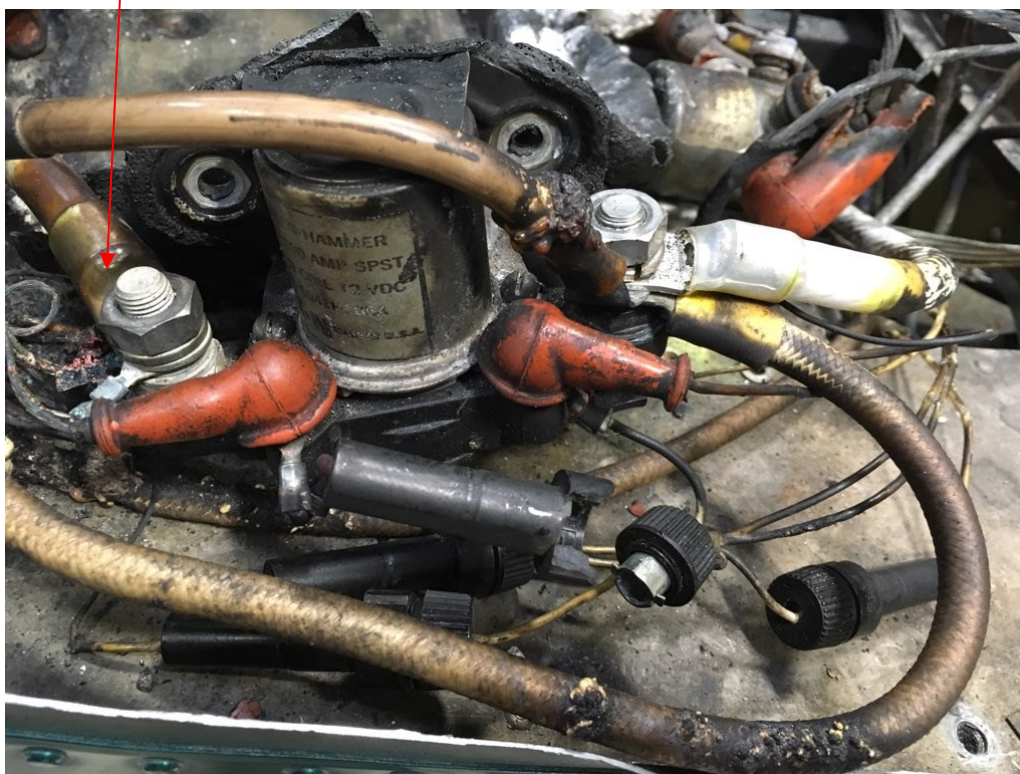
Figure 142: Assembly on aircraft
Source: BEA

The conductor (item 10) (**Figure 134**) between the positive terminal of the battery and the master solenoid was in position and secured to the terminal of the latter (**Figure 142**). Level with this attachment, the conductor was of a light brown colour but there was no sign of melting.

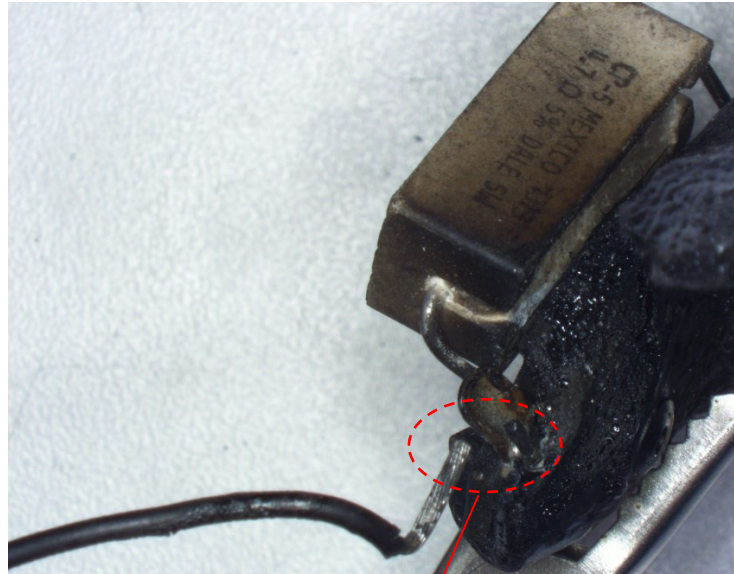
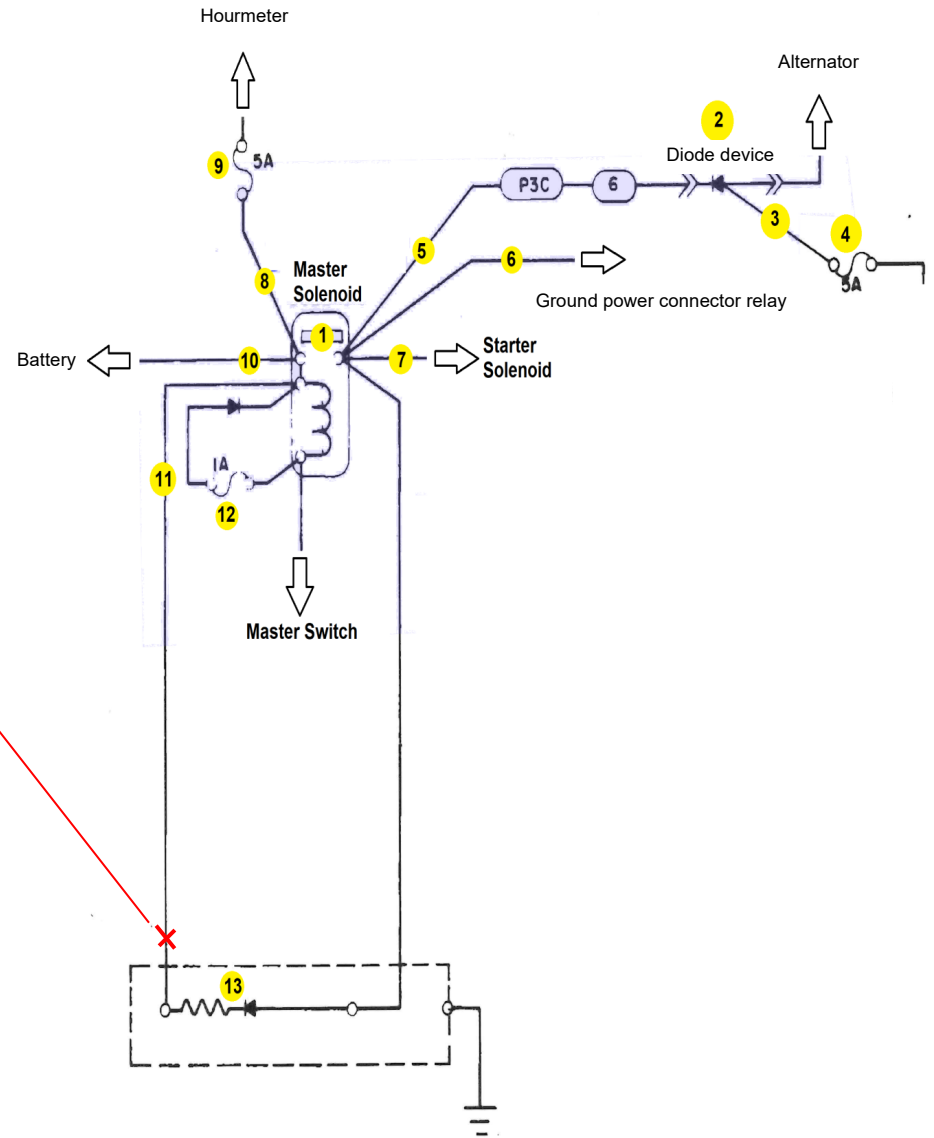
Figure 143: Conductor (item 11)
Source: BEA

The conductor (item 11) was in position and secured to the master solenoid terminal. However, this conductor was severed level with the resistor (item 13) (**Figure 143**). This break was situated level with the area where it was observed that the battery box had melted. The break of the conductor was most likely a consequence of the accident²³, melting of the conductor or rupture after embrittlement due to its exposure to an abnormally high temperature.

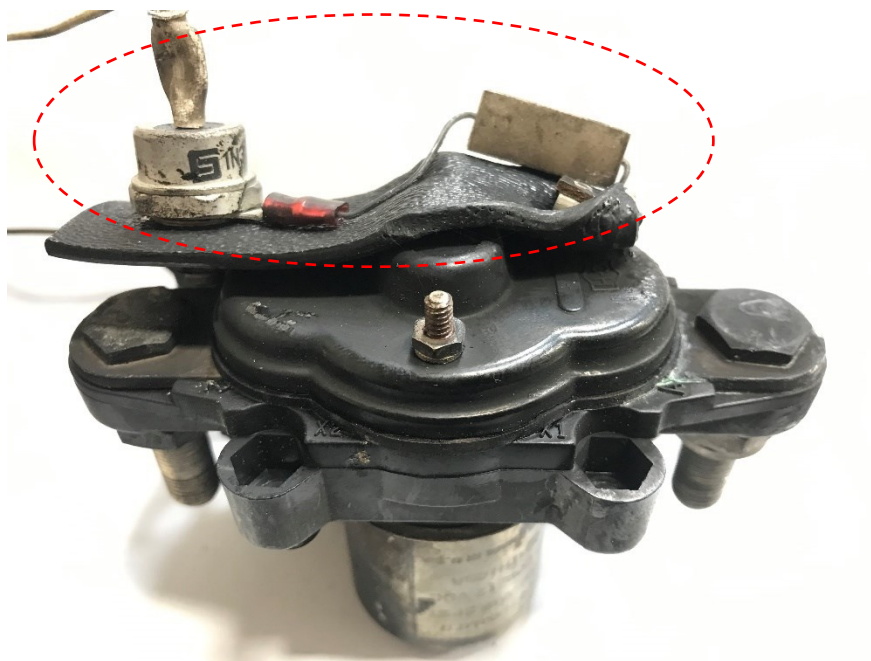
Figure 144: Device (item 13)
Source: BEA

The device (item 13) (resistor and diode) was whole without external damage (**Figure 144**).

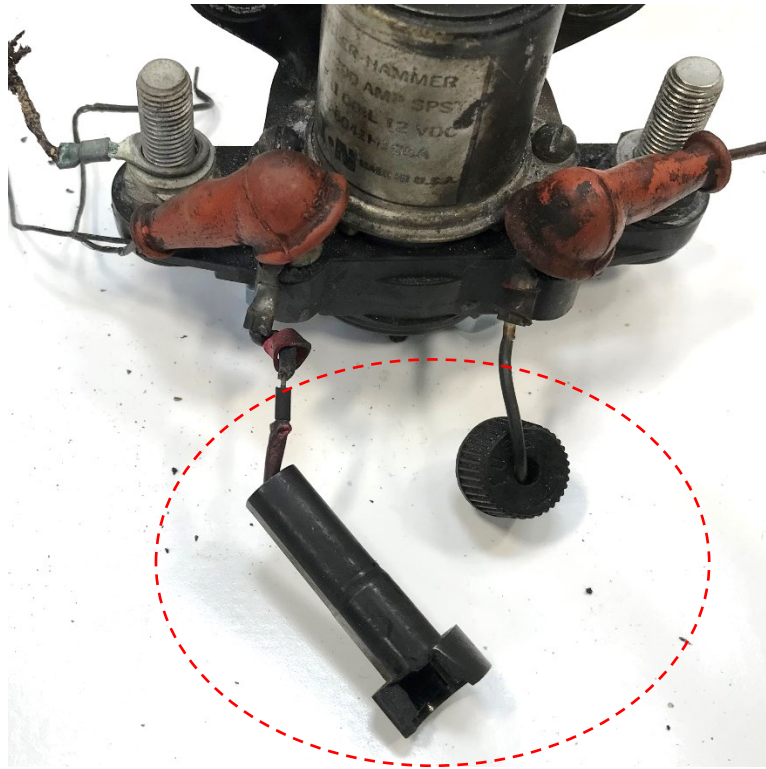
Figure 145: Fuse holder (item 12)
Source: BEA

The fuse holder (item 12) was found open, an area of the fuse holder had ruptured (**Figure 145** and **Figure 146**). The 1A fuse was found whole in the aircraft, nearby (**Figure 147**). What caused the fuse holder to rupture remains unknown. The detailed examination of the break did not provide more information because of the nature of the fuse holder material.

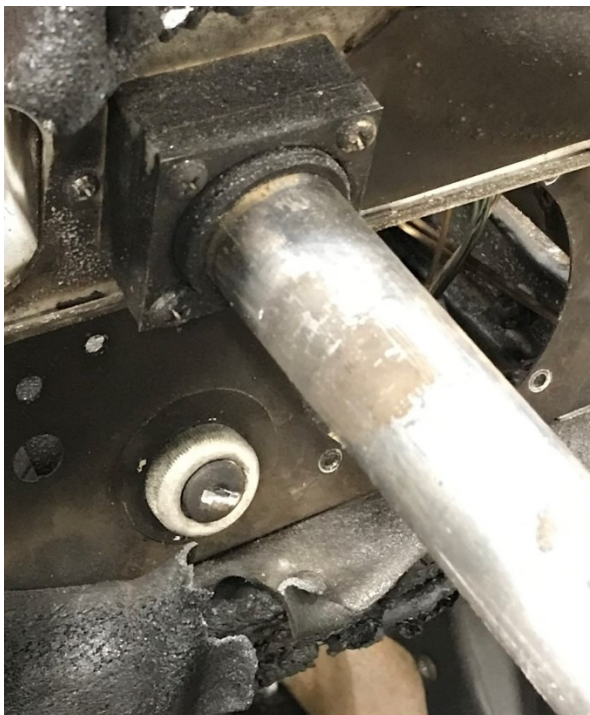
Figure 150: Start-up switch in position on instrument panel

The start-up switch was in position on the instrument panel. The ignition key was not present. The start-up switch was in the OFF position (**Figure 150**).

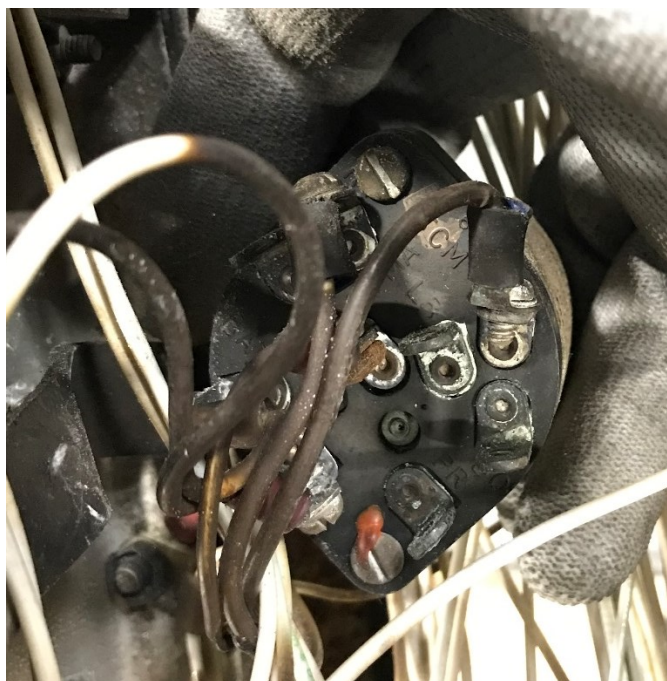
Figure 151: Rear face of start-up switch

Behind the switch, the conductors were in position and no damage was observed (**Figure 151**). The insulation of these conductors was of a brown colour due to the smoke and heat reached during the accident.

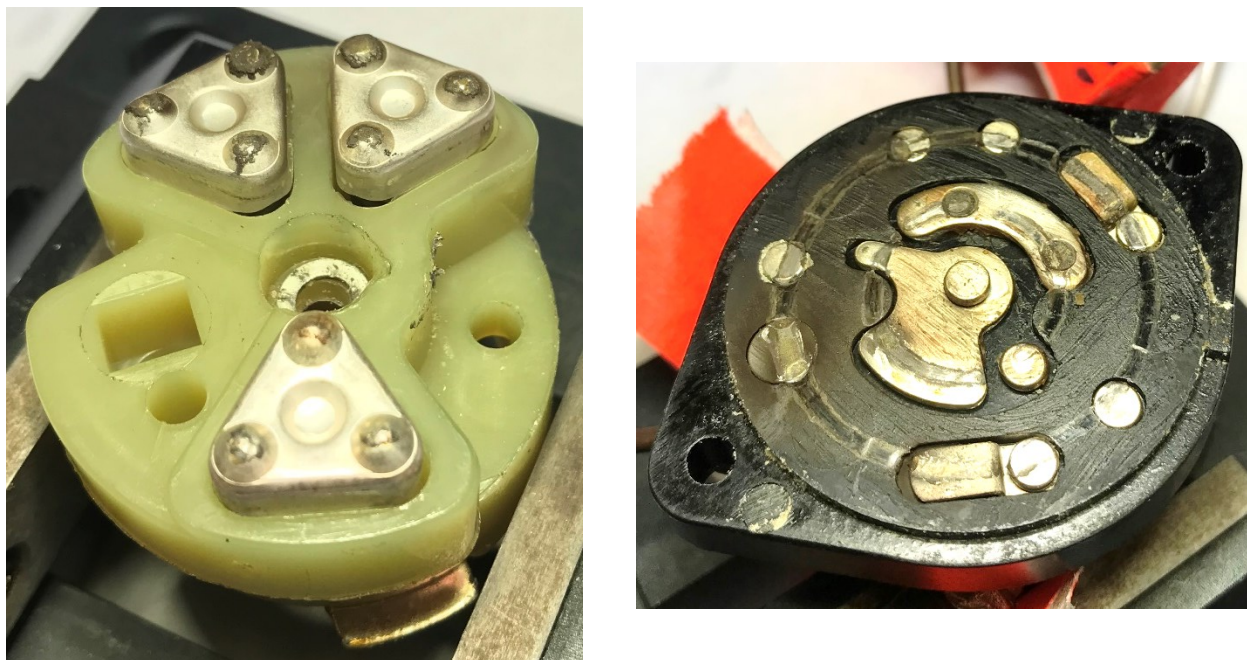
Figure 152: Electrical contact zones in start-up switch
Source: BEA

Black colouring and incipient damage to various electrical contact zones could be observed (**Figure 152**).

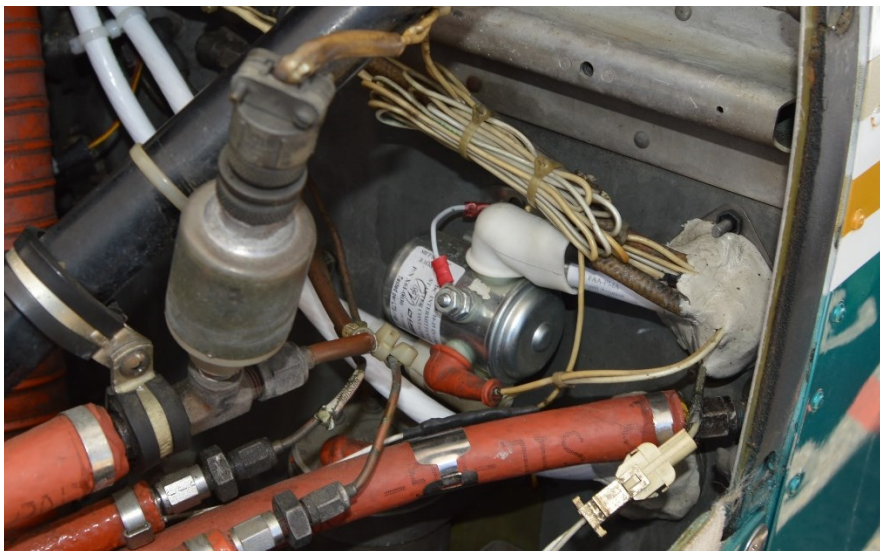
Figure 153: Starter solenoid in position in the engine compartment on the firewall
Source: BEA

The starter solenoid was in position in the aeroplane with the various associated conductors in position and secured (**Figure 153**). On the wreckage, it was observed that the starter solenoid was electrically open as would be expected, the start-up switch being in the OFF position.

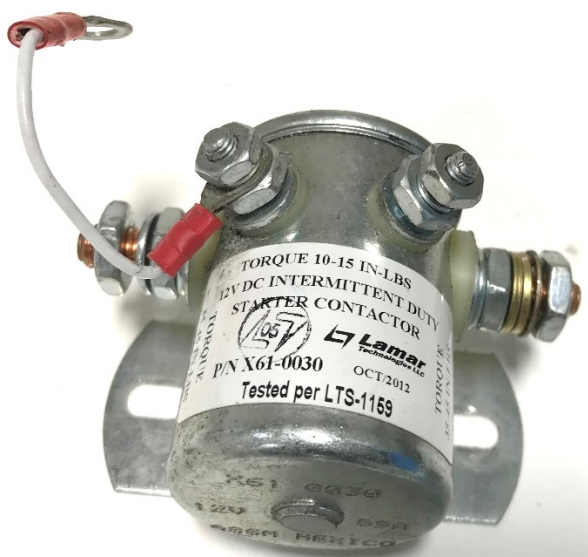
Figure 154: Starter solenoid removed from aircraft
Source: BEA

The starter solenoid showed no damage on its outer surface nor unusual colouring (**Figure 154** and **Figure 155**).

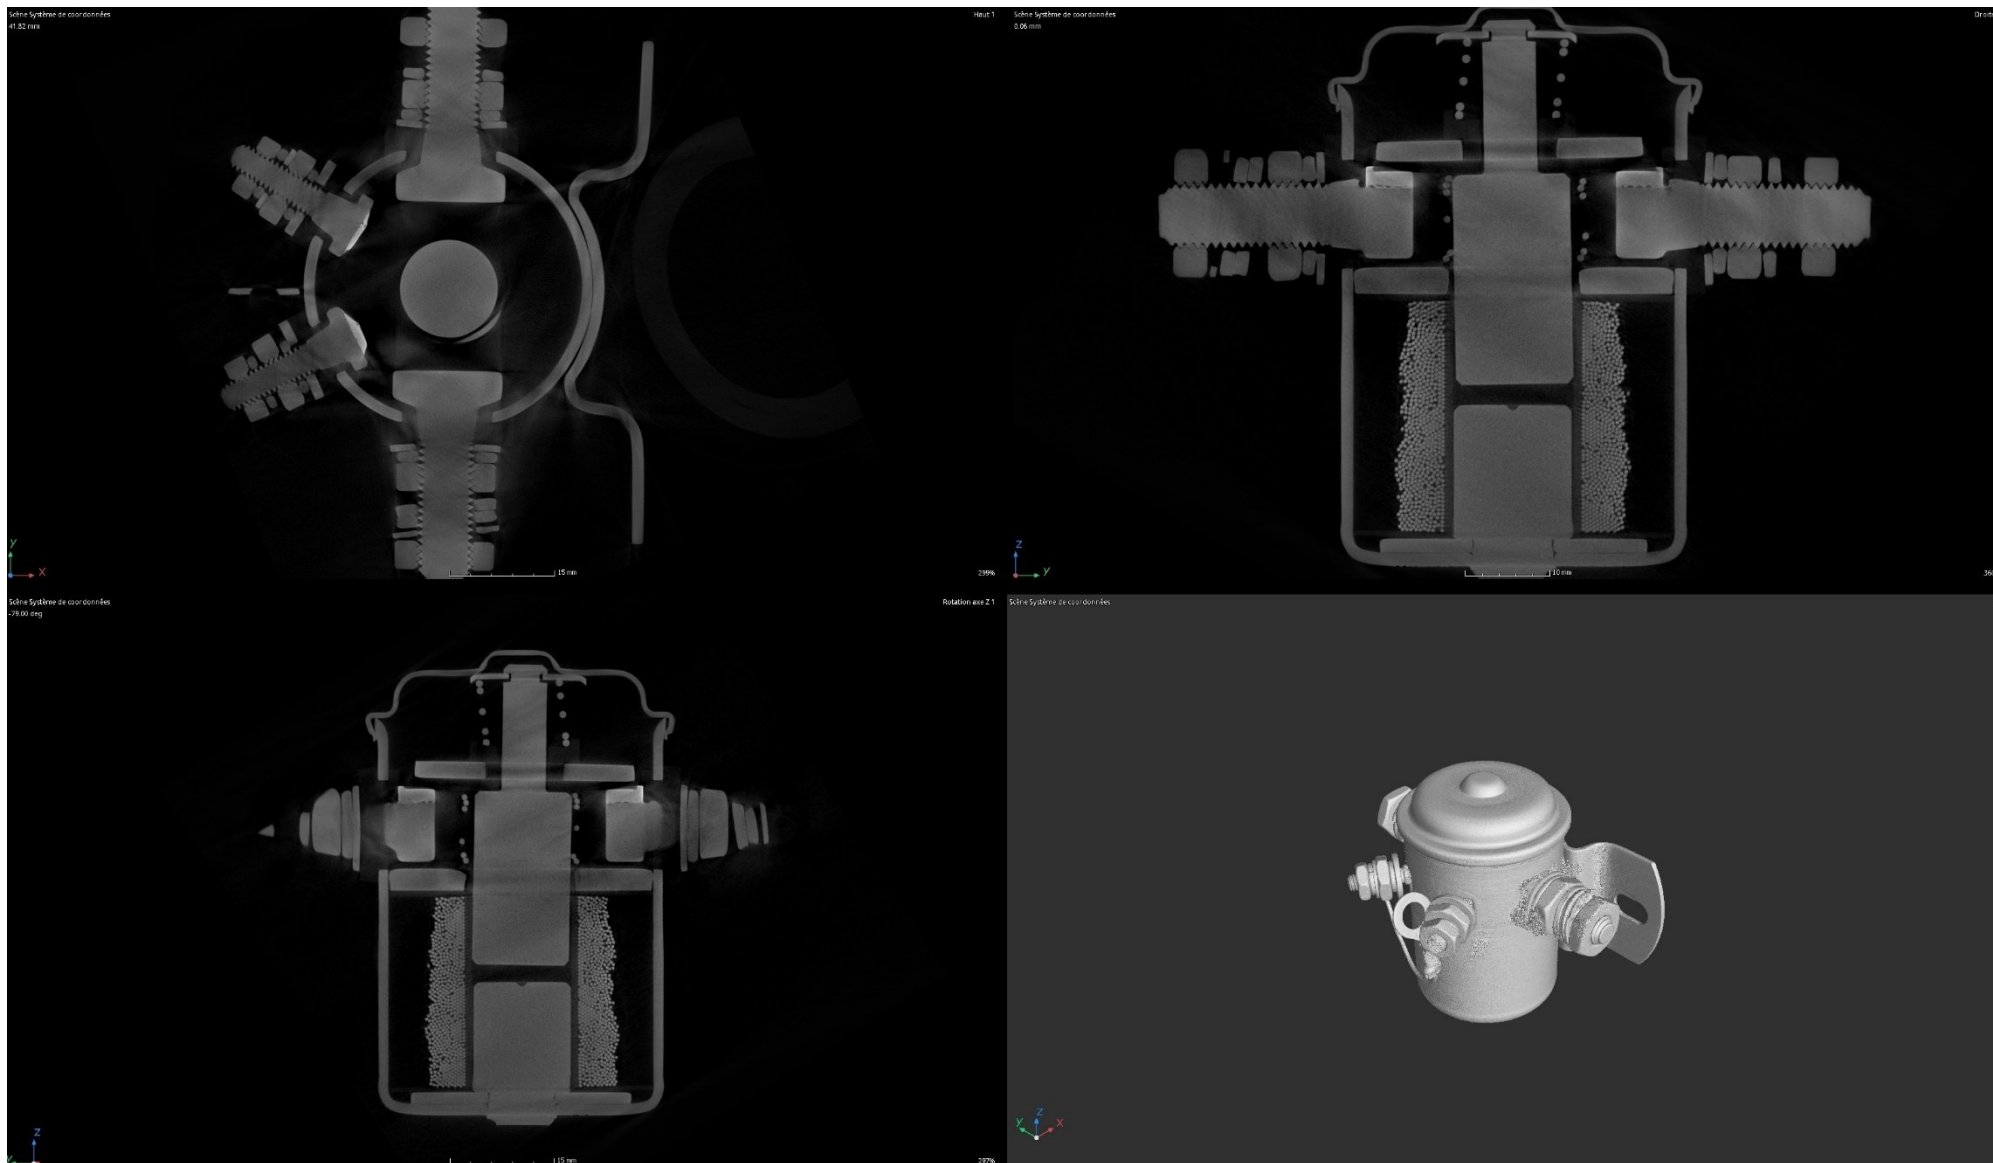
Figure 156: Images from tomographic examination
Source: BEA

This examination did not find any internal damage.

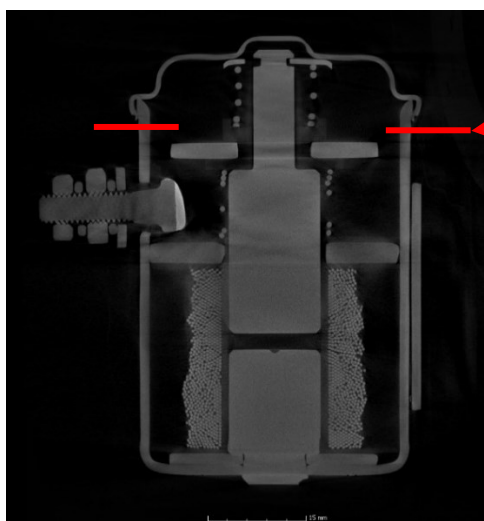
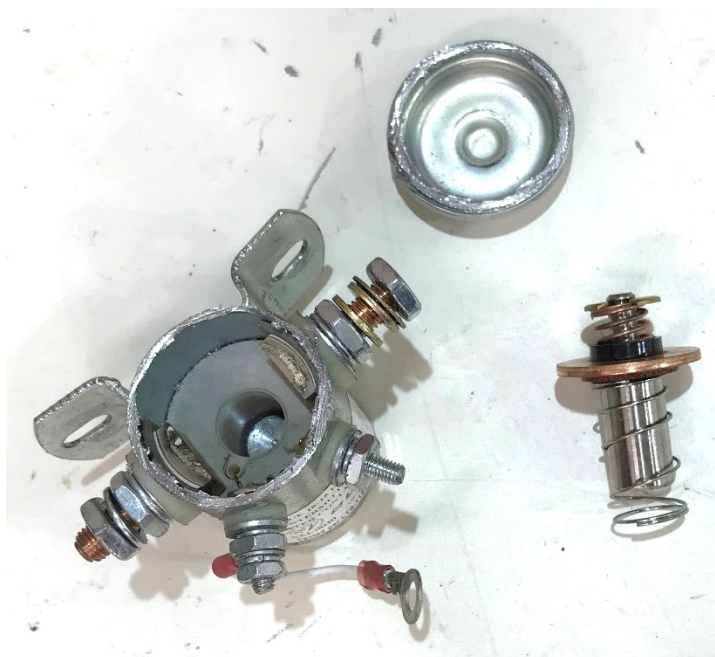
Figure 158: Destructive examination of starter solenoid
Source: BEA

The components were in position. Signs of the creation of small electrical arcs were observed. This type of damage is common on this type of equipment. This damage did not affect the functionality of the equipment.

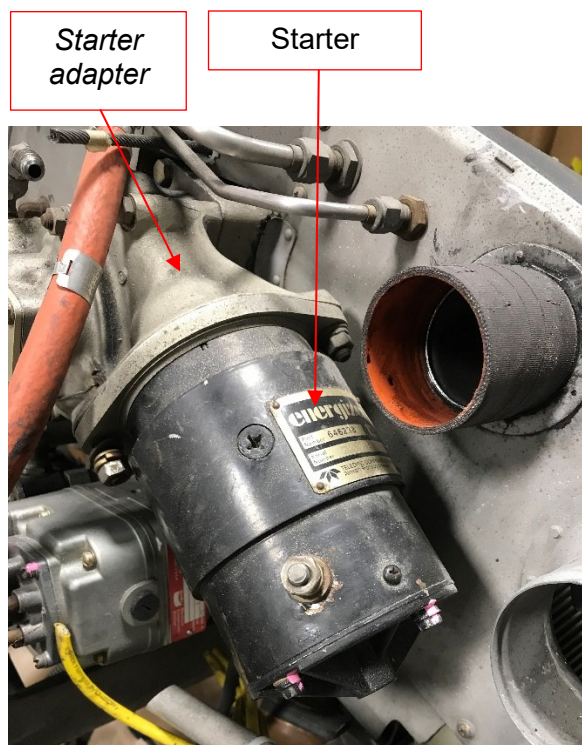
Figure 160: Starter in position on the starter adapter. Electrical power supply cable removed before photo taken
Source: BEA

The starter was in position on the engine (**Figure 160**), assembled and secured to the starter adapter.
