TECHNICAL REPORT

**Accident on 23 July 2020
at Bâle-Mulhouse airport (Haut-Rhin)
to the PIPER - PA-28RT-201T
registered HB-PNP**

Examination of wreckage

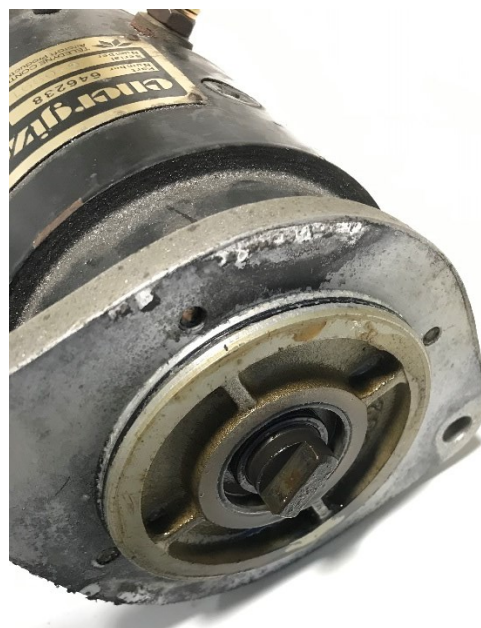
Figure 161: Starter drive shaft
Source: BEA

After disassembling it, it was observed that the starter drive shaft was whole and in position (**Figure 161**).

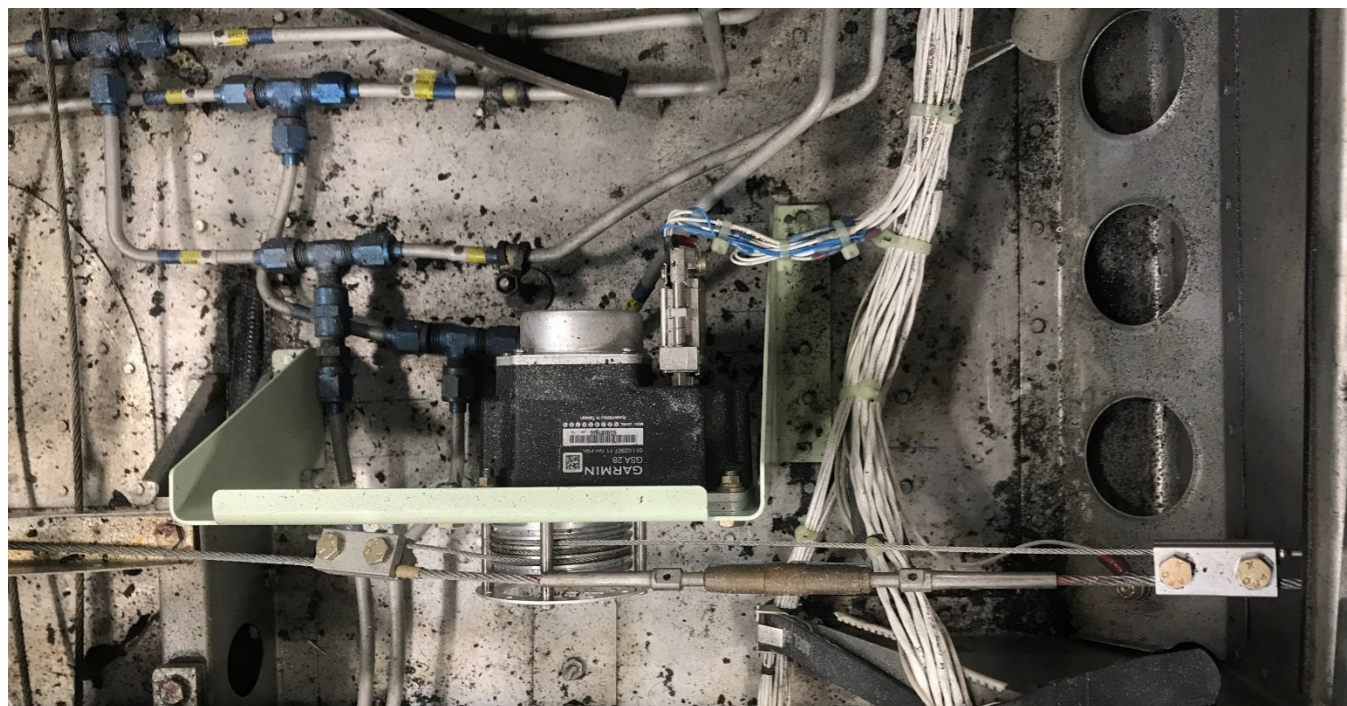
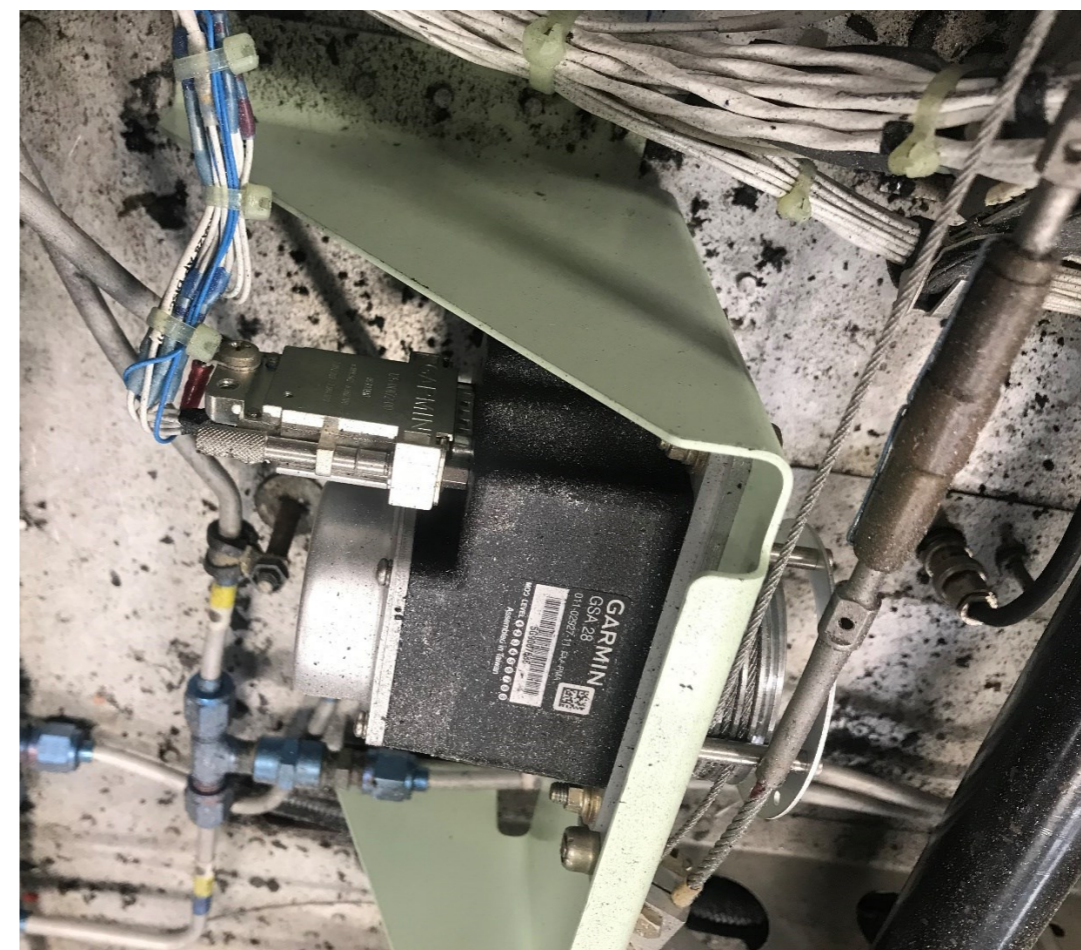
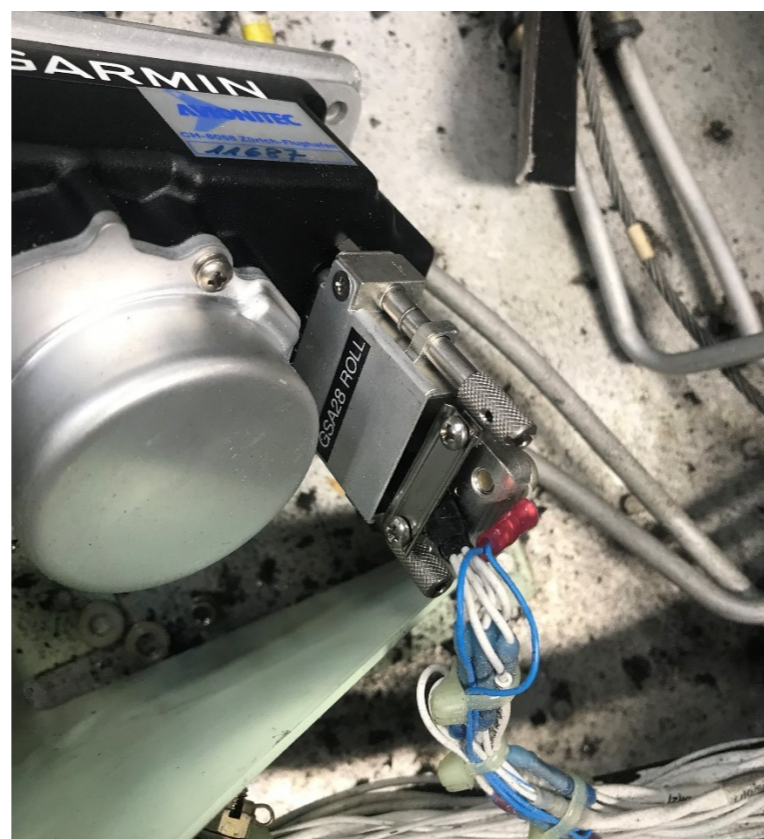
Figure 175: Servocontrol on roll axis
Source: BEA

The servocontrols were in position on the aircraft and nominally attached (**Figure 175** to **Figure 177**). The electrical connector was in position on each servocontrol, no damage was found on the connector. The ground of each servocontrol was attached and secured to the airframe.

No damage was found on the conductors of the associated electrical system. These conductors were continuous. The outer surface of these conductors was just of a dark colour locally due to the hot smoke released during the accident.

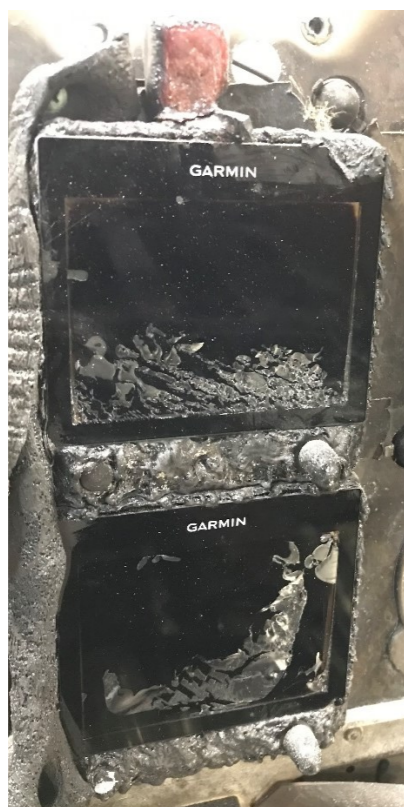
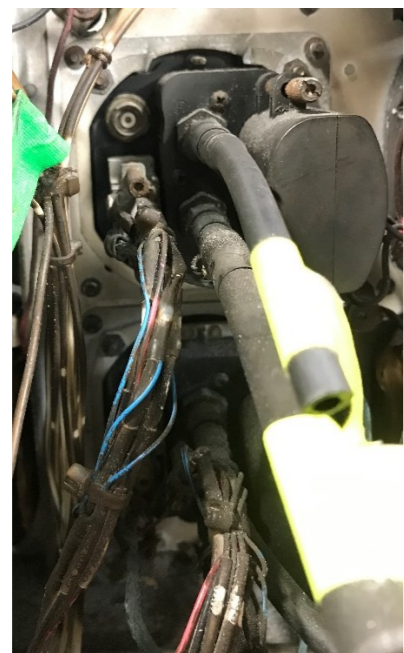
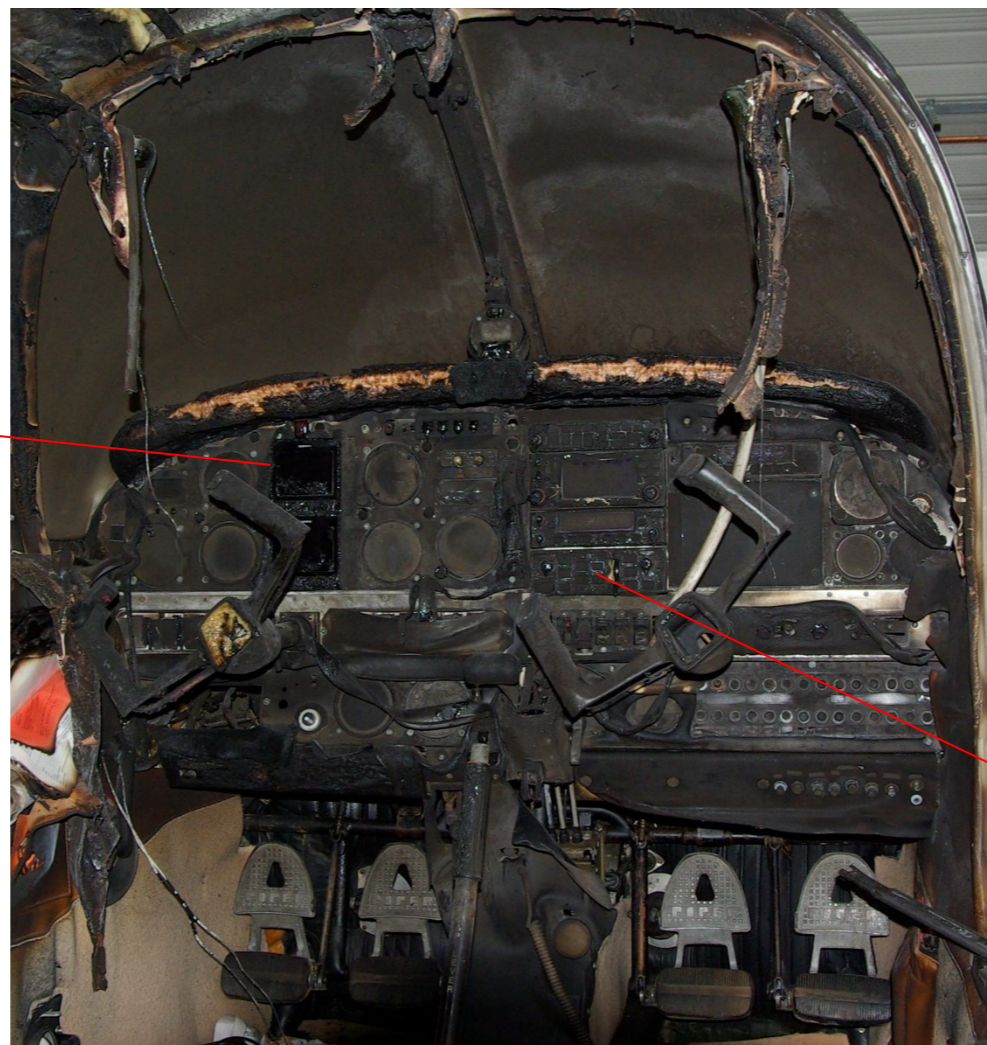
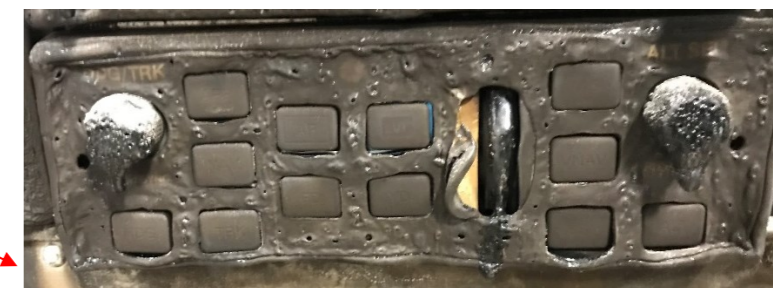
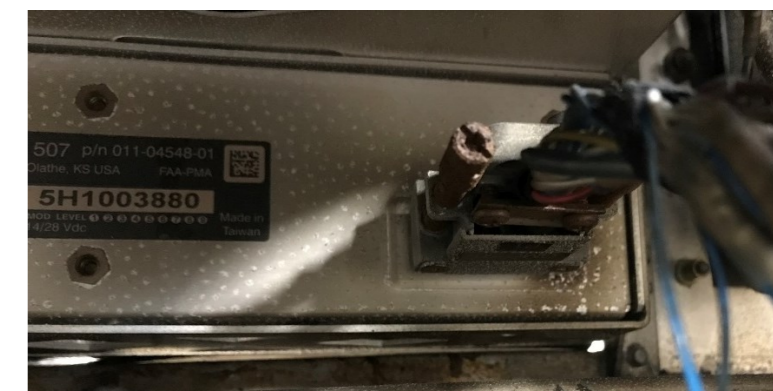
Figure 178: Interfaces (Garmin G5 and Garmin GFC 500) on instrument panel
Source: BEA

The interfaces were in position on the instrument panel. Their outer face was damaged by the hot smoke during the accident (**Figure 178**). Behind the equipment, the conductors were in position and no damage was found.

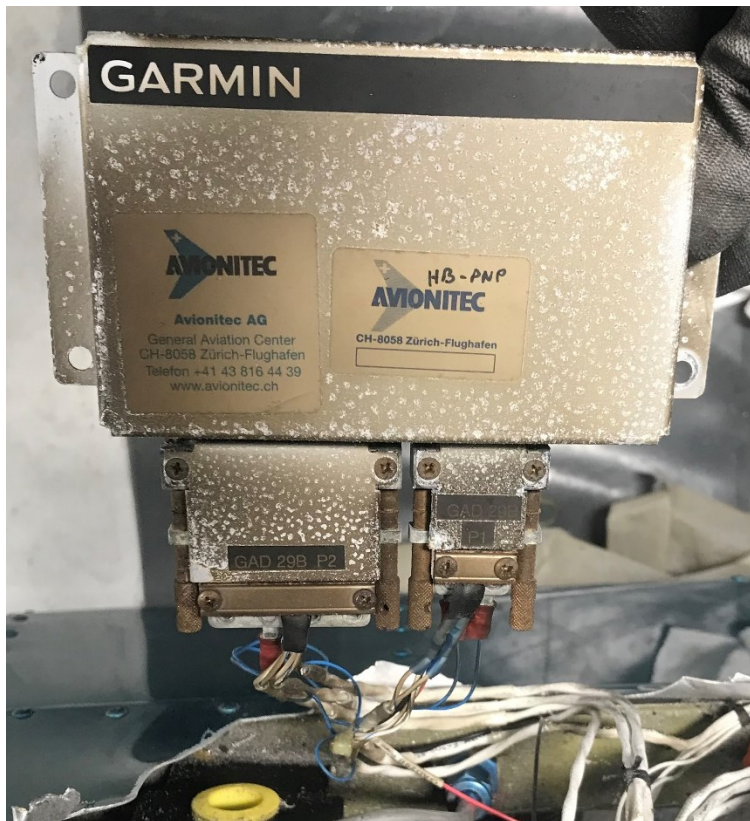
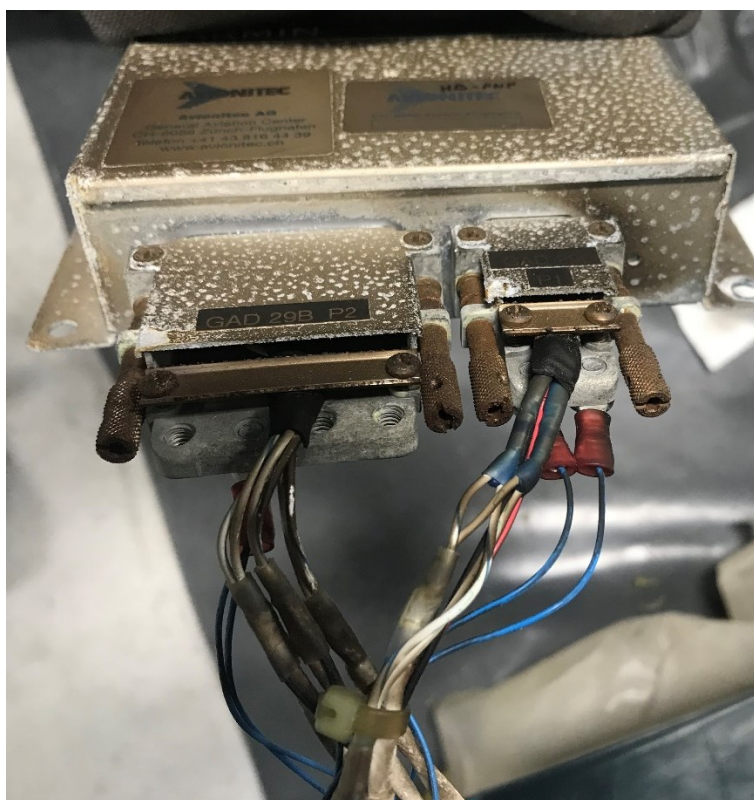
Figure 179: Garmin GAD 29 B adapter
Source: BEA

The Garmin GAD 29 B adapter was in position behind the instrument panel, along the right side. The adapter did not show any external visual damage (**Figure 179**). The associated conductors were in position, no damage was found.

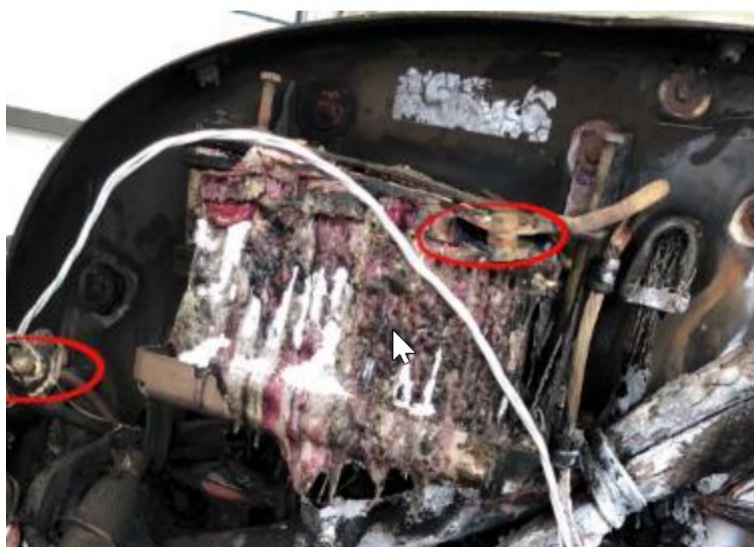
Figure 181: Destroyed battery of F-HPVP

The photos transmitted to the BEA show a substantially damaged battery. This damage was visually similar to that found on the battery of HB-PNP. In particular, singular damage to the positive terminal of the battery can be noted.

According to the information provided by Concorde Aircraft Batteries, this damage to the battery terminal is thought to be the consequences of excessive overheating of the conductor connected to this terminal due to the circulation of a high current, or external overheating. According to the expert mandated by the judicial authorities, signs of a short-circuit were identified on the conductor associated with the battery.
