# INVESTIGATION REPORT

**Serious incident** on 22 May 2015  
at Paris - Charles-de-Gaulle  
to Boeing 777-F  
registered **F-GUOC**  
operated by **Air France**

**BEA**

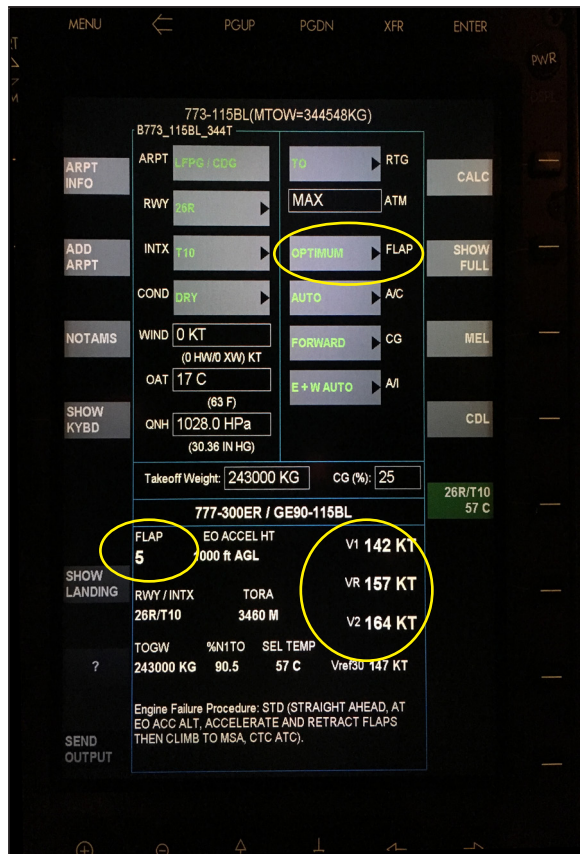
The BEA reenacted, in an Air France simulator, the entry of the data in the OPT and the FMS as it had been done by the crew during the flight preparation of the incident. The simulator used corresponded to a Boeing 777-300. Consequently, the values of the performance calculations do not correspond exactly to those of the event. Nevertheless, the data collected is representative of the incident.

The TOW entered in the OPT is erroneous: 243 tonnes instead of 343 tonnes.

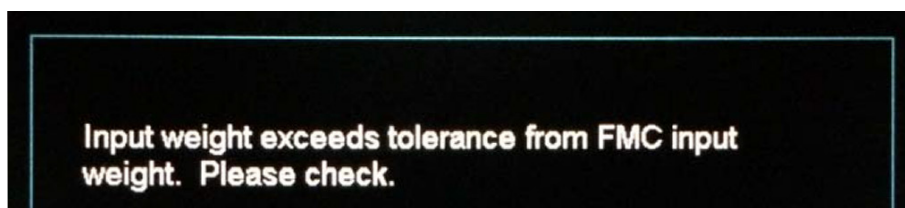
This EFB weight comparison feature was introduced in 2011. In the EFB, a COPY FMC DATA button is used to copy certain FMS data into the EFB. The EFB compares the TOW entered and the GR WT entered in the FMS. A message is generated by the EFB if the difference exceeds a predefined threshold:

Boeing said that it is an option that needs to be activated. Air France confirmed that the Boeing 777 registered F-GUOC was not equipped with this feature.
