INVESTIGATION REPORT

Accident to Piper PA28
registered **F-HEHM**
on 1 July 2015
at Treilles (Aude)

Collision with terrain in cruise in adverse meteorological conditions

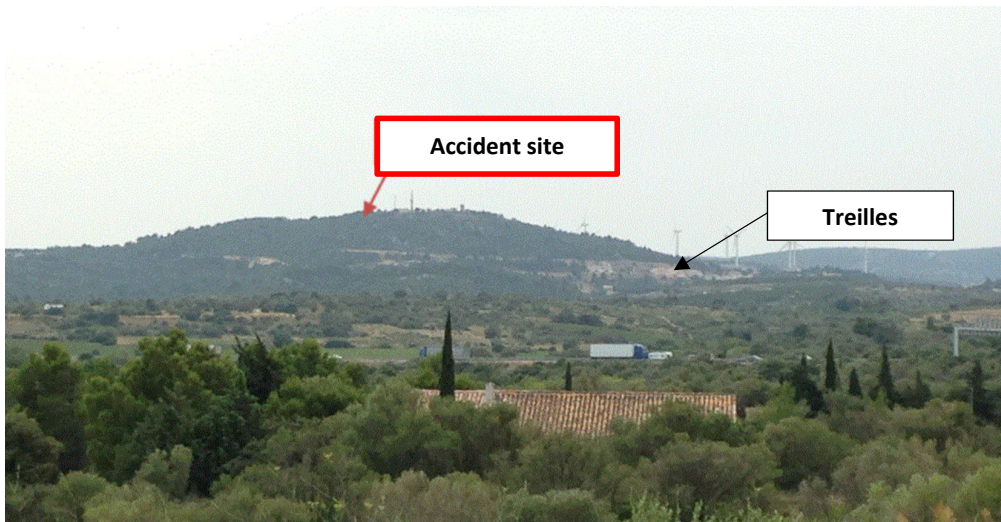
Figure 7: hill and Treilles village

The parts found at the second point of impact were the propeller, engine and landing gear. The examination of the engine found that it had been producing high power at the impact.
