**In-flight loss of control in a turbulent atmosphere,
collision with vegetation, then the ground**

Aircraft	Pipistrel Taurus 503 microlight identified 34-ABF
Date and time	13 July 2015 at 16 h 15 ⁽¹⁾
Operator	Private
Place	Eyglis (05)
Type of flight	General aviation
Persons on board	Pilot and one passenger
Consequences and damage	Pilot fatally injured, passenger seriously injured, microlight destroyed

This is a courtesy translation by the BEA of the Final Report on the Safety Investigation. As accurate as the translation may be, the original text in French is the work of reference.

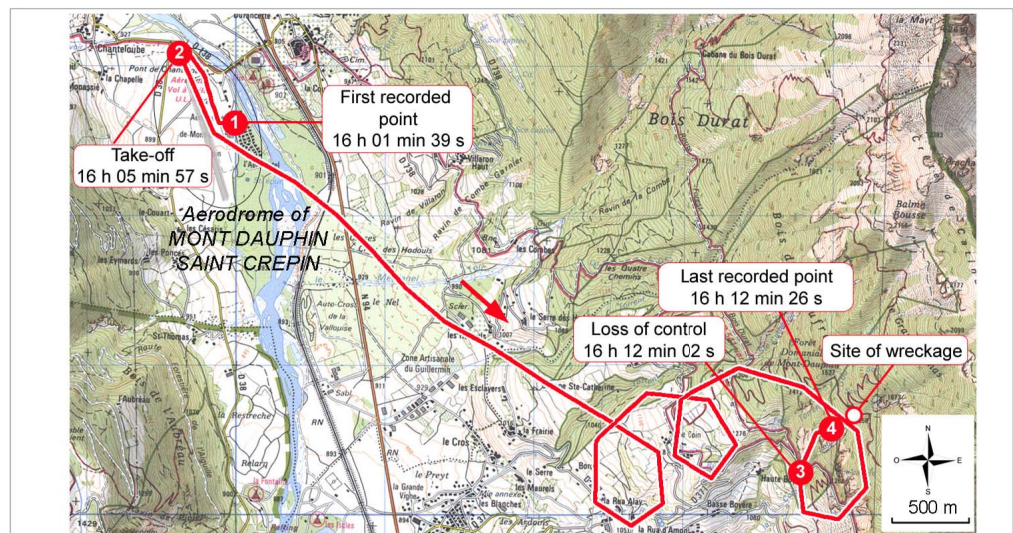
The microlight was equipped with an IGC Colibri computer. This computer records GNSS tracks on an SD card, which allowed the flight path to be calculated.

Cartographic source : IGN
