Accident to the Schempp Hirth "Ventus-2CxT" glider⁽¹⁾ registered **G-TABB** on 14 July 2017 at Val des Prés (Hautes-Alpes), "Crête de Peyrolle"⁽²⁾

Time	Around 16:55 ⁽³⁾
Operator	Private
Type of flight	General aviation
Persons on board	Pilot
Consequences and damage	Pilot fatally injured, aircraft destroyed

Loss of control in flight, collision with the terrain, slope soaring flight

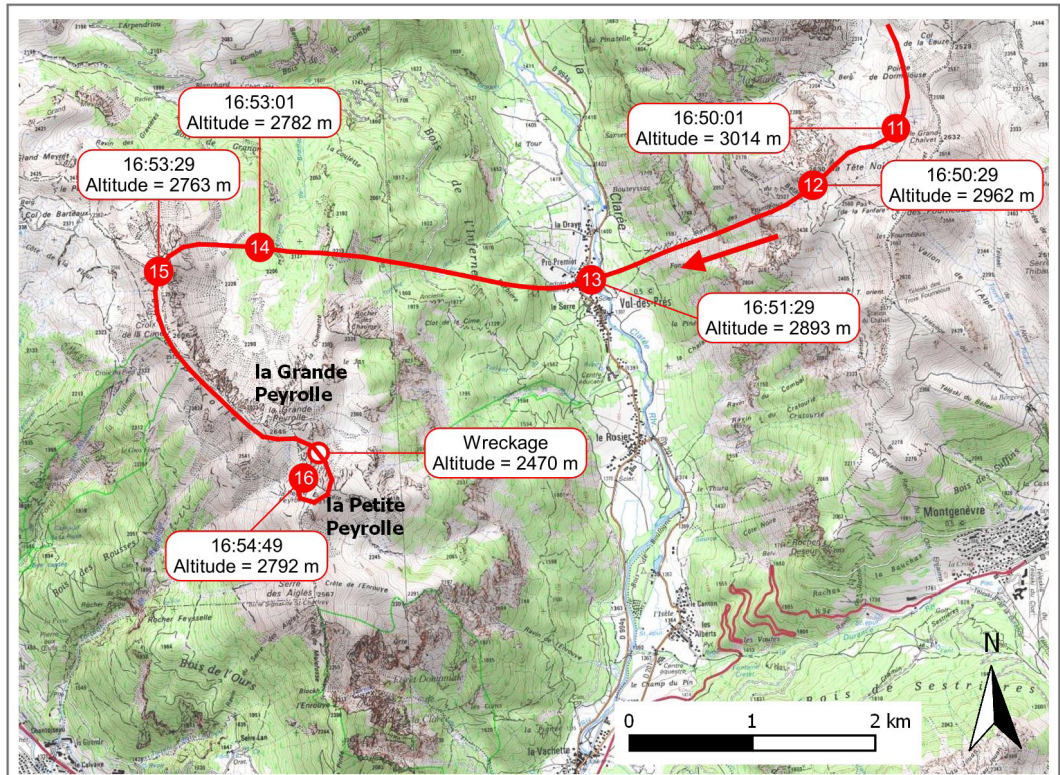
Map taken from IGN

The bank angle of the glider during the last turn, calculated from data, varied between 20° and 40°.

The wind direction and strength estimated from the data are the following: direction between 280° and 360°, speed around 30 km/h.
