INVESTIGATION REPORT

Accident to the AIRBUS A380-861

registered F-HPJE

on 30 September 2017

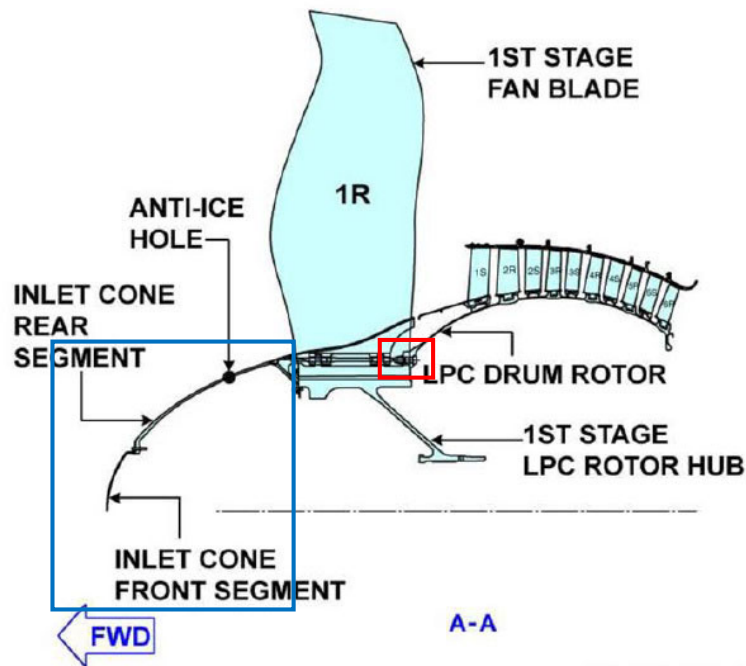
Figure 6: Cross-section of LP compressor of GP7270. The red rectangle identifies the bolts attaching the fan hub to the LP compressor drum. The blue rectangle identifies the inlet cone.

The engine air inlet cone is composed of a front section and a rear section ([Figure 6](#)) made of composite materials. A fragment of the rear section was found on the Greenland ice sheet during phase I of the searches. Two other fragments were found on the runway at Goose Bay. One of these fragments was part of the inner skin of the rear section and the other fragment was all of the front section still attached to a fragment of the rear section. No evidence of a bird strike was observed during the examinations carried out on these fragments. All the failures observed were characteristic of a sudden failure from overload.

The bolts attaching the fan hub to the LP compressor drum ([Figure 6](#)) along with the markings on the front face of the drum were examined to help understand the failure scenario. The analysis of the bolt shearing directions and the markings on the drum brought to light two clearly distinct bolt groups. This observation was interpreted as being the result of the fan hub fracturing into two fragments (without counting the conical part still integral with the low-pressure shaft).

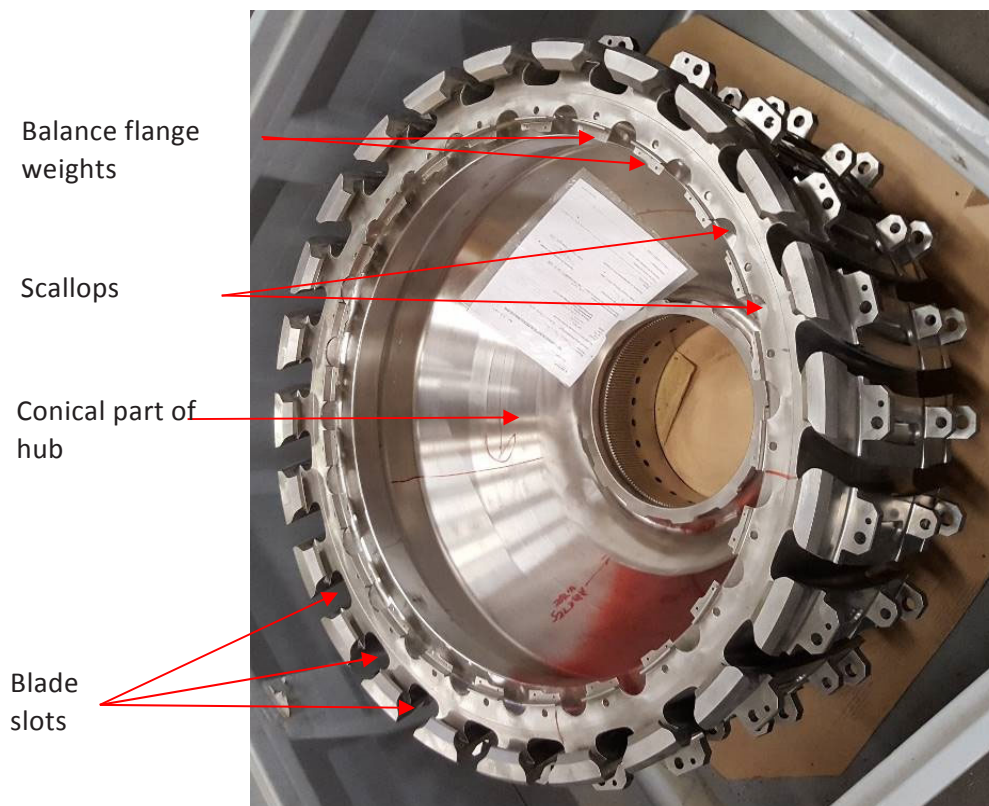
Figure 10: fan hub exemplar. The centre of the conical part is connected to the LP shaft. It is topped by a thicker cylindrical part with 24 machined blade slots.

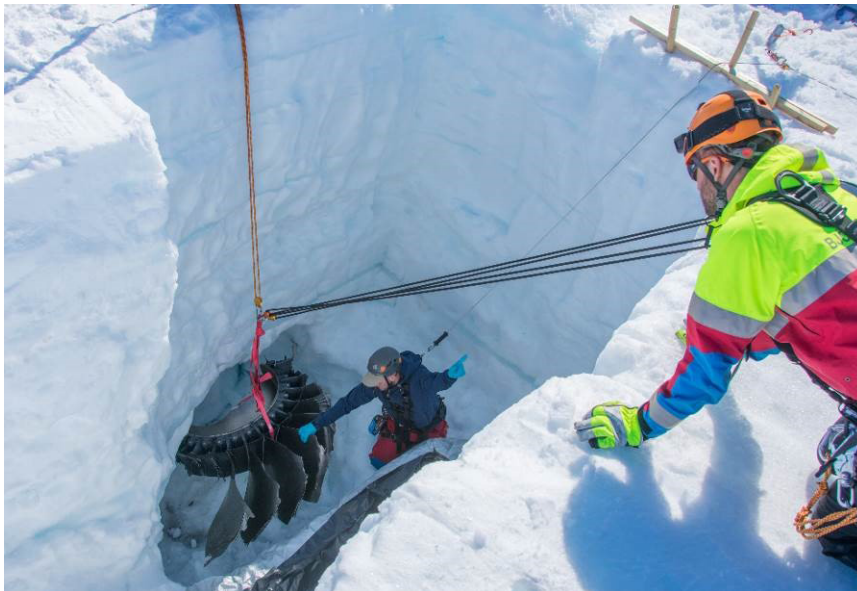
The finite element simulations carried out by P&W at the beginning of 2018, based on the hypothesis of a fan hub “*bore to rim*” fracture, provided information about the probable size, weight and ejection speeds of the hub fragments. New ballistic calculations were carried out based on this refined data in order to reduce the size of the search zone. At the end of 2018, the electromagnetic detection system developed by the HydroGeophysics Group (HGG) of Aarhus university (Denmark) was modified so as to be able to detect a titanium part at a distance of five to six metres under the snow. In parallel, the post-processing of the SETHI Radar data acquired during phase II had been completed. ONERA sent the coordinates of a high-probability target and of two less obvious targets to the investigation team. The decision to carry out a new expedition was taken at the end of February 2019 for a departure in May 2019. The expedition kick-off was delayed due to weather conditions which were incompatible with the mission. Despite this hold-up and the resulting reduction in the mission’s duration, an unambiguous detection was obtained at the very end of the campaign at the most promising spot indicated by ONERA. A signal about two orders of magnitude higher than that obtained for the buried test hub was recorded close to the spot where the GPR had already made a detection, indicative of buried metal. The detection was situated one metre north of a four-metre wide crevasse which had a six-metre thick bridge. An excavation campaign was organized in June 2019. A fan hub fragment was carefully extracted and transported to Narsarsuaq airport. The fragment returned a signal to the system used by HGG which was a lot stronger than that of the buried test hub, in part due to its larger size and shallower burial depth. The blades still attached and the presence of other materials (aluminium and steel) may also have increased the signal strength. The part was handed over to the BEA in July 2019 and examined at the engine manufacturer’s, P&W, in order to determine the cause of the failure.

Figure 15: Extraction of fan hub fragment

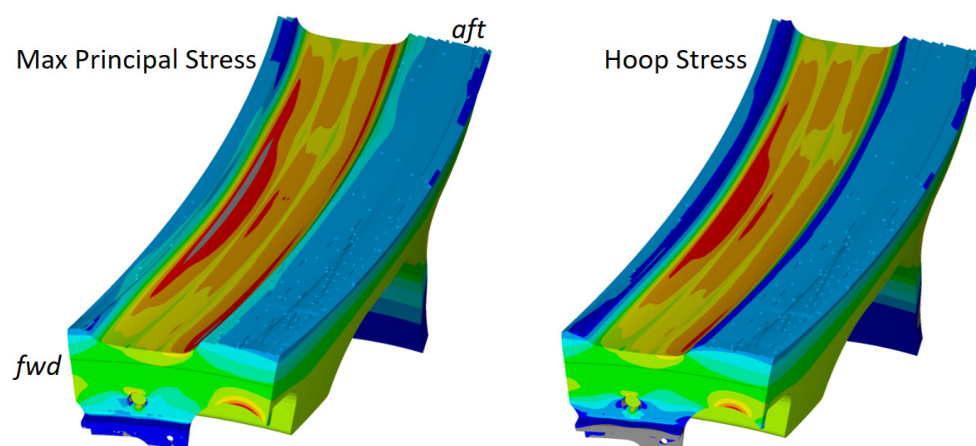
The fracture started in the subsurface slot bottom, close to the centre of the slot. The crack progressed perpendicularly to the hoop stresses caused by the centrifugal loads applied to the hub. This zone is not the zone with the highest stress. The critical zones in LCF defined by the manufacturer are situated on the hub front face (Figure 24) where maximum stresses are locally a lot greater. However, the crack's initiation area corresponds to a local high stress region (Figure 26). The presence of a subsurface macro-zone in the slot bottom probably contributed to the initiation of a crack in this zone which is subject to lower stresses than those of the critical zones.

Figure 26: Maximal principal stress (left) and hoop stress (right) in a slot bottom

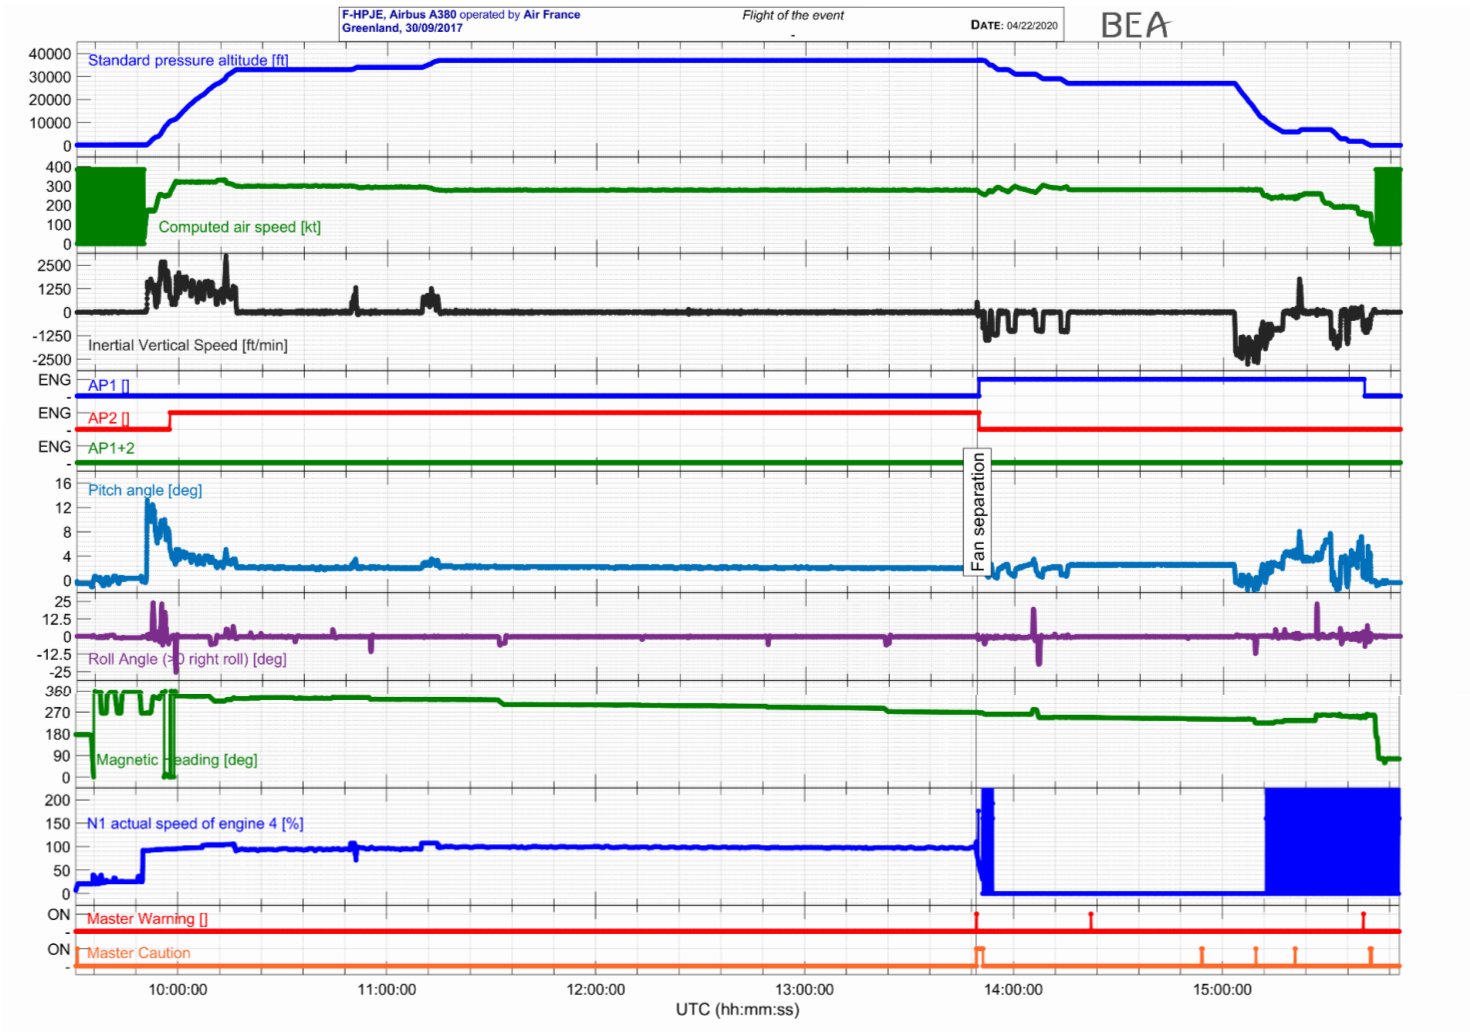
Figure 28: Occurrence flight

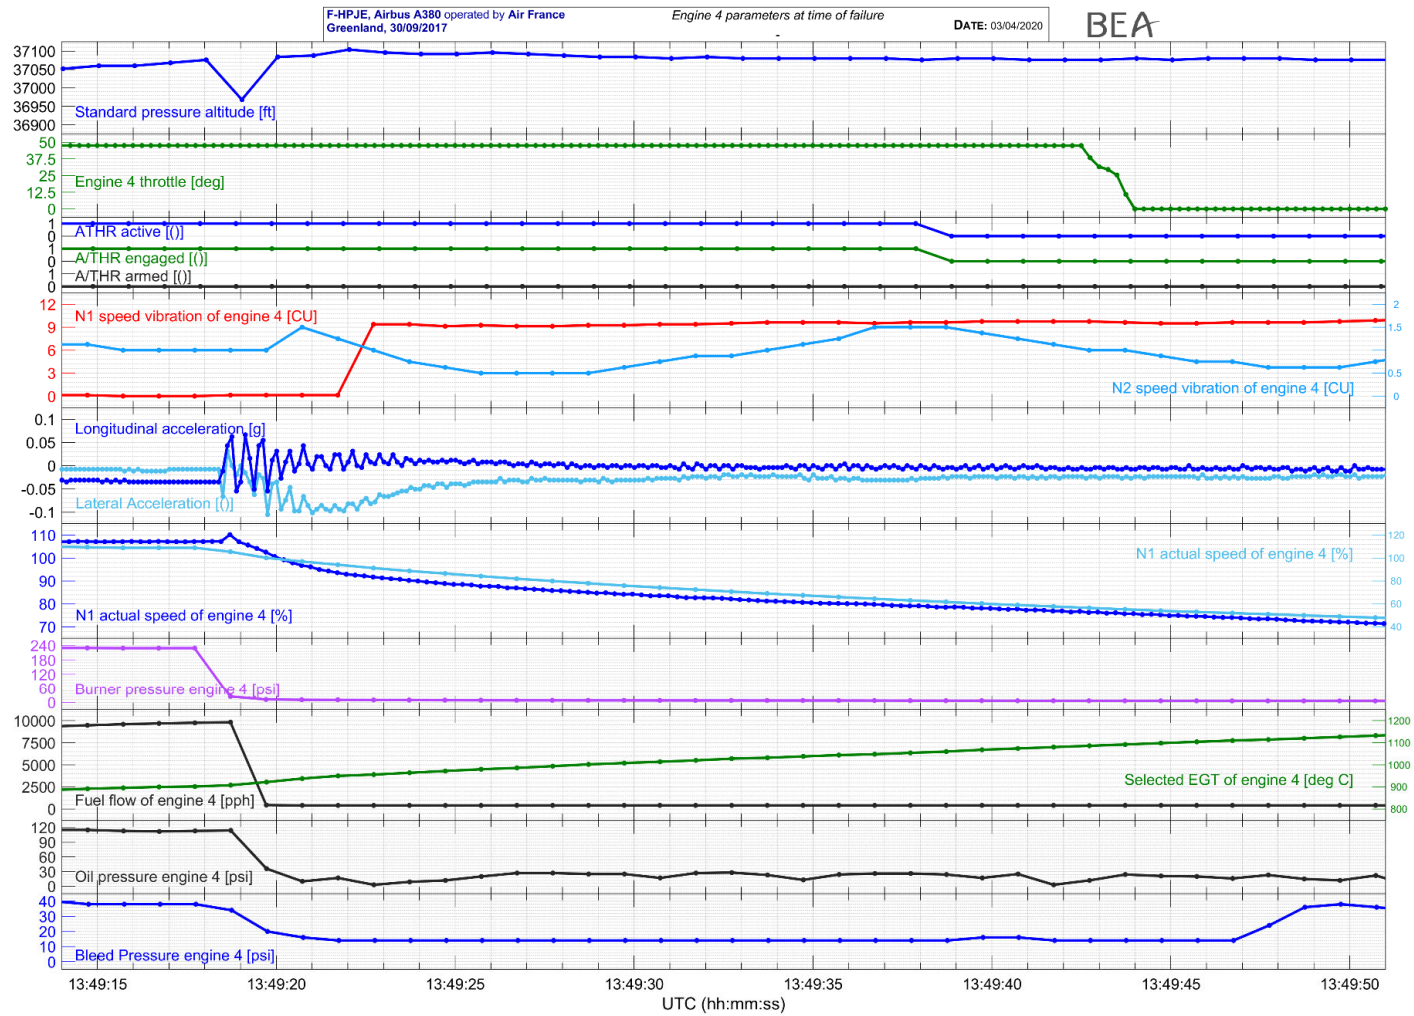
Figure 29: Engine No 4 parameters at time of failure

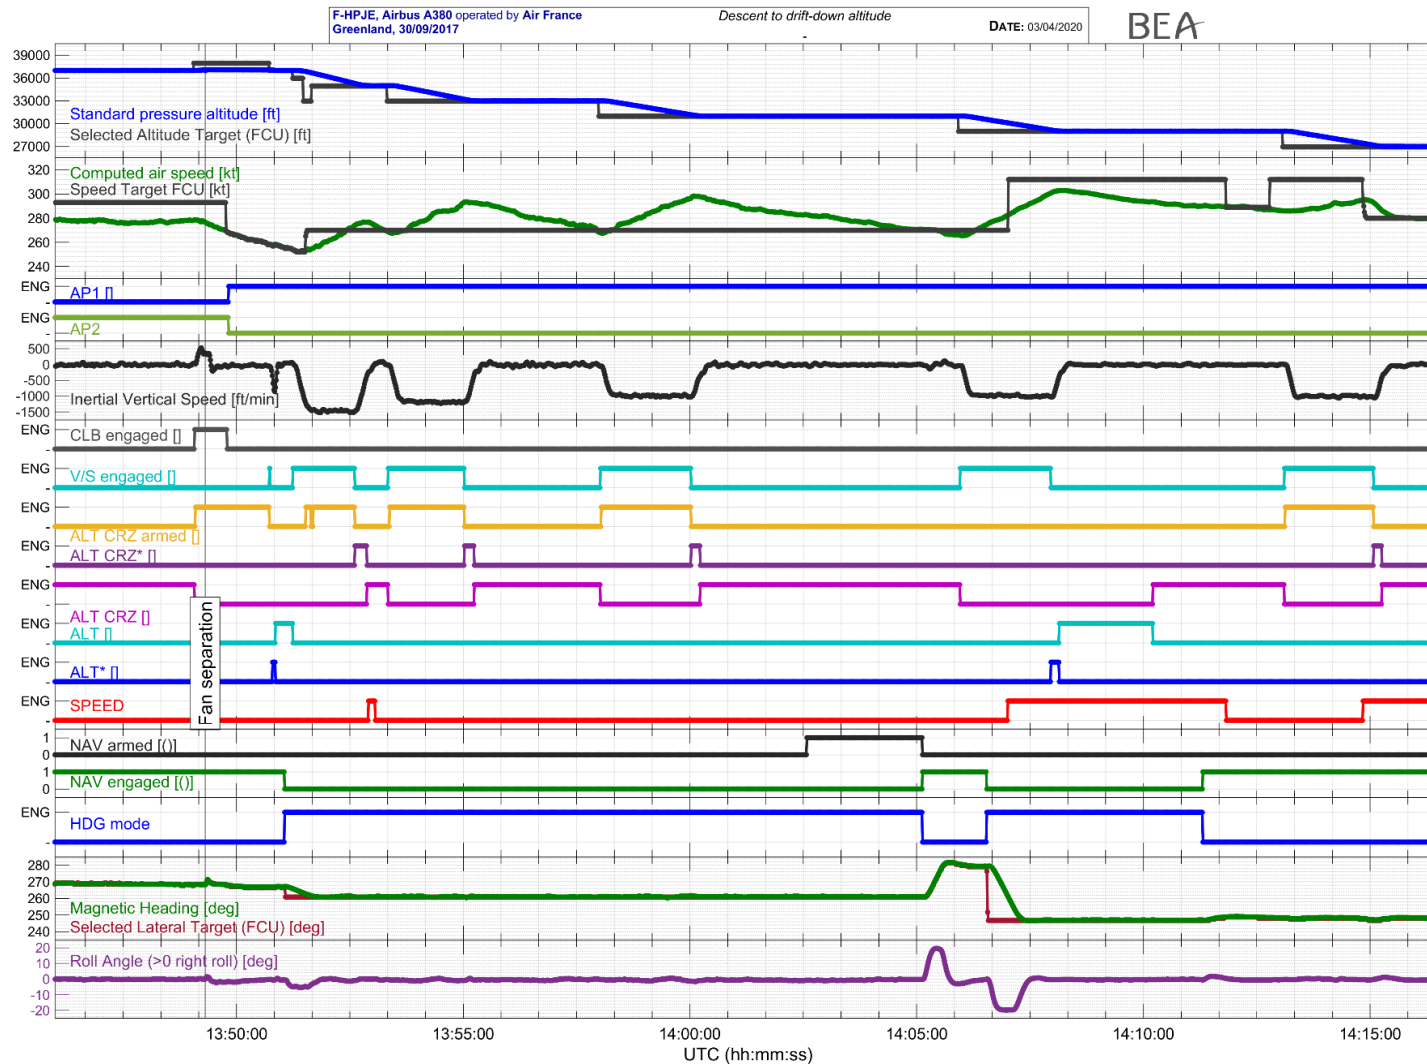
Figure 30: Descent to FL 270

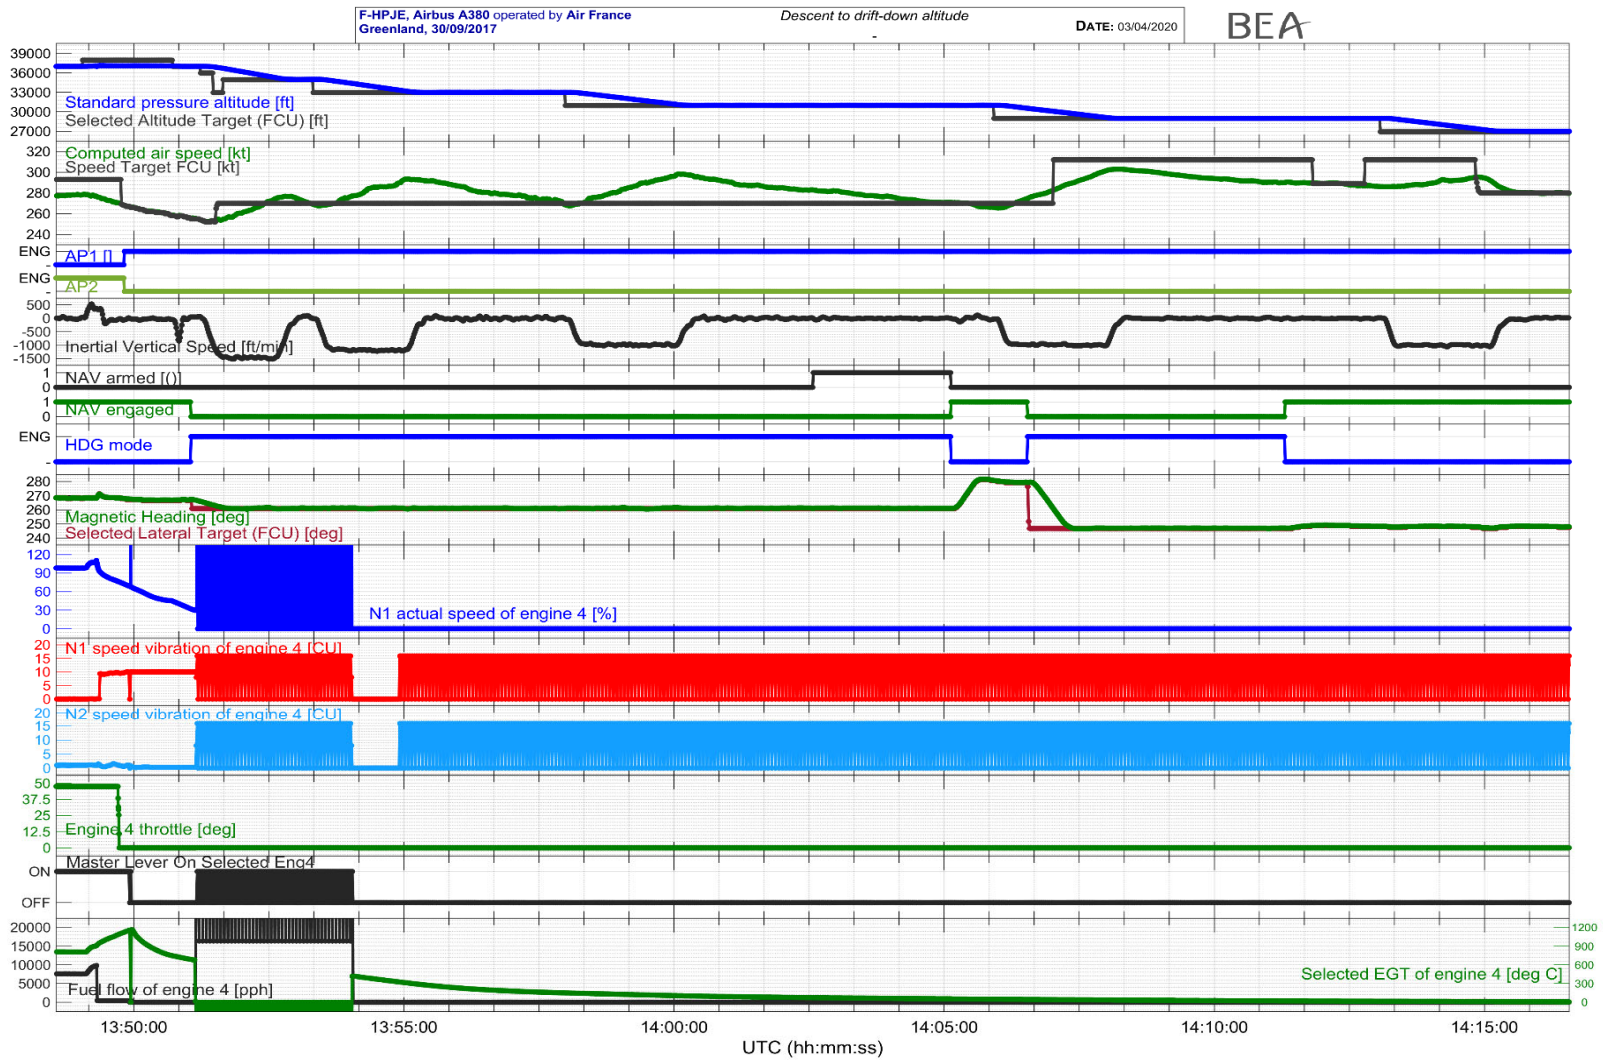
Figure 31: Engine 4 parameters during descent to FL 270
