Accident

to the Airbus A330-200 registered **F-GZCI**
operated by Air France
and to the Airbus A330-300 registered **N817NW**
operated by Delta Air Lines
on 31 October 2018
at Paris-Charles de Gaulle airport

Collision between an aeroplane taxiing on a taxiway and an aeroplane at standstill, second in line at the holding point

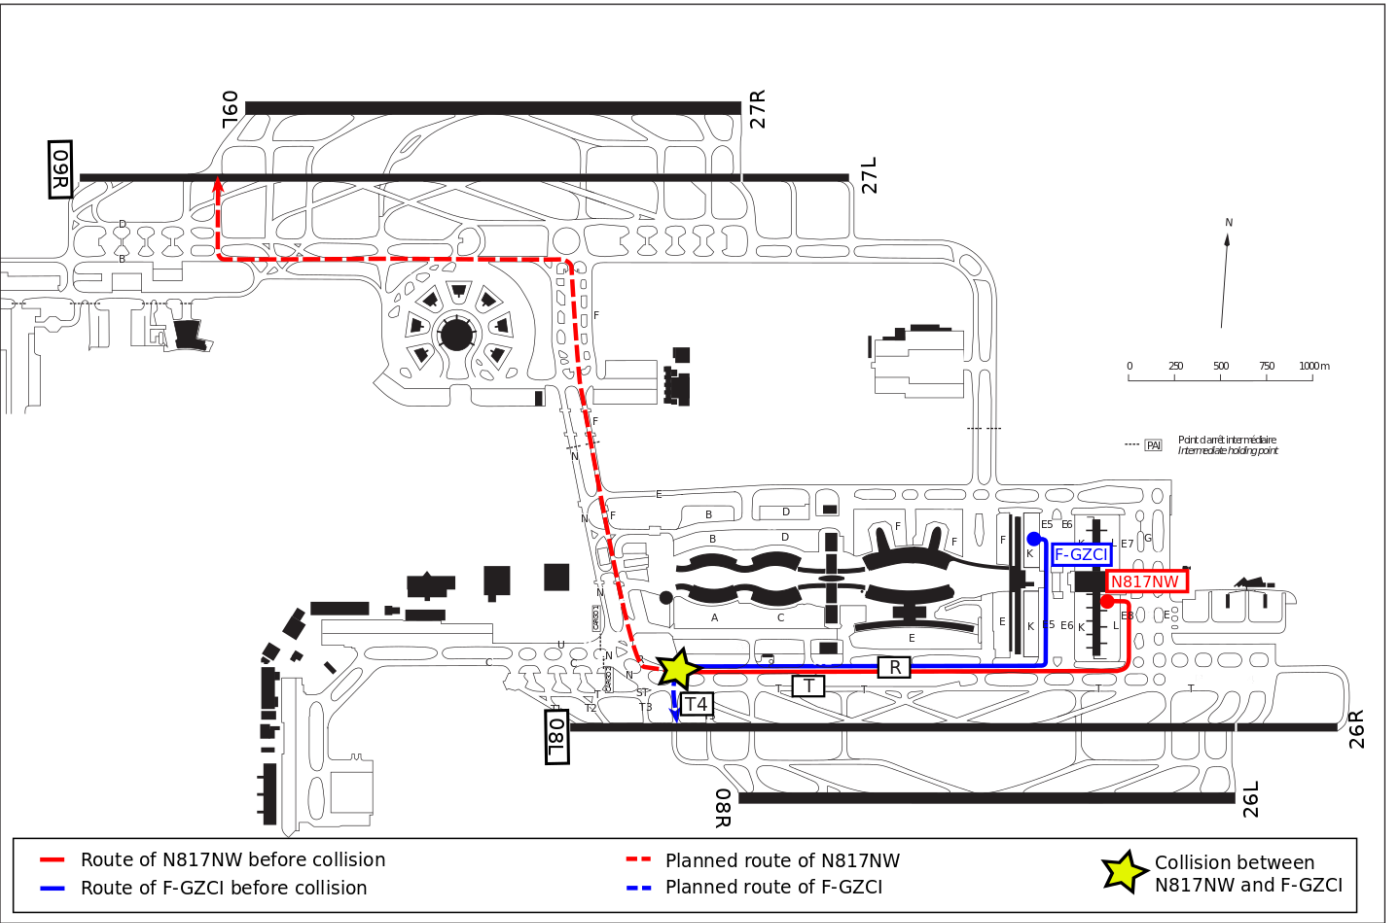
The Airbus A330 registered N817NW operated by Delta Air Lines, was carrying out flight DAL97 from Paris-CDG airport bound for Detroit in the United States. Take-off was planned from runway 09R of the north twin runways (see Figure 1 below).

Figure 1: illustration showing the routes taken and the planned routes for the two aeroplanes

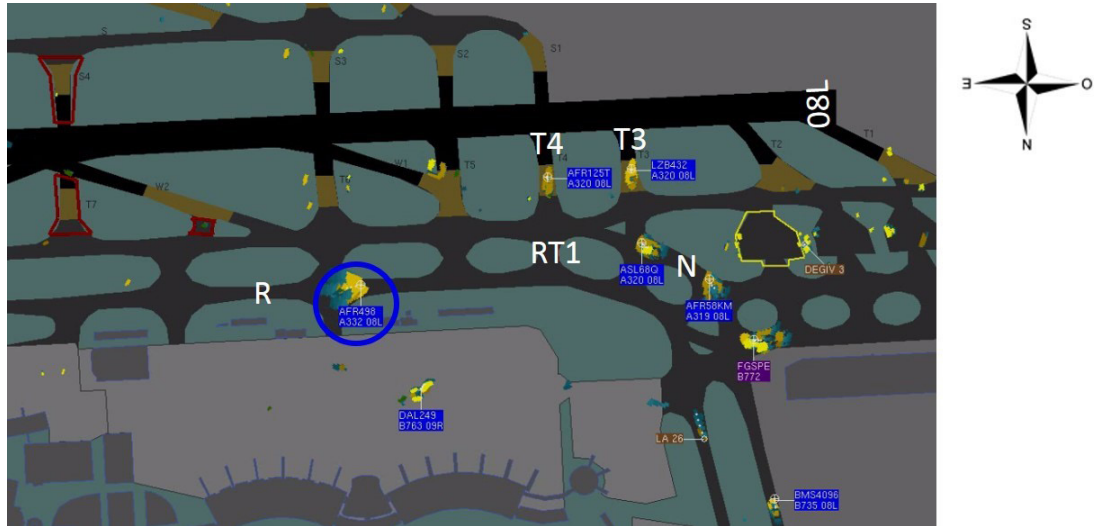
At 09:41:02, the SW ground controller asked the crew of flight AFR498 to hold its position. Several aeroplanes were in fact taxiing on taxiway N, most of them with the intention of taking off from runway 08L via taxiway T3 (see excerpt of AVISO display in Figure 2; this display with the south at the top of the screen corresponds to what the ground controller saw from the south control tower).

Figure 2: excerpt with annotations of the AVISO system display at 09:41:03 (AFR498 flight in blue circle)

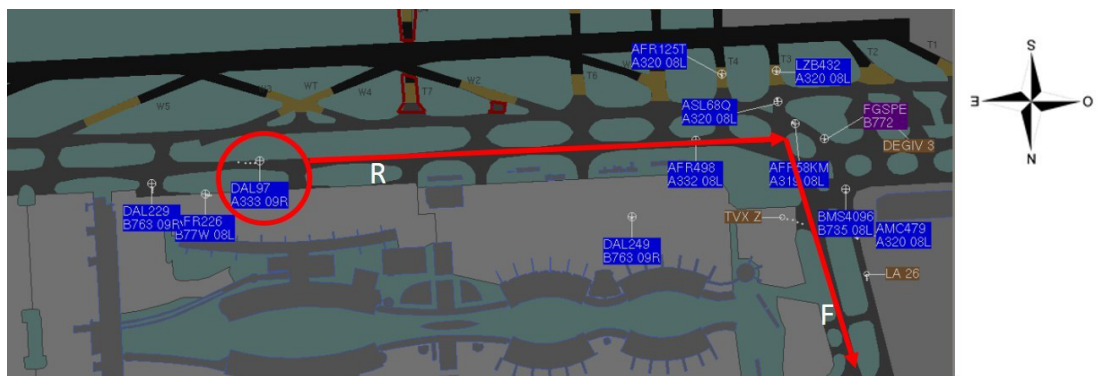
At 09:42:11, the crew of flight DAL97 contacted the SW ground controller⁽⁸⁾ and advised that they were on taxiway R. Three seconds later, the SW ground controller cleared them to taxi on taxiway F (see Figure 3).

Figure 3: excerpt with annotations of the AVISO system display at 09:42:15 (DAL97 flight in red circle with planned route in red)

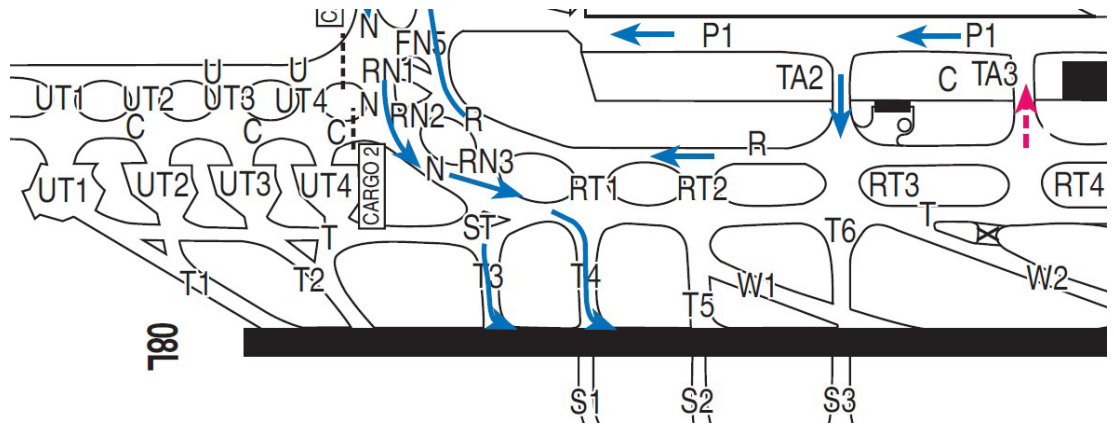
Figure 8 presents an excerpt from the ground movements chart of Paris-CDG airport operating “easterly operations” and shows the expected route to be taken to align on runway 08L and to head to the north twin runways via taxiway R.

Figure 8: excerpt from AIP AD 2 LFPG GMC 01 centred on taxiway RT1 (version of 11/10/2018)

The routes taken and to be taken by the two aeroplanes were consistent with this information.
