INVESTIGATION REPORT

Accident to Schroeder Fire Balloons G50/24
registered **F-HCCG**
on 5 October 2014
at Cazes-Mondenard (82)
operated by **Quercy Pluriel**

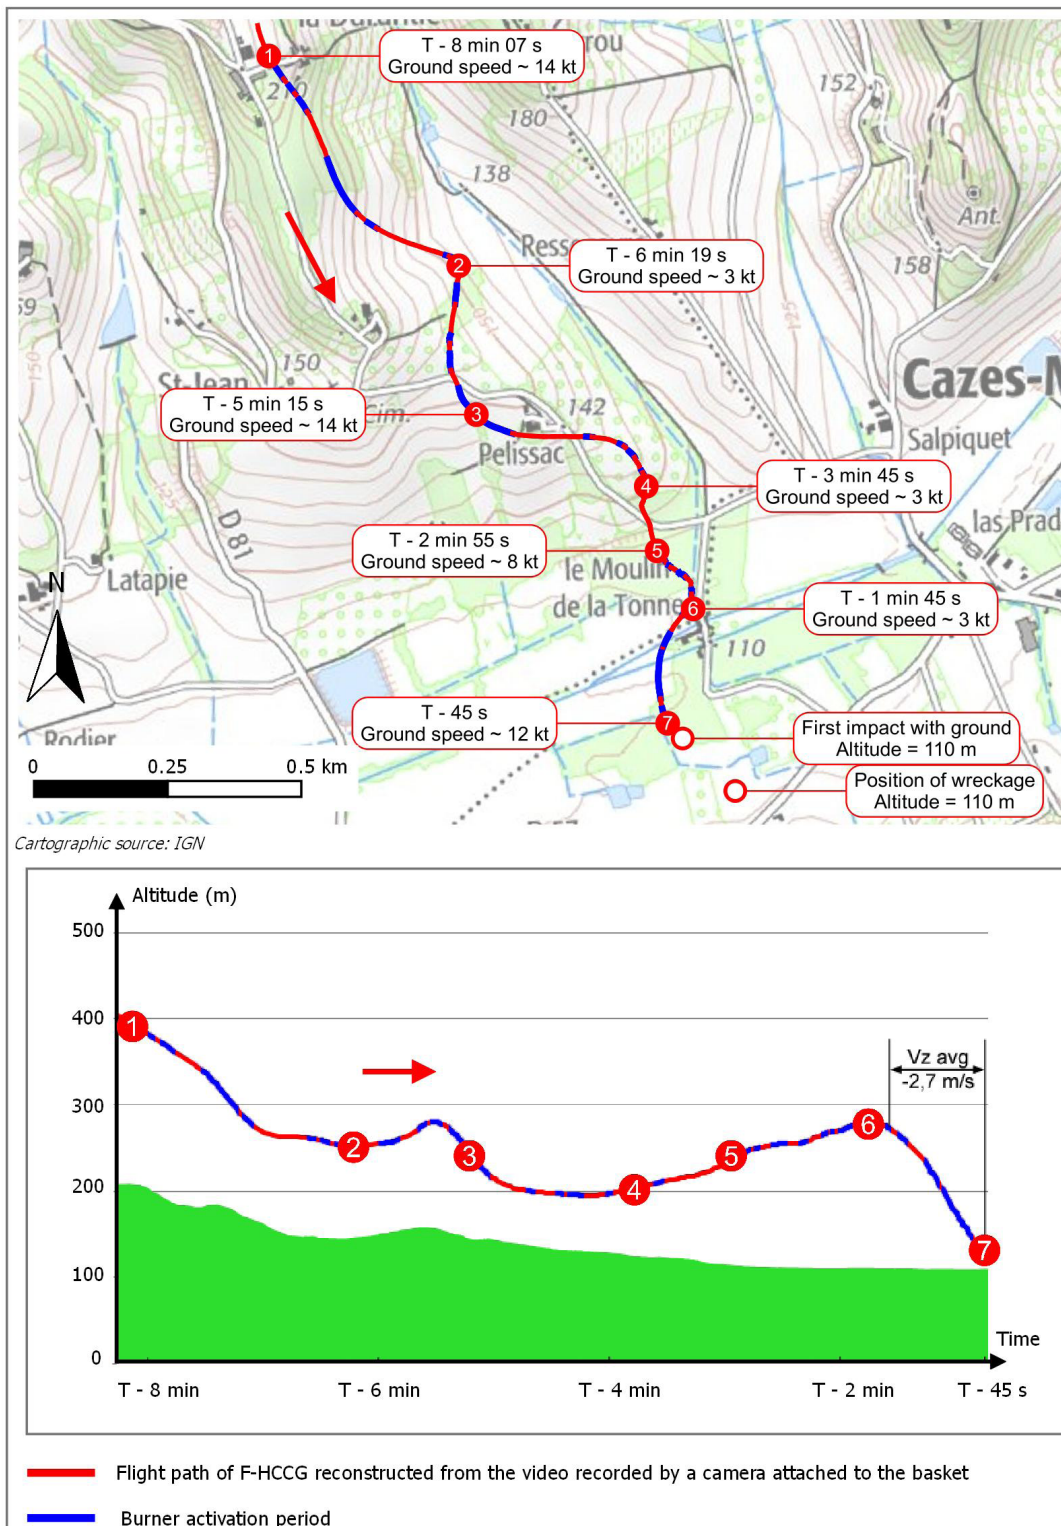
Figure 2: last part of flight path obtained from analysis of video recorded by camera

At about T+1 min, the pilot closed the fuel cylinder valves. The burner flames were extinguished. The basket was still on fire. The pilot and a passenger then tried to extinguish the flames with the balloon fire extinguisher, but did not succeed, then attempted to rescue the victim.

A few minutes later, the retrieve vehicle arrived with a second fire extinguisher which the pilot used against the blaze, without being able to extinguish it. The basket and its equipment burnt up completely due to the fire, fuelled several times by the gas from the tanks released by the safety valves.
