Report

Accident on **4 August 2010**
at « **Croisée d'Apatou** » (French Guyana)
to the **AS 350 B2** helicopter
registered **F-OIEL**
operated by **Yankee Lima Helicopters**

BEA

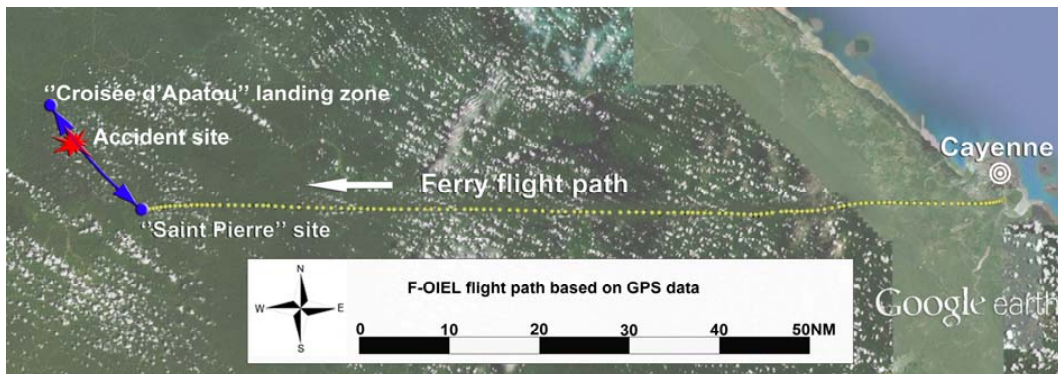
Figure 1- flight path based on GPS data

About one minute later, the helicopter crashed in the forest in an area that was difficult to access, around 1 NM from its departure point⁽²⁾. A few hours later the rescue services found the burnt-out wreckage.

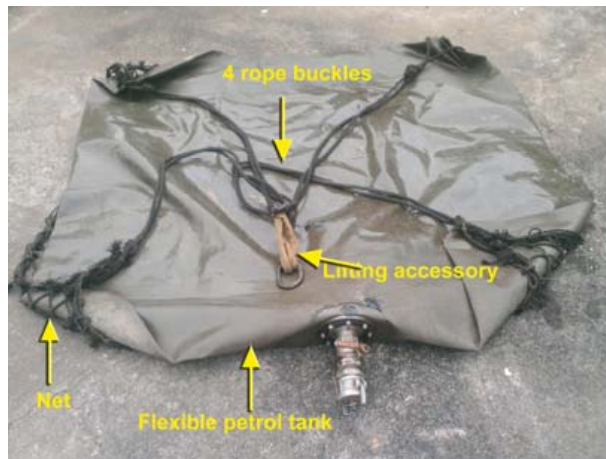
Figure 2 - assembled load and lifting accessory

The load was a flexible container and a square net. The four corners of the net were equipped with rope buckles.

When the various parts of the load are assembled, the flexible container is filled with about 1,100 litres of petrol. The weight of the whole load was about 900 kg.

The lifting accessory consists of five sling accessories. These sling accessories are assembled and make up what is commonly called a sling. It is about fifty centimetres long.

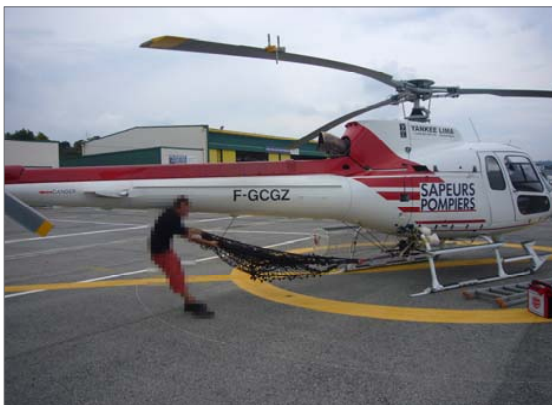
Figure 10 - configuration with 4 buckles in place

Following an accident that occurred in 2001, the operator had changed the length of the sling/net assembly to avoid it interfering with the tail rotor in case of accidental release of the load in flight. This short sling, designed and assembled by the user in order to take into account operational constraints, was in use on the day of the accident.

A reconstitution confirmed that this length prevented any contact with the tail rotor, even when only two of the four buckles remained in place in the hook.

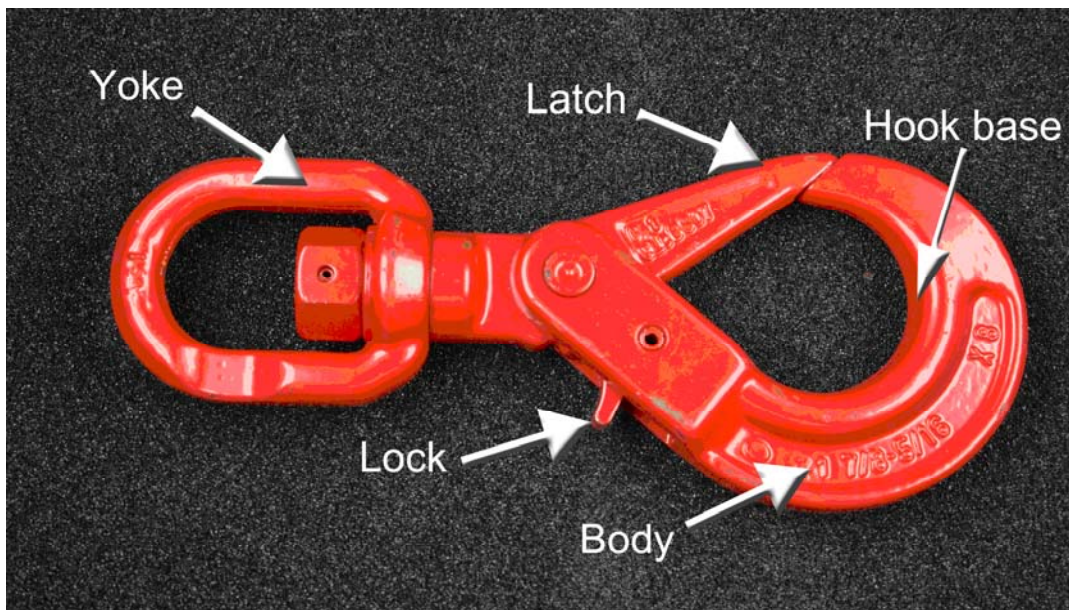
Figure 14 - constituents of a sample hook

In addition, a hook is designed and sized to work with a load applied at the base of the body. The maximum weight is calculated from traction tests performed under these conditions of use.

In the case of the assembly used during the accident, a part of the load was supported by the tip of the hook, which probably contributed to the deformation of the hook.

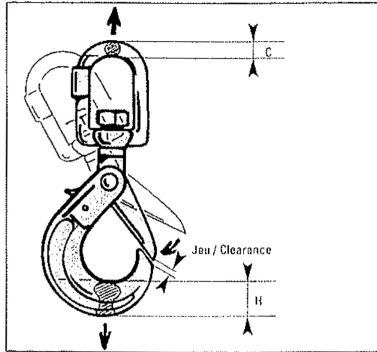
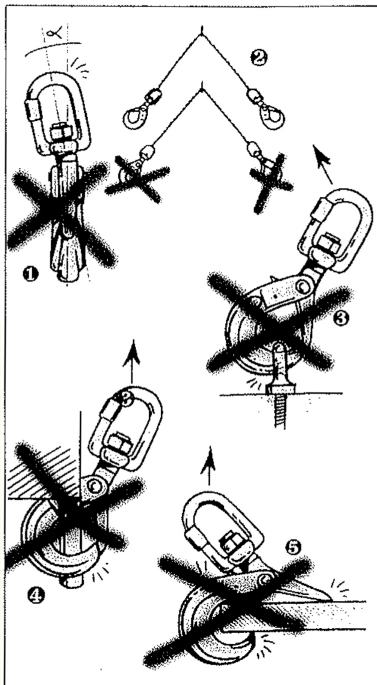
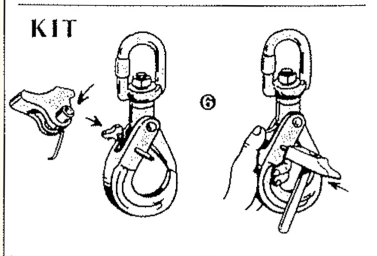
The hook found at the site of the accident had a residual opening of 7 to 8mm when locked. According to the manufacturer's documentation, the play must not exceed 3mm (see appendix 1).

Calibre crochet / Chain size (mm)	5/6	10	13	16	18/20
Marquage / Marking	CL0	CL2	CL3	CL4	CL5
Jeu maxi / Clearance maxi (mm)	3	3,5	3,5	4	5

• Inspecter la surface de contact, verrou sur linguet, si elle est matée, le verrou est à remplacer. Contactez votre distributeur SYSMA pour la fourniture d'un kit réparation verrou ⑥.

• Si le verrou est intact, le jeu provient de l'axe ou d'une déformation du crochet (usage abusif), le crochet est à rebuter.
